Job No. **2076** Survey Date **OCT 05**

Project Title  
**TUTBURY GLASSWORKS,  
STAFFORDSHIRE**

Subject  
**INTERPRETATION OF GPR  
ANOMALIES**

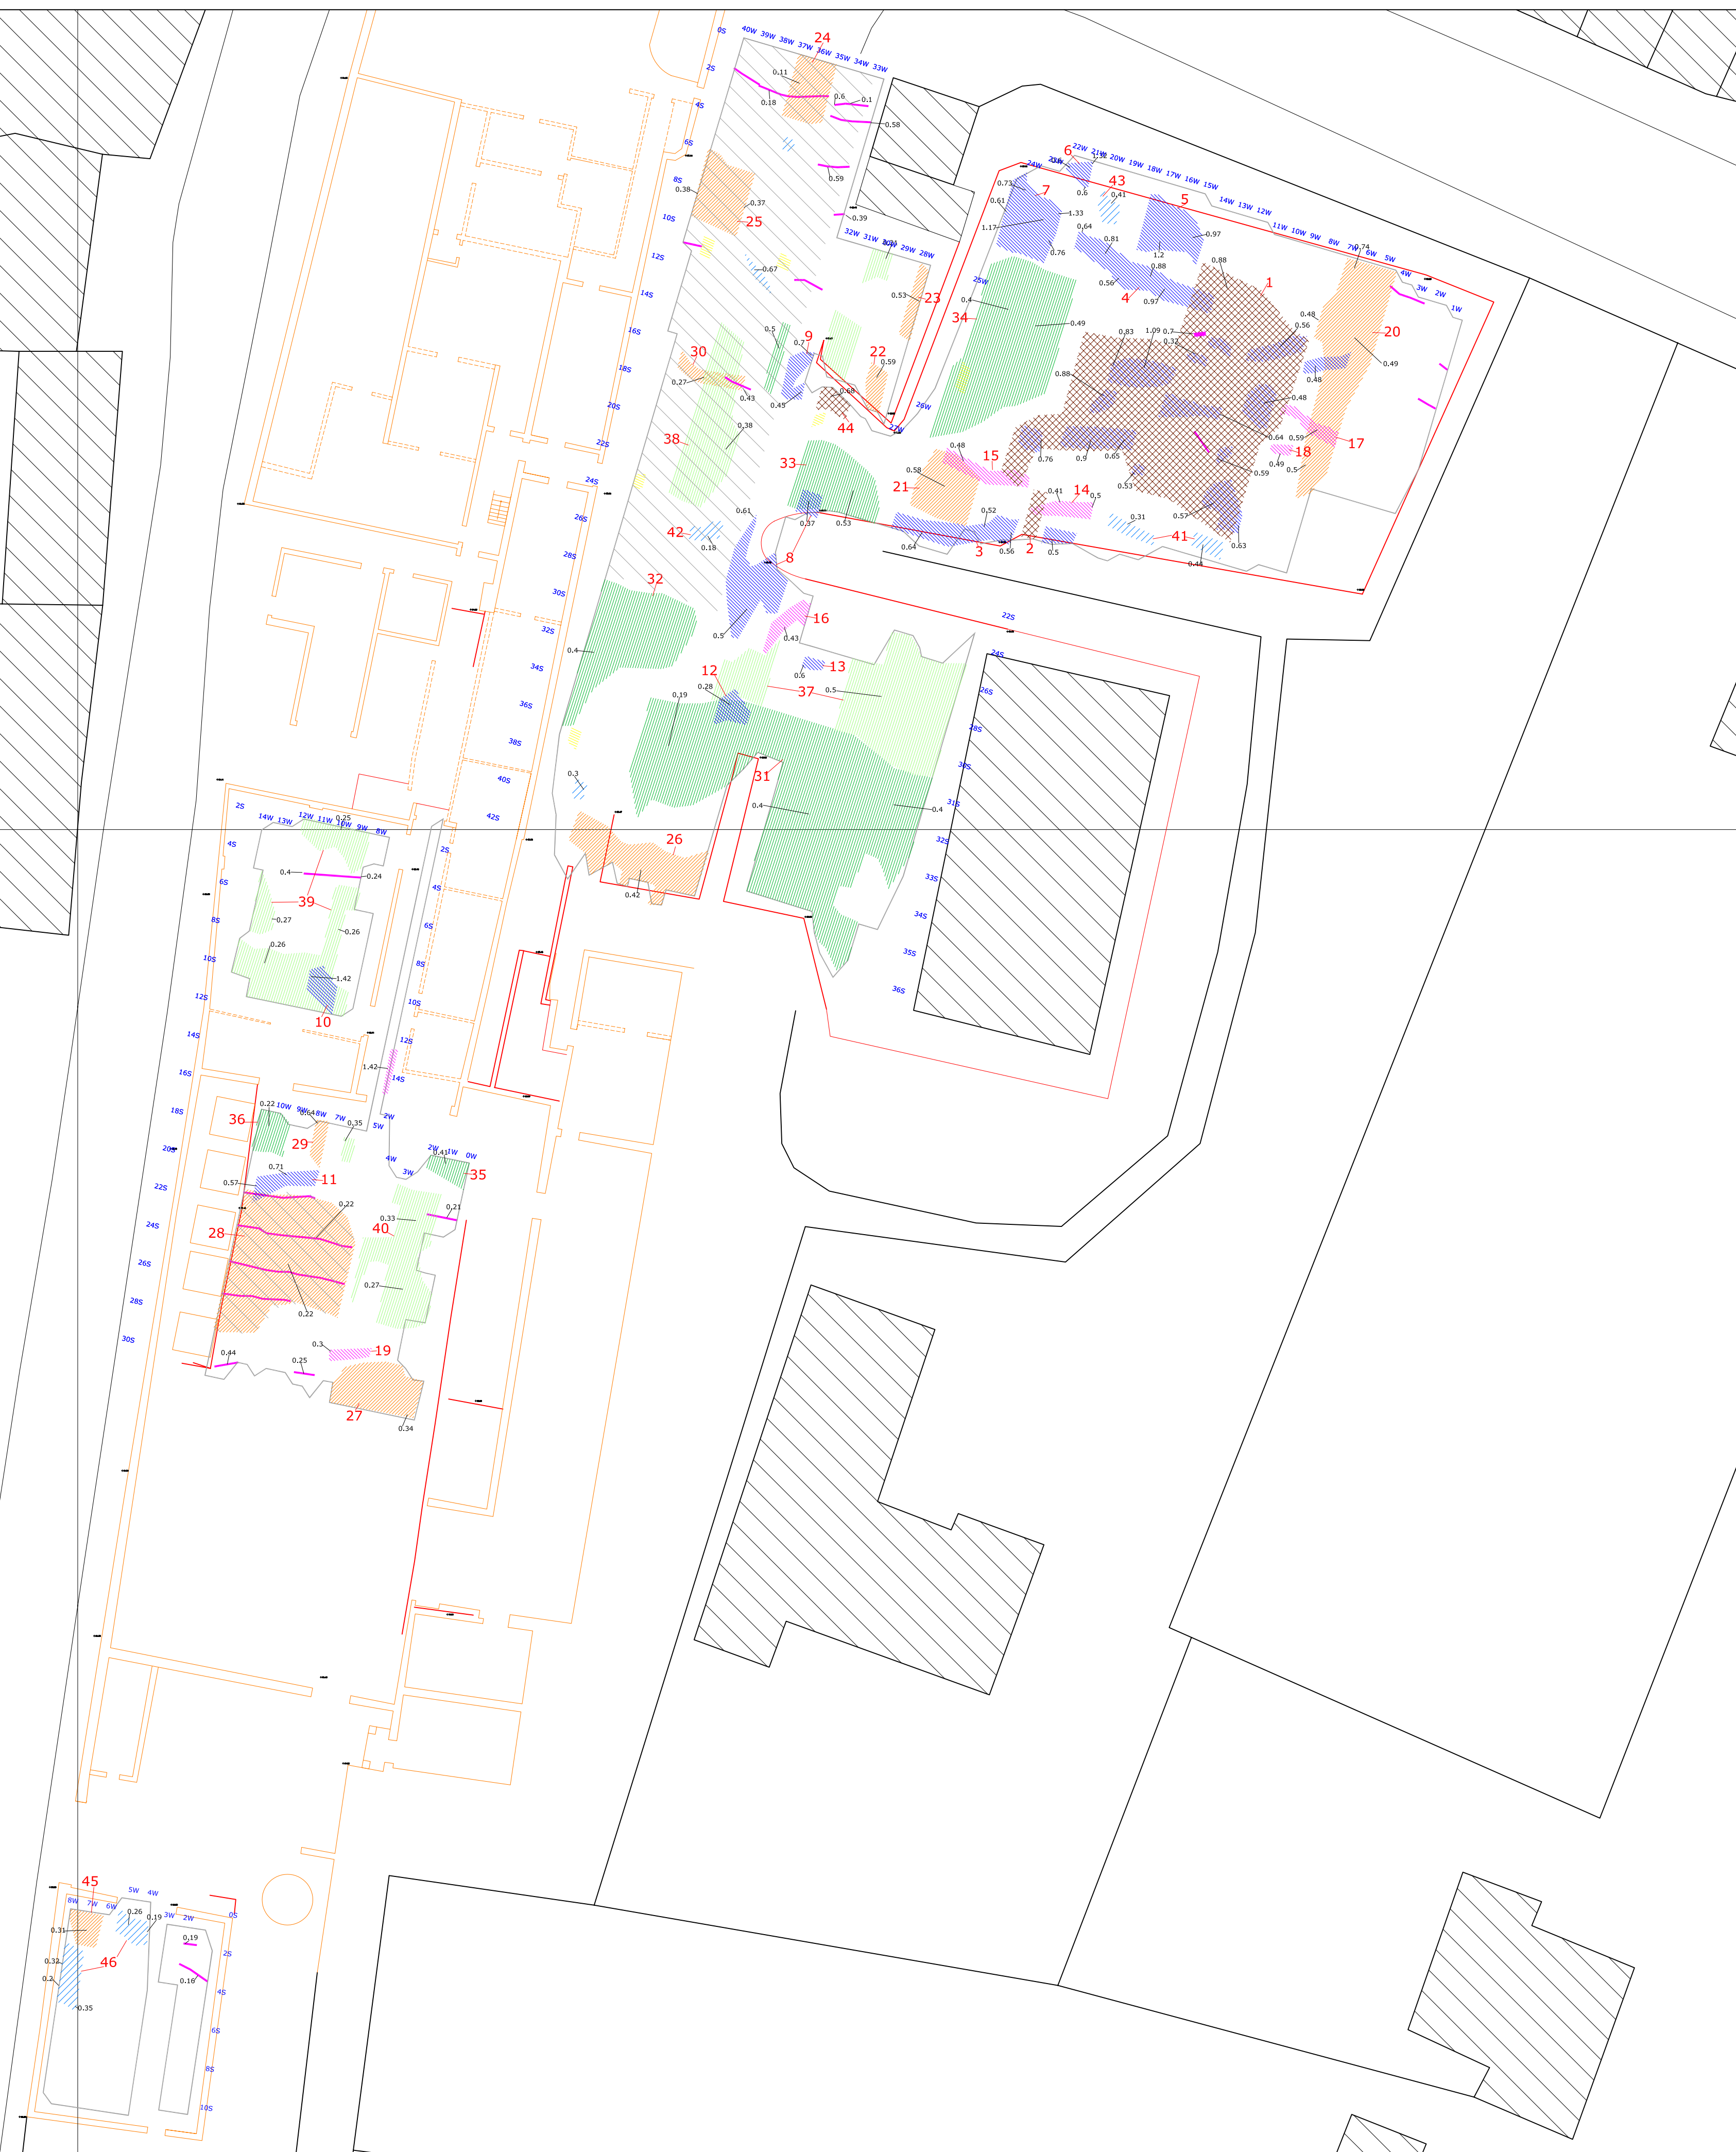
Plot <b>A1</b>	Checked by <b>PPB</b>	Issue No. <b>01</b>
Date <b>OCT 05</b>	Drawn by <b>HH</b>	Figure No. <b>12</b>

- Linear anomalies - possible services or structural supports
- Strong complex and discrete responses - possible structural remains or debris
- Weak complex and discrete responses - possible structural debris and areas of ground disturbance
- Discrete and complex responses - possible evidence of fragmented structural remains
- Broad crested anomalies - possible structural remains
- Strong planar and complex anomalies - may relate to a buried surface with interspersed structural remains
- Weak planar and complex anomalies - may relate to a buried surface with interspersed structural remains
- Weak discrete anomalies - possibly relating to structural remains
- Conductive surfaces caused by inspection cover and gullies
- Area of reinforced concrete

0,25 Approximate depth to top of anomaly
