EXETER ARCHAEOLOGY

Project Title	Job No.	2155
GEOPHYSICAL SURVEY - WATER SEWAGE TREATMENT NEAR EXETER AIRPORT		
Subject	ABSTRACTION AND INTERPRETATION OF GRADIOMETER ANOMALIES AREA 2

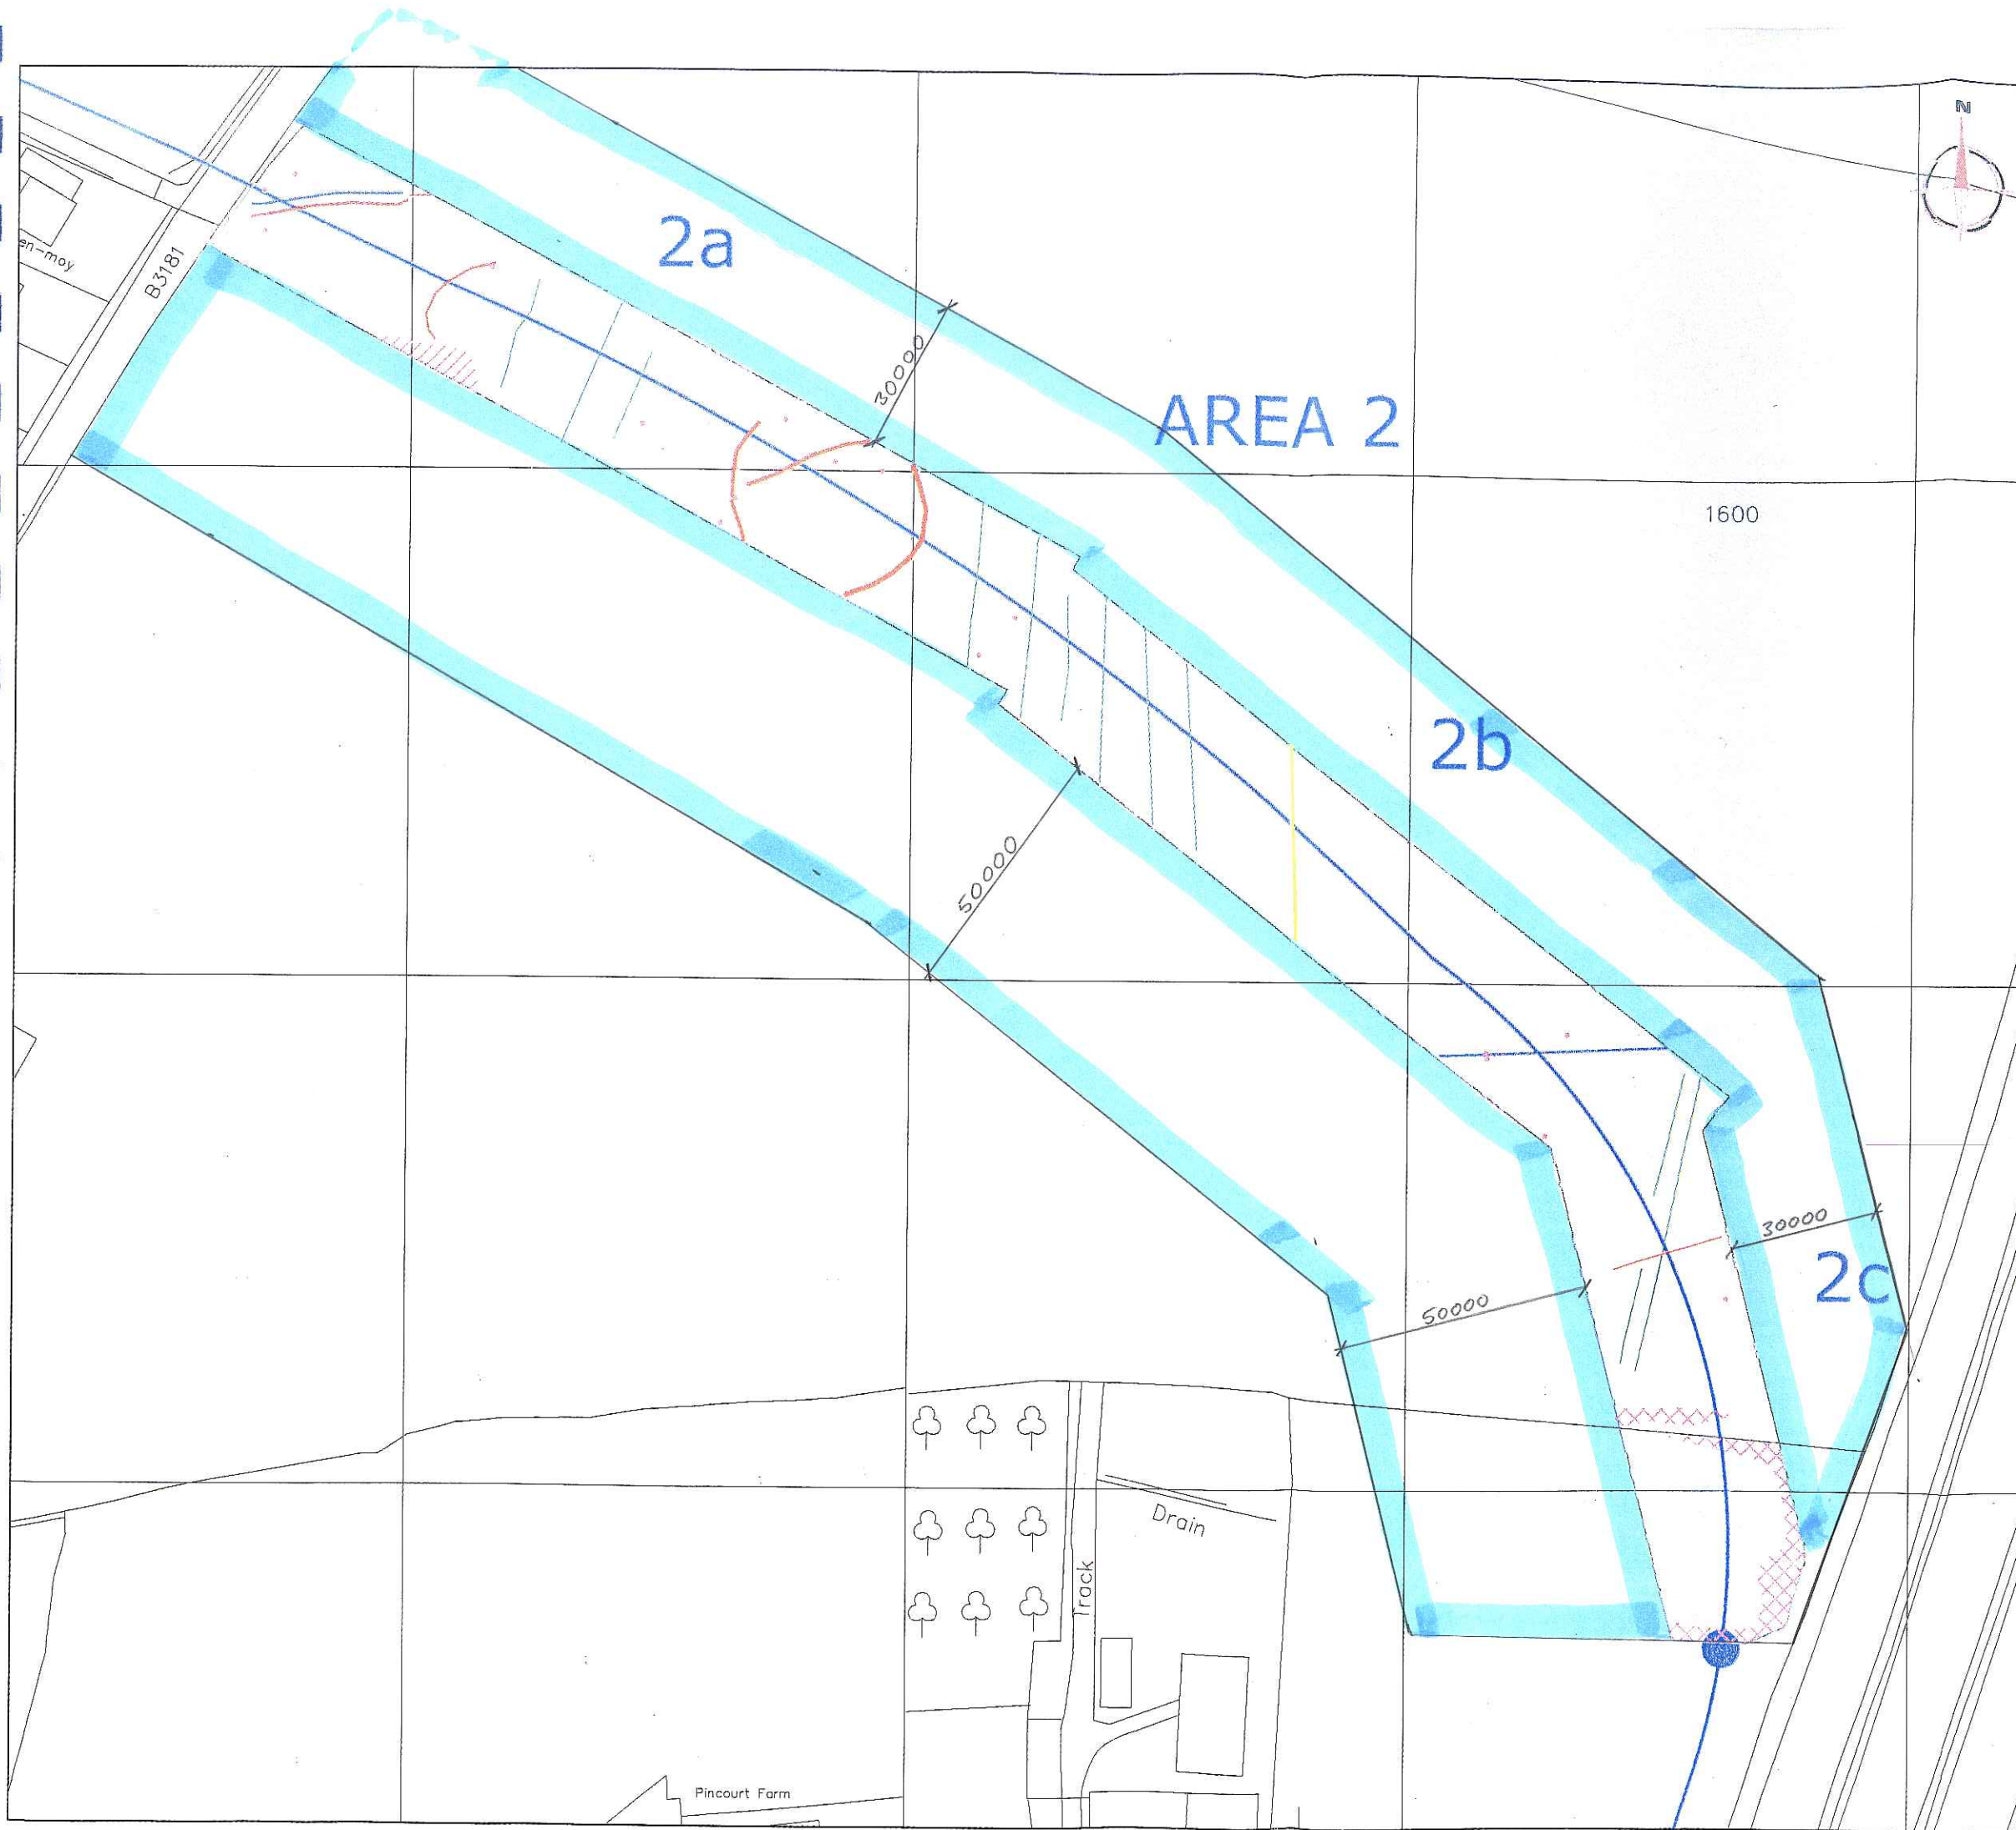
Plot	Checked by	Issue No.
A3	SAS	01
Survey date	Drawn by	Figure No.
JUNE 06	NG/HH	12

Discrete positive anomaly - possible pit

Positive anomaly with associated negative response - ferrous object

Magnetic disturbance - associated with pipe/cable

Positive linear anomaly - possibly relating to agricultural activity

Positive linear anomaly - cut feature of possible archaeological origin

Negative linear anomaly - possibly indicating a bank or previous earthwork

Area of magnetic debris - evidence of ground disturbance

Area of magnetic disturbance - associated with nearby field boundaries, roads or services
