**Lauder Primary School (Old School)** 2 Crofts Road, Lauder, Scottish Borders

**Archaeological Evaluation**

Report No. 2162

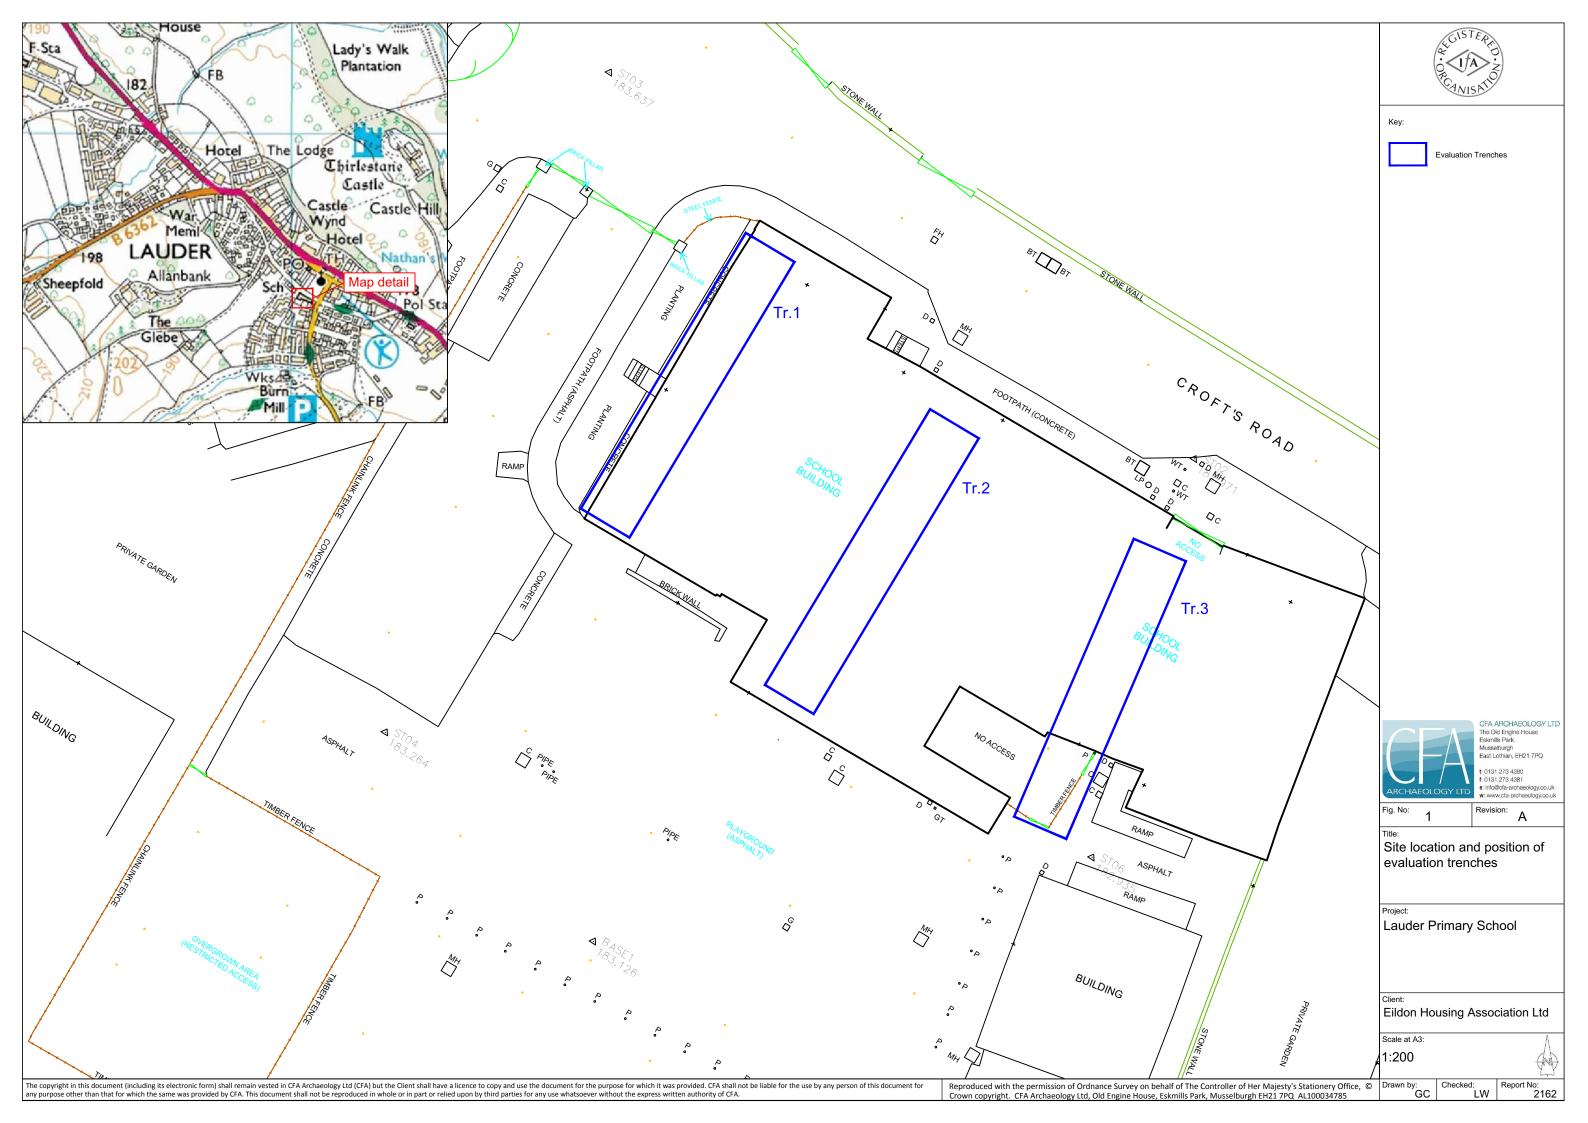
Three trenches were excavated during the evaluation (Fig. 1). The numbers in bold and parentheses refer to contexts (Appendix 1). No archaeological deposits or artefacts were found.

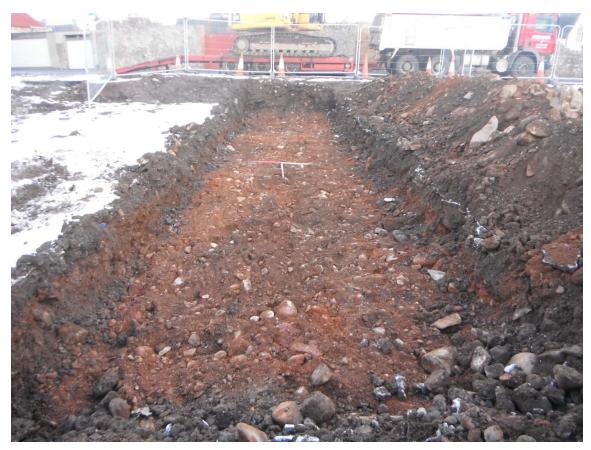
Fig.2 - Trench 1, looking north

Trench 1 was aligned north-south and measured 17 long, 3m wide and 0.55m deep (Fig. 2). The stratigraphy consisted of 0.5m of demolition rubble (001) directly overlying natural gravel (000).

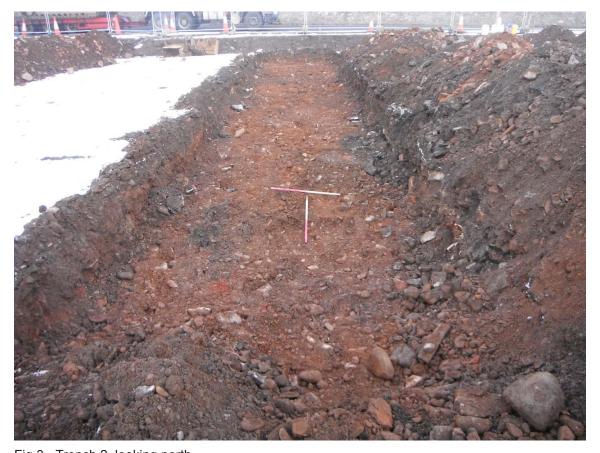
Fig.3 - Trench 2, looking north

Trench 2 was aligned north-south and measured 17 long, 3m wide and 0.6m deep (Fig. 3). The stratigraphy consisted of 0.6m of demolition rubble (**001**) directly overlying natural gravel (**000**).

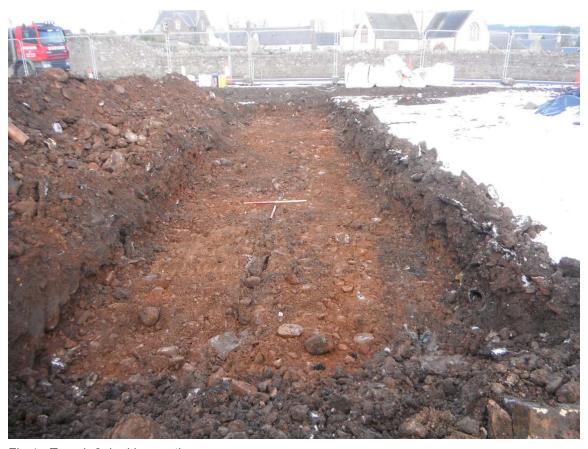
Fig.4 - Trench 3, looking north

Trench 3 was aligned north-south and measured 16 long, 3m wide and 0.5m deep (Fig. 4). The stratigraphy consisted of 0.4m of demolition rubble (001) directly overlying natural gravel (000).
