**A historic sea wall revealed;  
archaeological trial-trenching at the  
Proctor & Gamble London site,  
West Thurrock, Essex  
February 2013**

**commissioned by Huttons Construction Ltd  
on behalf of Proctor & Gamble London**

**CAT Report 683**  
February 2013

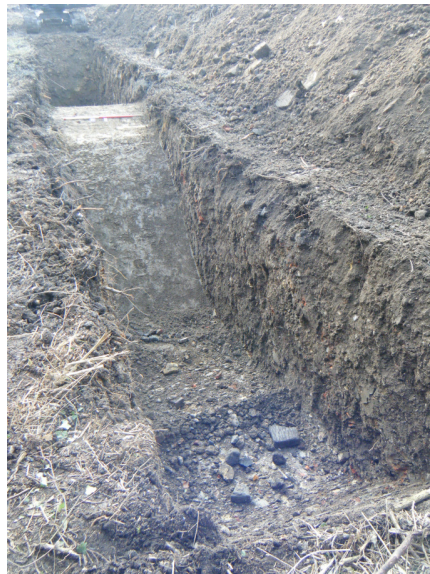
**Plate 1: The northern face of the clay bank, view south-west.**

The sea wall was a clay bank c 8m wide and 1.5m tall (F1). It was located in the position shown on both the 1867 and the 1896-1897 1:2500 OS maps (Fig 1). The bank was constructed from a medium grey alluvial clay with occasional stones, which was probably sourced locally. A thin layer of topsoil (L2; c 70mm thick) survived on the surface of the bank (Fig 2). It had been covered over using a dark grey/brown clayey-silt (L1) that contained a large amount of modern building materials such as slate, concrete and brick, as well as domestic and industrial waste (Fig 3). On the southern side of the clay bank, the alluvial clay began to level out at a depth of 1.8m below modern ground level (Fig 2). However, on the northern side of the clay bank, the modern made-ground (L1) continued below a depth of 1.9m (Fig 3), perhaps indicating that the alluvium used to construct the bank was excavated from this side of the sea wall.

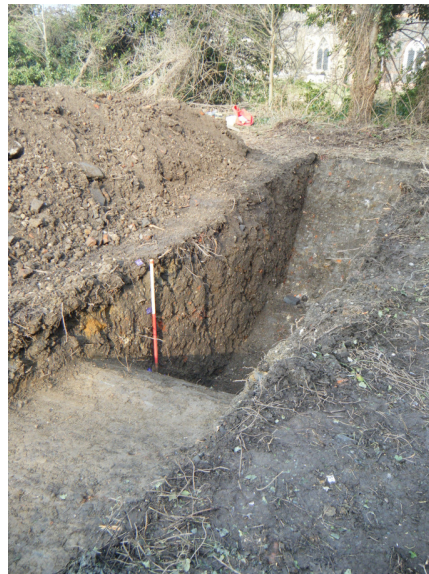
**Plate 2: The modern made-ground to the north of the clay bank, view north-west.**

It appears that the clay bank was left undisturbed when the land in this area was infilled. It is probable that the level of the land was raised to a sufficient height to just cover the bank.
