St Andrews Church  
Clewer  
Windsor  
Berkshire

**Archaeological  
Watching Brief Report**

**Document Type:** Watching Brief

**Installation of New Lighting,  
St Andrews Church,  
Windsor, Berkshire**

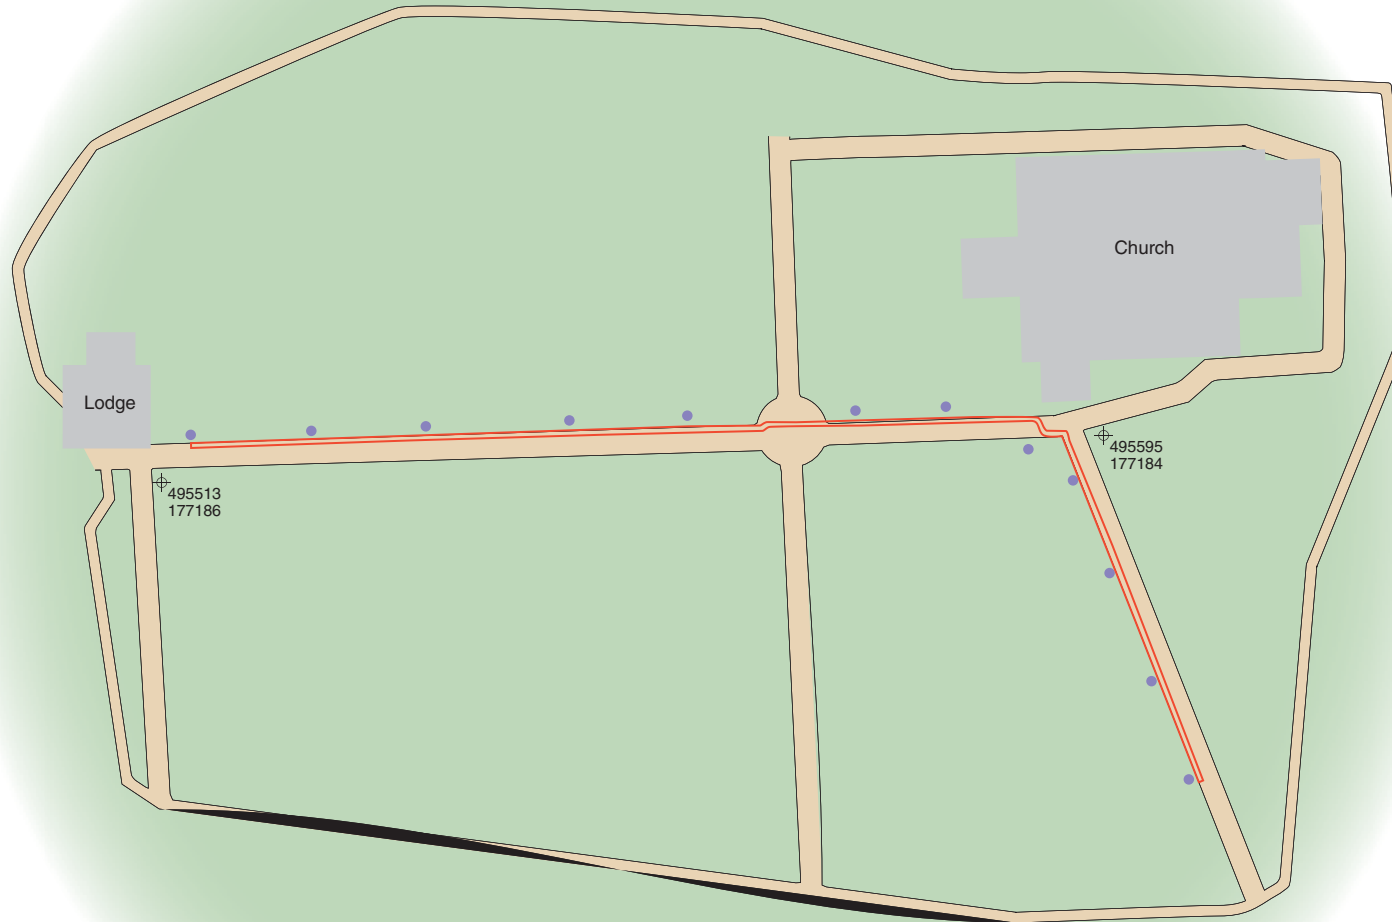
Figure 2: Site plan showing location of ducting trench and pits for lampposts

2.2.1 The watching brief monitored all areas of ground disturbance associated with 8 of the 12 pits for the proposed lampposts (PH1-8, Fig. 2), and intermittently monitored the excavation of the associated trench for the installation of ducting. The trench was excavated using a 0.75 tonne mechanical excavator and was approximately 0.4 - 0.5 m wide and 0.5 m deep. The pits were excavated with a mechanical auger and measured 0.35 m in diameter and 0.8 m deep.
