Building 81 Upper Heyford Airbase Oxfordshire

Historic Buildings Recording and Investigation

October 2009

Historic building recording

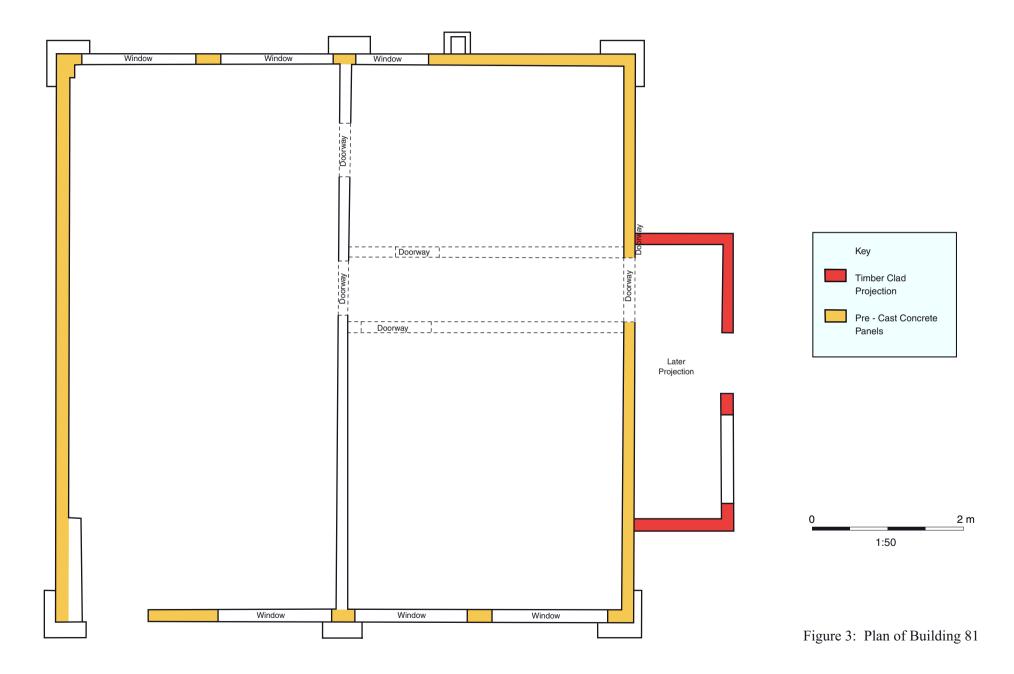
3.2.3 The internal layout has been only seen through the windows due to asbestos contamination inside so no accurate measured recording has been possible. It is divided into two halves by a partition wall, one of which remains clear whereas the other comprises a corridor and some other smaller premises.

- 3.4.2 The building is internally divided in two halves: east and west. The partition walls are likely to have been built with a material lighter and easier to remove than the concrete panels used for the external shell.

- 3.4.3 The eastern half is a clear space with a desk next to the door, in the north end. The west wall has two doorways; one joining this room with the corridor that leads to the doorway in the west façade and the other one to access the probable WC.

- 3.4.4 The western half of the building has at least two rooms and a corridor. The corridor is off centre (slightly to the south) and runs from the doorway in the west façade to the clear room in the east half. The north room is the largest in this half of the building and the doorway is in its southern wall's eastern end. To the north of the corridor there is at least one room which is likely to be a WC although it can not be confirmed because the doors remain closed and the windows are translucent. There is another door to the east end of the corridor's southern wall which also remains closed but looks like a cupboard.

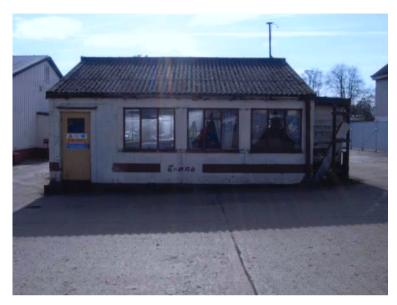
Plate 1: Building 81 North Elevation

- 3.3.1 The north façade has two windows in the west half and another window and a doorway in the east half. Each window has three tall rectangular panes; those at either end being casements. The doorway is the easternmost opening and it is accessible by means of a step due to the ground sloping towards the east.

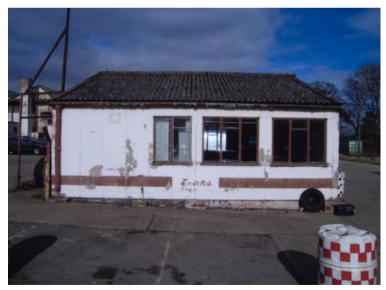
Plate 3: Building 81 South Elevation

- 3.3.3 The south façade has two windows in the east half matching those in the north façade. It also has one smaller window in the east end of the west half which has only two tall rectangular, translucent (rather than transparent) panes and only one casement. The rest of the wall is made of the same concrete panels seen elsewhere. Under the window with translucent panes there is a pipe coming out from the wall suggesting that the room inside is likely to be a WC.

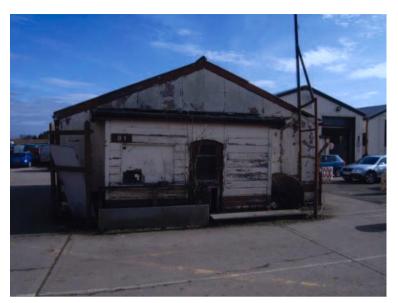
Plate 2: Building 81 West Elevation

- 3.3.2 The west façade has a doorway slightly to the south of the mid-point and has no windows (Plate 3). A small timber-clad lobby projection (3.45 x 1.3m) overlies the doorway. The upper half of the lobby's door has a square pane with a horizontal casement window on it; the lower half has vertical boards. To the north of this door there is a window currently boarded. This structure is covered by a flat roof with waterproof mesh.

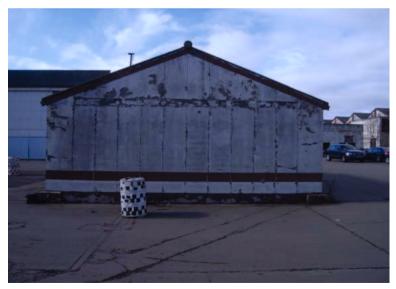
Plate 4: Building 81 East Elevation

- 3.3.4 The east façade is a solid concrete vertical panels with neither doorways no windows. It does not have any other feature.

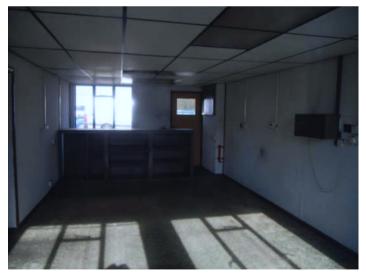
Plate 8: Building 81 General Interior View

- 3.4.1 Due to the presence of asbestos access inside the building was restricted. However, some notes and photographs could be taken through windows. It has also been possible to sketch the internal layout of the building.
