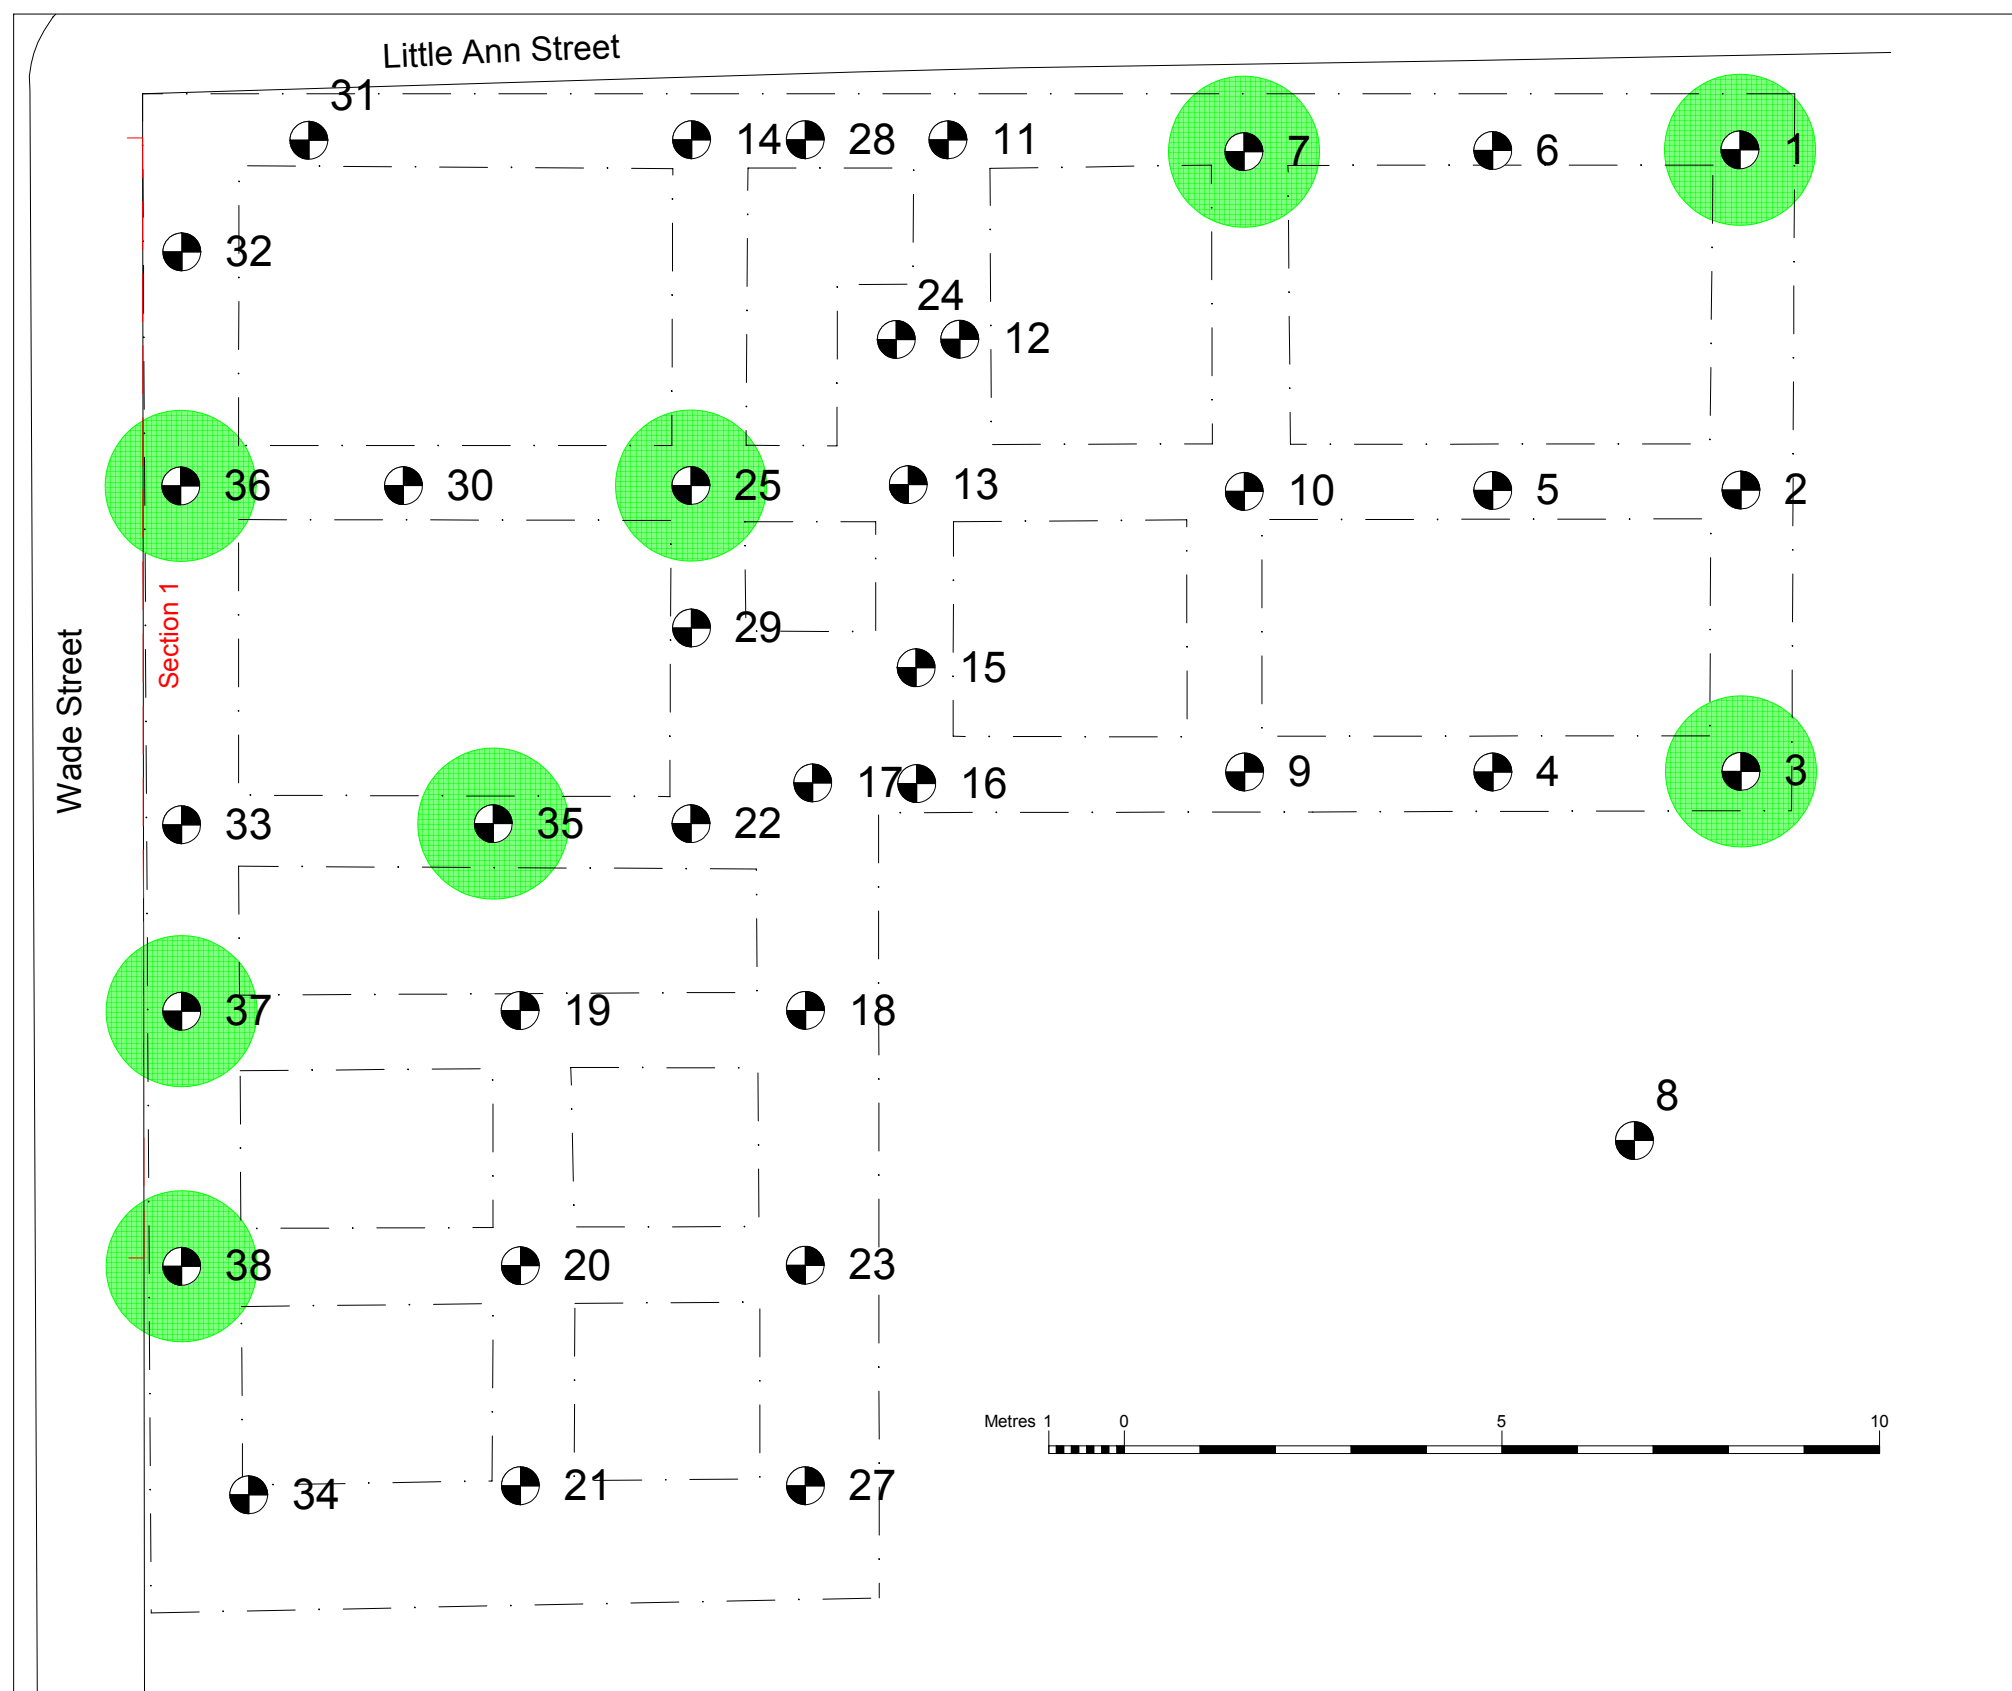
Figure 4

Location Plan of Boreholes superimposed over foundation trench plan
Presence of suspected Greensand layer indicated in green
