CS Archaeology

29 Northlands, Lutterworth Drive, Doncaster: App. No. 0902604/FULFT

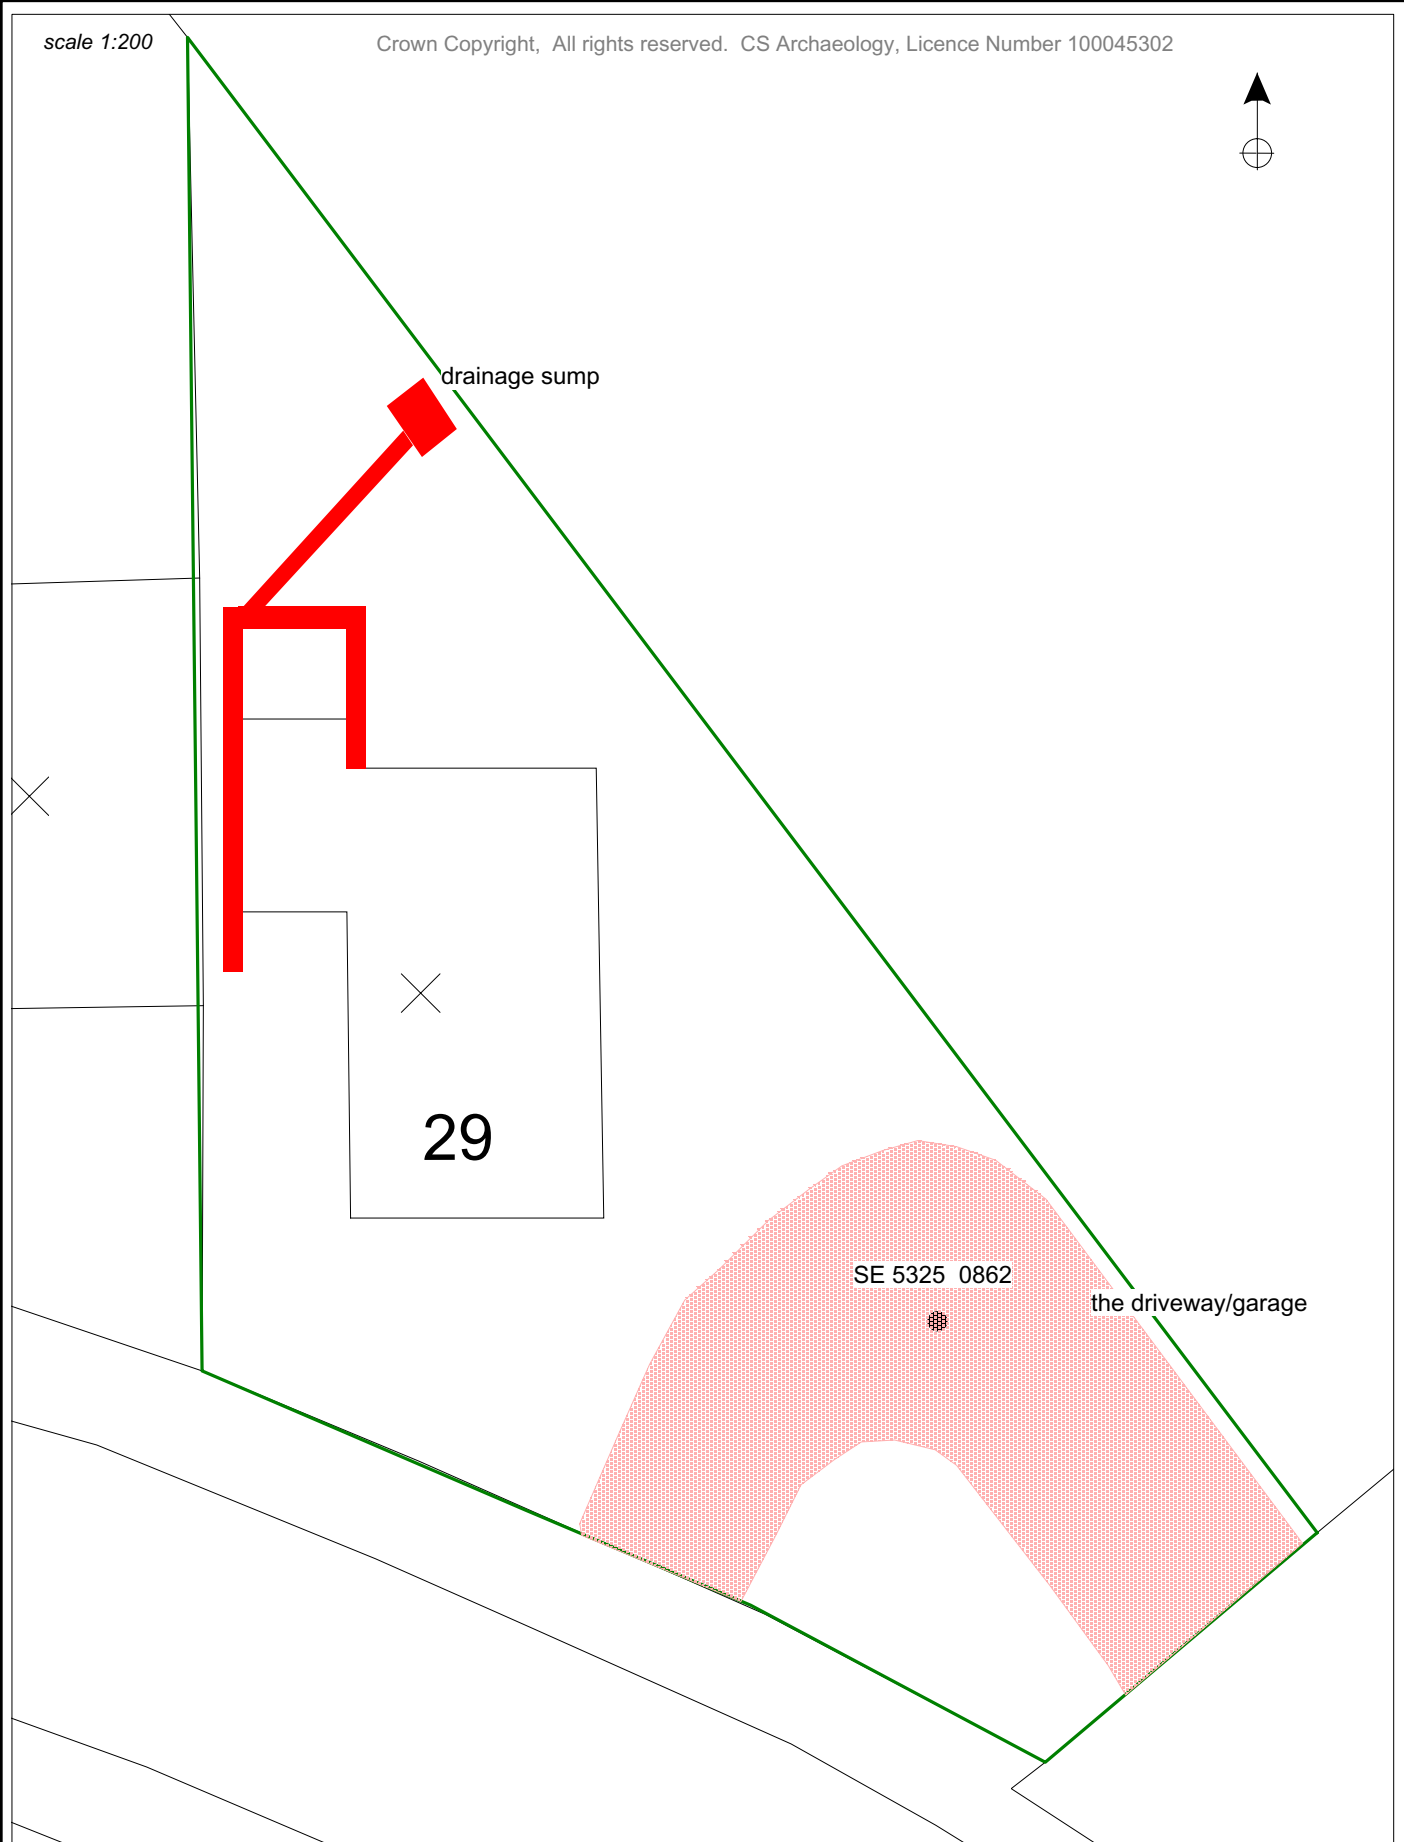
The Site - 29 Northlands (0.06161 Ha)

Just to conclude matters, I attended the site intermittently over three days (3-4/11/2010 and 22/6/2011) until the full extent of the excavations were revealed. The site was divided into two sections ([Figure 1](#)). The first section consisted of the new garage/driveway and the second the strip foundations for a house extension. Any potential impacts to the archaeology from the garage/driveway were negligible, since only the top soil was truncated, and no archaeological features were visible. The removed soils consisted of between 0.1 and 0.2m of brown silty loam with frequent limestone fragments.

The strip foundations did truncate deeper stratigraphy and extended down to the natural limestone bedrock. The stratigraphy was characterised at the drainage sump ([Figure 1](#)) and consisted of 0.5m of topsoil (mid brown sandy silt) and 0.1m of subsoil (reddish brown sandy silt) above natural limestone bedrock. No archaeological features or artefacts were recovered.

shallow impact area (0.01362 Ha)

deep impact area
