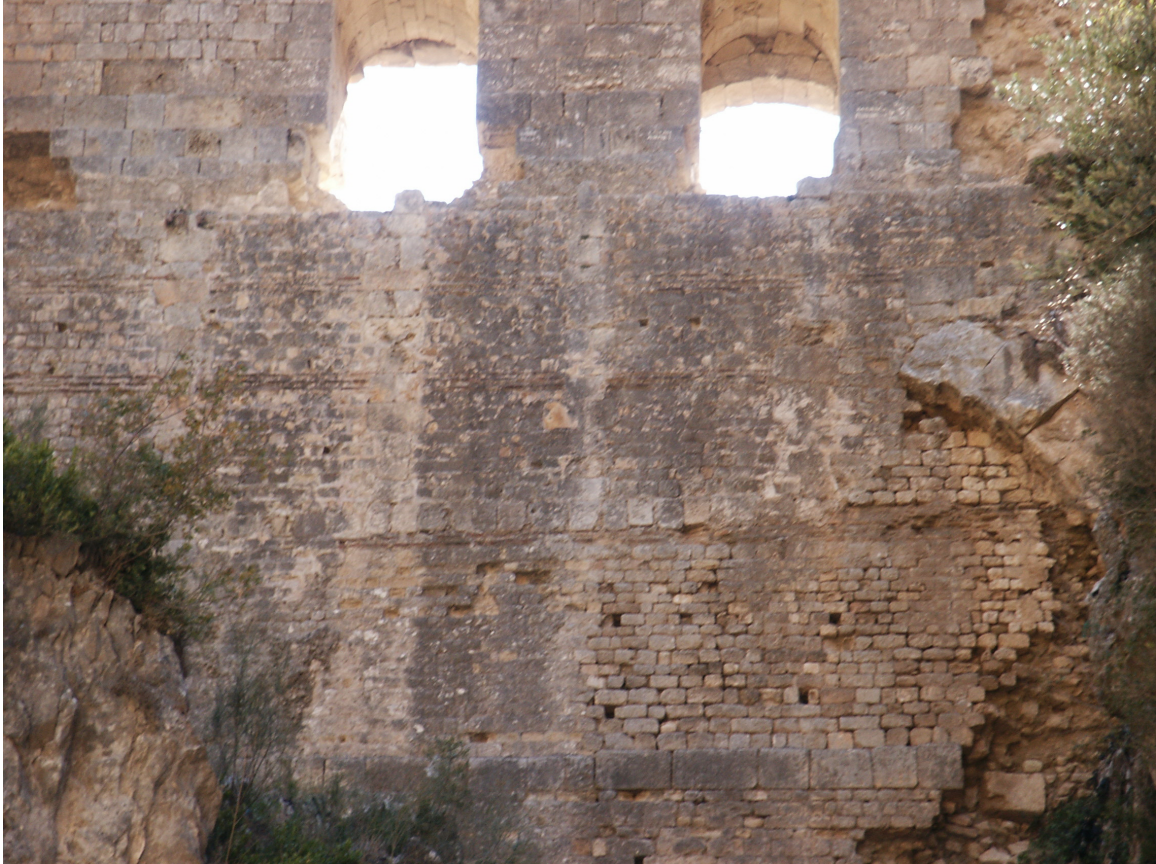
Fig. 4.8: Detail of the 'Iron Gates' dam, Antioch showing the brick courses [photo: author].

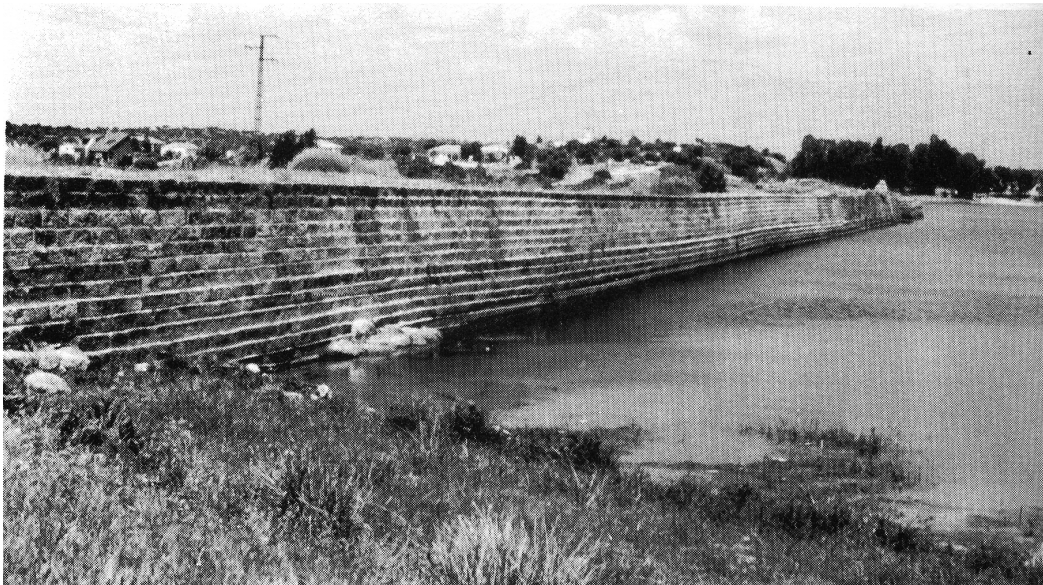
Fig. 4.9: Stepped dam at Proserpina, serving the city of Mérida, Spain [Hodge 1992, fig. 41].
