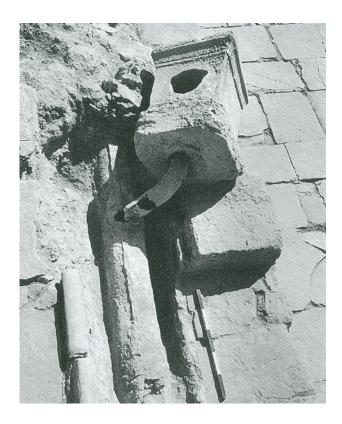
Fig. 8.21: Lead pipe network feeding fountain at the edge of the pool in Area D [Hirschfeld 1997, fig. 45].

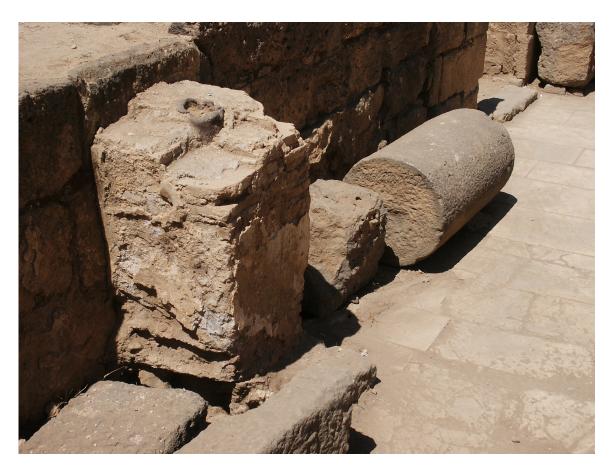
Fig. 8.22: Lead pipe in fountain base (possibly a reused altar or statue base), Bosra [photo: author].

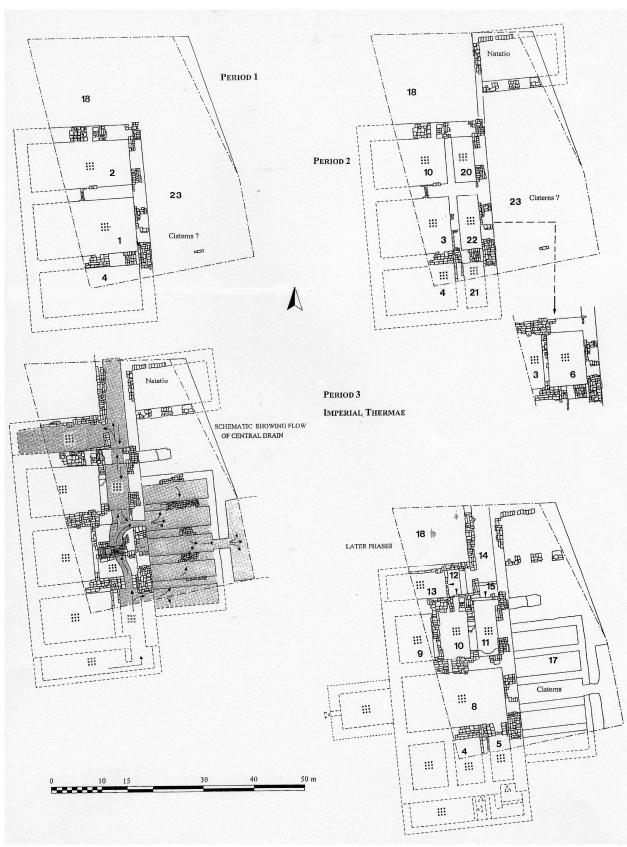
Fig. 8.27: Successive building phases in the Beirut bathhouse [Thorpe 1998-9, fig. 13].
