Penistone Road, Sheffield, South Yorkshire

Archaeological Desk-based Assessment

ARCUS report 1278.1(2) April 2009

Client: St. Modwen

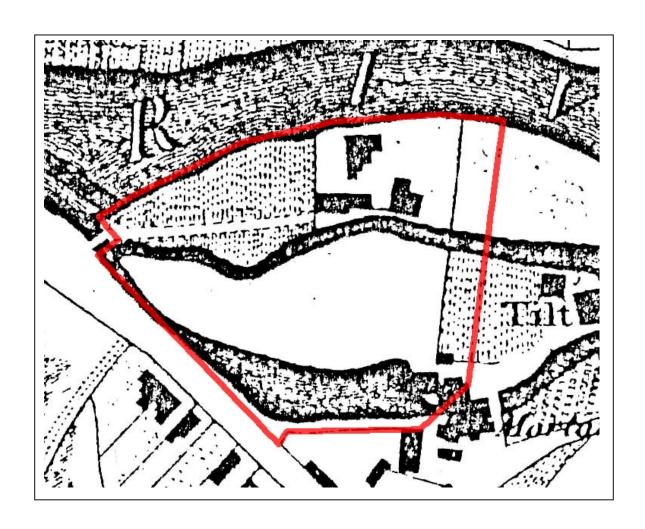
Project:	Scale:	Date:
	Penistone Road, Sheffield	-	April 2009
		NGR:	Drawn:
ARCUS	Title:	SK 345 388	M. Stenton
Unit 6, Riverside Block Sheaf Bank Business Park Prospect Road	1808 Fairbank map	Project No:	Illustration No:
Sheffield S2 3EN Tel: 0114 2225106 Fax: 0114 2224346		1278	3

William Fairbank III produced a map of Sheffield in 1808 (Illustration 3). This showed the whole of the Morton Wheels site and the locations of features such as the wheels, dam, goits, bridge and outbuildings that had been roughly sketched the previous year were depicted with greater clarity on the 1808 map. Several features were shown for the first time on this map, including areas of land under cultivation on the north-east side of the dam and in the westernmost plot to the north of the goit. The footbridge at the south-west corner of the site was shown leading to a path or track that ran east through the cultivated area to the plot containing the three large, detached buildings.

The 1808 map marked a 'tilt' at the Lower Morton Wheel to the north-east of the proposed development area, suggesting that the goit was powering a forge that had been constructed in that location. It is not clear if an 1810 record of a 'new tilt' at the site referred to this feature or if a further tilt had been constructed elsewhere within the site by that date.

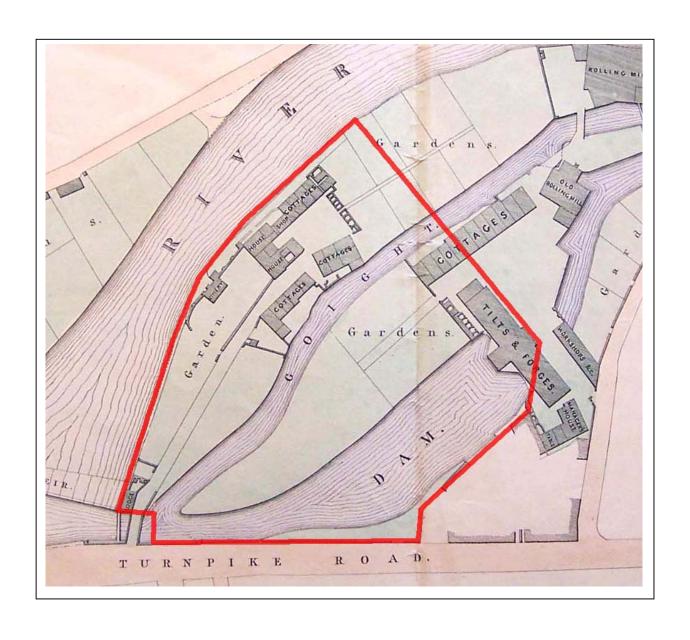
Butchers, a long-established Sheffield steel company, conducted a substantial redevelopment of the site. These changes were shown on William Flockton's 1845 plan (**Illustration 4**). Flocktons were a firm of Sheffield architects and are likely to have designed the new buildings within the site. The 1845 plan suggested that the Morton Wheels had been demolished and replaced by the new Philadelphia Works. The latter were shown as a sub-rectangular building marked 'tilts and forges', which occupied the southern parts of the former Morton Wheels site but which ran further to the north-west and south-east.

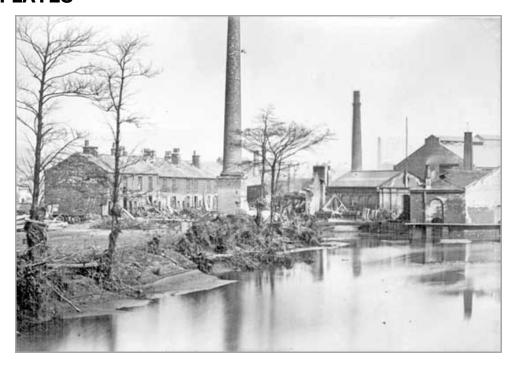
Plate 1 – Looking north-east towards mill dam, cottages, works chimney and part of Philadelphia Steel Works, following 1864 Sheffield Flood (Picture Sheffield y00945).

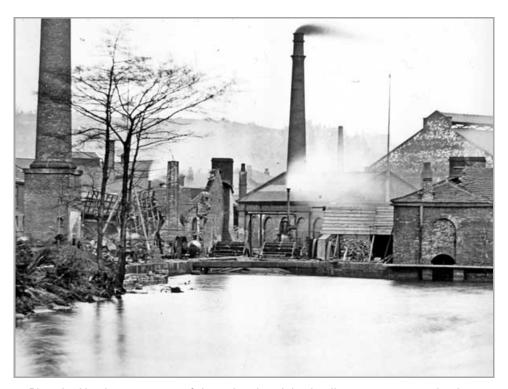
Plate 2 – North-east corner of dam, showing sluice leading to two water wheels at centre. Remains of gable wall to left of wheels suggests wheelhouse destroyed during flood. North Wheel of post-medieval Morton Wheels located formerly in area of small building at right (Picture Sheffield w00450).

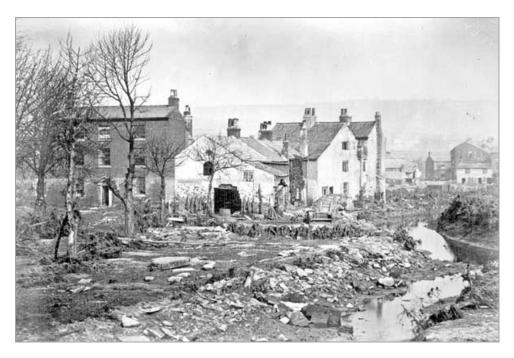
Plate 3 – Domestic housing to north of goit (shown bottom right), following 1864 Sheffield Flood. Large house at left named 'The Grove' on 1854 OS map (Picture Sheffield y00943).

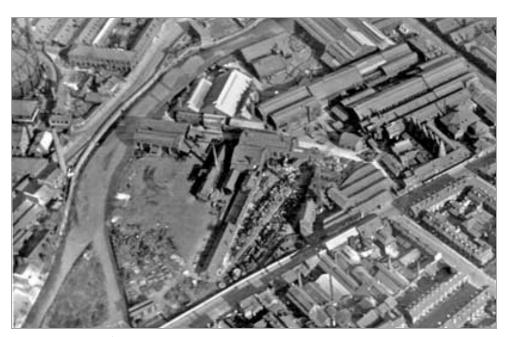
Plate 4 – Mid-20th-century aerial photograph of site during final phase of Philadelphia Works. River Don at left, with former dam site in area of rubble at centre-right (Picture Sheffield s12360).

Subsequent mid-20th-century aerial photographs showed the modern development of the site, with various buildings replacing the 19th-century industrial units to the north of the Penistone Road frontage (Picture Sheffield s22114). Several of these structures were themselves replaced during the later 20th century, although the 1981 Ordnance Survey map (**Illustration 8**) suggested that the majority of the site's standing buildings had been constructed by that date.

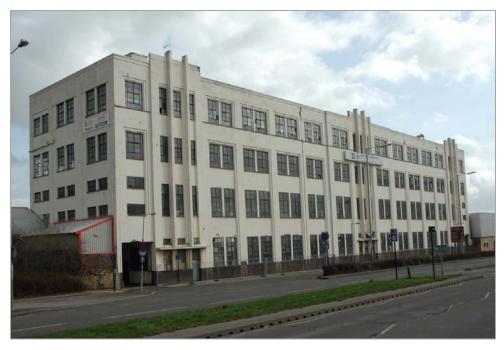
Plate 5 – Osborn Mushet Tools, Art Deco structure probably built during the 1940s, on site of Morton Wheels dam. Looking north-east from Penistone Road.

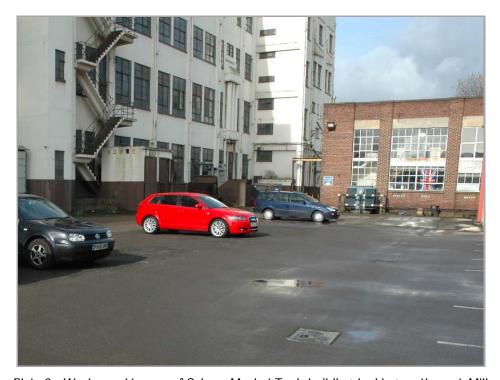
Plate 6 – Works yard to rear of Osborn Mushet Tools building, looking south-west. Mill dam located formerly in area occupied by Osborn building and yard, with goit running north-east through site of single-storey building at centre-right.

Large parts of the site are occupied by access roads and works yards (**Plates 6** to **10**), which are typically surfaced in tarmac or concrete. A triangular area of scrub and trees is present at the north of the site (**Plates 11** and **12**). No obvious evidence of pre-20th-century standing structures or potential sub-surface archaeological deposits were observed during the site visit.

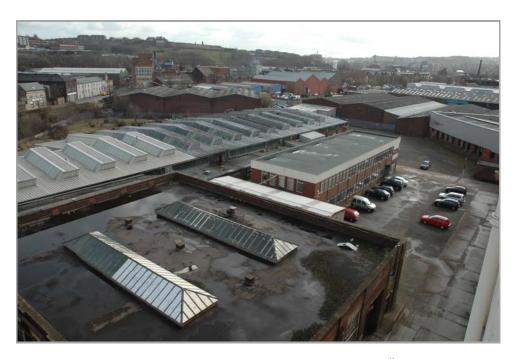
Plate 7 - Looking north-east from roof of Osborn Mushet Tools. 16th-century Morton Wheels and 19th-century Philadelphia Works stood in area at centre-right, with mill dam in yard at lower right. Buildings at left occupy site of goit.

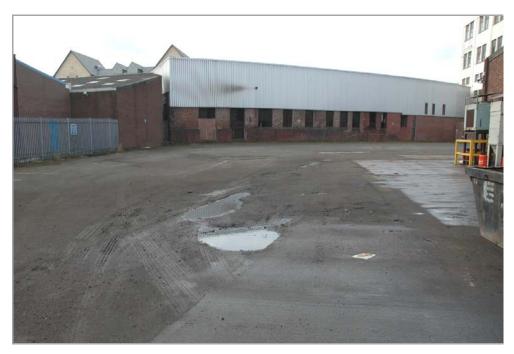
Plate 8 - Yard at east of site. Mill dam wall and tail goit located formerly in area towards centre of shot. Morton Wheels located formerly in upper part of yard, with Philadelphia Works situated in foreground.

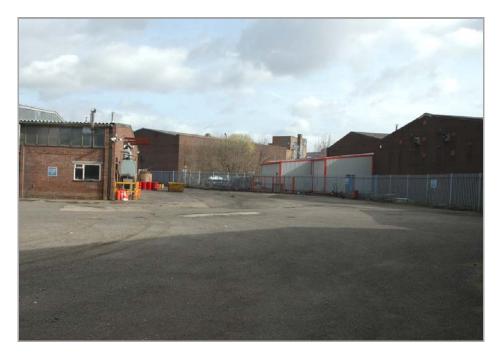
Plate 9 - Yard at east of site. Dam located from left to centre of yard, with sites of Morton Wheels and Philadelphia Works at right of yard. Site of large chimney in Plates 1 and 2 located within footprint of building at centre-left.

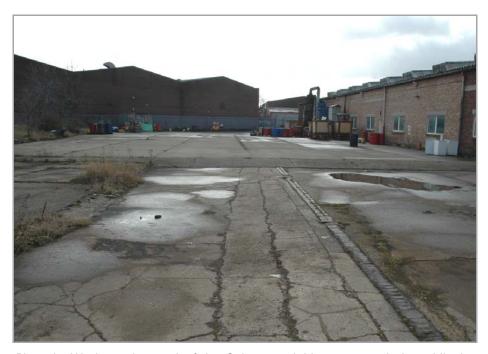
Plate 10 – Works yard at north of site. Goit crossed this area on 1759 plan, while the white buildings shown in Plate 3 occupied the foreground from the late 18th century.

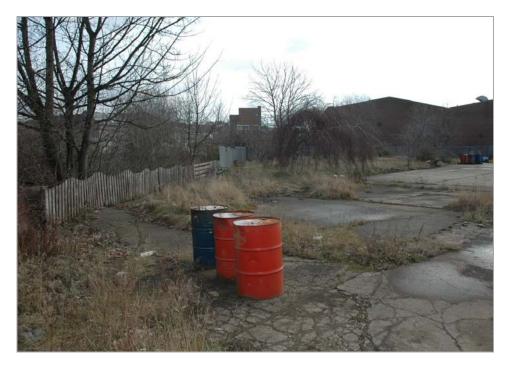
Plate 11 – Area of scrub at north of site. Cottages and gardens shown in this area in 1845.

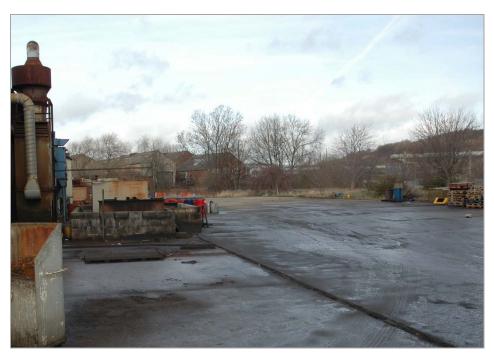
Plate 12 – North of site, looking west towards site of Garden House, shop and cottages shown on 1845 map. Goit and cottages occupied area at lower and centre-right of shot.
