SITE	1 Hillcrest, Holtby, York						
CLIENT NAME	Mr. G. Millington						
YAT PROJECT#	5862 <b>YAT REPORT #</b> 2015/20						
MUSEUM ACCESSION #	NA	GRID REFERENCE	SE 67443 54116				
PLANNING REFERENCE #	15/00761/FUL <b>AAI OPS NOTICE #</b> NA

A watching brief was undertaken at 1 Hillcrest, Holtby, York, by York Archaeological Trust on 5/8/2015, to observe the excavation of foundation trenches for a house extension.

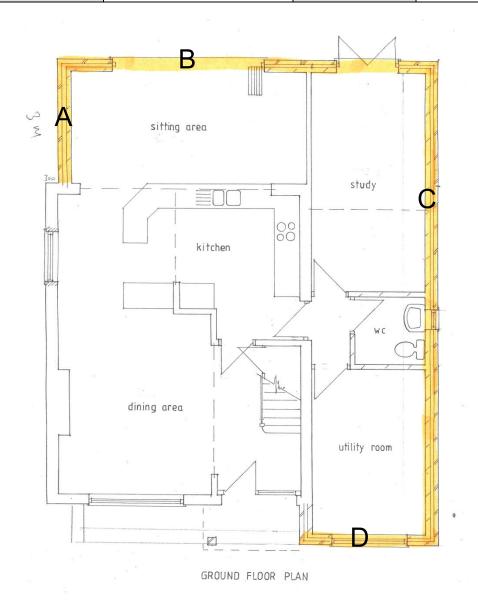
Figure 2 The observed area (highlighted in yellow). Not to scale. Developer supplied plan

The trenches were excavated in the following order (locations indicated on Figure 2)

- A) a 3m long trench on a north-west/south-east alignment forming the north-western side of the proposed study
- B) a 9m long trench on a north-east to south-west alignment, parallel to and 3m south-east of the rear wall of the present house
- C) a 12m long trench on a north-west/south-east alignment parallel to and 3m south-west of the south-western wall of the present house
- D) a 3.3, long trench on a north-east/south-west alignment forming the front wall of the proposed utility room

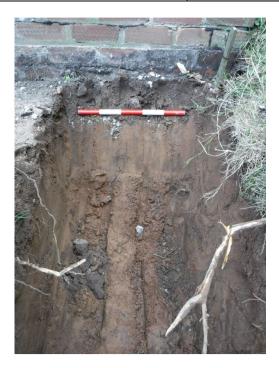
Plate 1 Trench A facing north-west, showing Contexts 1007-8. Scale unit 0.1m

The earliest deposit seen in all of the trenches was light orange brown sandy clay (Context 1008) with very occasional small angular stones up to 0.05m in size. This deposit subtly changed over the observed area, having a higher clay content at the front of the house, and being sandier at the rear. The upper surface of the natural was at 0.5-0.7m below the present ground level.

The natural was sealed by a deposit of light orange-brown to mid-brown sandy clay (Context 1007) up to 0.5m thick. There were no artefacts within this, and it was either glacial in origin, or could represent a post-glacial build-up of soil. It was clearly not the result of human occupation.

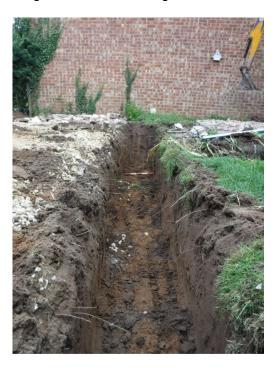
Plate 2 Trench B facing south-west showing Contexts 1000 and 1007-8. Scale unit 0.1m.

In trenches A and B the uppermost deposit seen was turf and topsoil 0.15m thick (Context 1000). In Trench C the upper surface was a gravel path above a membrane (Context 1001). In trench D the uppermost deposit was garden-soil (Context 1002).

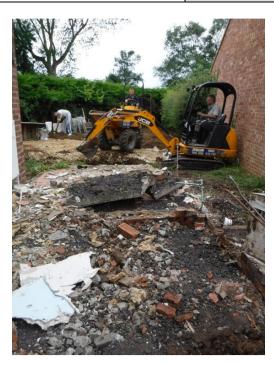
Plate 3 The area of the former garage and concrete slab of the former utility room to the south-west of the present house

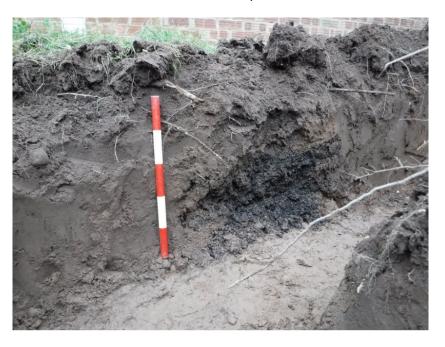
Plate 4. Context 1006 facing south-west. Scale unit 0.1m

In Trench C (the area of the proposed study and utility room) Context 1007 was truncated and disturbed by modern features relating to the present house. There was a deposit of clinker (Context 1006) the upper surface of which was 0.45m below ground level, and this was located 0.69m northwest of the southern end of the trench. This was clearly part of a modern construction cut backfill which had just been clipped in the south-western side of the foundation trench.

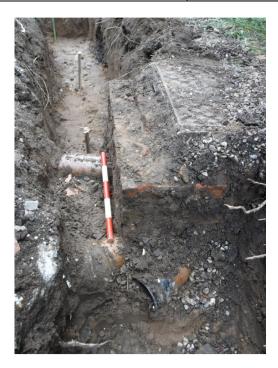
Plate 5 Manhole 1006 facing south-east. Scale unit 0.1m

A brick manhole (Context 1005) 0.83m long and 0.6m deep was located 3m north-west of the southern end of Trench C. Three pipes led into this manhole, two of which were still connected to the present house, but one of which was not. A length of unattached ceramic pipe was removed by the machine close to the man hole. Just to the north of the manhole there was a connection box for a gas supply pipe. The associated yellow plastic pipe (Context 1004) was very shallow being between 0.2-0.4m below ground level. This pipe was moved out of the way to enable excavation of the foundation trench to continue. The brick and concrete footings of the former garage (Context 1003) were partially removed at the northern end of Trench C.

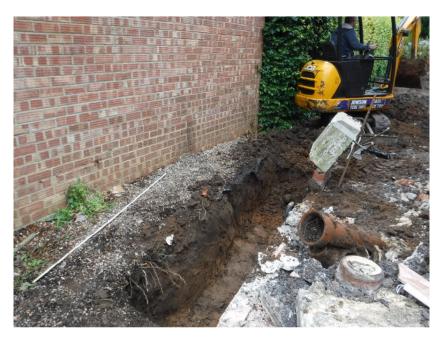
Plate 6. Trench C facing north-west, showing the gas connection box and Context 1001.

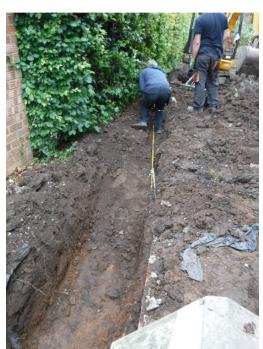
Plate 7 Careful exposure of the gas connection pipe facing north-west

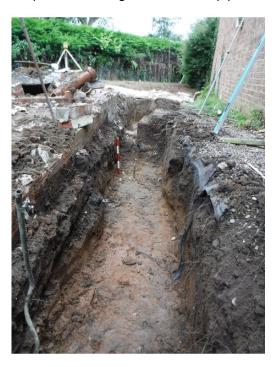
Plate 8 Trench C facing south-east shoeing Context 1003 along the left side of the trench. Scale unit 0.2m

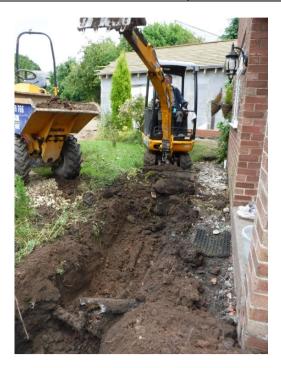
Plate 9 Excavation of Trench D facing north-east.
