YORK ARCHAEOLOGICAL TRUST REPORT

SITE	4 Mount Terrace WB		
CLIENT NAME	DC Architecture		
YAT PROJECT #	5976	YAT REPORT #	2017/53
MUSEUM ACCESSION #	N/A	GRID REFERENCE	SE 5928 5120
PLANNING REFERENCE #	16/02441/FUL	AAI OPS NOTICE #	N/A

Between the 27th March and the 4th May 2017 a watching brief took place during the excavation of a trench for new steps, underpinning, and the diversion of water mains in the rear yard of 4 Mount Terrace, York. (Figure 1).

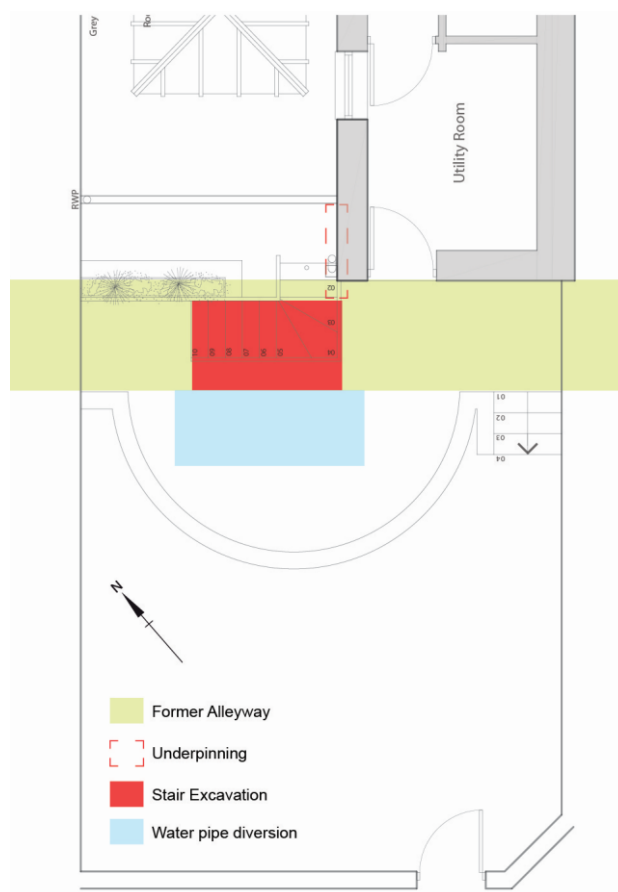
Figure 2 Works Location 1:100
(after drawing 16/02441/FUL 1591-110-A1)

The initial methodology was relatively simple, being based on the excavation of an area to enlarge a staircase from the basement level into the garden. However, this was complicated by the requirement for underpinning of the utility room and diversion of the mains water pipe servicing this, and other, properties. All excavation was undertaken using hand tools. See Figure 2 for works location.

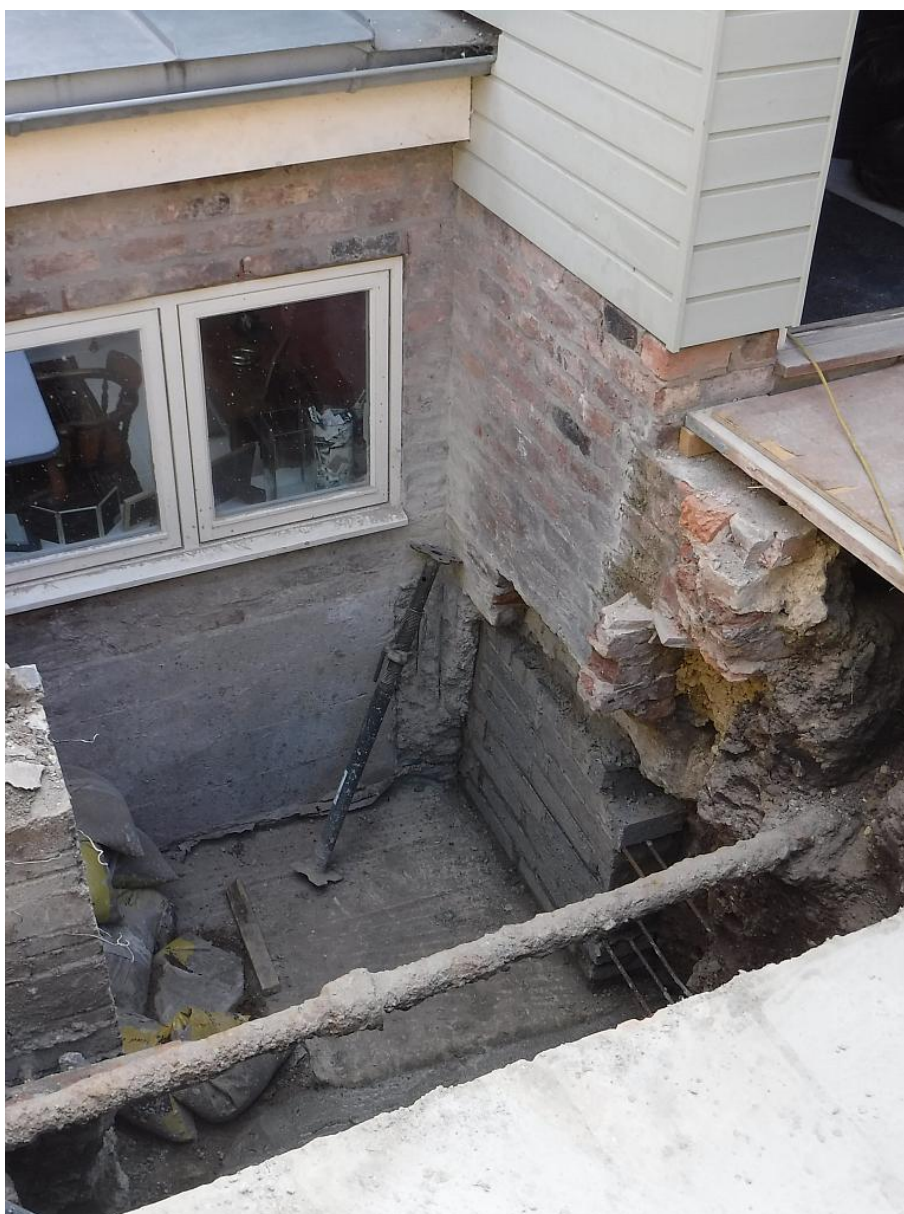
Underpinning – The depth of the underpinning trench (c.2.25m BGL) meant that only natural deposits were observed during this excavation process (see Plate 1 below).

Plate 1 Underpinning facing east
Concrete base also acting as base for new stairway

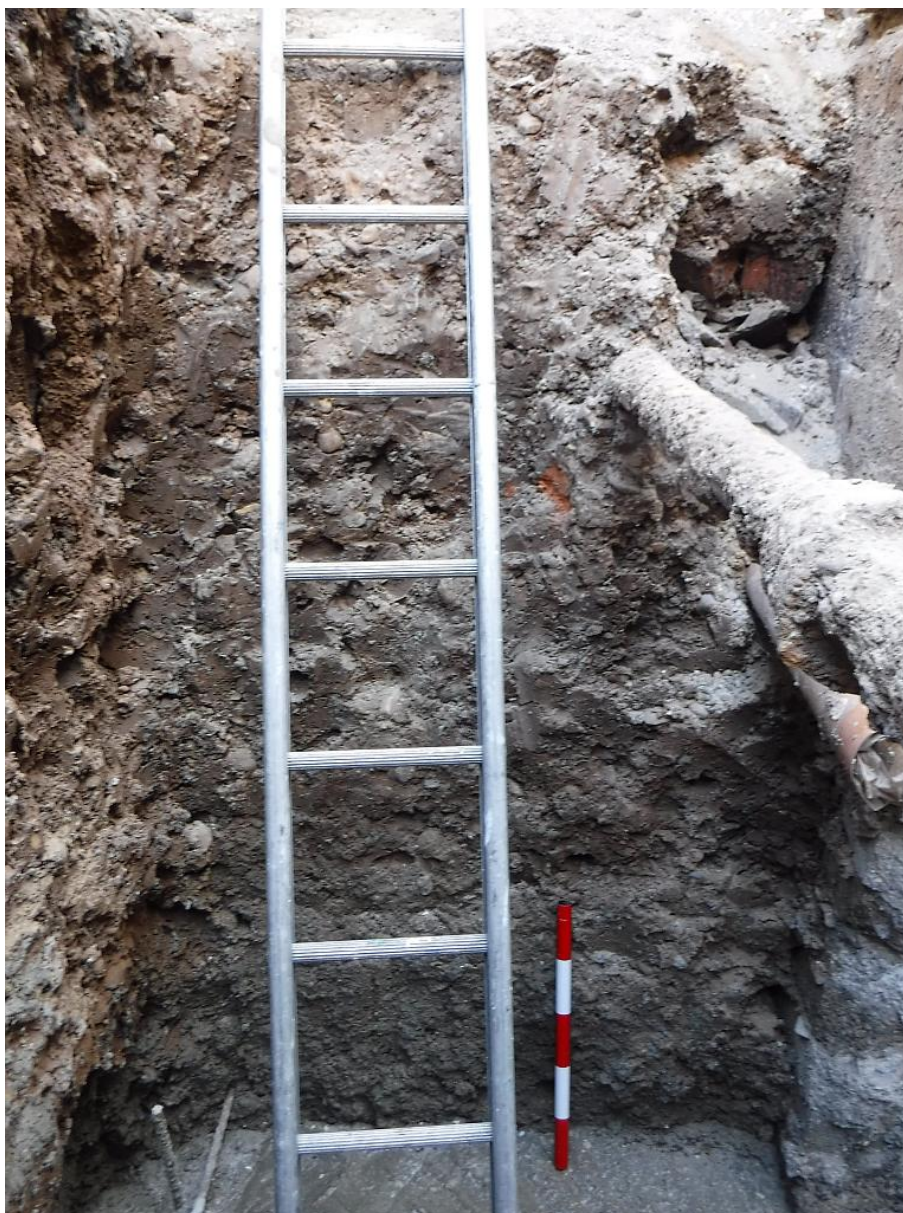
Stair excavation – This work removed material up to c.2.25m BGL which was primarily undisturbed natural. The previous basement excavations, referenced above, had also observed these excavations with minimal archaeology being encountered (see Plate 2).

Plate 2 Section of stairway excavation facing northwest
(scale unit 100mm)

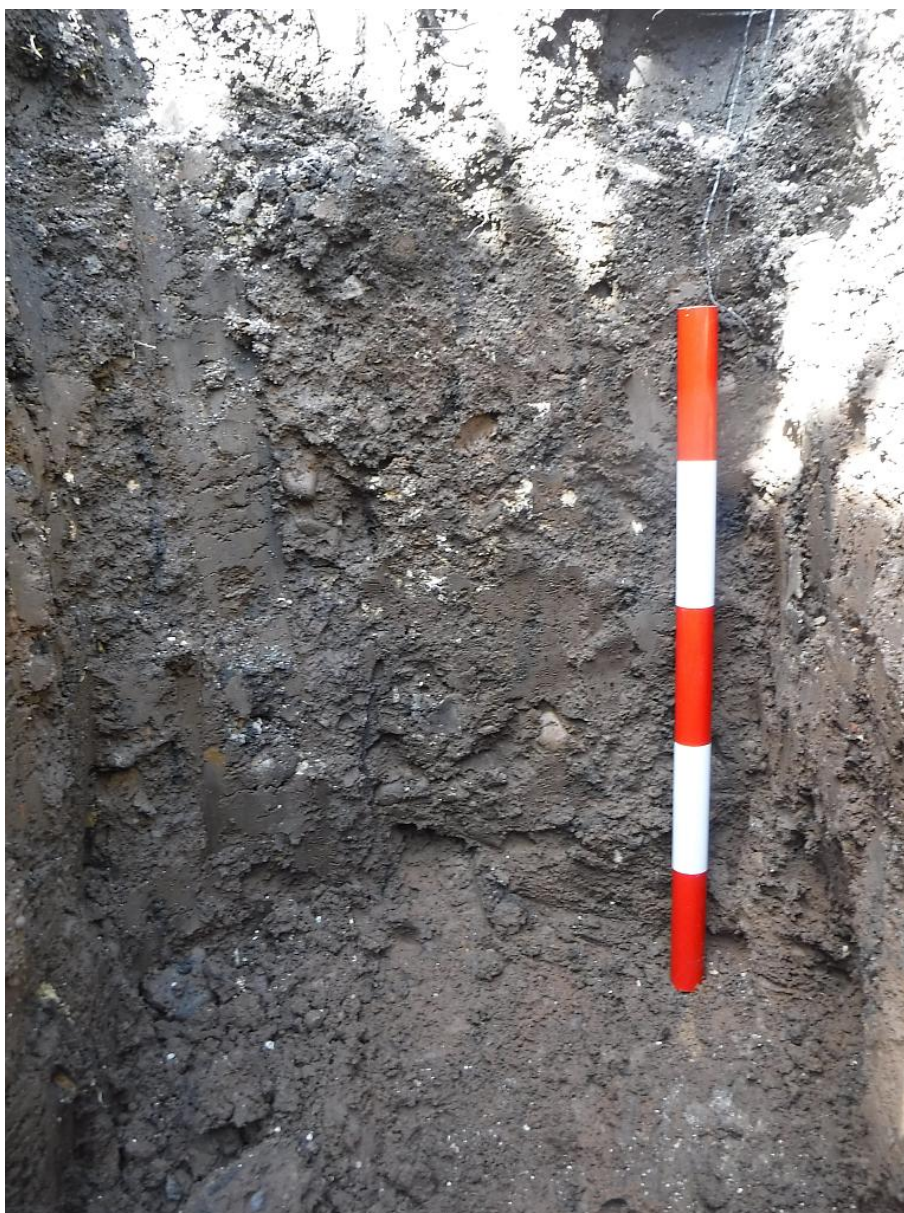
The sequence visible in section indicated c.200mm of disturbance at the top with c.500mm of disturbed post-medieval 'garden' soils grading through to ploughsoil below (Plate 3). The earliest finds were a few fragments of medieval tile and a single sherd of medieval pottery, the bulk of material being post-medieval brick and flowerpot fragments. No finds were retained.

Plate 3 Section into undisturbed soils facing north-west (scale unit 100mm)
