SITE	The Laurels, Church Fenton					
CLIENT NAME	Evora Construction Ltd					
YAT PROJECT #	5946 YAT REPORT # 2017/08					
MUSEUM ACCESSION #	N/A	GRID REFERENCE	SE 5148 3704			
PLANNING REFERENCE #	8/62/177D/PA 2016/0484/REM AAI OPS NOTICE # N/A

YAT undertook a watching brief commencing on the 12th December 2016 at the Laurels, Church Fenton (Figure 1), on groundworks related to the construction of 25 dwellings, garages and associated access road. This was carried out in response to an archaeological planning condition imposed by North Yorkshire County Council. The reason for the archaeological condition was that the site is thought to form part of a medieval moated manor complex. Following observation of the road strip and the foundations for 8 dwellings no features or deposits of archaeological importance were identified. Following these results a decision was made in consultation with Peter Rowe Principal Archaeologist for North Yorkshire County Council for the watching brief to be curtailed.

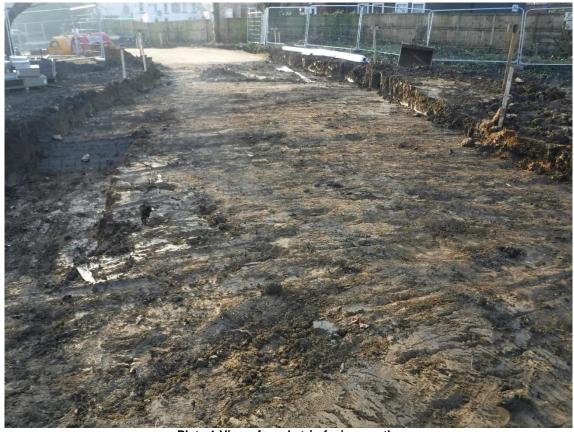
Plate 1 View of road strip facing south.

The only features identified during the operations were 19th - 20th Century field drains and ground consolidation deposits. During the road strip two modern field drains aligned NNE-SSW were encountered consisting of a 0.11m diameter ceramic drainage pipe. At the southern end of the road strip, a 0.10m thick consolidation deposit was uncovered overlying subsoil. This consisted of friable, dark grey, clayey silt. Finds from this deposit were pottery, glass, and bathroom tile dating to the 19th-20th Century, these were not retained.

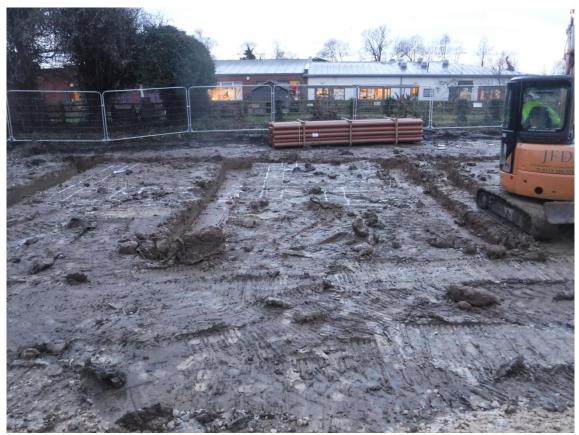
Plate 2 Excavation of foundations facing west.

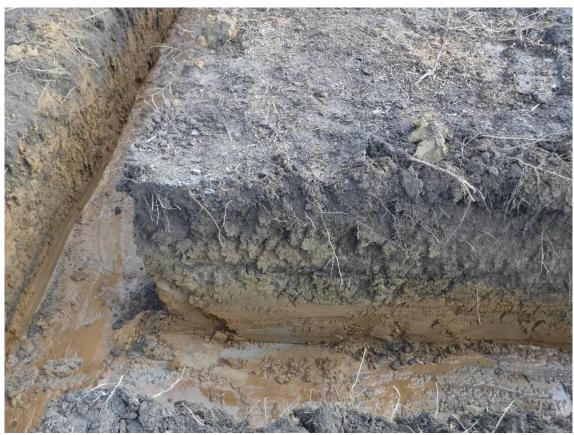
Plate 3 Deposit sequence within foundation.

The deposit sequence encountered during the watching brief is described below. Natural consisted of a soft to friable, yellow, sandy clay found at a depth of 0.50m BGL. Above this was a 0.20m thick deposit of firm, brownish grey, silty clay subsoil. This was sealed by a friable, brownish grey clayey silt topsoil deposit that was 0.30 in thickness.
