# YORK ARCHAEOLOGICAL TRUST REPORT

<b>SITE ADDRESS</b>	38 Clarence Street, York		
<b>CLIENT NAME</b>	Harris Construction		
<b>YAT PROJECT #</b>	5955	<b>YAT REPORT #</b>	2017/10
<b>MUSEUM ACCESSION #</b>	N/A	<b>GRID REFERENCE</b>	SE 6031 5264
<b>PLANNING REFERENCE #</b>	16/01151/FUL	<b>AAI OPS NOTICE #</b>	N/A

On the 11<sup>th</sup> of September 2017 a watching brief took place during the excavation of a raft foundation and other ground works for a detached building to the rear of 38 Clarence Street, York. The site lies within an Area of Archaeological Importance and the City of York Central Historic Conservation Area.

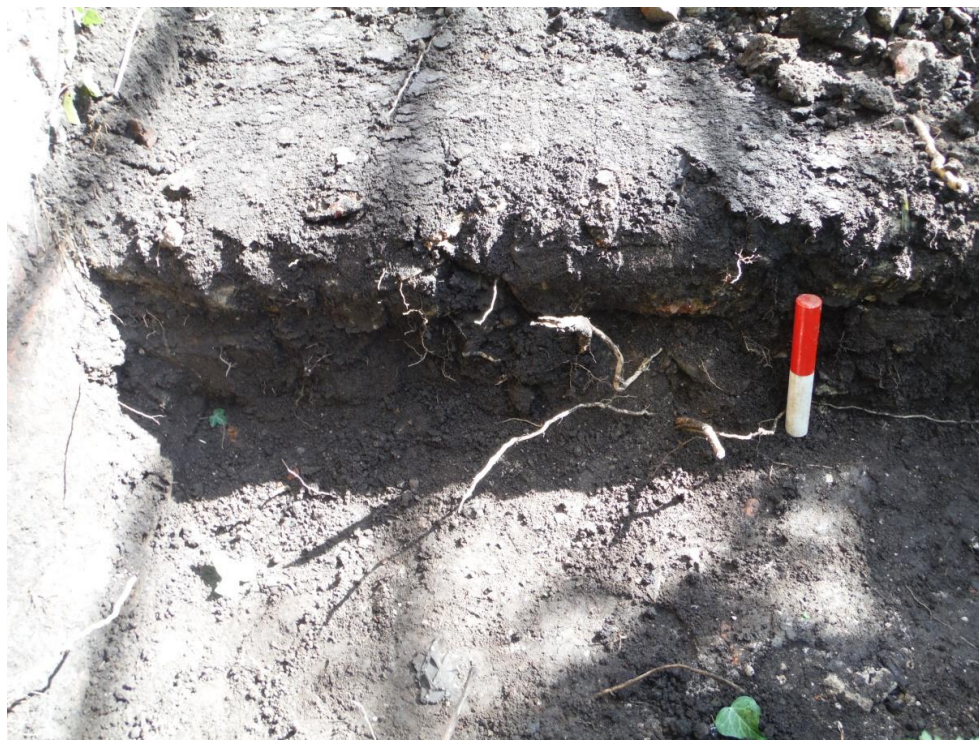
The wall foundation strip and the ramp foundation strip revealed a consistent sequence of topsoil overlying subsoil (Plate 1). The topsoil was between 250mm and 300mm thick and comprised a friable, dark brownish grey, sandy silt. This overlay a subsoil which was exposed to a maximum thickness of 200mm and comprised a friable, mid brownish grey, sandy silt. Both deposits were heavily disturbed by roots and contained moderately frequent inclusions of modern brick and tile.

Plate 1: Deposit sequence visible in garden wall trench footing (looking south-east)

See **Figure 2** for the layout of excavations and **Plate 1** for the representative section (below).

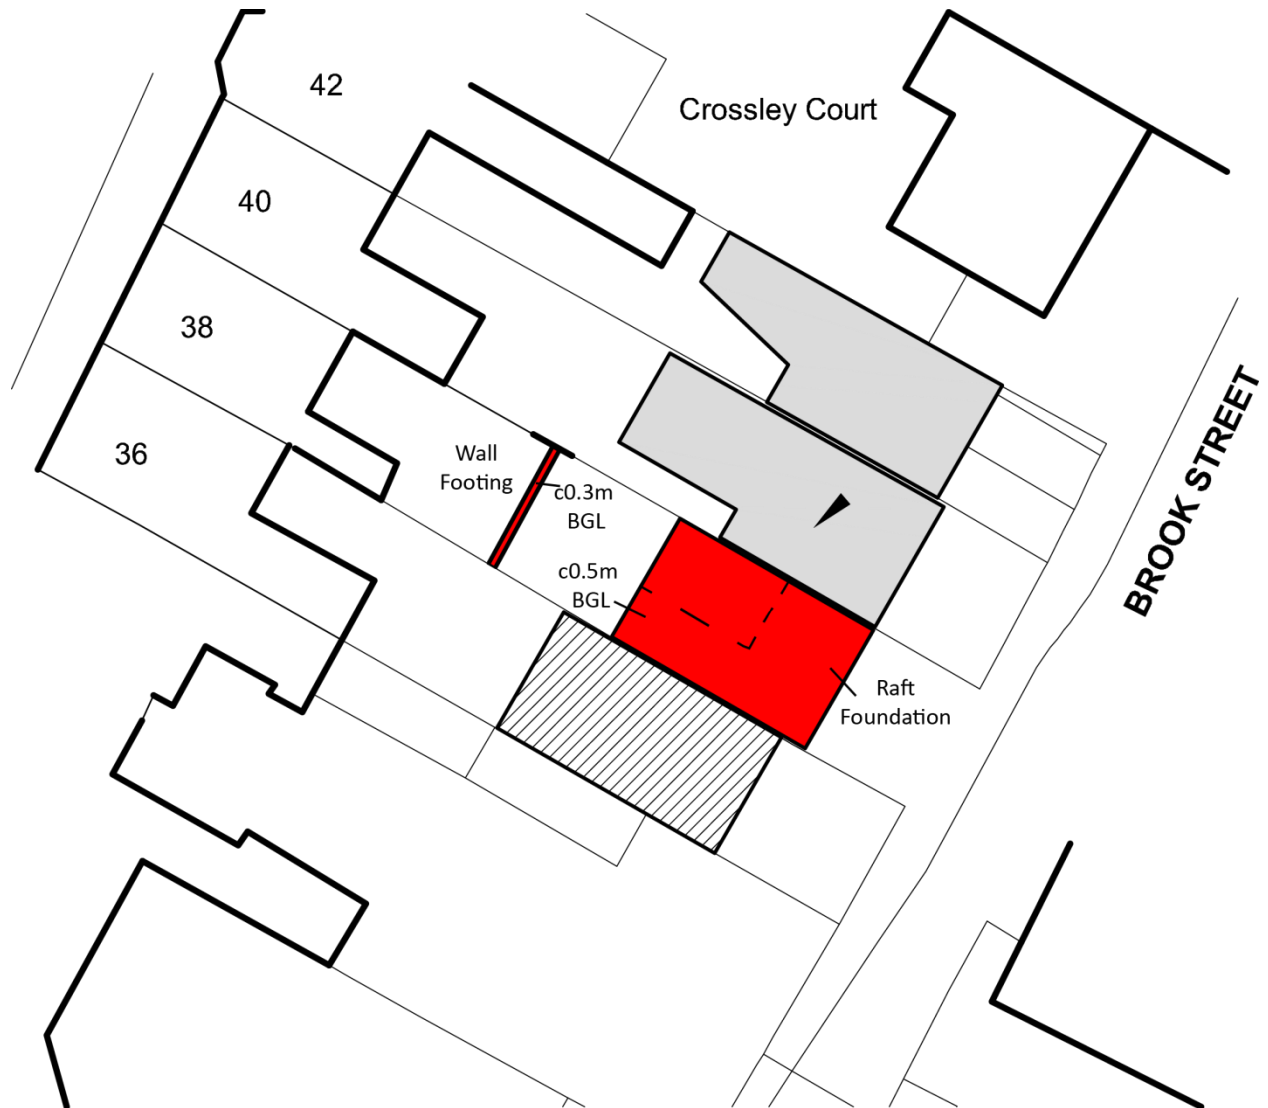
Figure 2: Layout of excavations at 1:250 Scale (Area enclosed by dashed line not observed)
