# YORK ARCHAEOLOGICAL TRUST

<b>SITE</b>	10 Precentor's Court, York		
<b>CLIENT NAME</b>	City of York Council		
<b>YAT PROJECT #</b>	6081	<b>YAT REPORT #</b>	2019/110
<b>MUSEUM ACCESSION #</b>	N/A	<b>GRID REFERENCE</b>	SE 60160 52254
<b>PLANNING REFERENCE #</b>	19/01434/FUL	<b>AAI OPS NOTICE #</b>	N/A

## INTRODUCTION

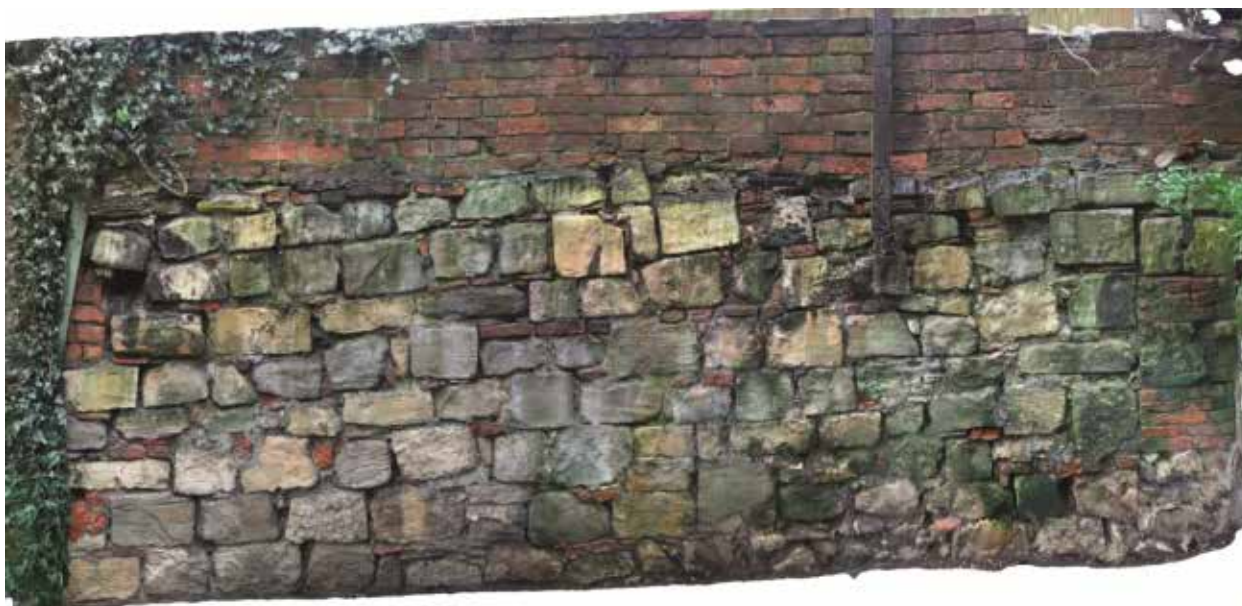
A 5.5m section of the boundary wall was surveyed using a Fujifilm digital camera. Due to low light levels and persistent rain, additional photographs were taken using a smartphone. Measured survey points were placed in the wall elevation to allow the final images to be scaled. The photographs were processed using Agisoft Metashape Professional to create a rectified orthophoto of the wall (Plate 1).

Plate 1. Rectified orthophoto of the boundary wall, facing south-east.

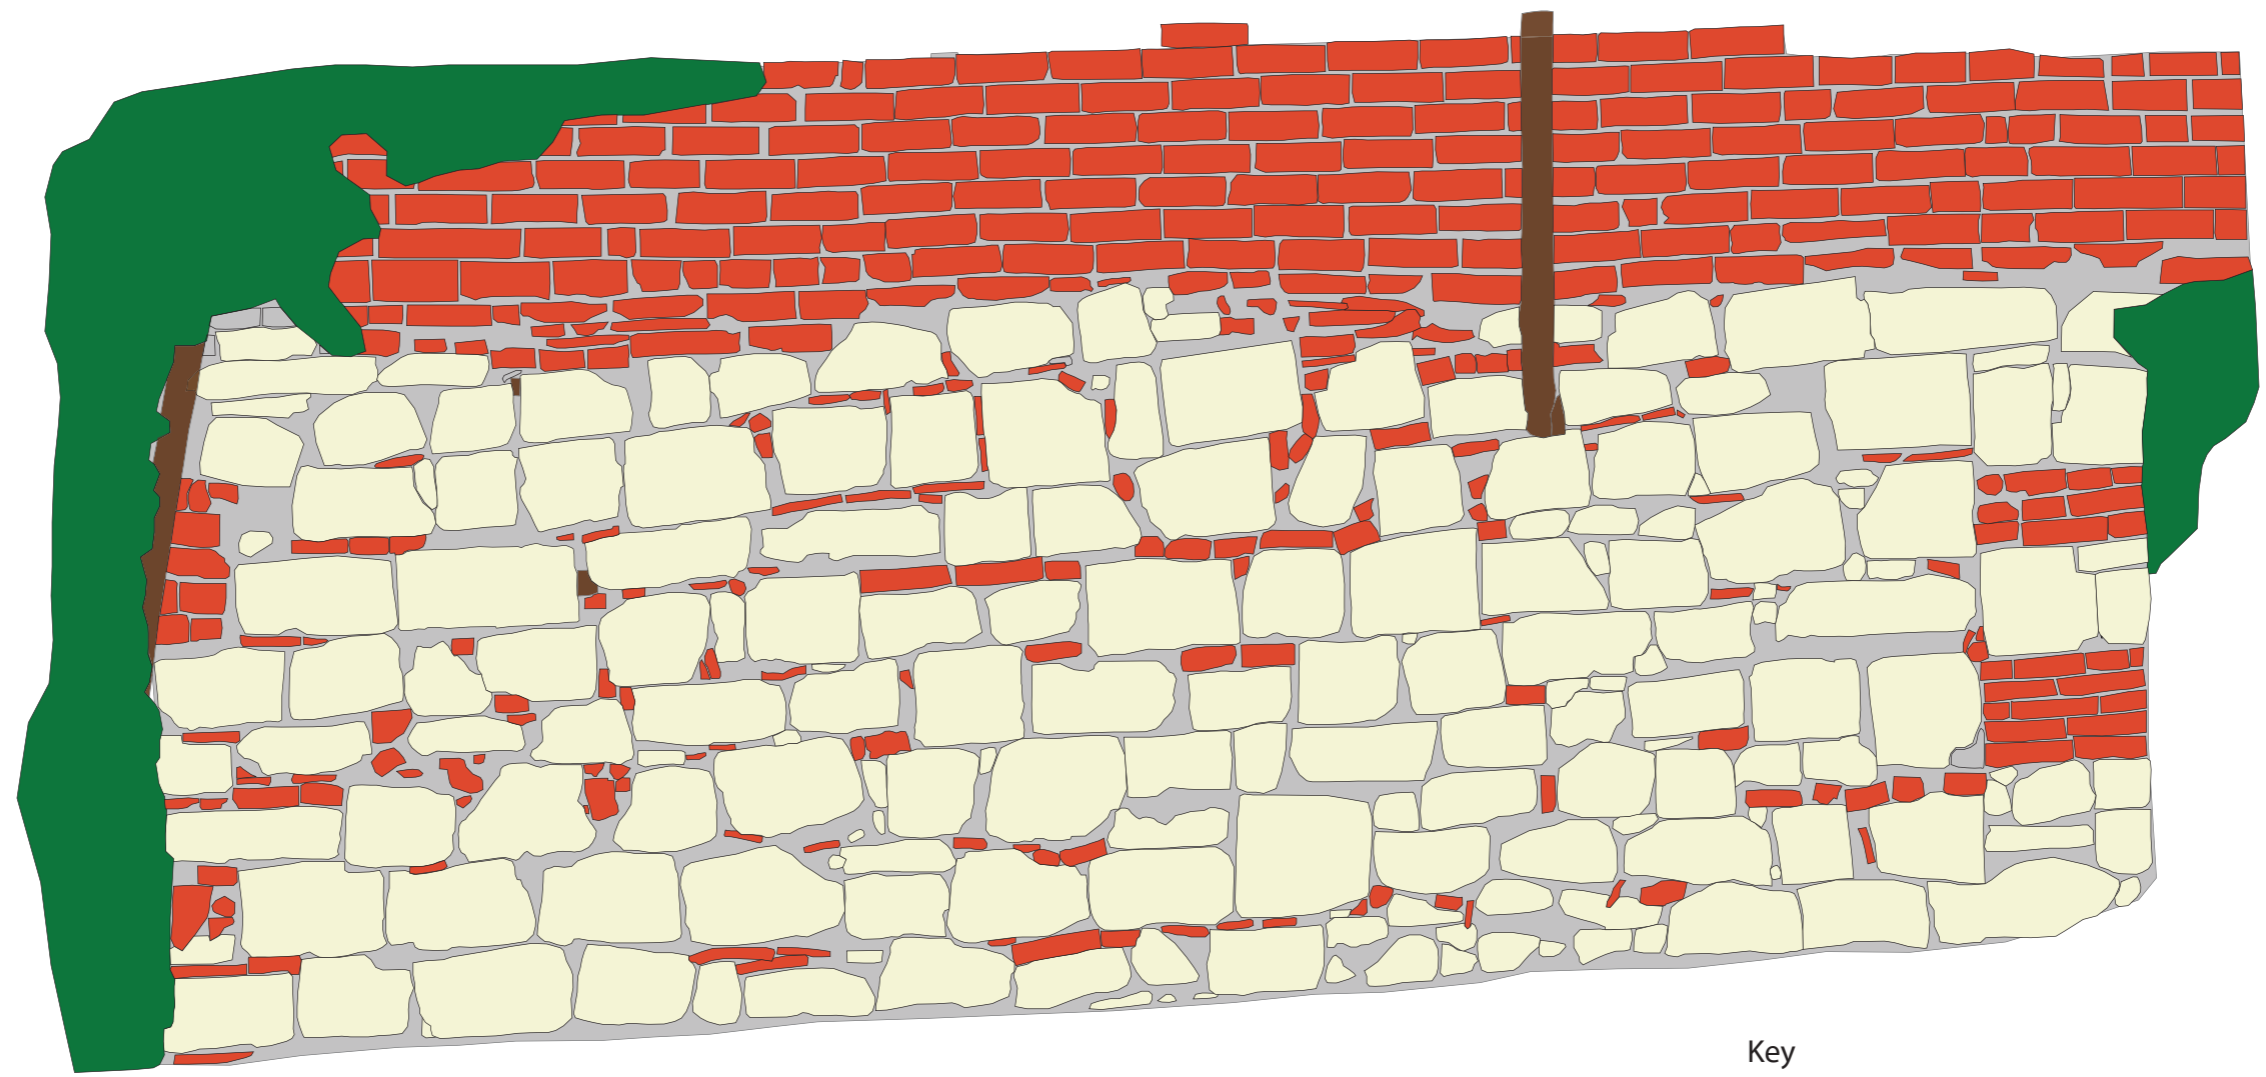
The photogrammetry survey was set to a scale of 1:20 and used to create an elevation drawing detailing the coursing and materials used within the wall (Figure 2). The wall contains a large amount of re-used medieval masonry, but the presence of post-medieval brick would make a later date more likely. The wall is marked on the 1852 OS map, and it may have been built around the same time as

10 Precentor's Court in the 18<sup>th</sup> century (Jackson 2018, 1).

Fig. 2. North-west facing elevation of boundary wall.
