SITE	Duncombe Place and High Petergate, YO1 7EF						
CLIENT NAME	North Midland Construction						
YAT PROJECT #	N/A	N/A YAT REPORT # 2019/54					
MUSEUM ACCESSION #	N/A	GRID REFERENCE	SE 6021 5215				
PLANNING REFERENCE #		AAI OPS NOTICE #	19005

A watching brief on the excavation of a cable trench was undertaken by York Archaeological Trust on behalf of North Midland Construction between 1st April and the 4th April 2019 at Duncombe Place and High Petergate, YO1 7EF, NGR SE 6021 5215 (Figure 1). The objective of the watching brief was to record any archaeological deposits or structures exposed by the ground works as the site was adjacent to the Minster Precinct Scheduled Ancient Monument, and was within the York Central Historic Core Conservation Area and the York Area of Archaeological Importance (AAI).

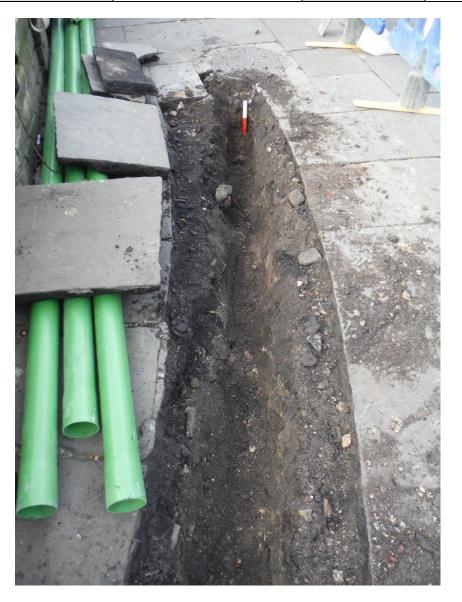
At the south west and north west end of the trench, the stone flags were lifted to reveal a thin layer of loose, dark grayish black, silty cinder bedding material that was between 50mm and 150mm thick. Below this was a mixed rubble deposit consisting of a friable to loose dark grayish brown silty sand (Plate 1). This deposit contained a fragment of antler tine and large amounts of 19th-century brick, tile and pottery, and continued beyond the limit of excavation. Within this rubble deposit, approximately 250mm–300mm BGL, were two walls made of sandstone (Plate 2, total wall visible to dimensions of 300x280x150mm) and brick, concrete and limestone (Plate 3, total wall visible to dimensions of 530x250x70mm). Below the sandstone wall were small fragments of 19th-century brick and tile. They were photographed, located on a plan (Figure 1), and then excavated. It was difficult to determine their alignment and how far beyond the trench edges they extend is unkown.

Plate 1 South-west facing view of the cinder bedding and 19th-century mixed demolition/construction deposit. Scale 20cm.

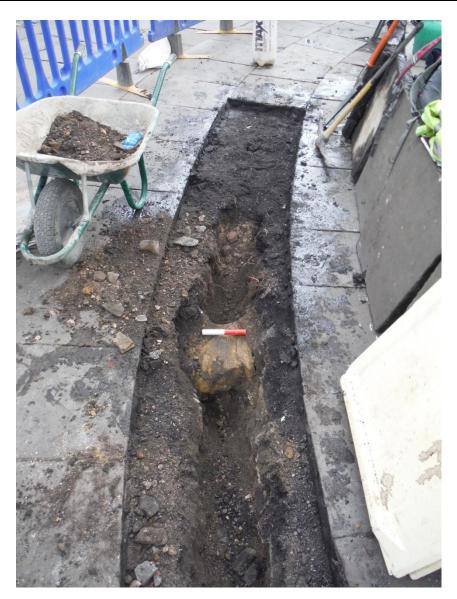
Plate 2 North-east facing view of part of a sandstone wall built on top of 19thcentury brick and tile fragments. Scale 20cm

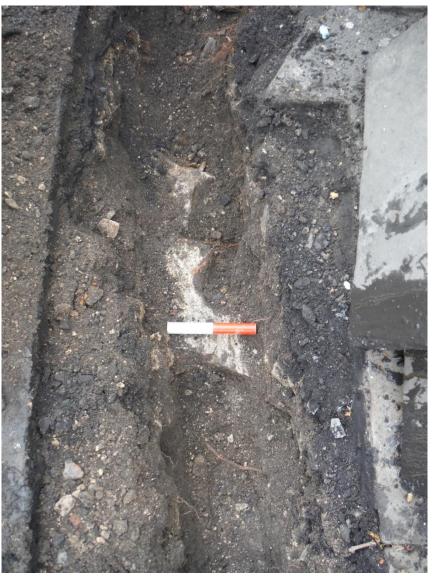
Plate 3 East facing view of brick, concrete and limestone wall. Scale 20cm

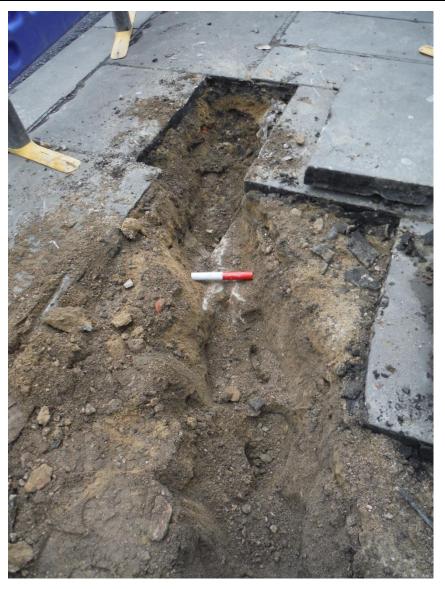
In the middle section of the trench the paving stones appeared to have been recently re-laid as they were bedded on a loose to friable light brownish yellow sand. Within this lighter material, approximately 350mm BGL, part of a limestone wall was exposed (Plate 4). It was made up of three different sized blocks of roughly shaped stone that each measured 400x240x200mm, 210x180x100mm and 270x210x120mm (Plate 5). This appeared to continue beyond the limit of excavation on a north-east / south-west alignment. Again this wall was photographed and located, then excavated.

Plate 4 South-west facing view of limestone wall. Scale 20cm

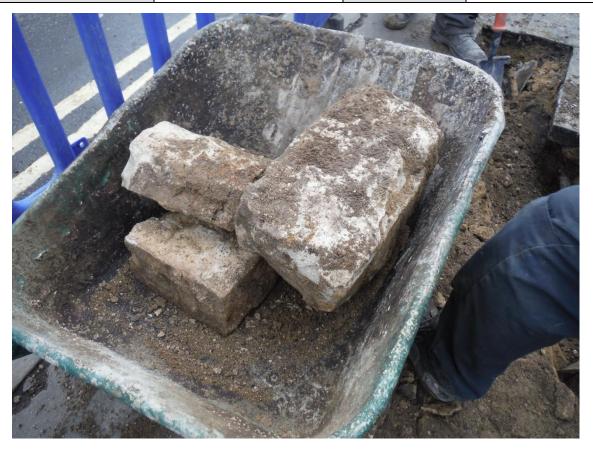
Plate 5 Detail shot of three roughly shaped limestone fragments from wall in cable trench

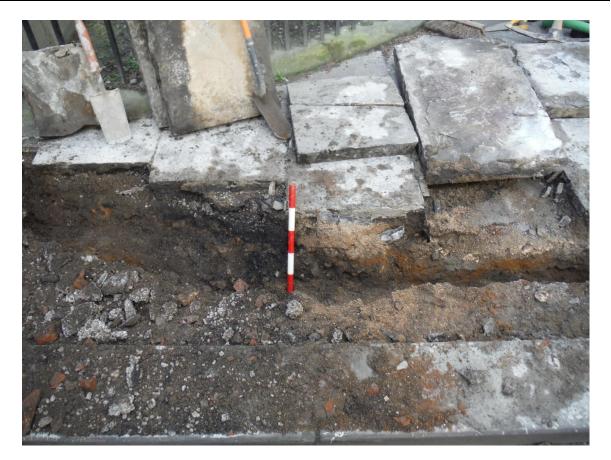
At the eastern end of the trench the sequence changed slightly again with the paving flags laid on a 60mm bed of the same loose pale brownish yellow sand. This bedding overlaid a very mixed loose to friable, dark grayish brown silty sand deposit, and the pale sand had disappeared completely by the last two metres of the trench (Plate 6). The darker lower deposit contained frequent small to

Plate 6 South-east view of cable trench section at the Jackson-Stops end of the service trench showing the end of the sandy bedding material, and the re-emergence of the dark mixed demolition/construction deposit seen at the other end of the trench (Plate 1). Scale 50cm.
