**Photographic Building Record**

**Marsden Park Cottage  
Marsden Park  
Walton Road  
Nelson  
Lancashire**

**MAP 5.23.2014**

**SD 86041 37991**

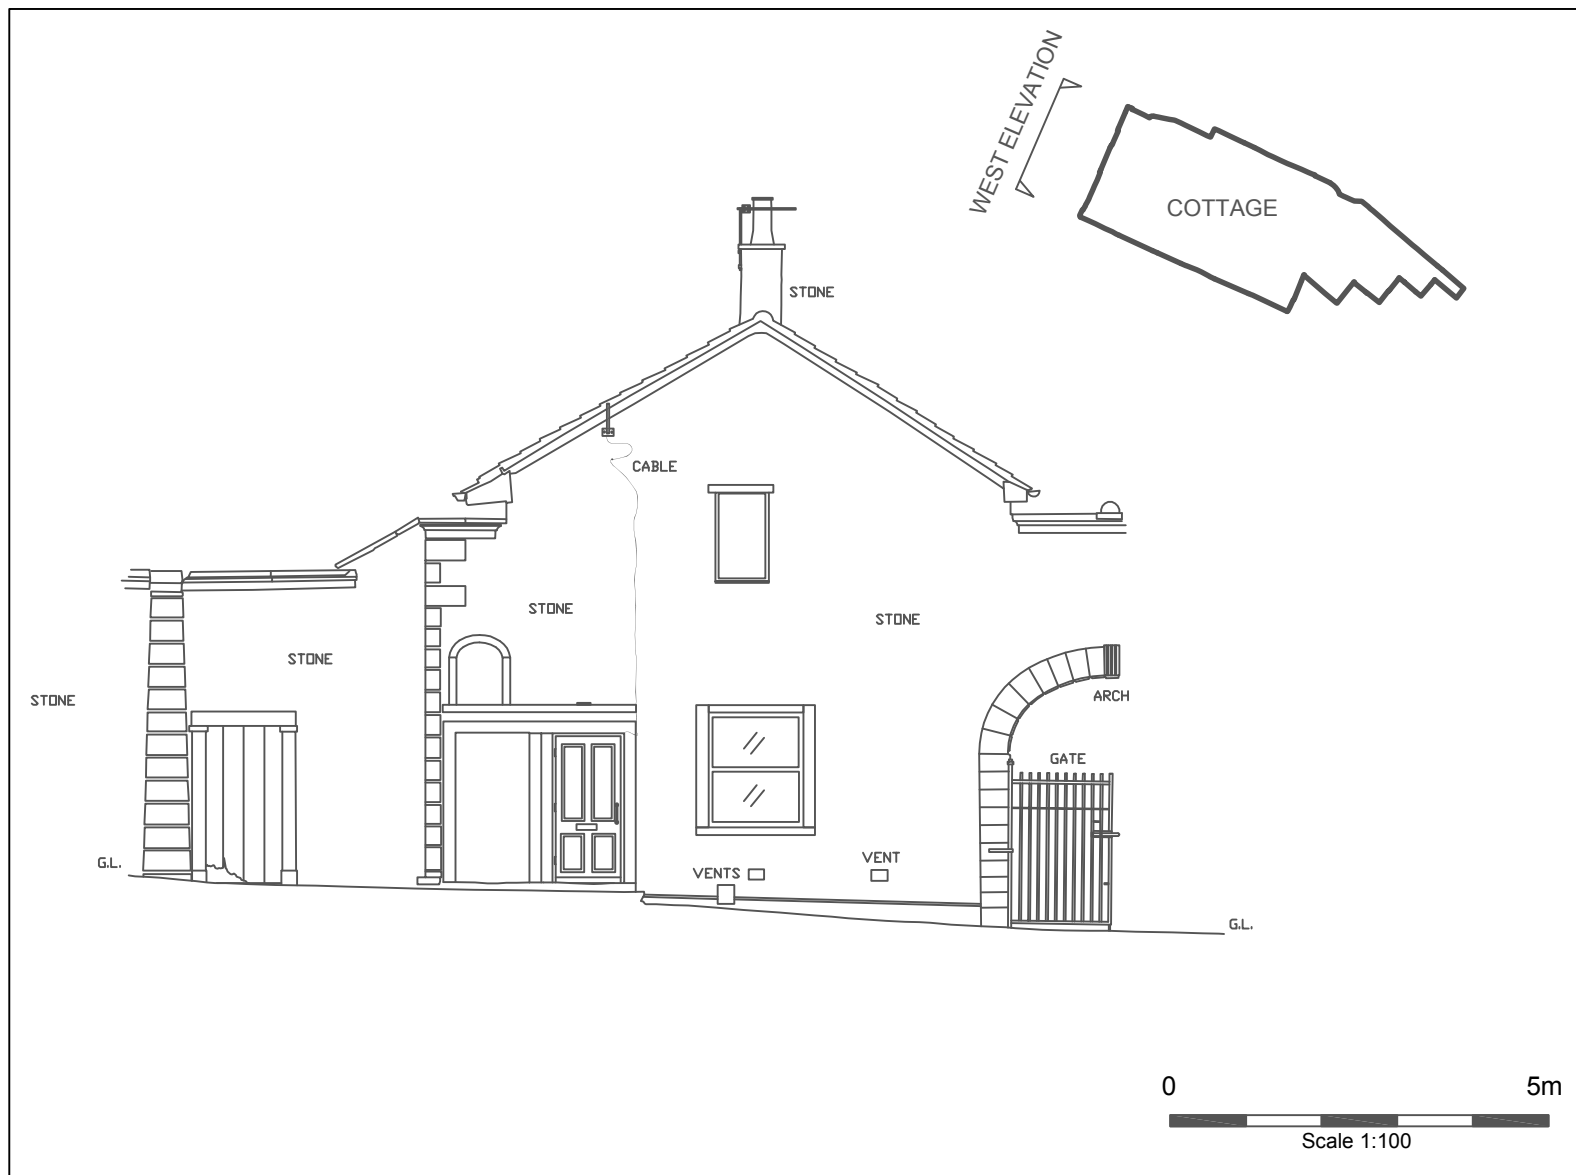
Figure 8. Marsden Park Cottage: West Elevation.

6.2.3 The west gable end of Marsden Park Cottage had a blocked doorway and another entrance in the boundary wall to the left, and a blocked segmental-arched opening above the blocked door (Pl. 5). In the cottage elevation, there was a central square window on the ground floor and a small rectangular window inserted on the first floor. The ground floor doorways and windows had square-cut plain surrounds (Pl. 4).

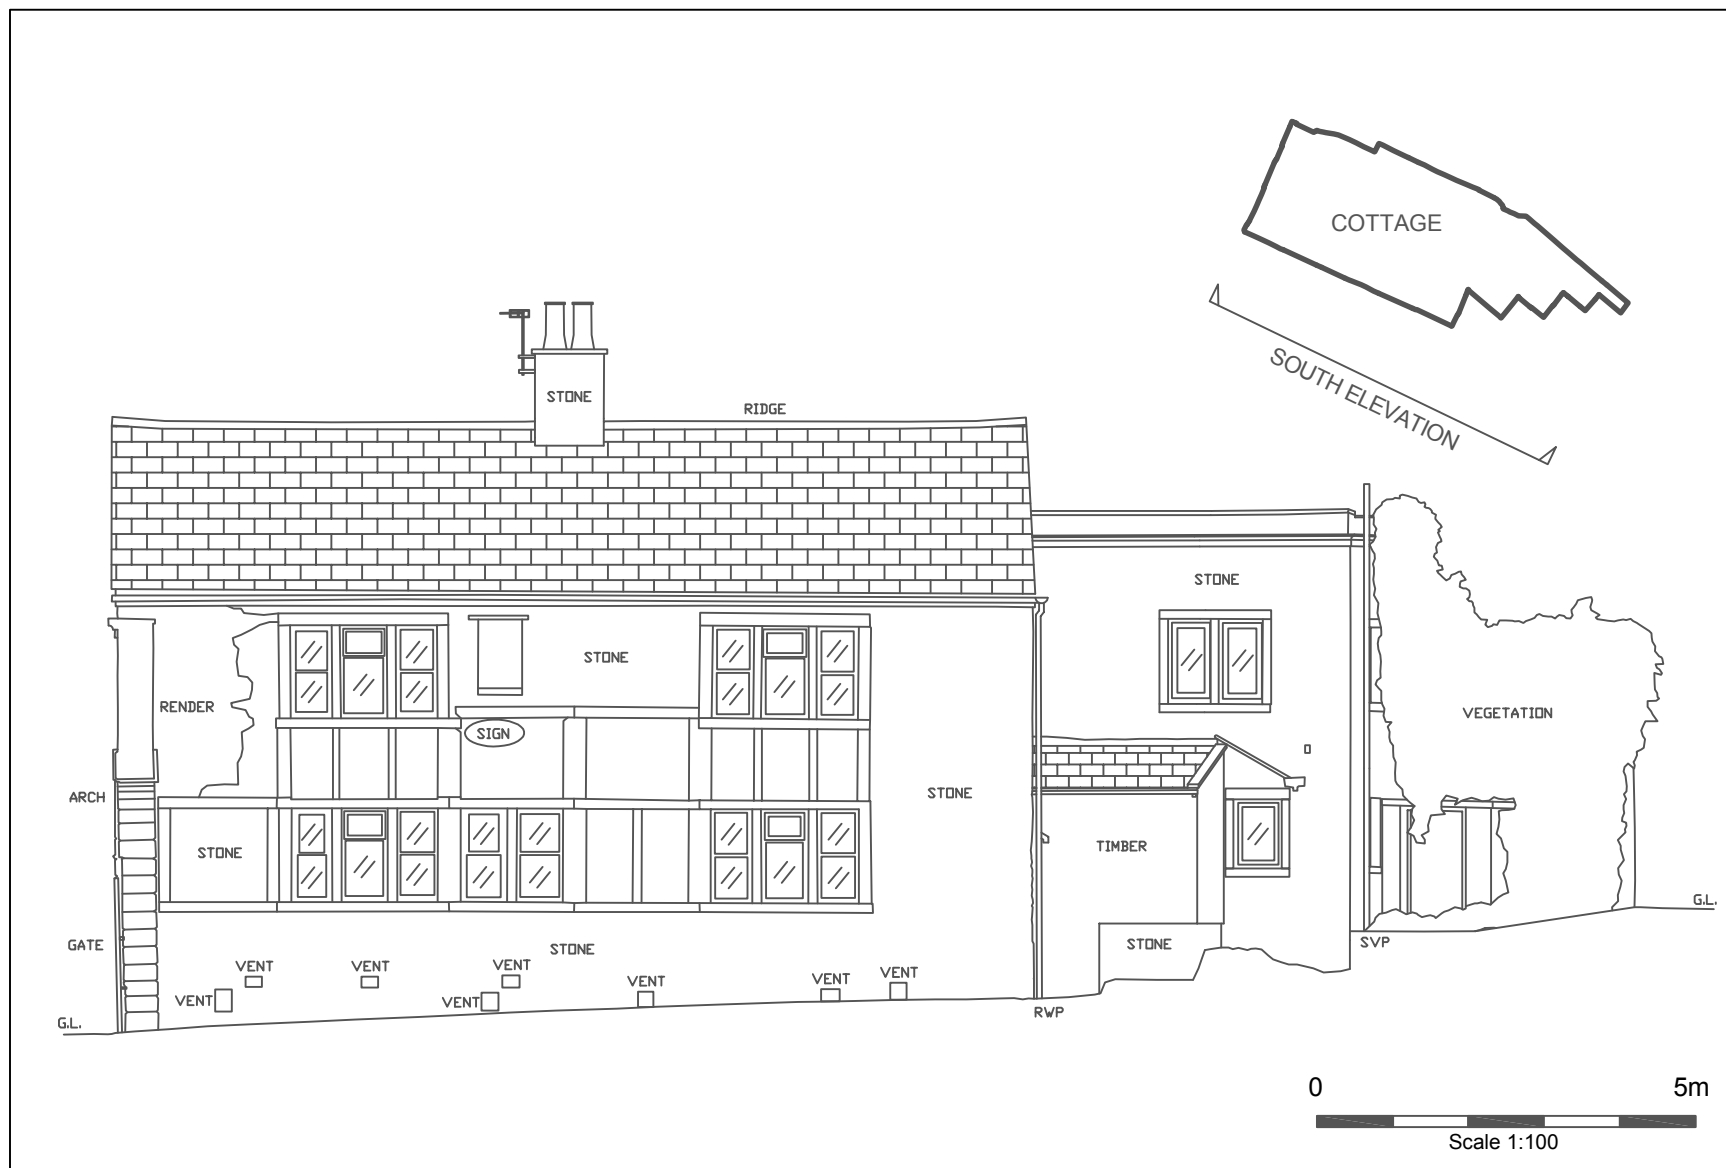
Figure 9. Marsden Park Cottage: South Elevation.

6.2.4 The south elevation on the ground floor had a series of four windows with square-cut mullions and transoms with two three light windows, one two light window, one blocked window and two rectangular three light windows (Pls. 8, 15-18). The middle row of mullions and transoms had been blocked. On the first floor there are two three light mullion windows. On the first floor between the windows was an oval painted plaque with remains of painted lettering, only partially legible ("MARSD.../ Founded.../ Edwd.../ Esqr."), said to commemorate the foundation of an asylum in these buildings c.1850.

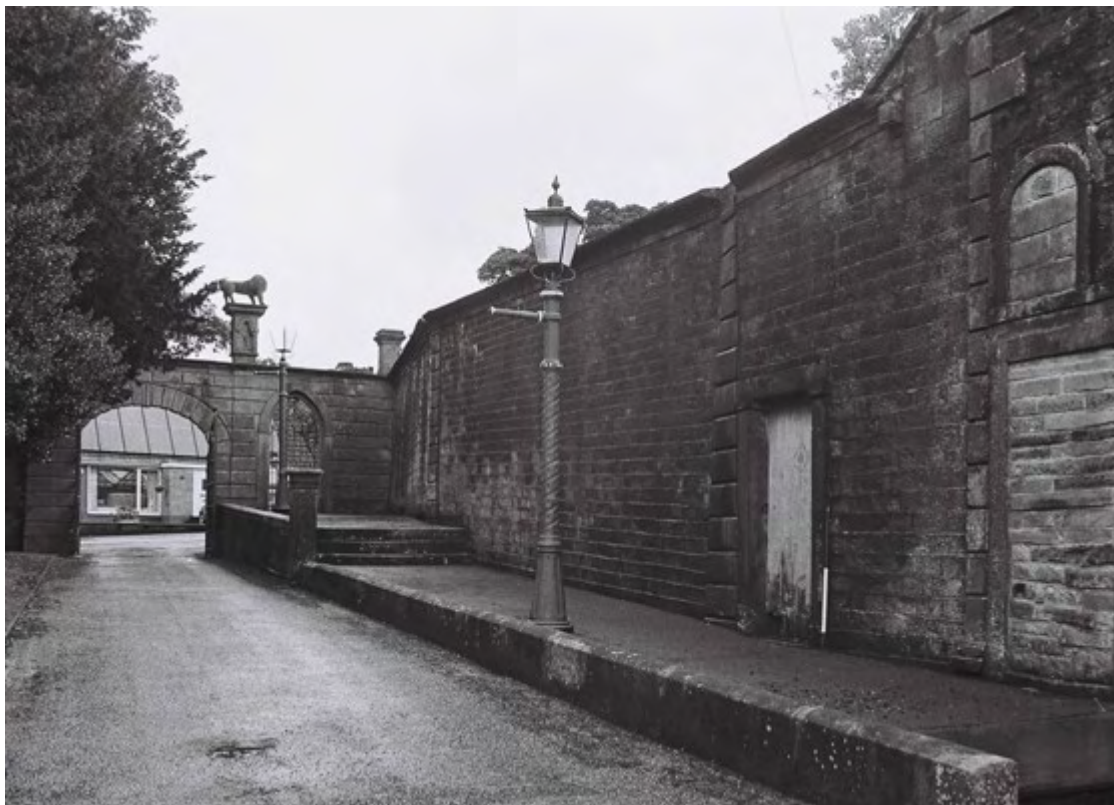
Plate 2. Marsden Park Boundary Wall. Facing North-east.

6.2.1 The cottage was unused at the time of the survey with the main entrances on the west elevation and the rear entrance on the north elevation (Fig. 4; Pls. 3-4 & 10-11). There was a located gate on the archway into Marsden Park (Pls. 6 & 19). The cottage was attached to Marsden Hall Cottage to the south by the archway. The archway has a rusticated surround and linen-fold enriched keystone, and a pair of low wrought-iron bar gates with dogbars. To the north of Marsden Park Cottage is a tall boundary wall separating the park from the walled garden (Pl. 2).

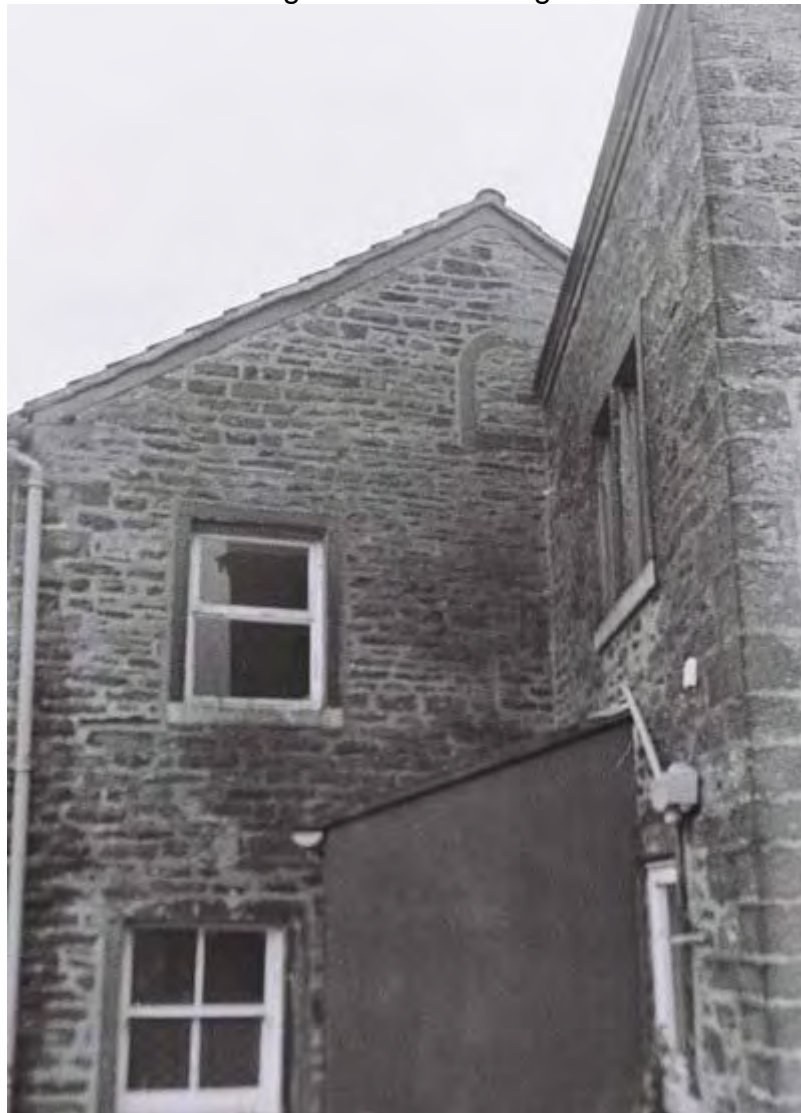
Plate 14. Marsden Park Cottage Exterior : Blocked Attic Window. Facing South.

6.2.5 Attached to the rear gable was an early nineteenth century two storey stone built extension. There were windows in the extension, on the south and east elevations on the ground and first floors. The extension partially covered over a round-headed attic window (Pl. 14).

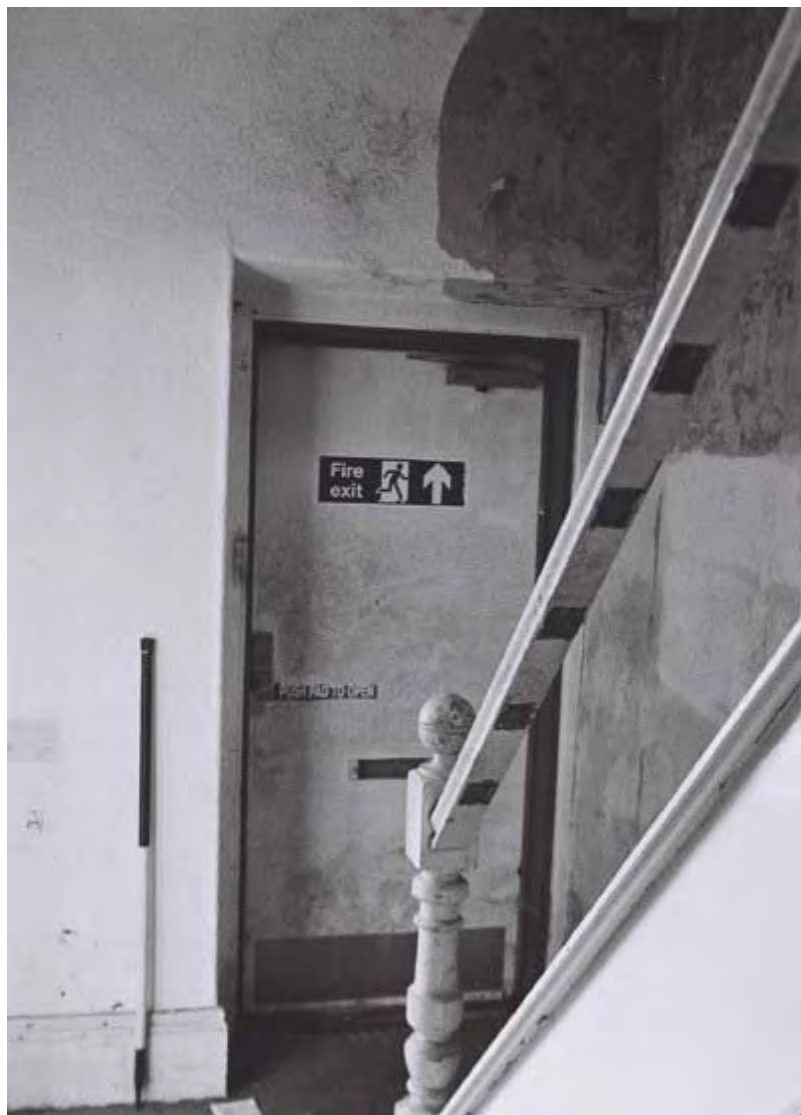
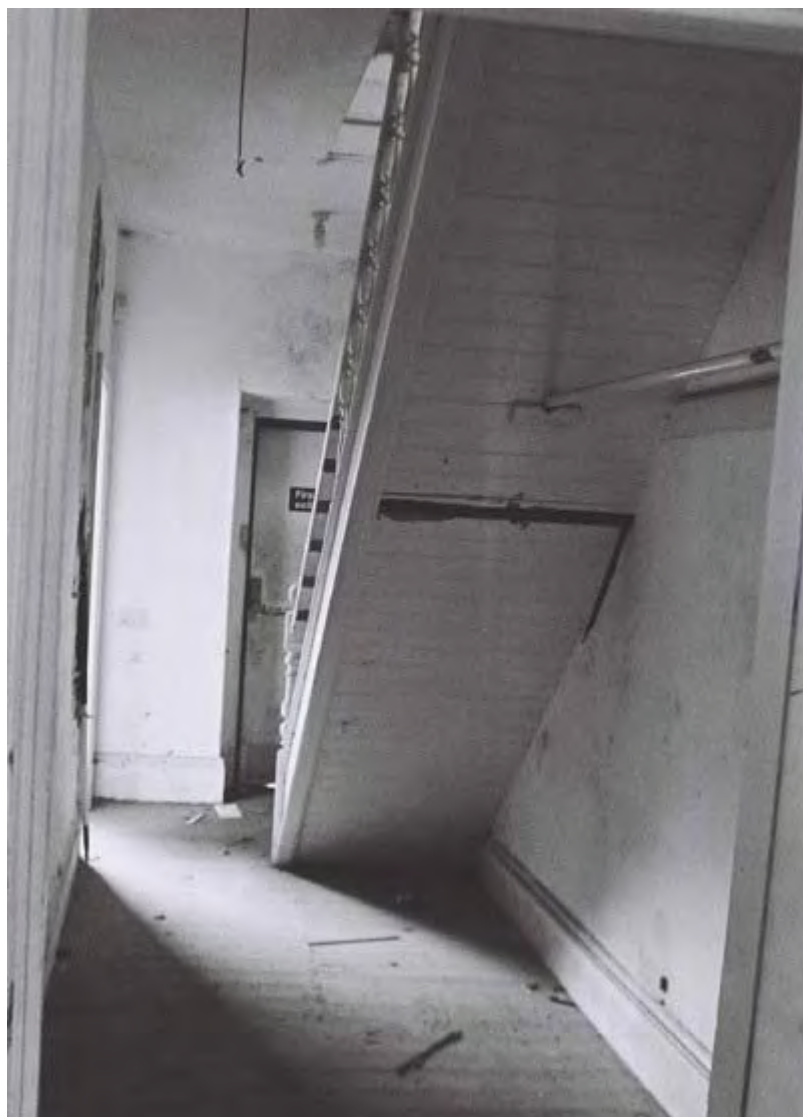
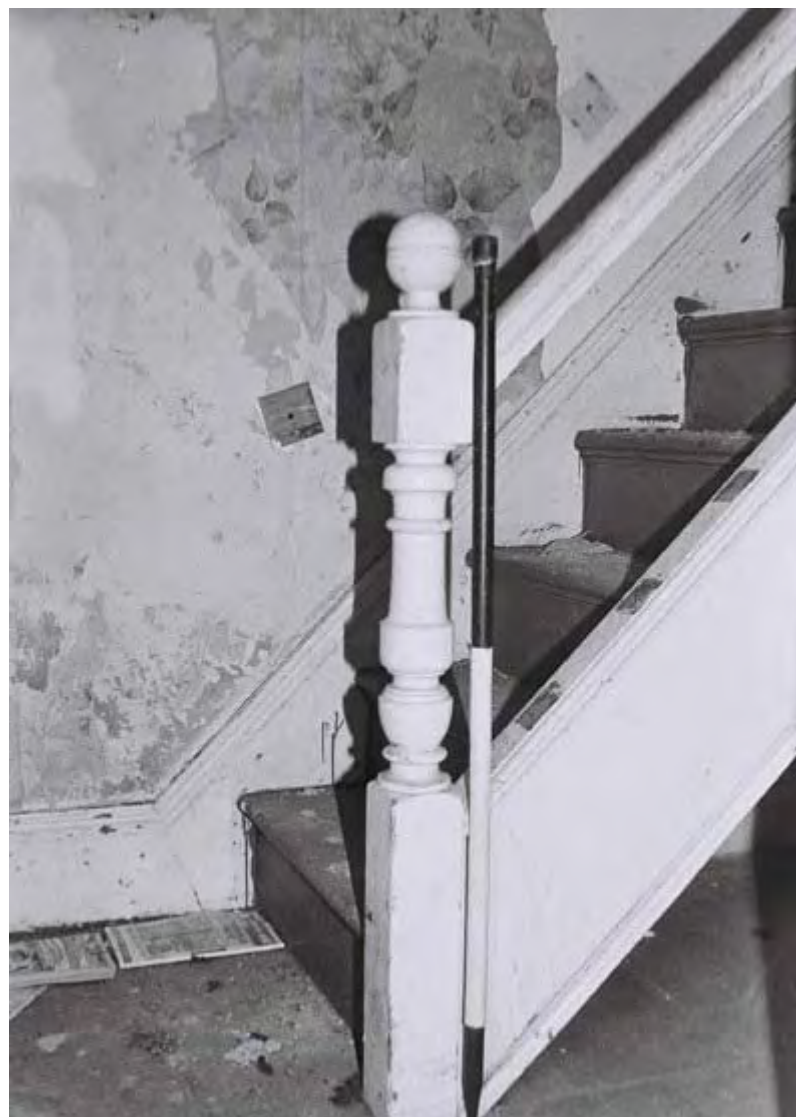
6.3.2 The main entrance from Marsden Park opened onto a narrow hall with stairs to the first floor (Pls. 20-22)

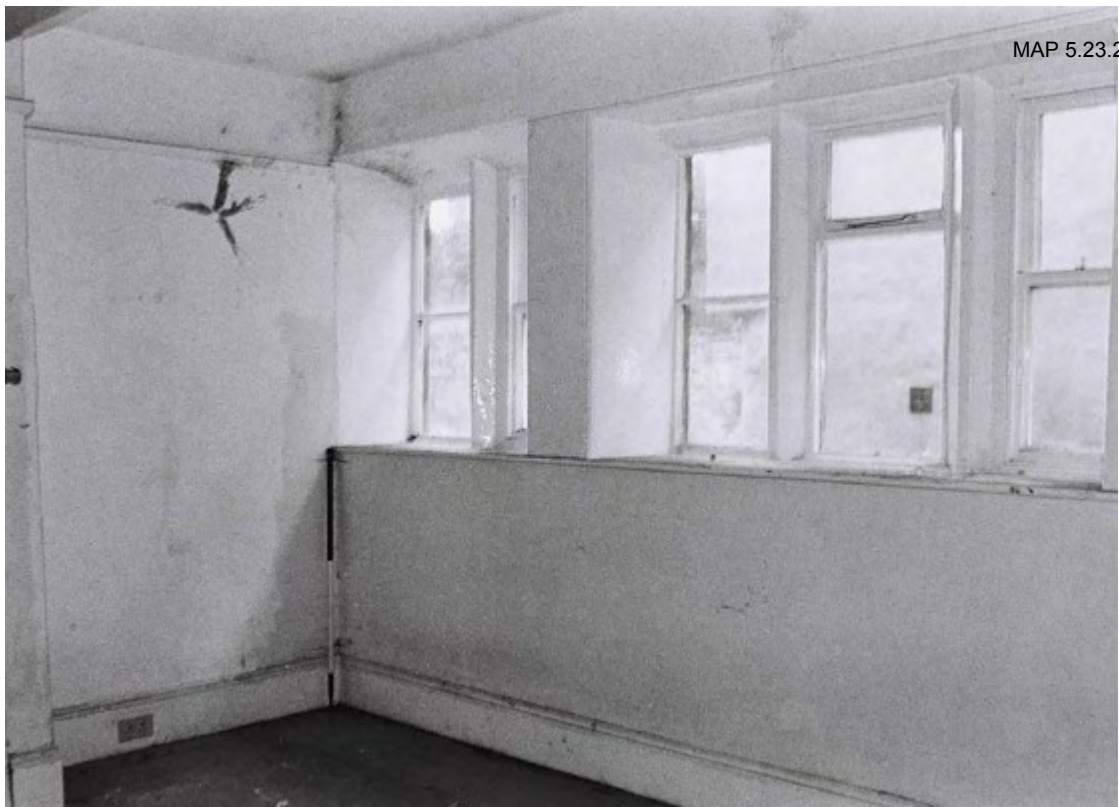
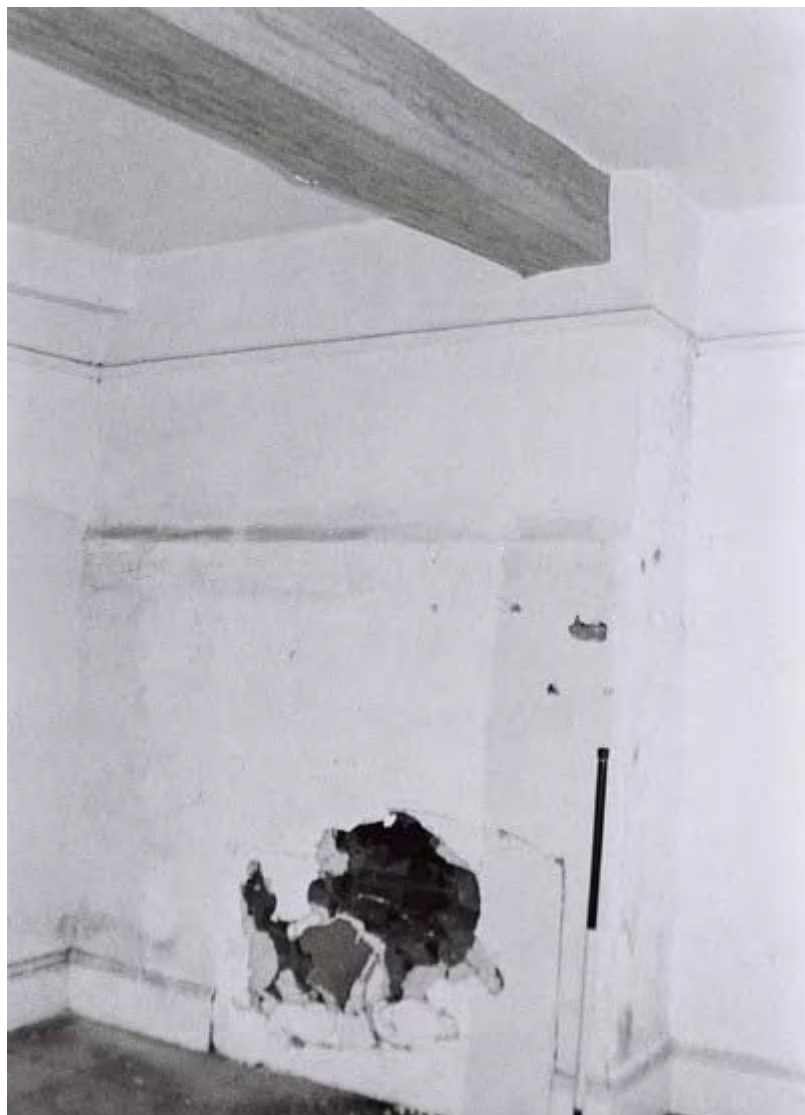
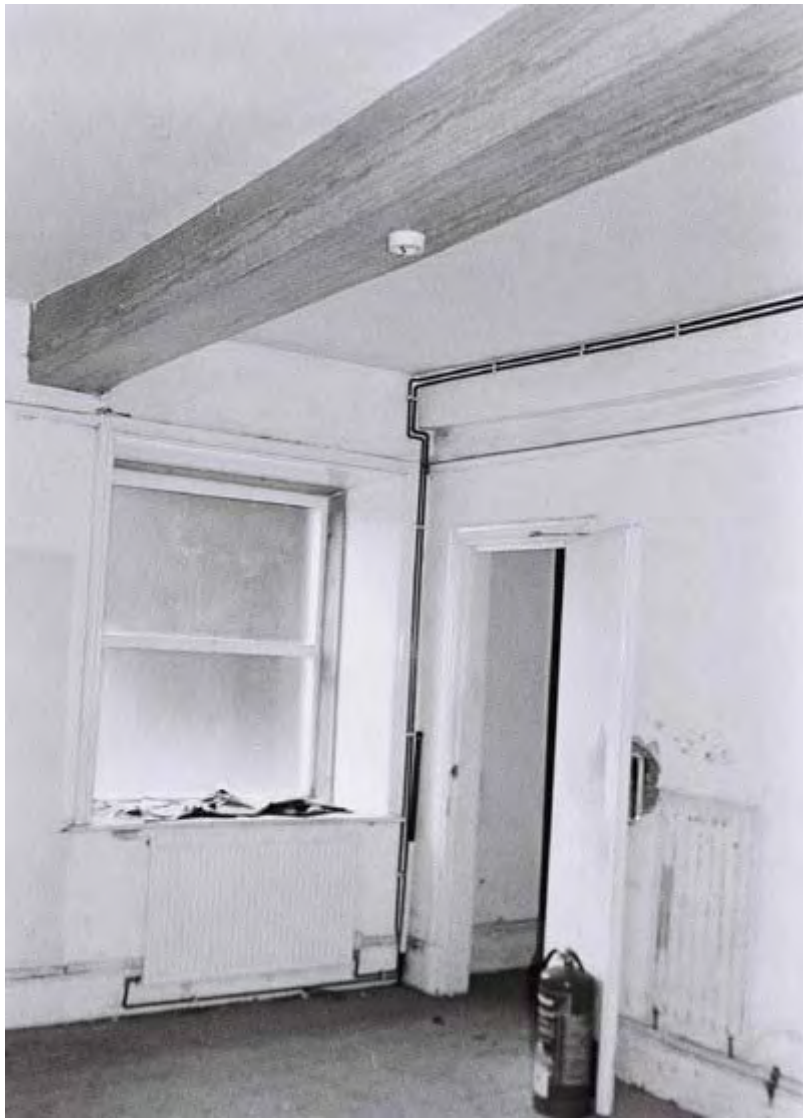
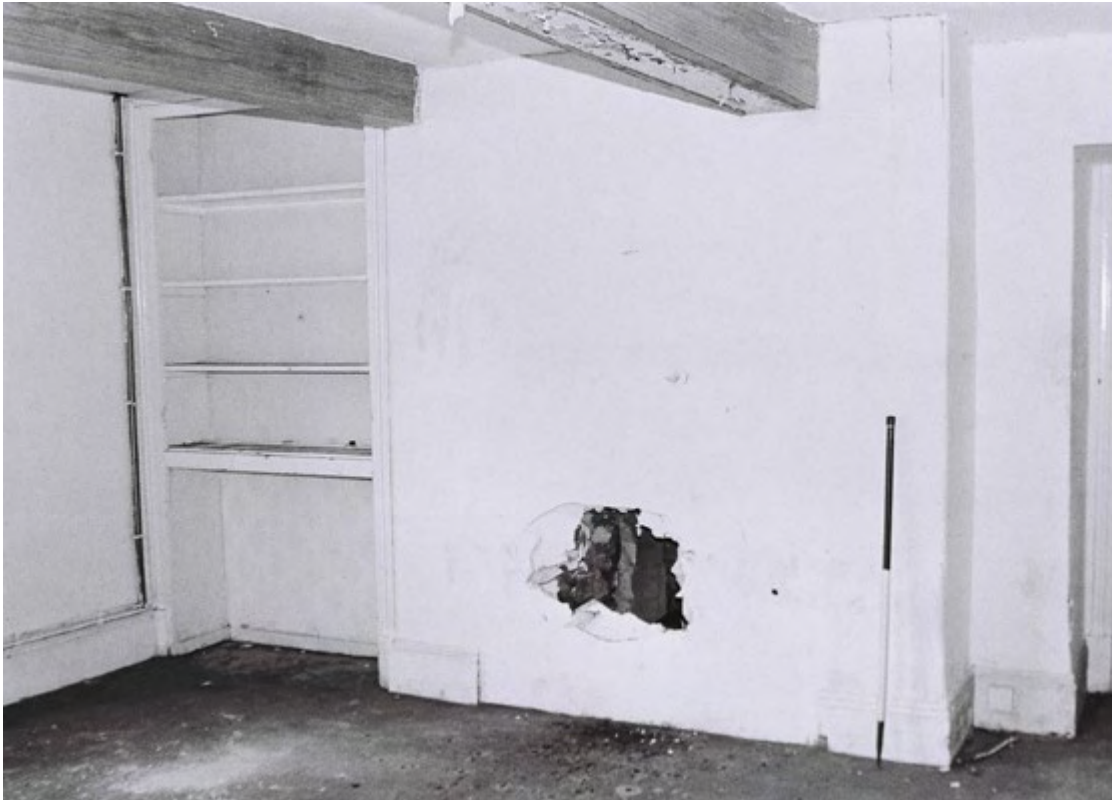
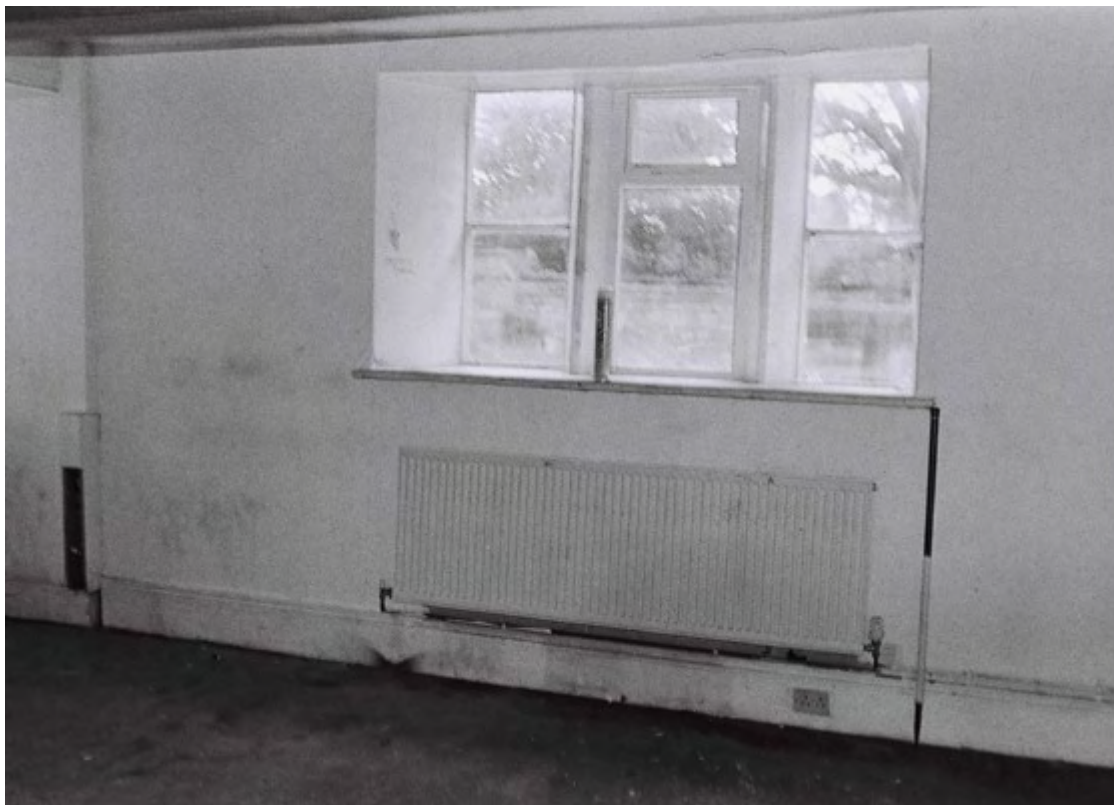
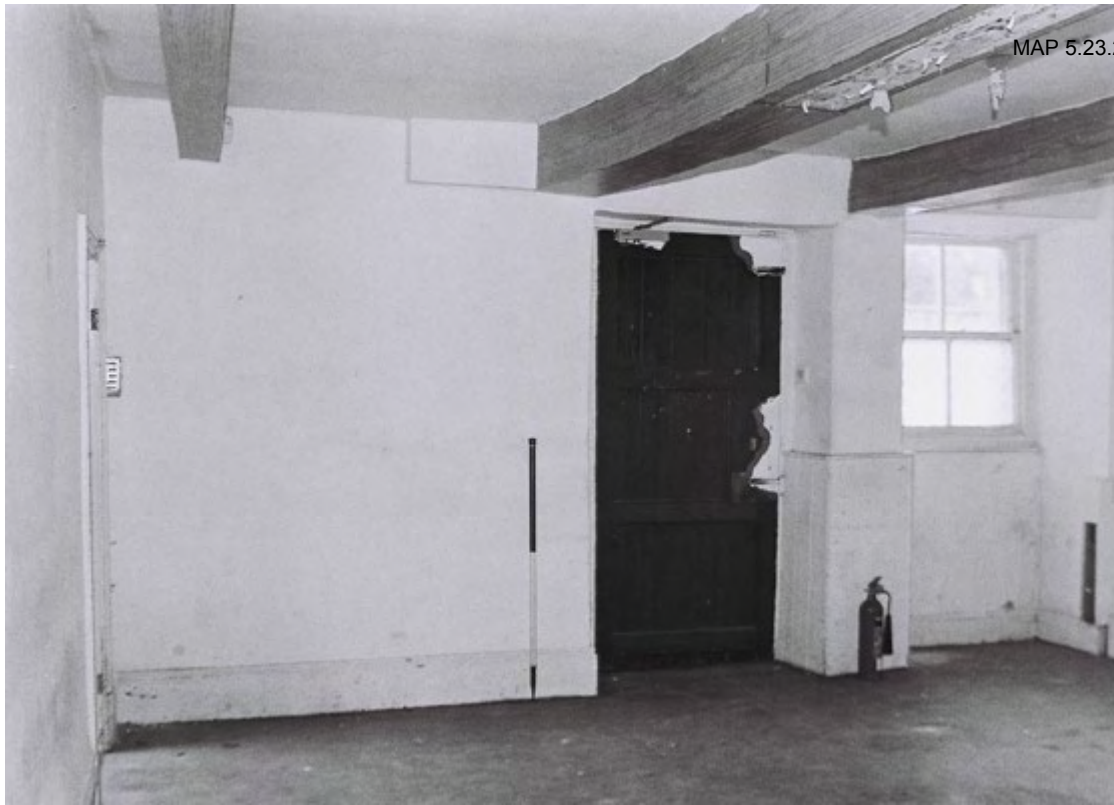
- 6.3.3 The main rooms on the ground floor had ceiling beams, the joists supporting the upper floor, with two visible in the western room and three in the eastern room (Pls. 23-29).

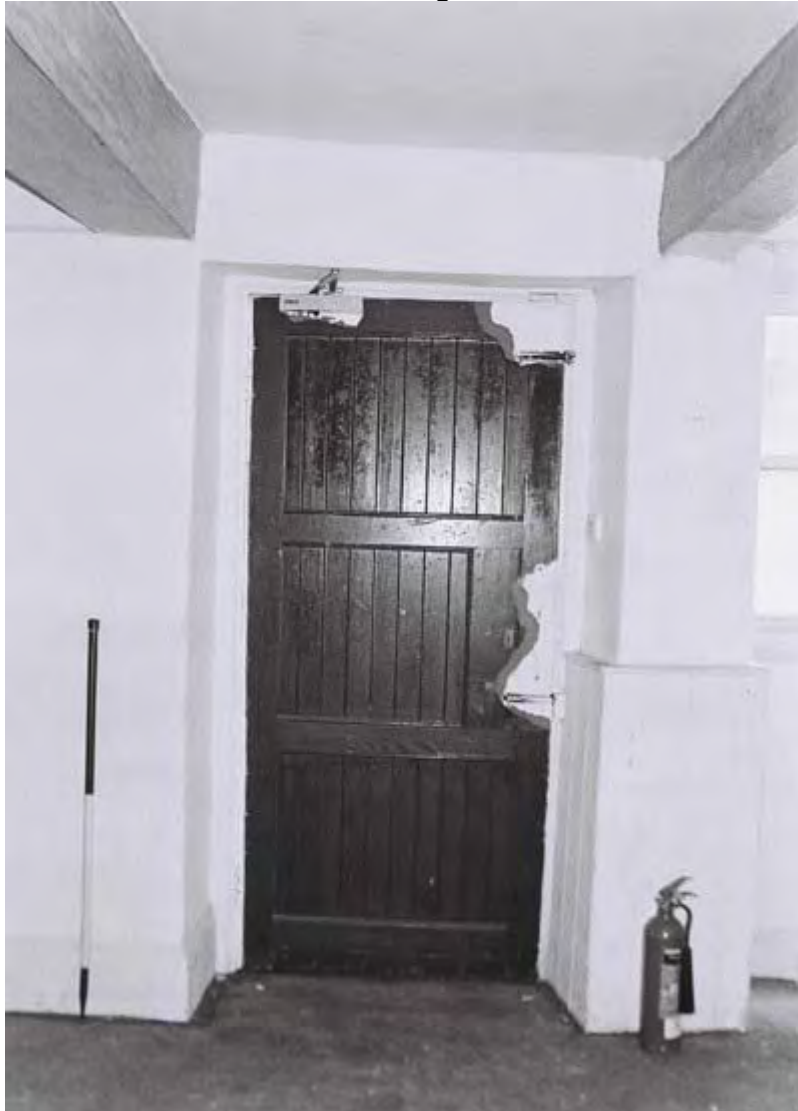
Plate 30. Marsden Park Cottage Interior. Ground Floor. Facing East.

- 6.3.4 There was a thick plank door between the east room and the hall into the extension (Pl. 30). The northern doorway led into a small pantry/cupboard and the door had an arched surround with central keystone (Pls. 31-34). The door into the kitchen to the east had a rectangular stone surround.
