JOHN MOORE HERITAGE SERVICES

HERITAGE IMPACT STATEMENT

WILCOTE HOUSE, HIGH STREET

HARWELL, OXFORDSHIRE

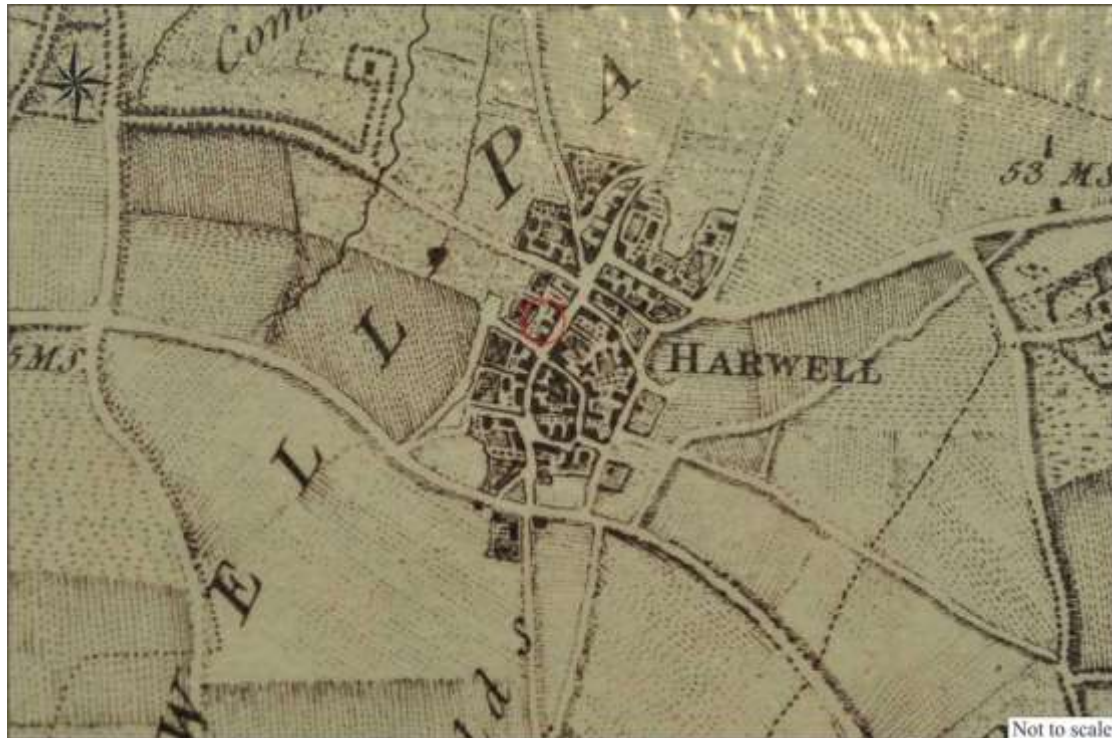
Figure 1 Map of 1761

A range of maps were consulted dating from the 18th century to the 20th century. The earliest map is Rocque's map of 1761 (BRO T/M 128) shows a series of properties on the west side of the High Street, but the detail is such that we cannot determine the location of minor buildings (Fig. 1). What can be stated is that the west side of the High Street was occupied by a series of tofts. A similar situation can be stated from Greenwood's maps of 1823-4 (BRO PM39/2) and 1829 (PRO D/ERuP5), (Fig. 3).

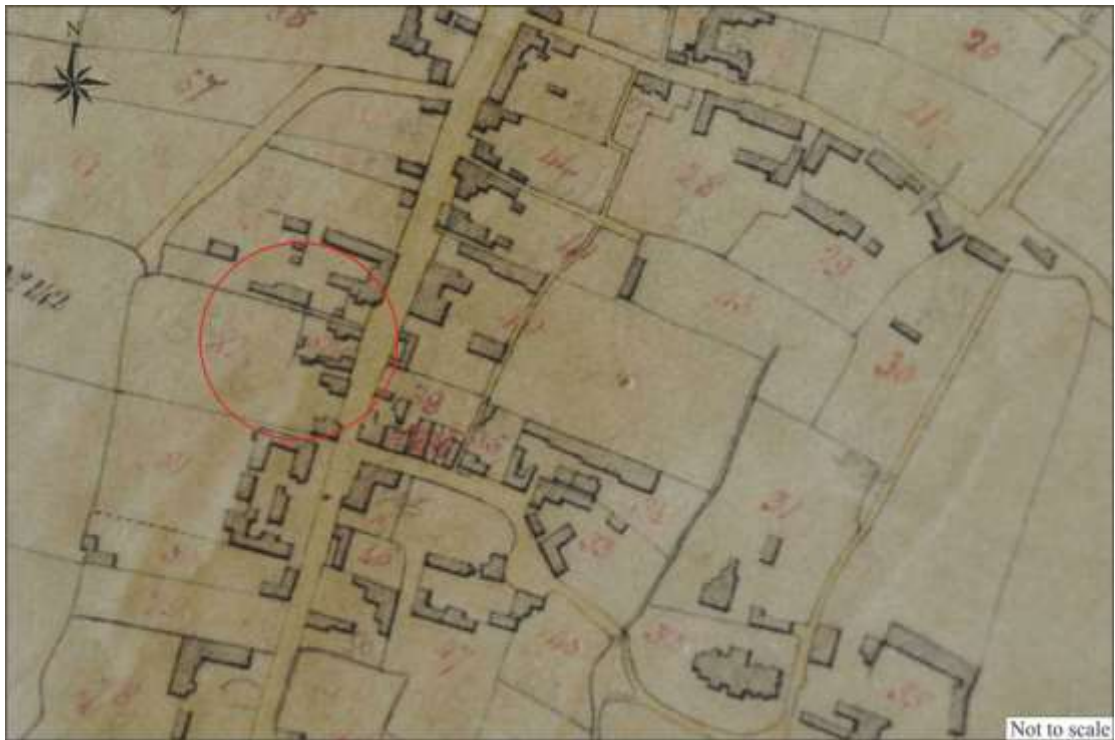
Figure 2 Inclosure map of 1804

The Inclosure map of 1804 (BRO CPC64/20/1) has slight discrepancies in its accuracy between the buildings on the east and west side of the High Street (Fig. 2). However, the Almshouse is clearly marked as a winged building on the east of the road, which originally orientates the structures. To the north and alongside the remains of a road it is possible to identify White Cottage and House as a long linear structure as it is today, but which has a small south projecting wing, which is gone from some later maps. To the south it is also possible to note the remains of Lime Tree House as a large double winged structure; on later maps the west wing has been demolished. To the north of this and facing onto the road is the area of the former

public house, the buildings on this plot are three in number and do not conform to the later structures; two of these structures front onto the road and one of them backs

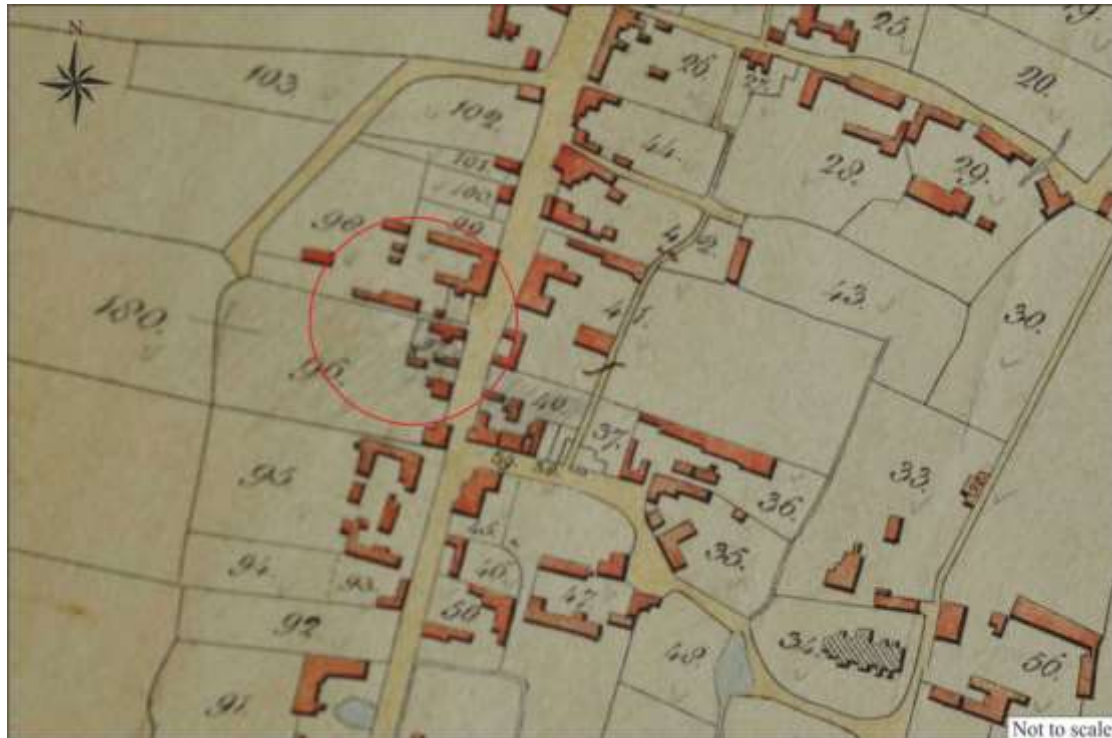
Figure 4 Tithe map of 1841

structure. However, on the proposal site it is apparent that the land was formerly attached to White Cottage and that there is an L-shaped structure in the southeast corner of the plot, which could feasibly represent the two outbuildings which are affected by this development. If this is so it would indicate that these structures or at least the imprints of the structures are at least datable to the late 18th century in origin and part of a former arrangement associated with White Cottage. A building is located on the rear part of that property. The Tithe Map of 1841 (BRO D/D1 64/1) shows a similar arrangement of buildings, and is evidently almost a copy of the earlier Inclosure Map, though there are some alterations (Fig. 4). Wilcote House has a date of 1852 across the front of the building emblazoned in blue brick.

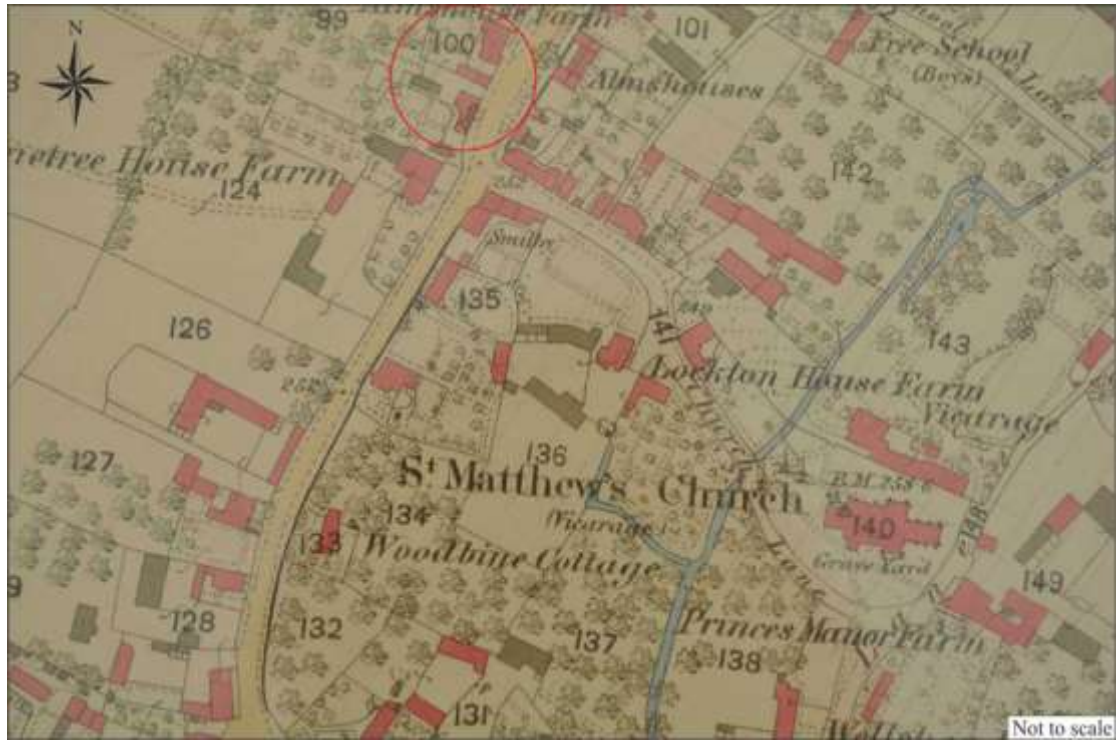
Figure 5 OS First Series map of 1876

The First Series Ordnance Survey map of 1876 (OS XV.10) shows the street line as it is at present indicating that Wilcote House was in its present form in the front, however to the rear of the building the northwest wing is only a stump of what it is now (Fig. 5). The building which now operates as a shop is depicted on the map, but only the section in the front. The Second Series Ordnance Survey map (OS XV.10) shows the same outline, but shows the extension or north wing to the rear of Wilcote House (Fig. 6). Thus this part of the building can be dated to 1876 to 1899, and is a late Victorian structure. The linear building along the south side of the property is extended at this time, thus putting a similar date on the buildings here. The Third Series Ordnance Survey map (OS XV.10) shows the same outline of the property (Fig. 7), as does the fourth series Ordnance Survey map (OS XV.10), (Fig. 8).

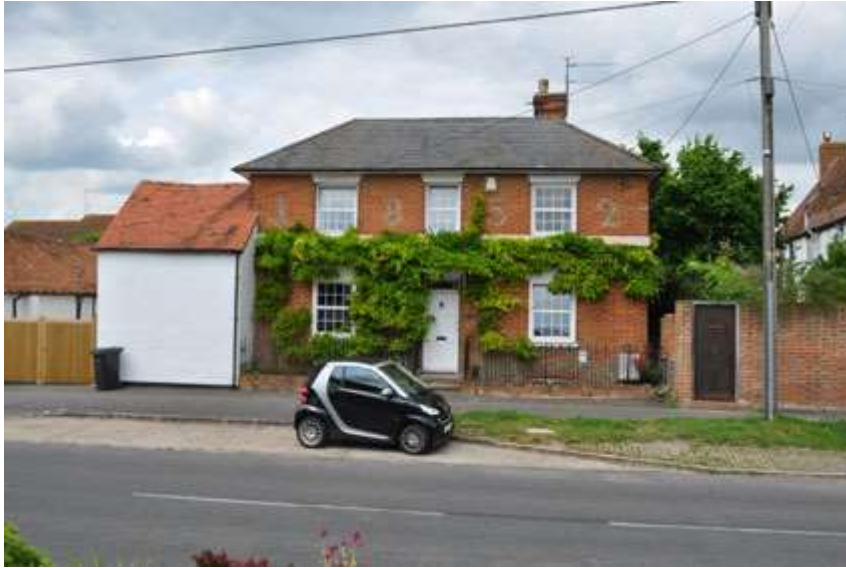
Plate 1 Front façade of Wilcote House

The front façade of Wilcote House, which is the most critical for the conservation area, has a number of component parts (plate 1). The front façade of the house is of red brick with blue brick decoration. The structure has three bays and is of two storeys. On the right there are indications of a cellar, and three modern casement

windows duplicating sash design. The central bay contains a six panelled door on the ground floor with steps to and window light and porch above. There is a modern casement window above. To the left there are two modern casement windows replicating sash windows. The sash windows have soldiered lintels, most of which are painted white. The lower part of the wall has a wide band of blue brick, perhaps trying to emulate the idea of a plinth. Between the ground floor and first floor windows there is a raised plane band covered in plaster or render. Above the band and spaced outside and between the first floor windows is the date 1832. The above roof is hipped with a chimney on the right.

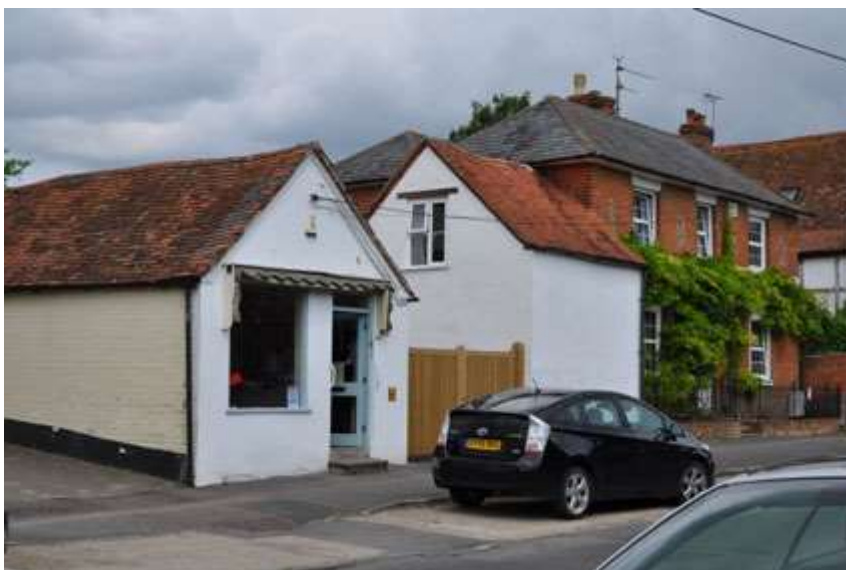
Plate 2 Front façade of southern linear shaped building and parts of east façade.

To the left of the front façade is a high single storey projection (plates 1 and 2), which unlike the Regency part of the property extends to the street line as it is marked on the maps of 1804 and 1841. The north wall, east wall and the south wall are rendered and painted white. The extension is covered in red clay tile.

The south wall of the structure contains a red brick wall below part of a hipped roof system with a central valley. Against which on the right there is a high single storey projection with a gable end. This contains a window, with a new casement, and black painted timber lintel. The structure is rendered. There is a single storey extension to the rear.
