BARROW CASCADE HOUSE, DERWENTWATER, CUMBRIA

Archaeological Desk-Based Assessment

Client: John Cunningham
Architects

© Greenlane Archaeology Ltd
July 2006

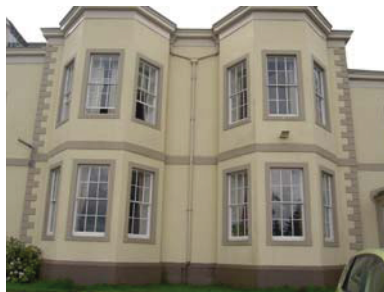
Cantled bays, centre

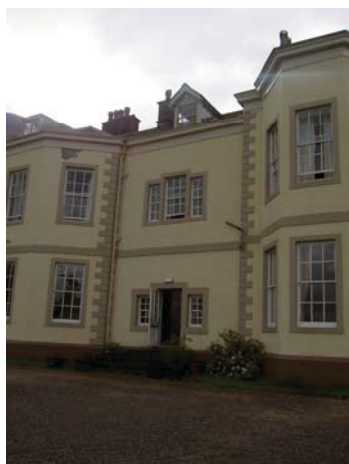
Venetian openings east of centre

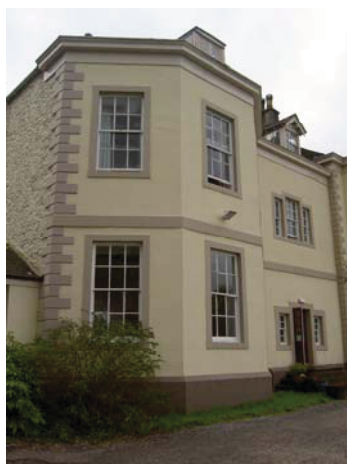
Cantled bay, east end

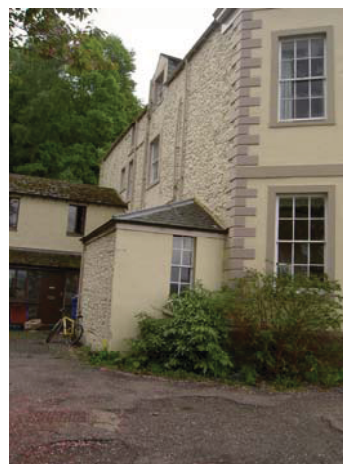
Outshut, east end

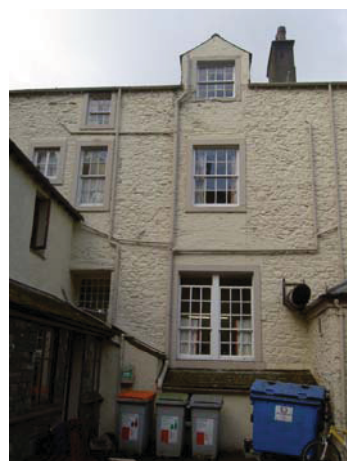
Central part of east elevation

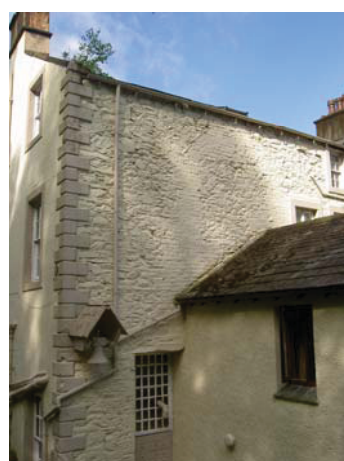
South side of east elevation and flue scars

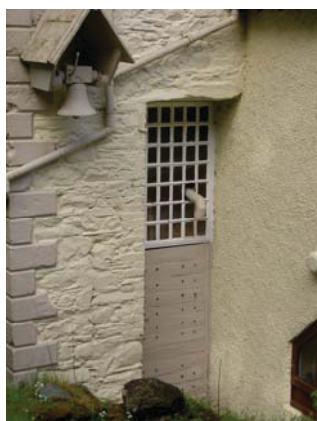
Bell and doorway, south side of east elevation

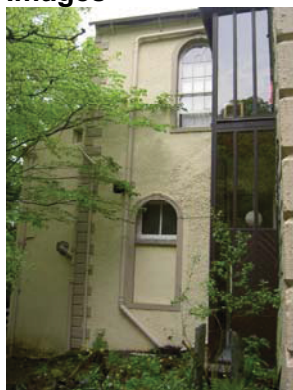
West wing

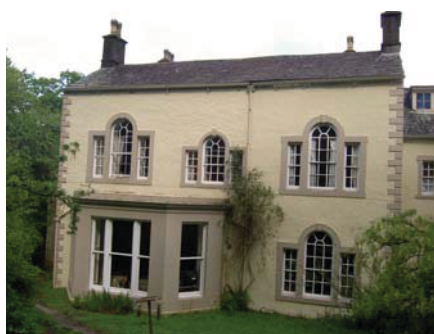
Central section

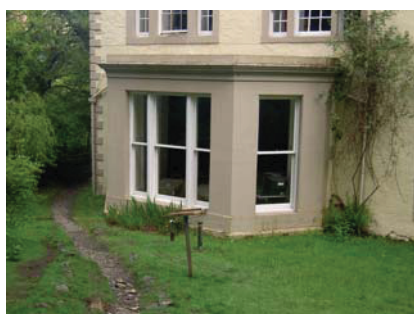
Detail of canted bay window

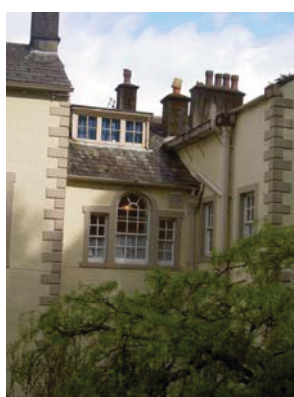
Detail of hopper on east wing

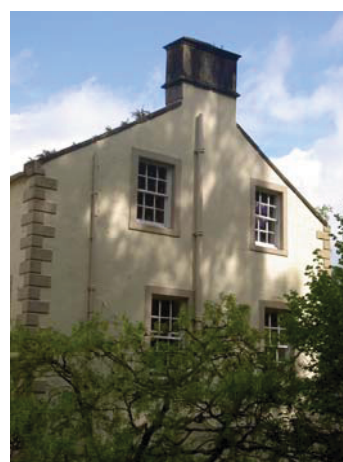
East gable extension

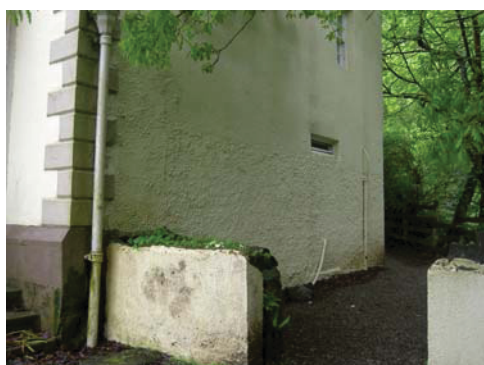
Remains of flanking wall and blocked doorway

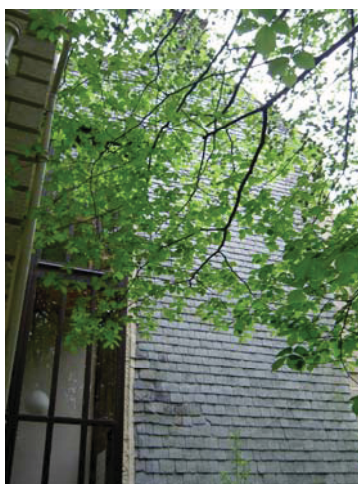
Slate hung gable

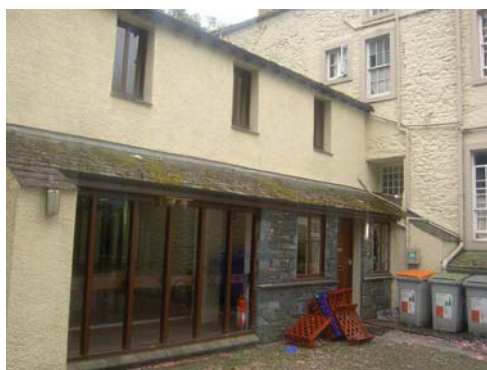
West end of north elevation

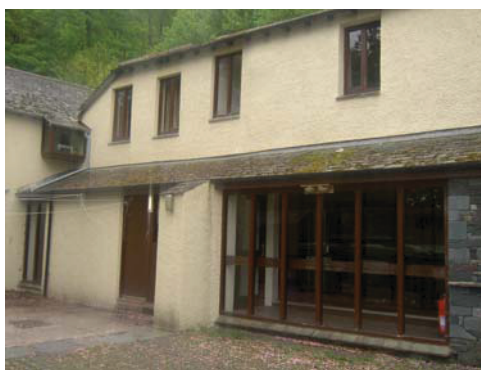
East end of north elevation

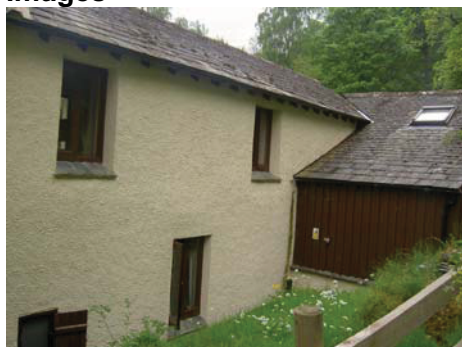
West end of south elevation

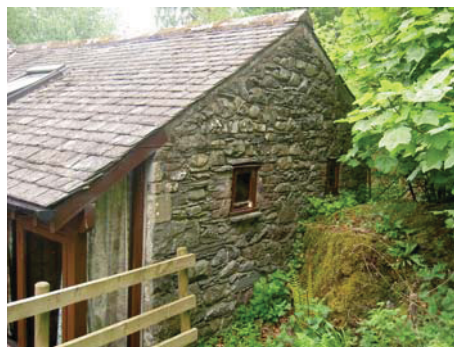
East end of south elevation

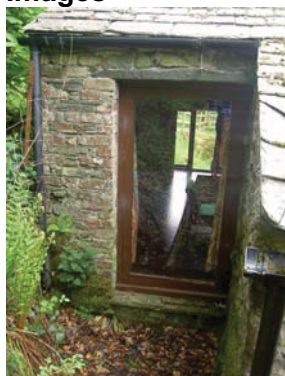
Window on south side

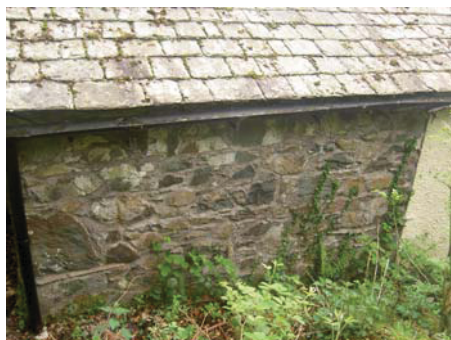
Wall at south side

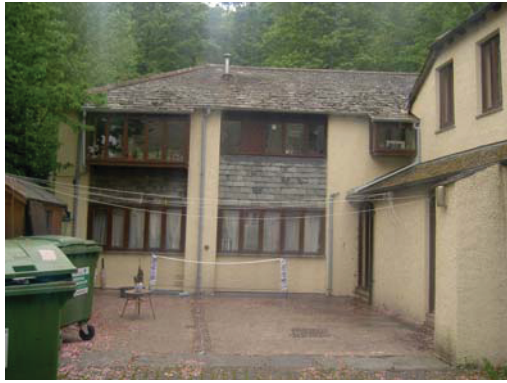
West elevation

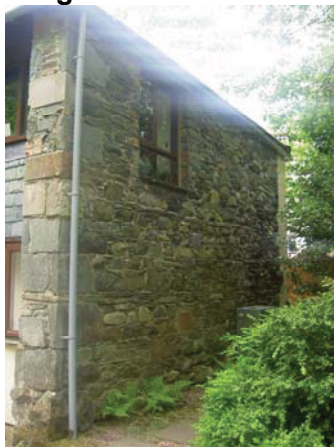
North elevation

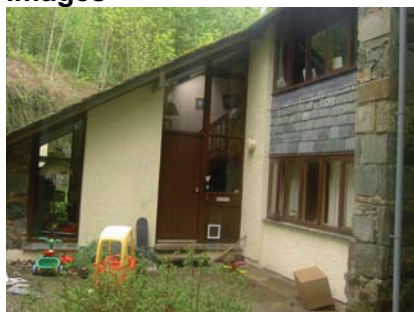
North end of east elevation

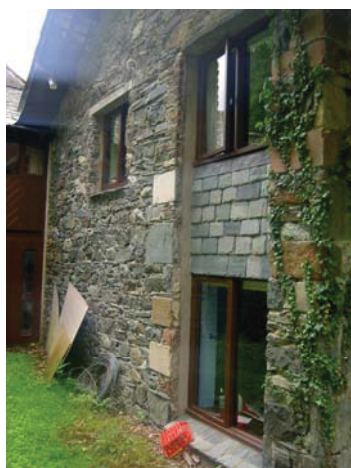
South elevation

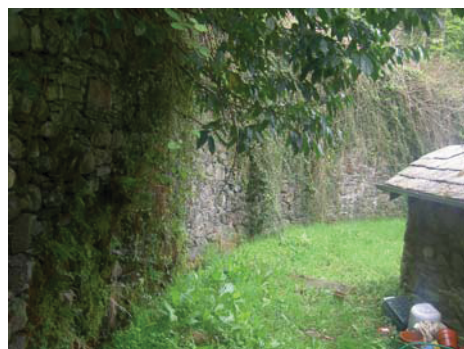
General view of wall

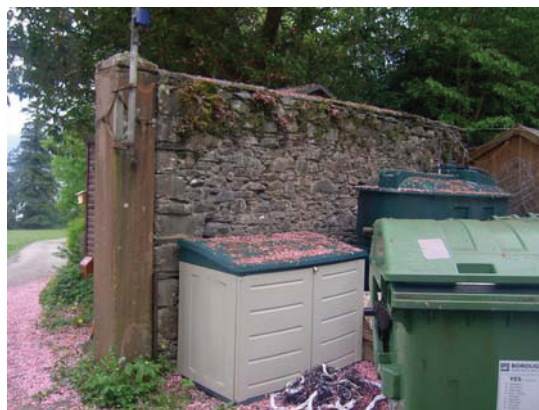
Remaining gate pillar

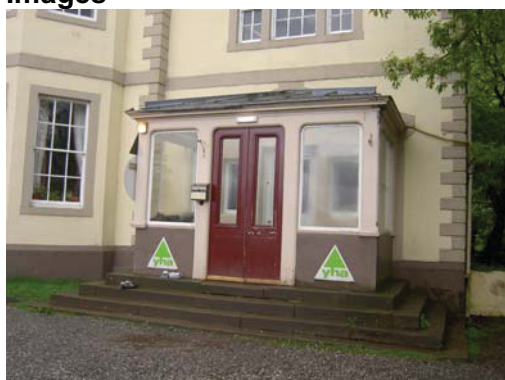
North external elevation

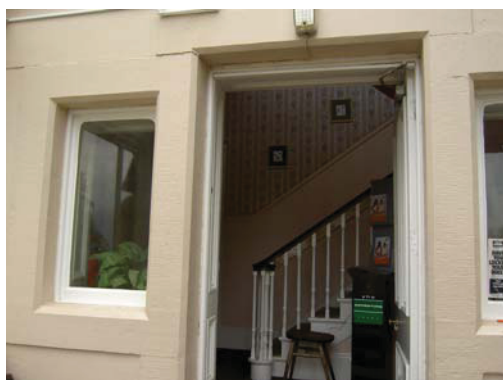
Detail of Venetian doorway

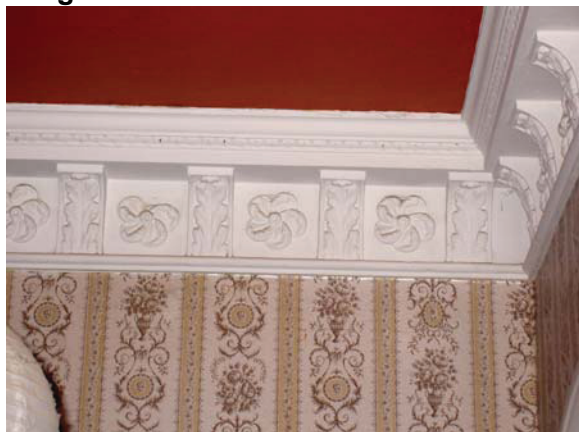
Cornice detail

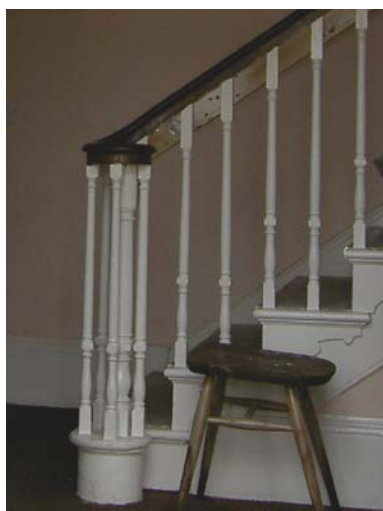
Twisted handrail end

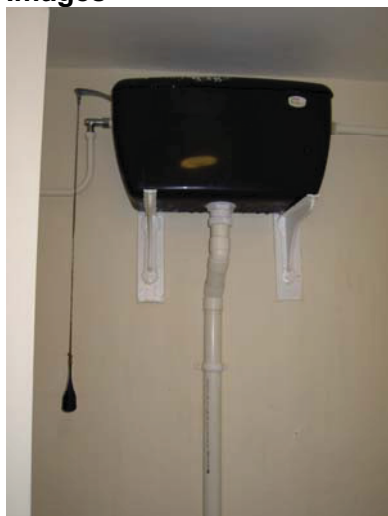
Toilet cistern on iron brackets

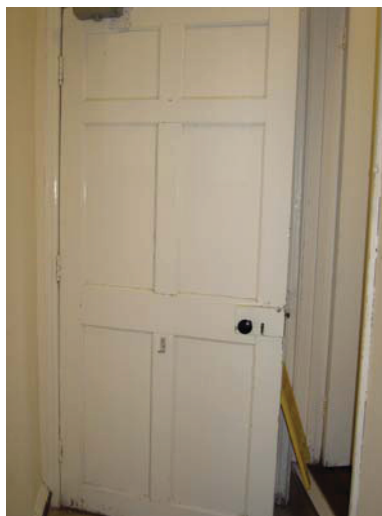
Door in east elevation

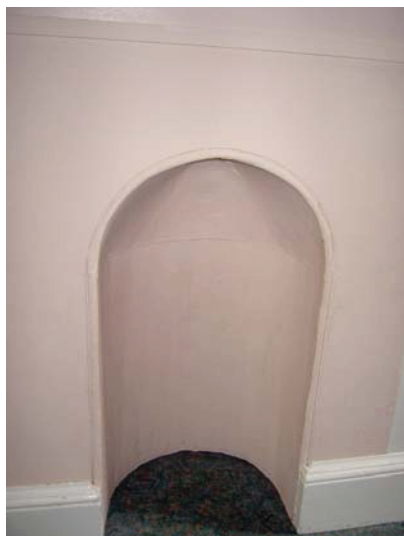
Alcove in east elevation

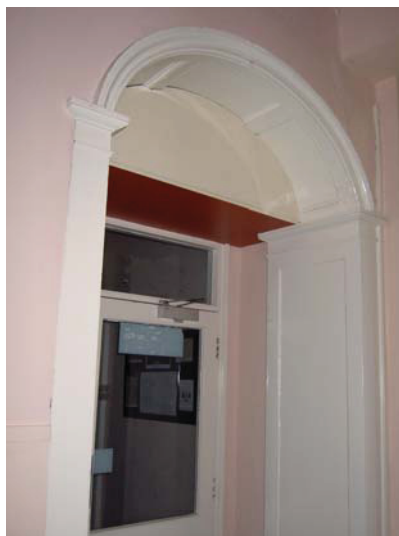
Doorway between G4 and G5

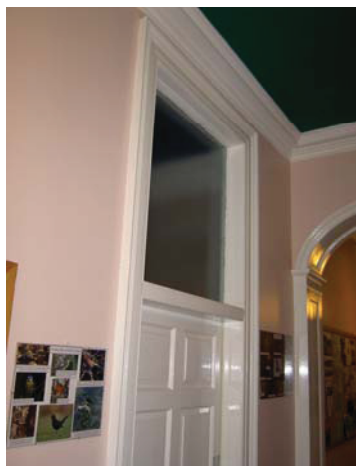
Door with overlight in north elevation

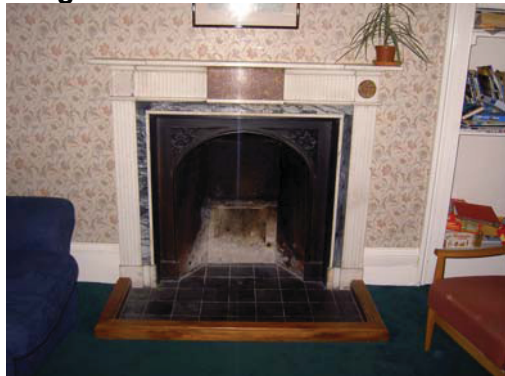
Fireplaces: against west elevation, white marble surround decorated with fluting and coloured marble inserts and with iron back decorated with Gothic style tracery, leaves and rolled moulding – late 18th century with 19th century insert?, good condition

Fire place on west wall

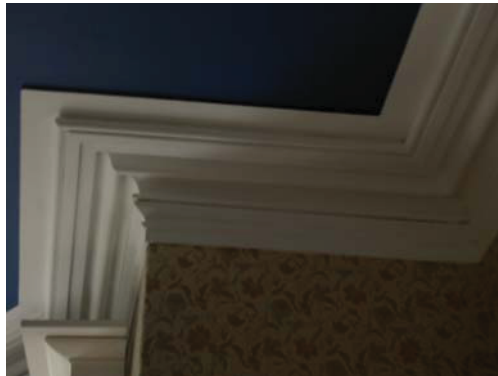
Roof/ceiling: plaster and paint finish with moulded cornice decorated with beading – late 18th century(?), good condition

Detail of cornice

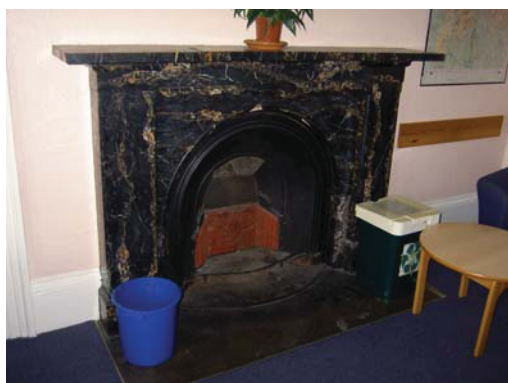
Fireplaces: against east elevation, black marble surround with lamb's tongue chamfer decoration on engaged pilasters and round-headed central opening and iron insert with beaded decoration – late 18th century, poor condition

Fireplace against east elevation

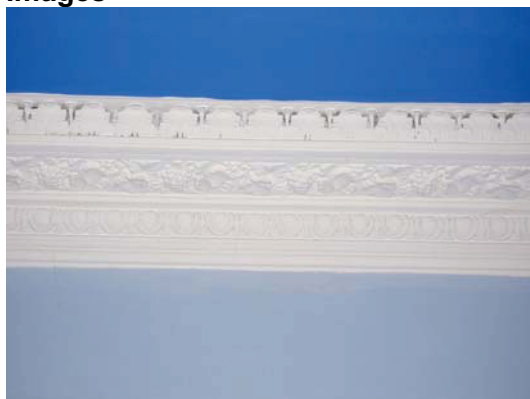
Roof/ceiling: plaster and paint finish with moulded cornice decorated with acanthus leaves, vine leaves and grapes, and egg and dart – late 18th century, good condition

Cornice detail

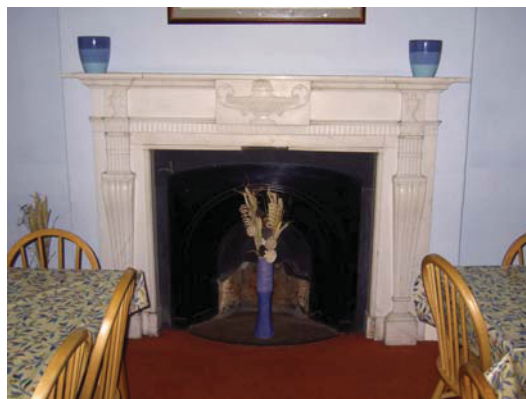
Fireplaces: against west elevation, white marble surround decorated with urns in relief and fluted baluster style pilasters, iron inserted grate with roll moulding – late 18th century, fair condition

The fireplace against the west elevation

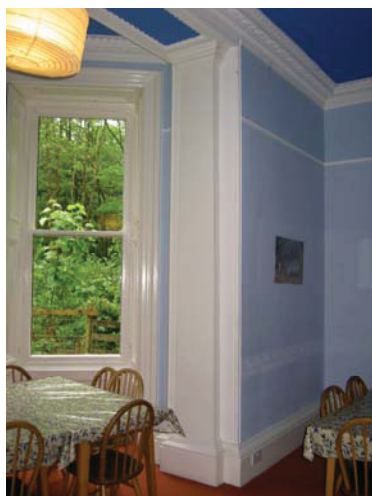
Other features: arched opening into bay windows has engaged pilasters with moulded bases and architraves and plaster detailing beneath the arch continuing that of the cornice – late 18th century, good condition

Pilasters surrounding bay window

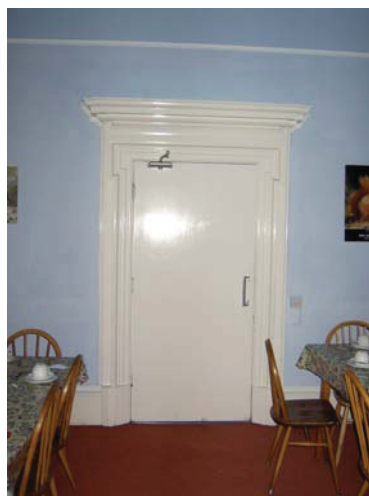
Doors: to north, very ornate with moulded and lugged surround and entablature – late 18th century, good condition. To east is an inserted or heavily altered doorway – 20th century(?), poor condition

Decorative door to north

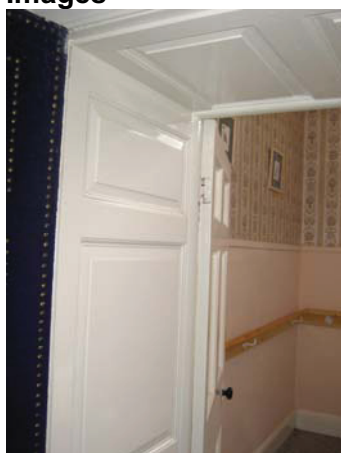
Doors: deep doorway in north elevation with outer and inner doors, outer as per F1 description, internal covered in black felt and brass studs, but presumably covering a six panel door – late 18th century, with modern alterations, fair condition

Panelled door surround

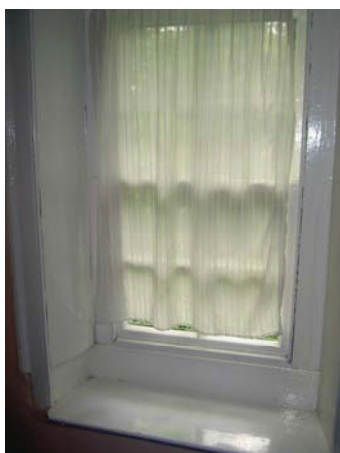
Windows: small window in west elevation with ovolo-moulded and beaded side panels, partially damaged sill and missing shutters – late 18th century, poor condition

Window in west elevation

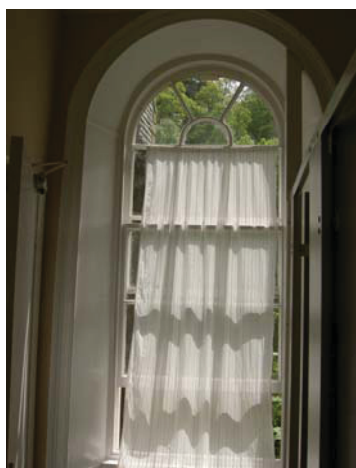
Windows: Venetian-style window in south elevation, round-headed with cyma moulded and beaded surround, sill cut down at both ends, perhaps suggesting it was originally part of a full Venetian window? – late 18th century, poor condition. Three small windows at high level in west elevation, each two-light with hinged casements and twisted detailing on latches – late 19th – 20th century, fair condition

Venetian window to south

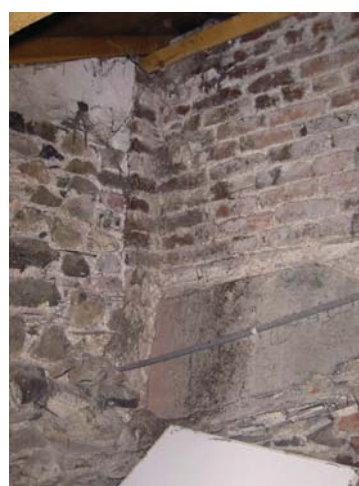
Walls: plaster and paint finish – modern, fair condition. In the roof-space the half of the north and east wall are constructed from hand-made brick, while the rest is more randomly coursed stone. The brick wall on the north side butts the stone wall at its west end – late 18th century, fair condition.

Butt joint of brick and stone walling

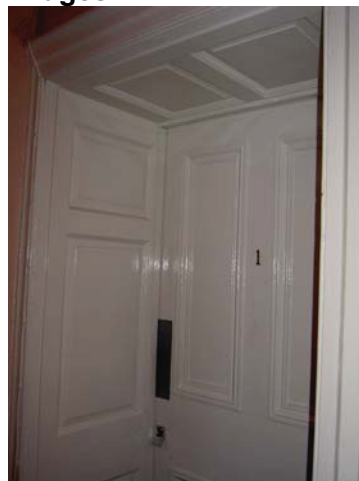
Doors: door to east at west end (into F5) has four panels, with cyma moulding and beaded decoration, and an ovolo moulded surround – late 18th century, good condition. At the west end the doorway linking the two sections of the corridor is inserted – modern, fair condition. Along the east/west part of the corridor there are several more doors. At the west end there is a door to the south with a very plain finish – modern, good condition. There are two doors to the south at the east end of the corridor, both with six bevel raised and fielded panels and panelled jambs – late 18th century, good condition. The doorway in the north elevation has four panels with cyma moulding and bevel raised and fielded panels, panelled jambs and ovolo-moulded surrounds (although the east side is covered by the stub wall) – late 18th century, good condition. At the east end of the corridor there is another six panel door with ovolo moulding and bevel raised and field panels in the jambs – late 18th

North door to F5

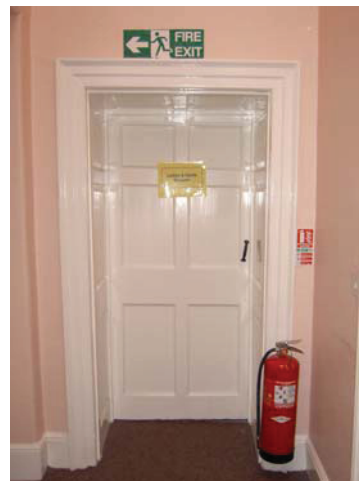
century, good condition. The doorway in the north-east corner is filled by a fire door – modern, fair condition

Door at east end of corridor

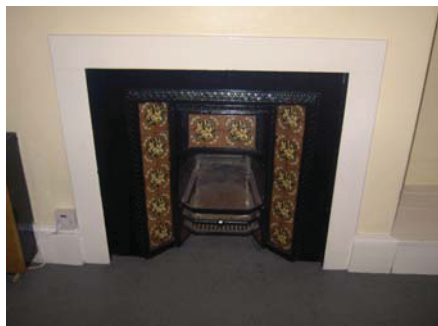
Fireplaces: chimneybreast against north elevation, fireplace with square surround and iron insert with transfer printed and painted tiles – late 18th century with late 19th century addition, good condition

Fireplace

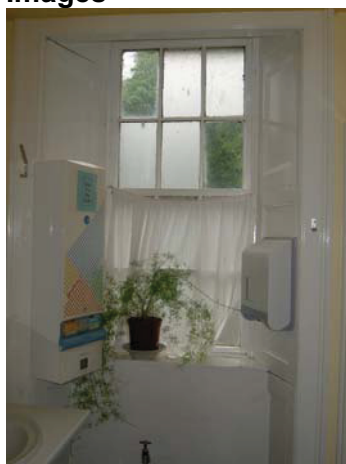
Windows: two in east elevation, one to north has splayed jambs, beaded panelling, including trapezoid panelling beneath the lintel, and cyma moulded surrounds and a sill has been added and the lower part has been partially filled – late 18th century with modern alterations. The southern window is a more recent insert and has a four-light hinged casement with curled latch fittings – late 19th – 20th century, good condition

Window

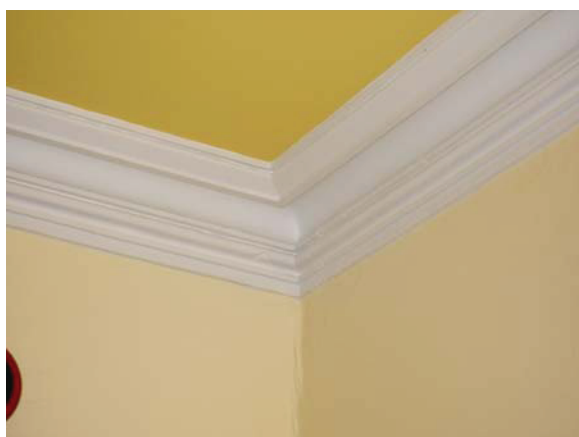
Roof/ceiling: plaster and paint finish – modern, good condition. Cavetto moulded cornice – late 18th century, good condition

Detail of cornice

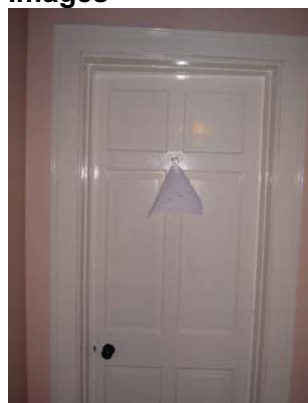
Doors: the room is essentially divided into a toilet and vestibule by a doorway mid-way down, this has six panels decorated with cyma moulding and beading – late 18th century, good condition. To the south is another doorway with a beaded and cyma moulded surround with scars for a hinges for a door but no door remaining – late 18th century, poor condition. To the east is another door in a similar style with six panels and a beaded surround – late 18th century, good condition

Door to south

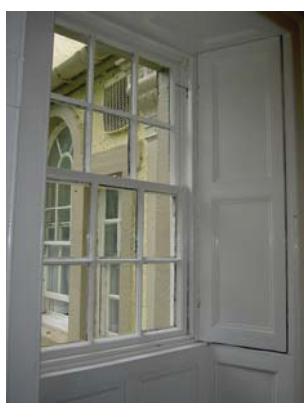
Windows: two in west elevation, southern most with splayed jambs extending to the floor, the lower part covered by modern panelling and with a sink attached, the upper part still has beaded shutters and cyma moulded panelling, including trapezoidal panels above – late 18th century with modern alterations, fair condition. The northernmost is a similar style but in better condition, with the original shutter fittings remaining – late 18th century, good condition

Northern window to west

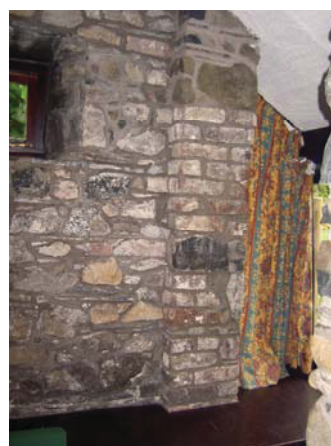
Rebuilding in brick

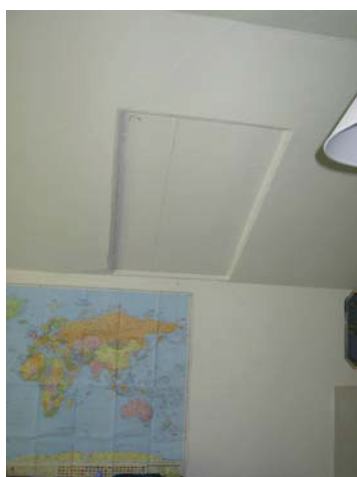
Blocked skylight

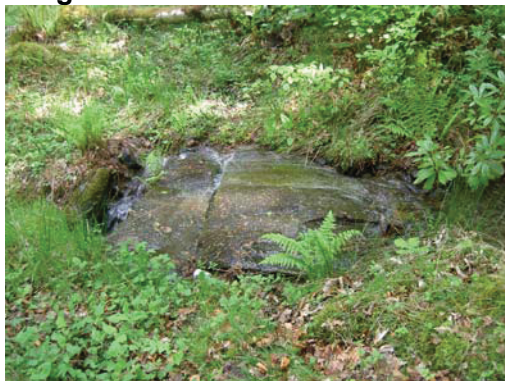
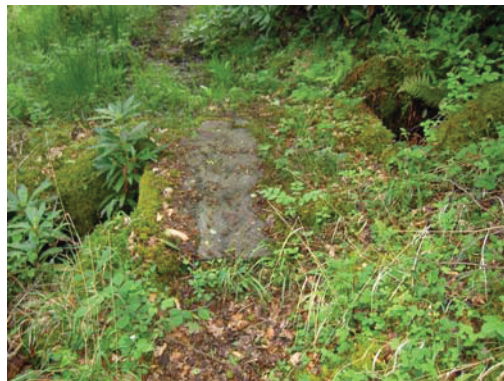
Condition fair

Clapper bridges

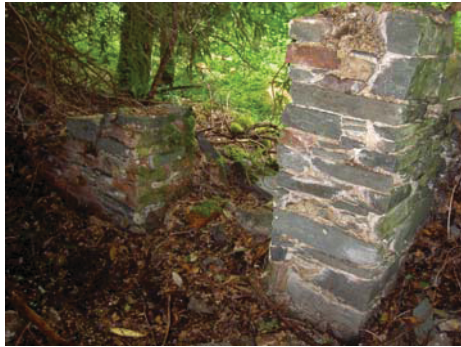
Condition poor

Ruined hermitage from the inside

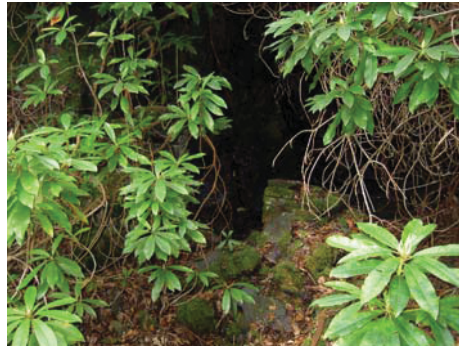
Ruined hermitage from the outside

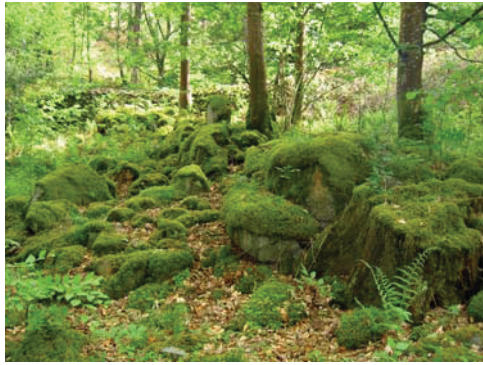
Description ruinous field boundary orientated north-east/south-west with drain along south-east side. It is constructed from large rounded stones including some extremely large orthostats, and has a number of large decaying tree stumps growing out of it. It is up to 1.4m thick and 1m tall. It incorporates a clapper bridge at its mid-point where it is cut by a footpath and it also pre-dates a field boundary to the north-east, which is built on top of it.

Condition poor

Orthostats in ruined boundary

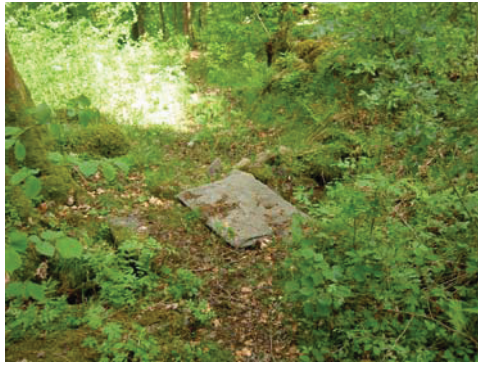
Clapper bridge cutting ruined boundary

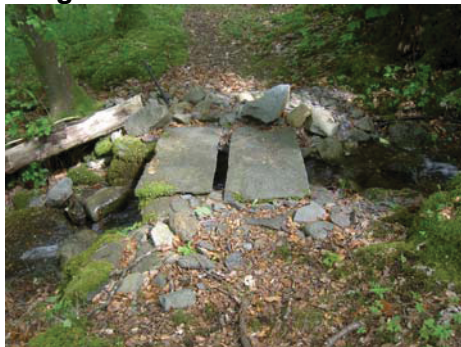
Condition fair

Clapper bridge
