Historic Building Record

**Old Crookhey Farmhouse,
Garstang Road, Cockerham,
Lancaster**

Prepared by
C.J.O'Flaherty MRICS, MSc
January 2009

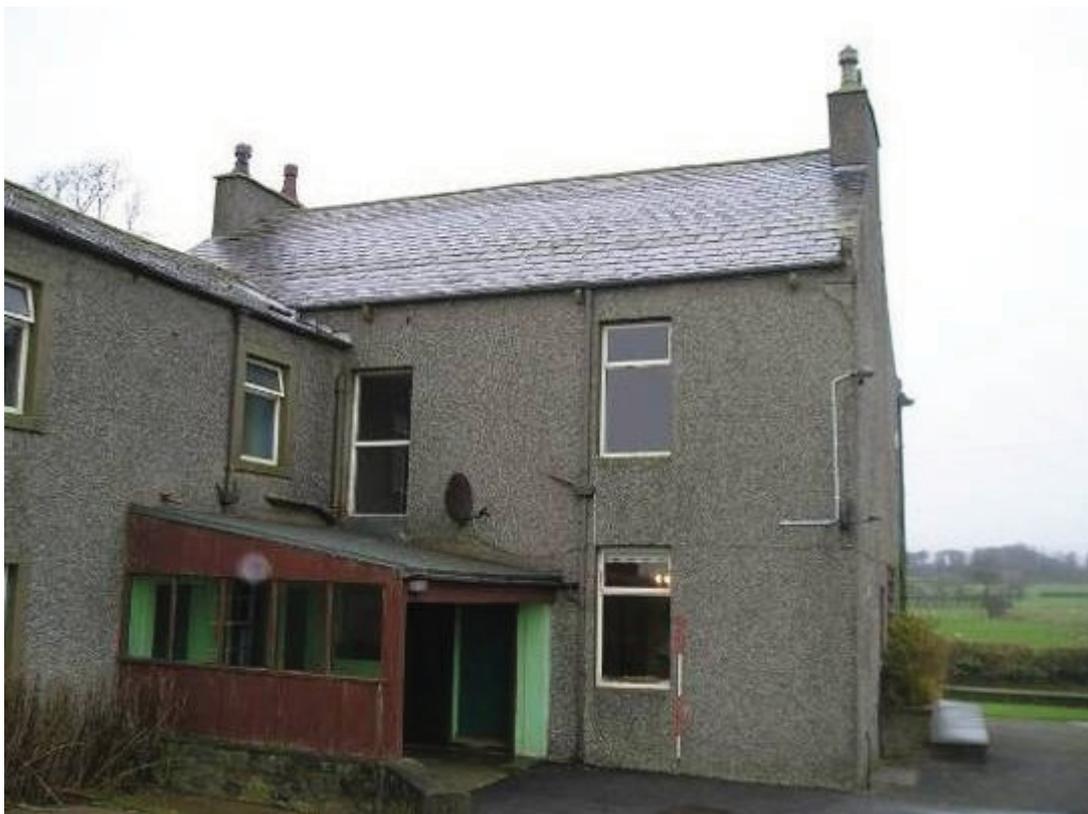
3. Rear elevation of the main part with the rear wing to the left. The lean-to structure at the junction of main part and wing is a timber shelter. This cuts across a tall stair window to the main house immediately adjacent to the intersecting wing. The render finish is not original: it is presumed that rendering was applied to aid waterproofing of the structure, and likewise to the interior the perimeter walls in several locations have been dry-lined

The dry dash cement render could be removed and, depending on the condition of the stonework, this could be re-pointed. The render may have been applied to improve weather resistance against wind driven rain. Re-rendering in a more appropriate material could be an option.

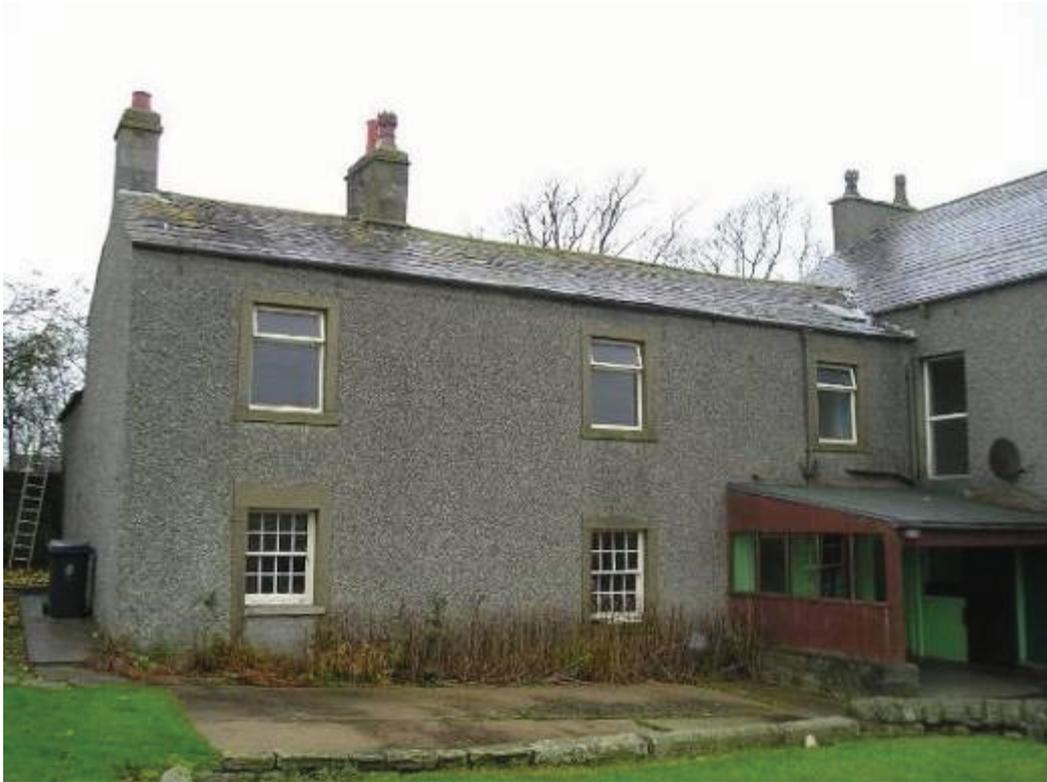
4. Southern elevation of rear wing with main house part to the right. The left window at ground floor was formerly a door (note blocked up wall beneath cill). The applied rendering could well hide evidence of phased addition: for example, it is feasible that the left end bay (to the left of the mid chimney) is an addition, as indicated by the close proximity of two chimneys and load bearing cross wall in the position of the mid chimney.

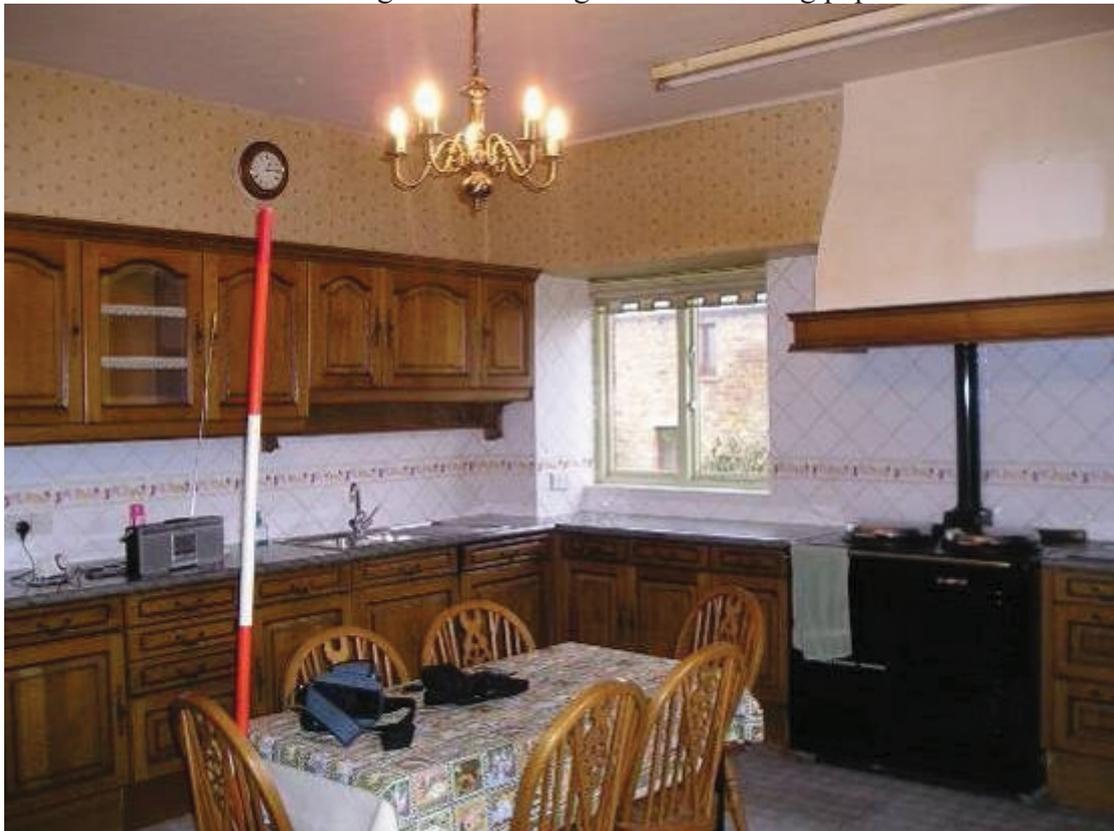
28. Rear left ground floor room to main house, now a kitchen. Former chimney beneath the decorative stove hood has been removed and a beam bulkhead inserted.

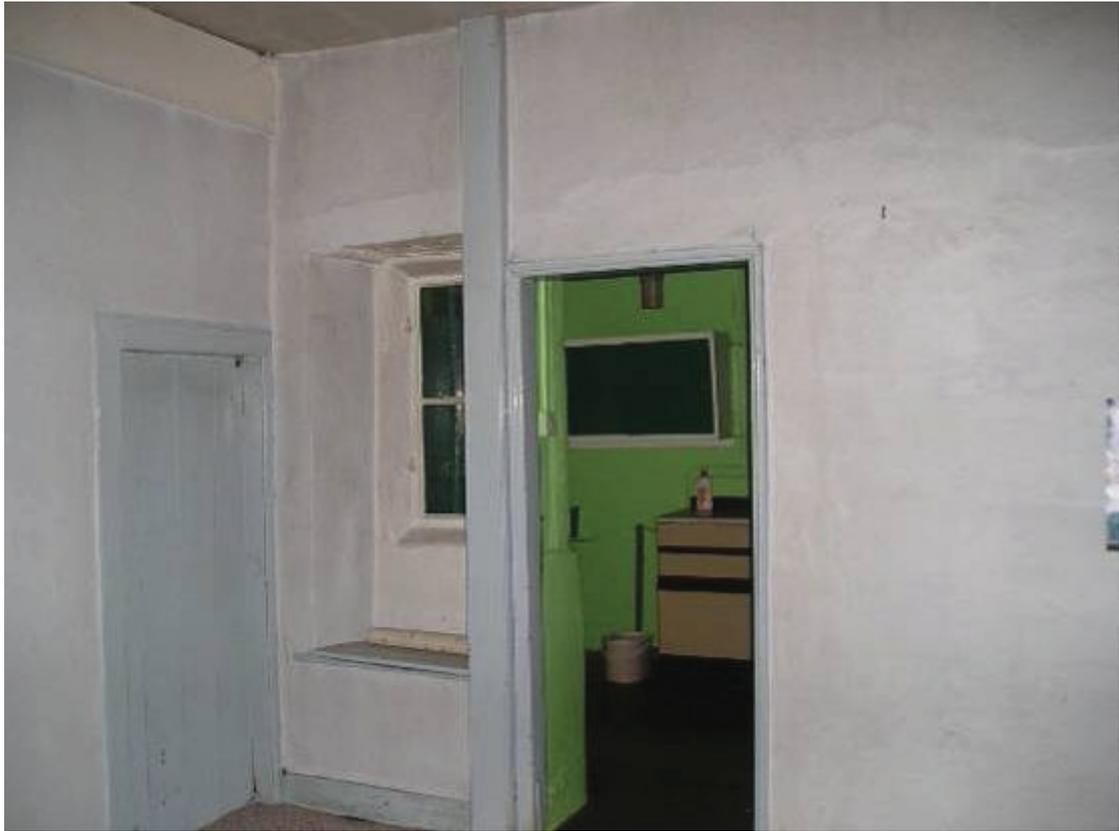
34. Rear right 'kitchen', looking through door out to the rear to an adjoining space that forms the commencement of the rear wing. The door left is that that enters the room from the understair area, above which there is evidence of former mounting panel for servant bell system. The window is an altered original stone mullion window part of which now is the door (centre)

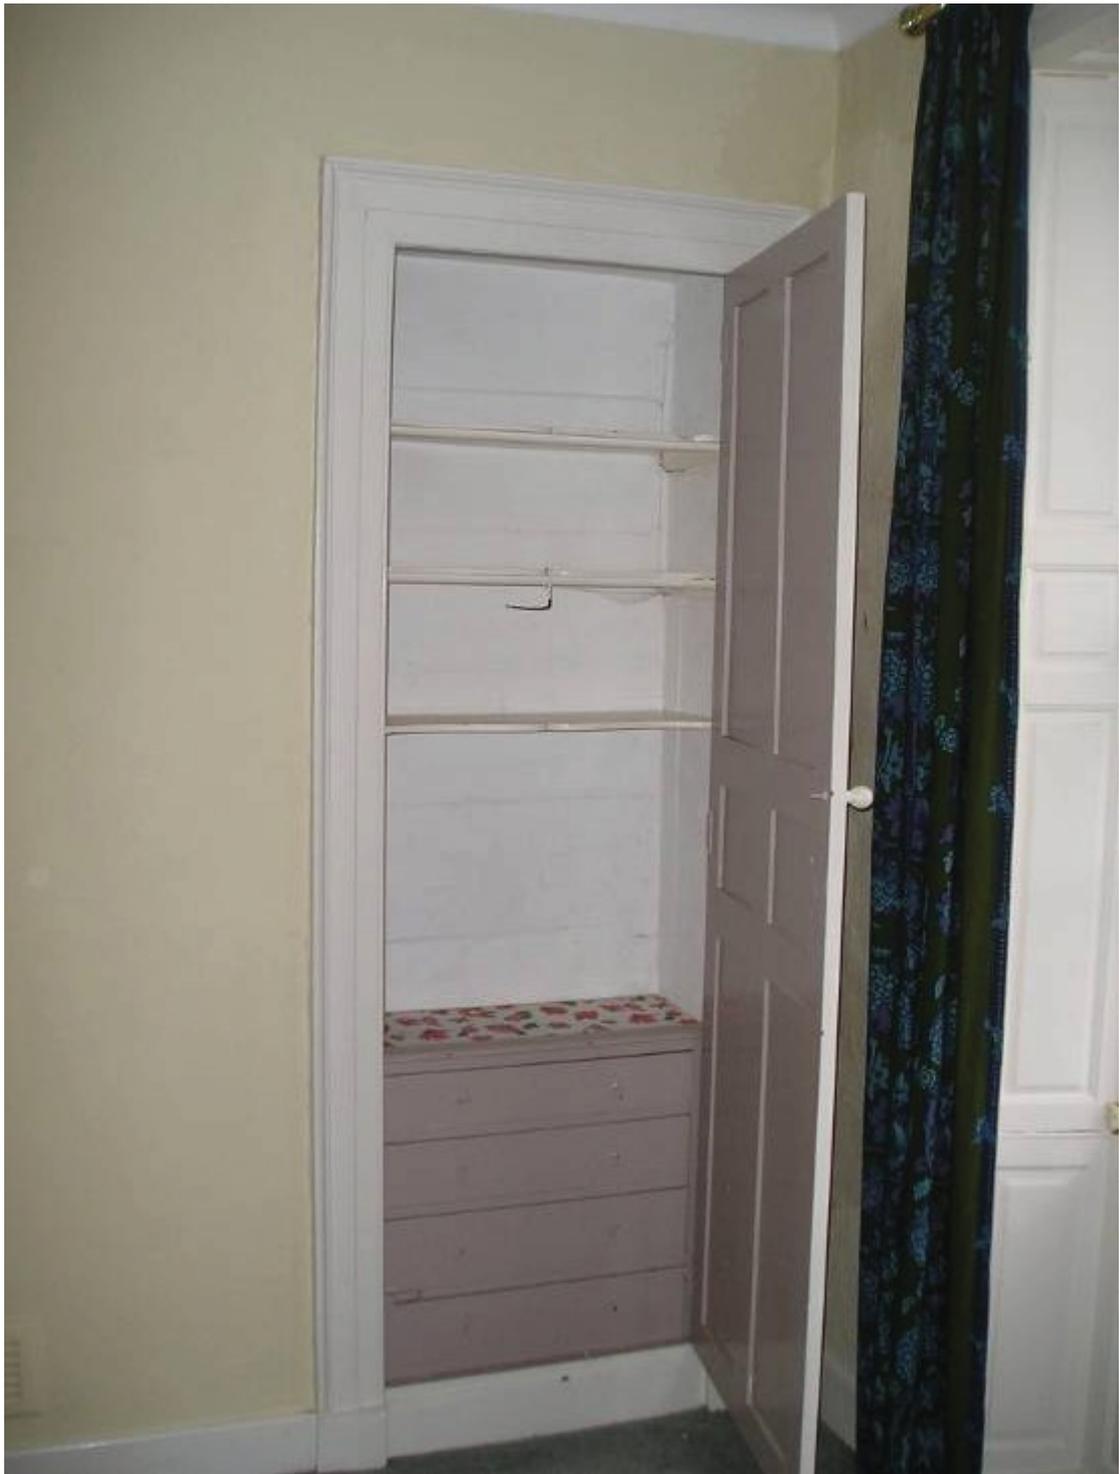
53. Front right bedroom – built in cupboard, scalloped edge shelves and drawers with historic ironmongery

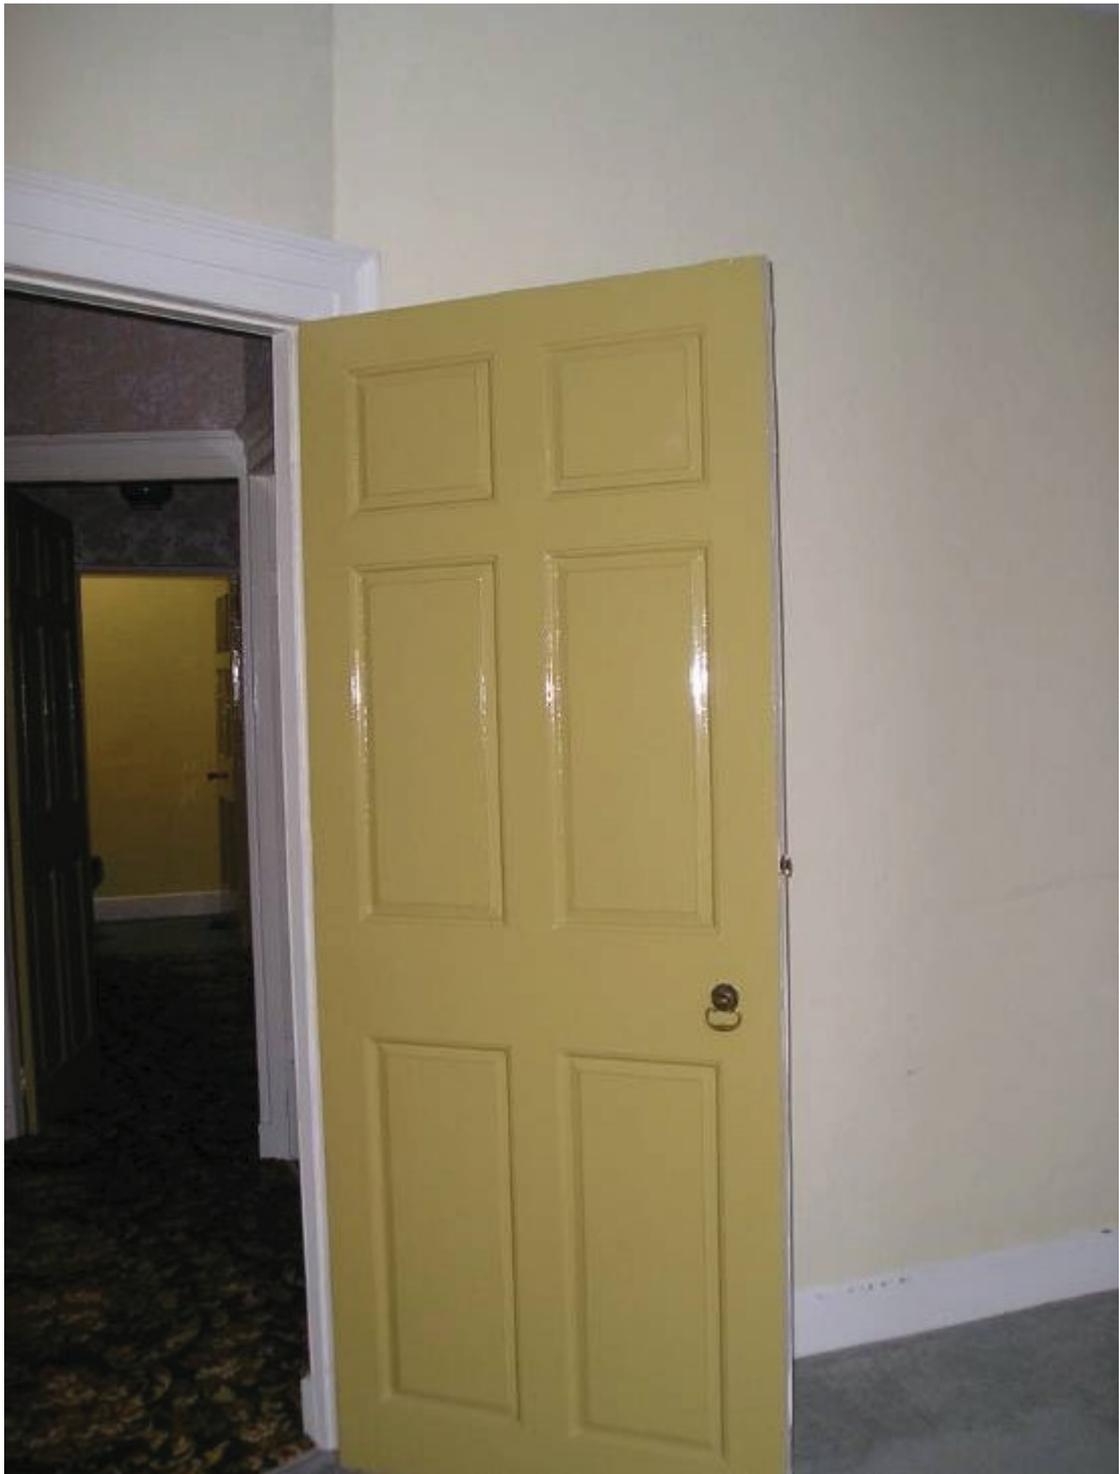
54. Typical six panel door to rooms off first floor landing

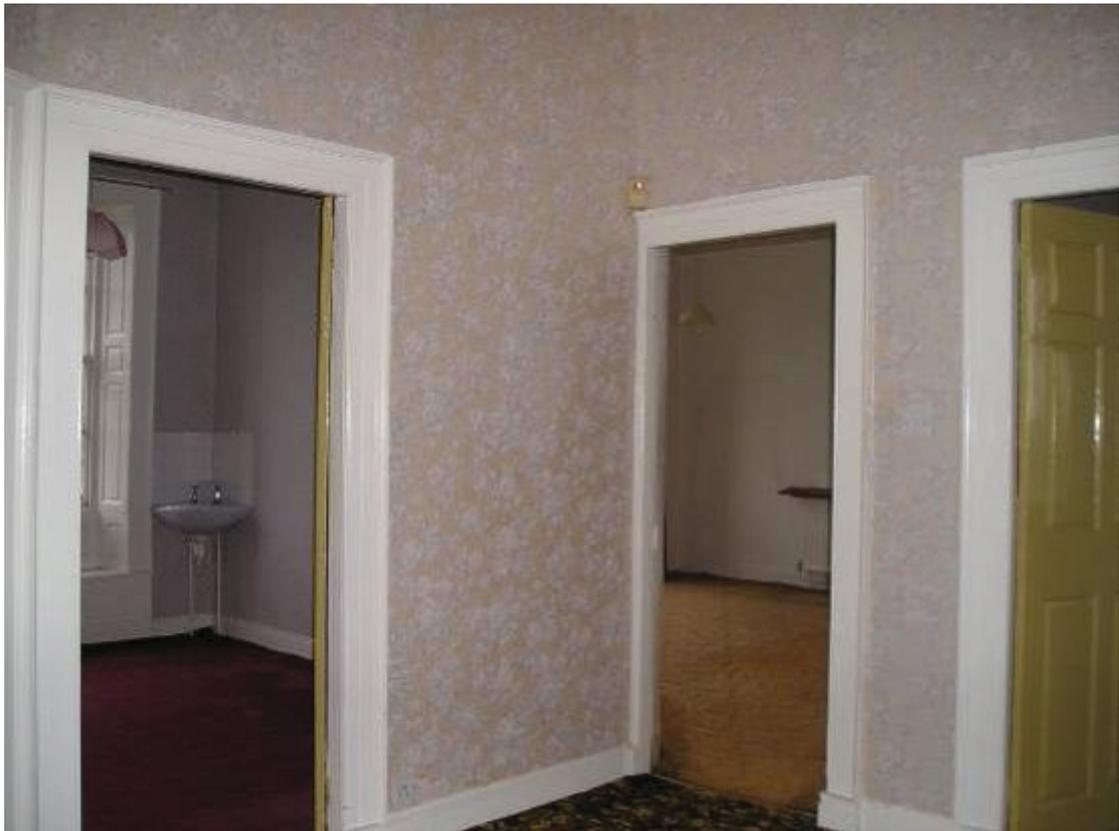
55. First floor, landing showing doors to front centre bedroom (left), front left bedroom (centre) and rear left bedroom (right)

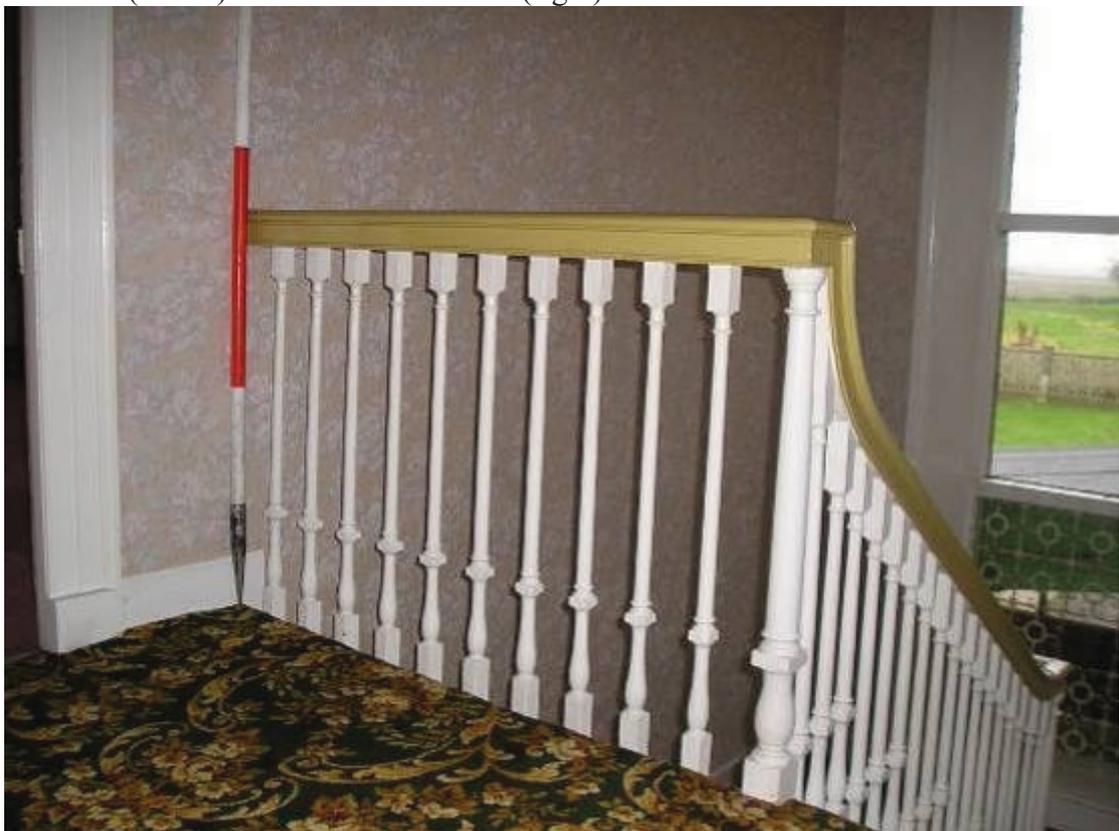
56. First floor landing – head of staircase

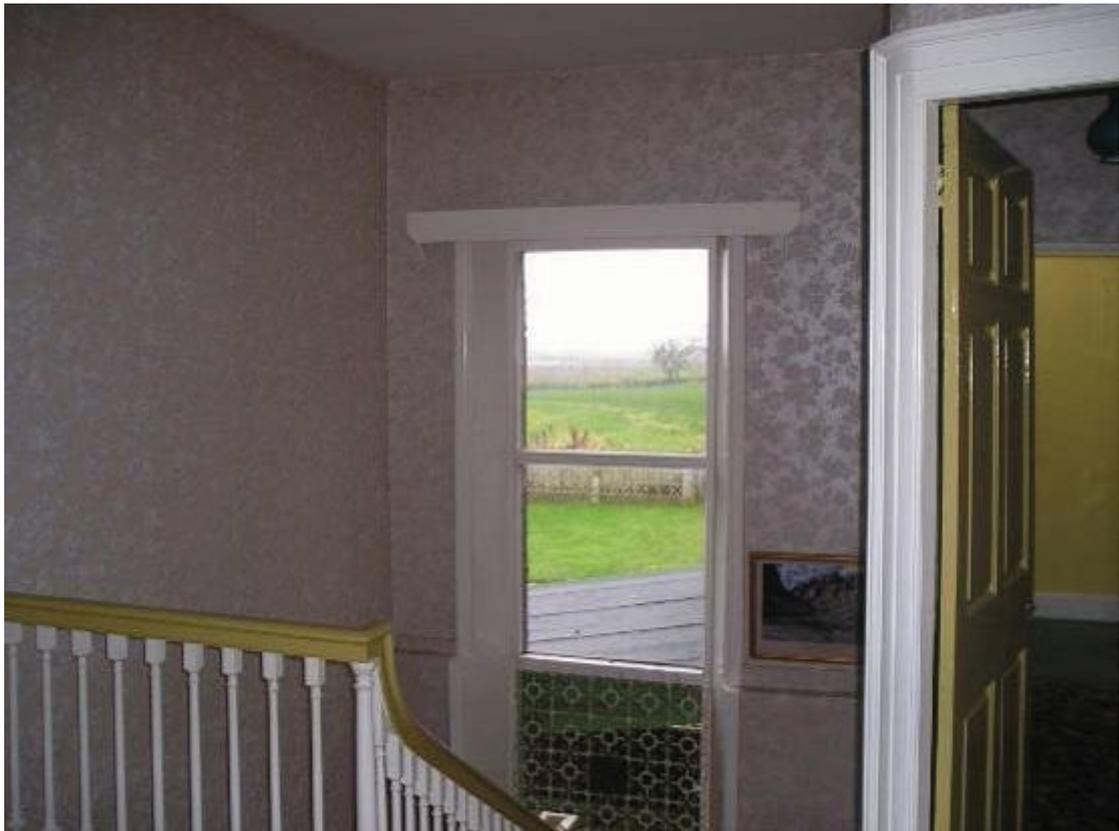
57. As 56, showing top of stair window and also door (left) into altered bathroom/wc to rear right corner of first floor accommodation

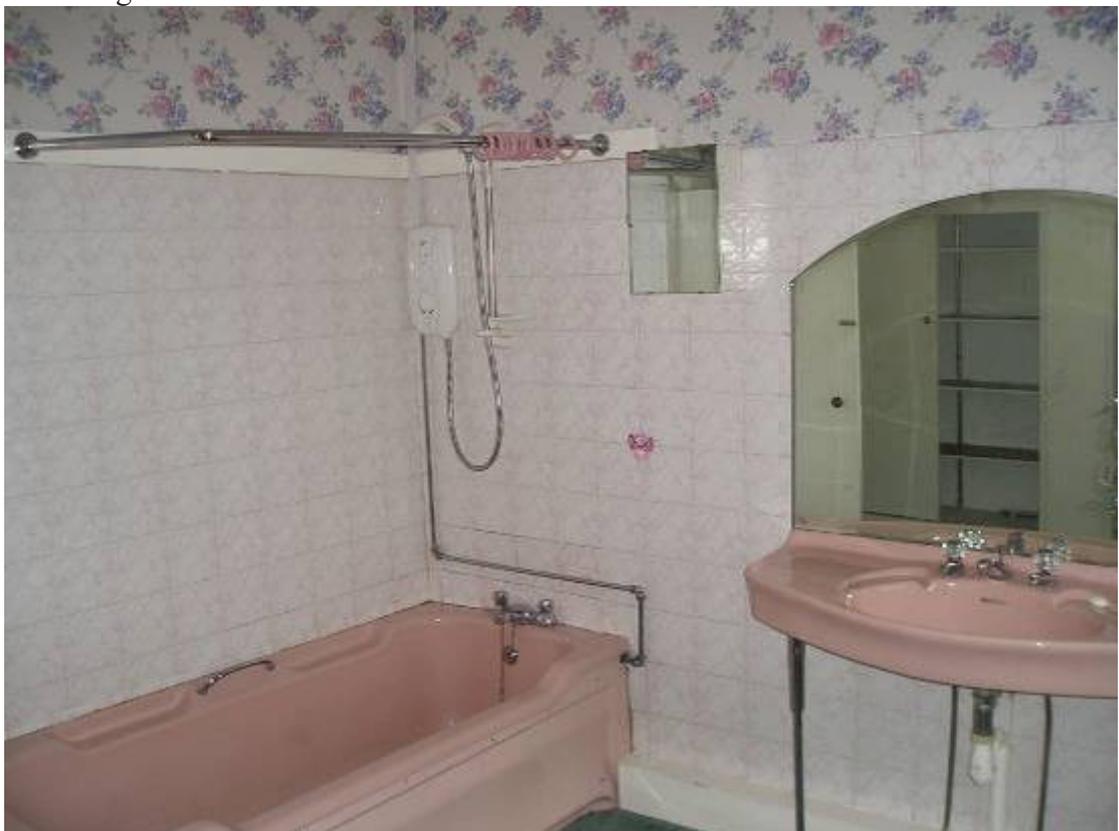
58. Bathroom to rear right corner (mentioned to 57 above)

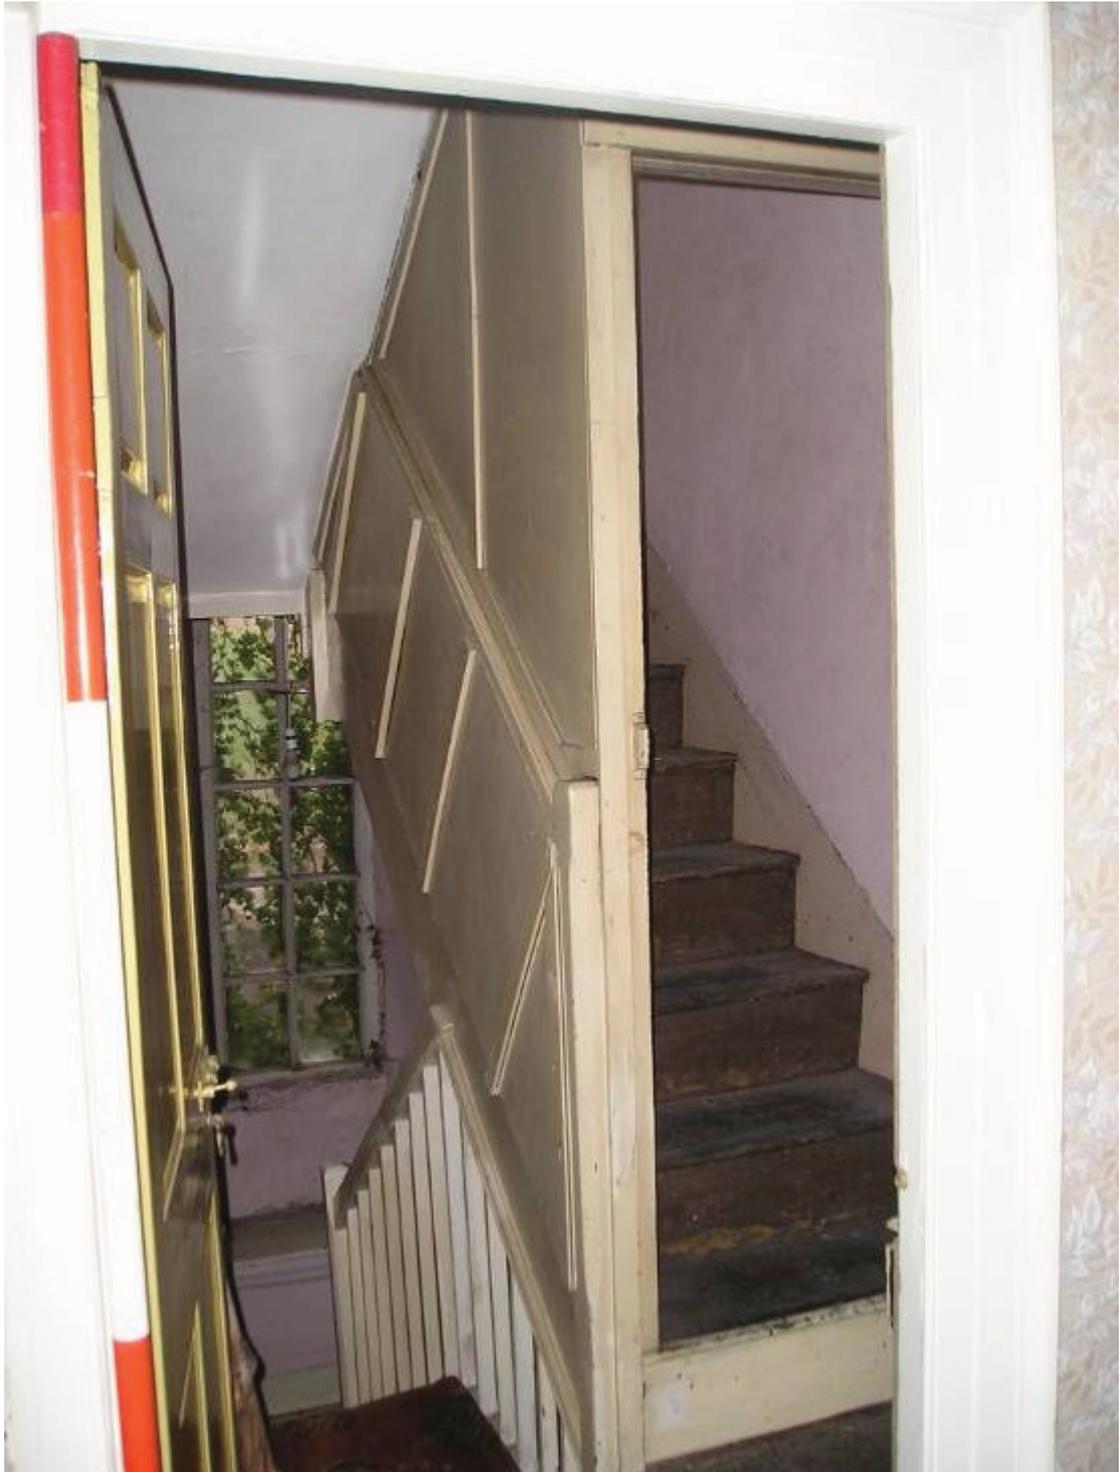
59. Rear service stair viewed through door off main landing showing stair flight up from rear right kitchen and flight up to attic rooms

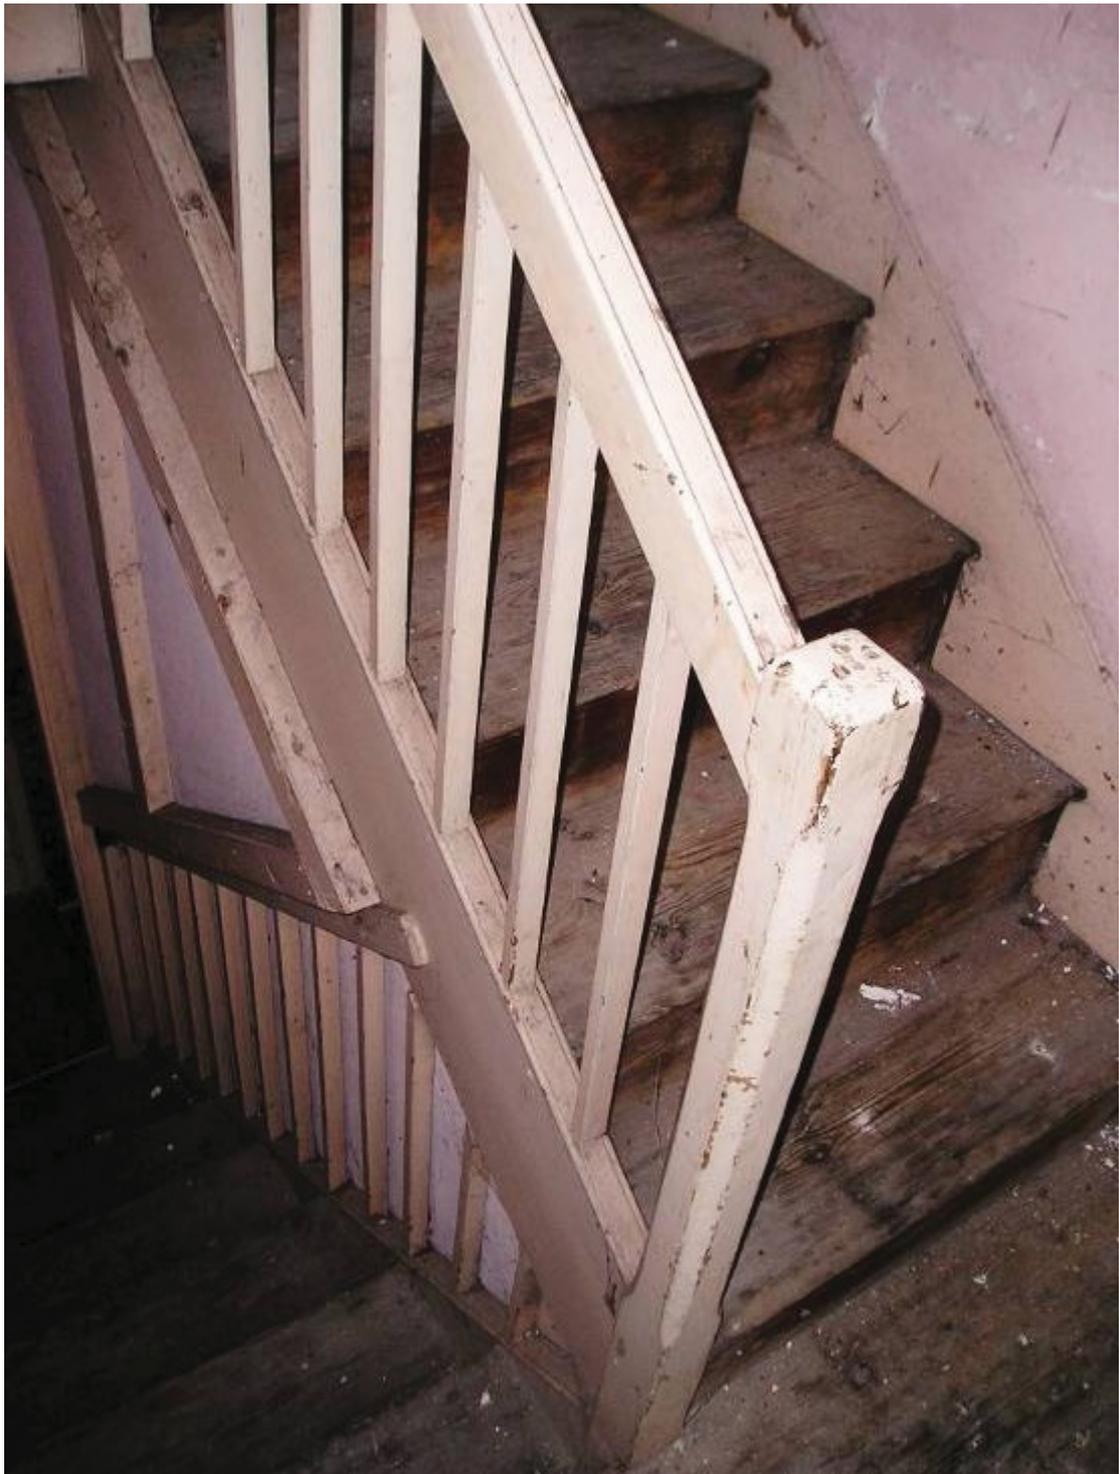
60. Detail of plain treatment to service stair joinery

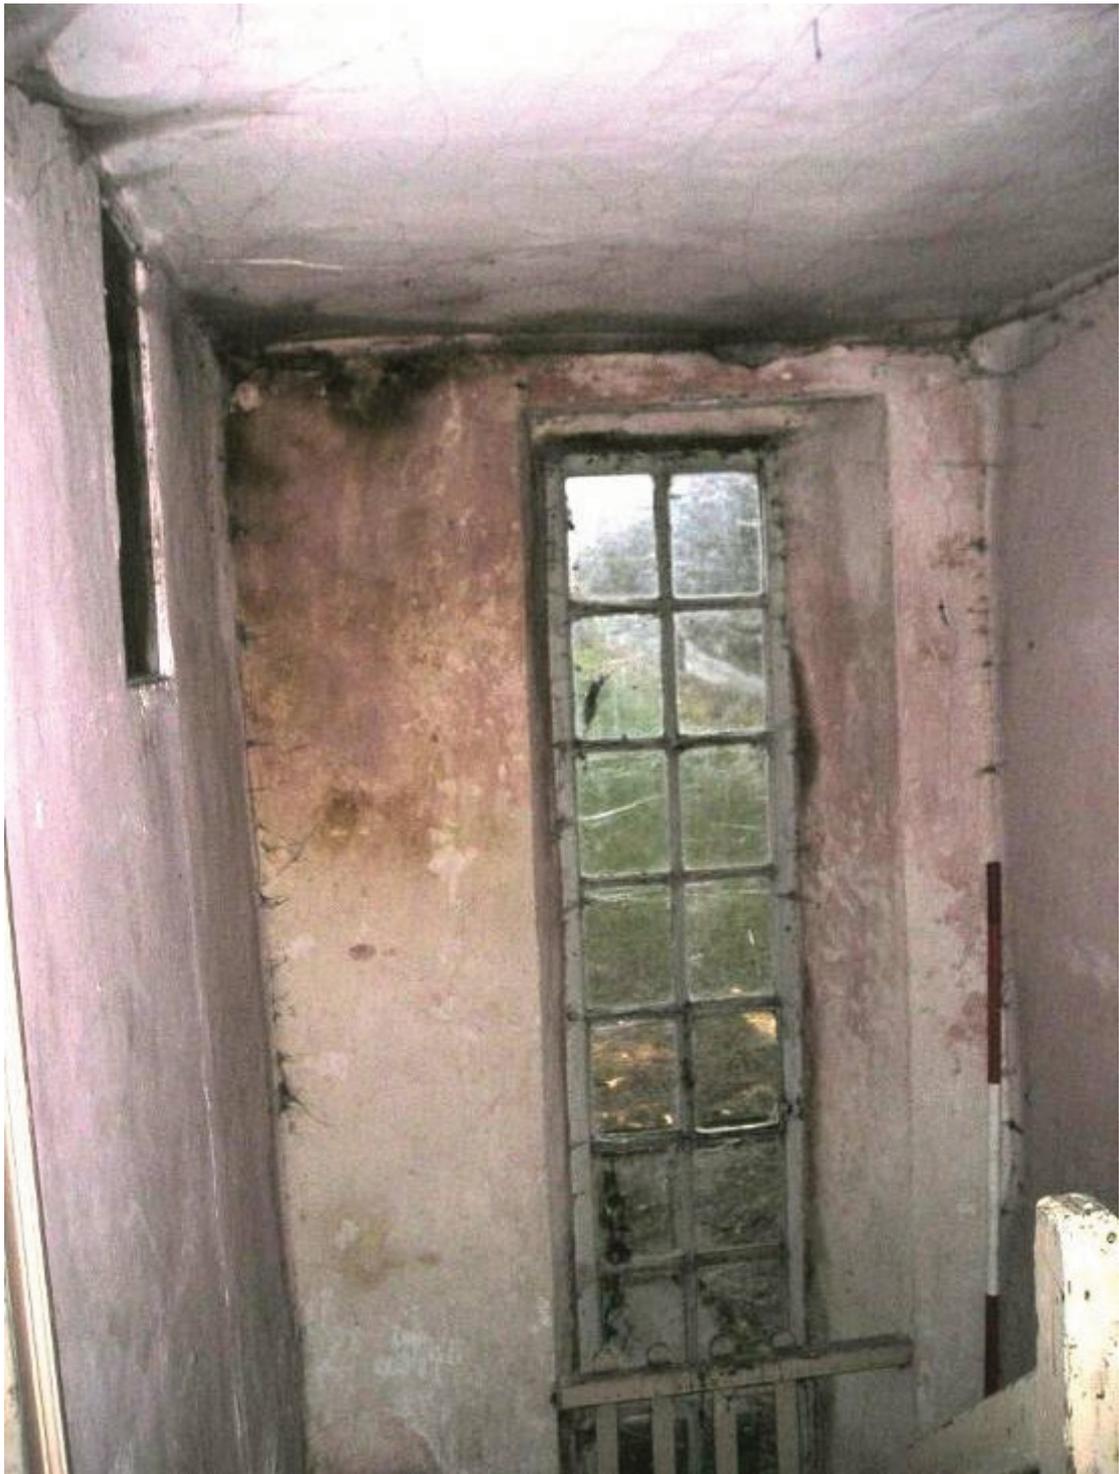
61. Full height stair window to service stair from attic landing

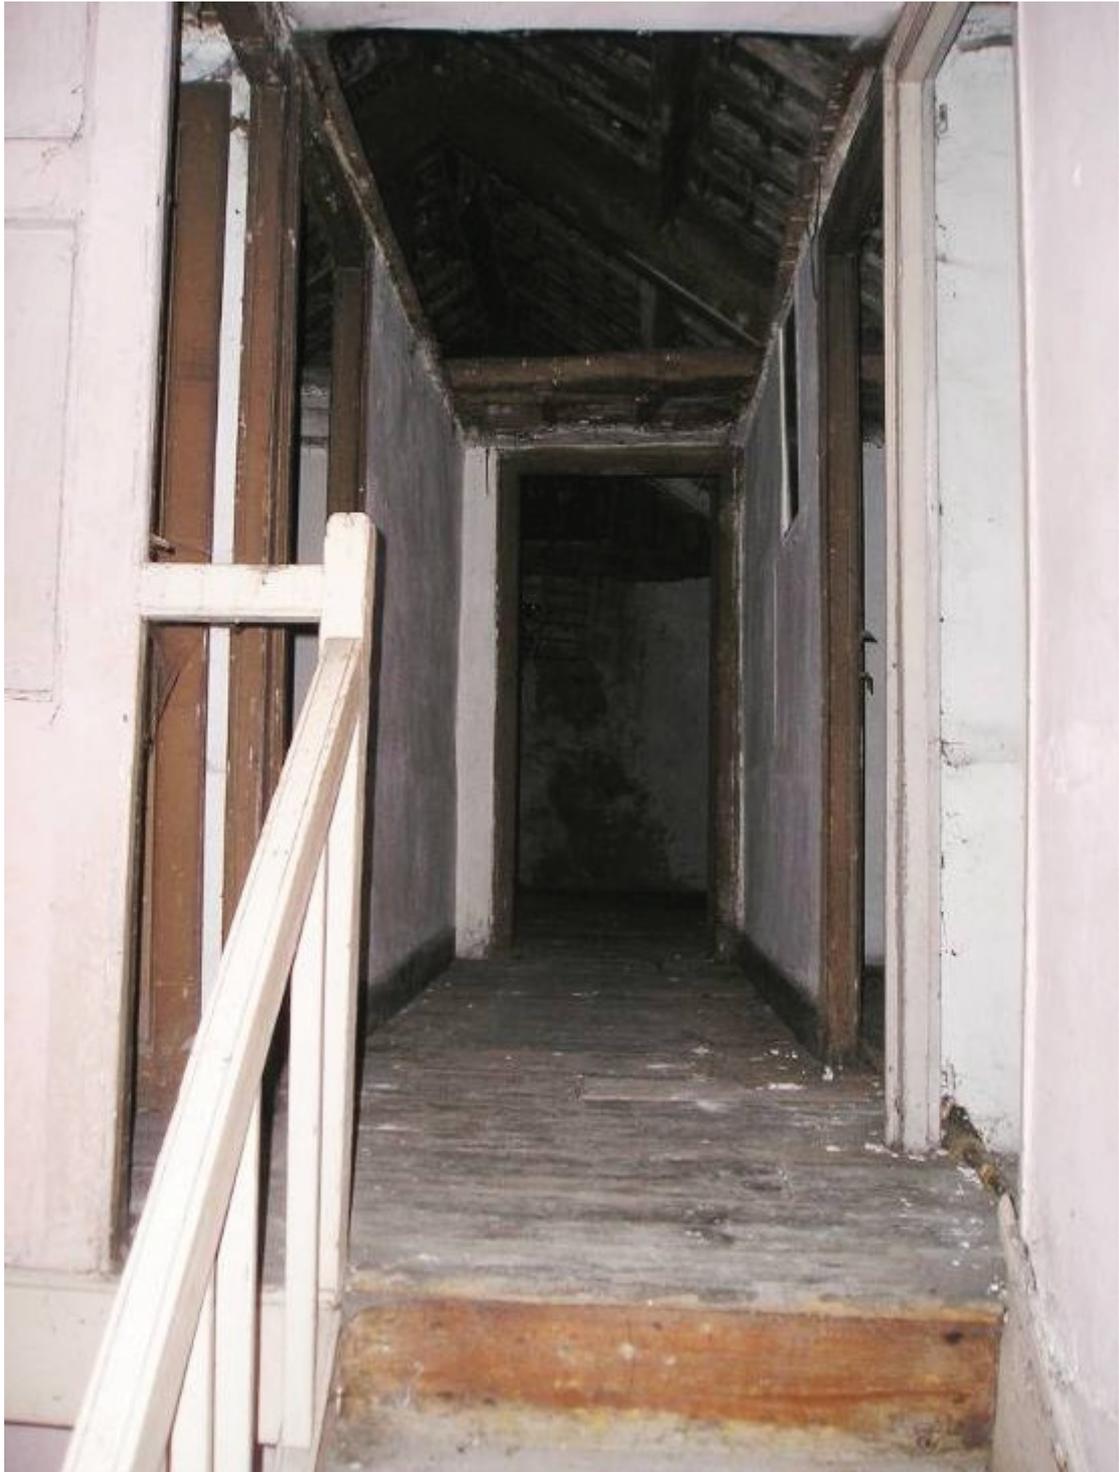
62. View into attic from service stair

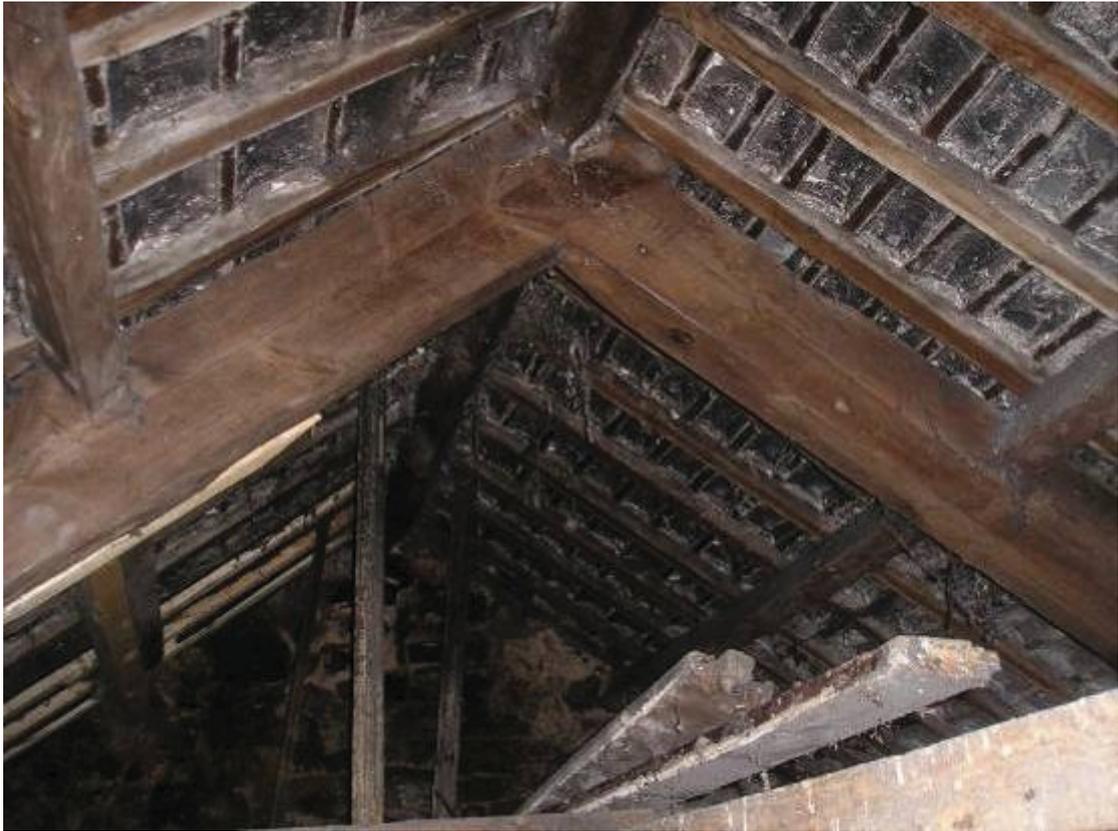
63. Main house attic – typical lapped truss principal joint at apex and trenched purlins

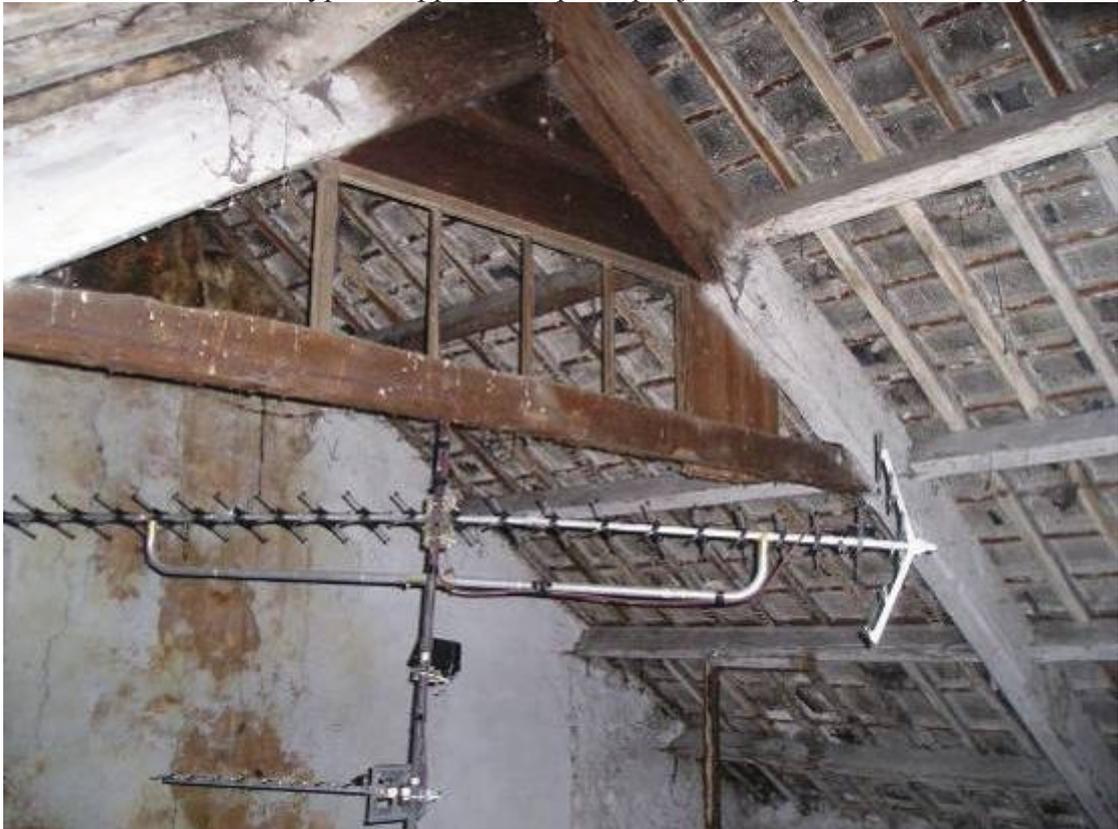
64. Attic – simple truss with principals, trenched purlins and upper brace to which uprights show how a partition was formerly lined to provide division along the line of the truss

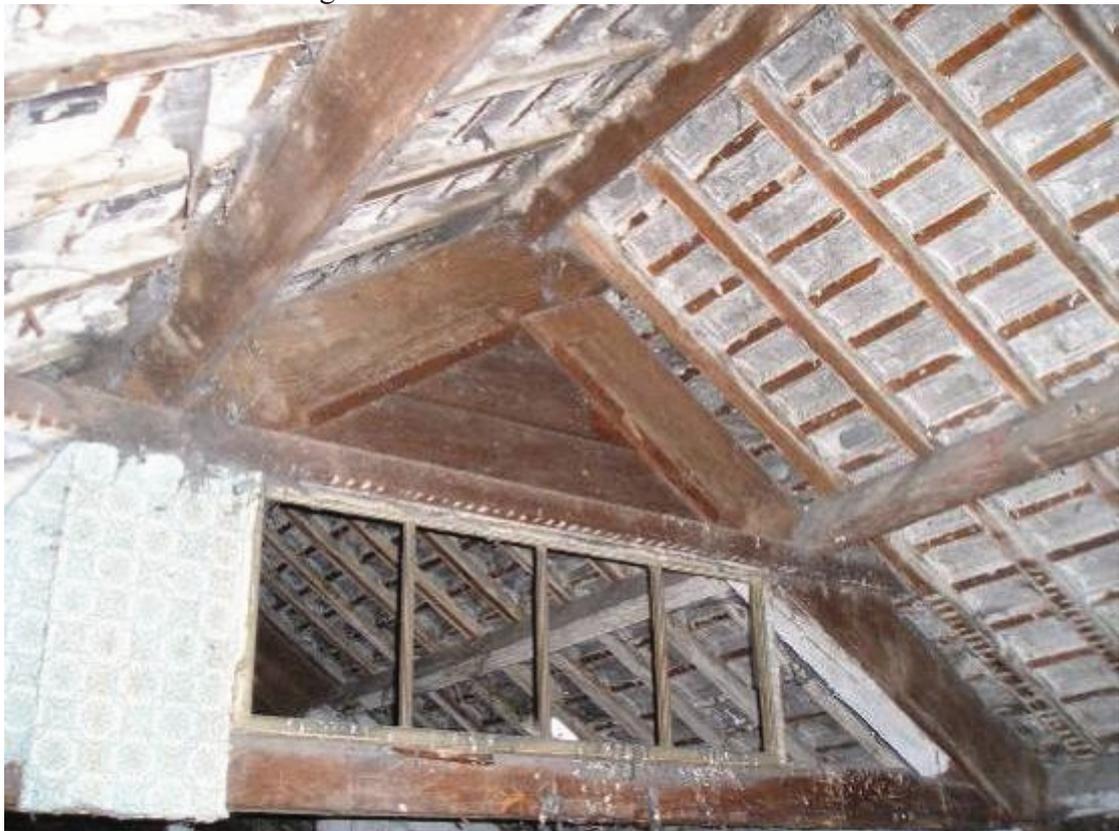
66. Truss detail, again showing uprights and applied decorations showing former partition forming attic bedrooms

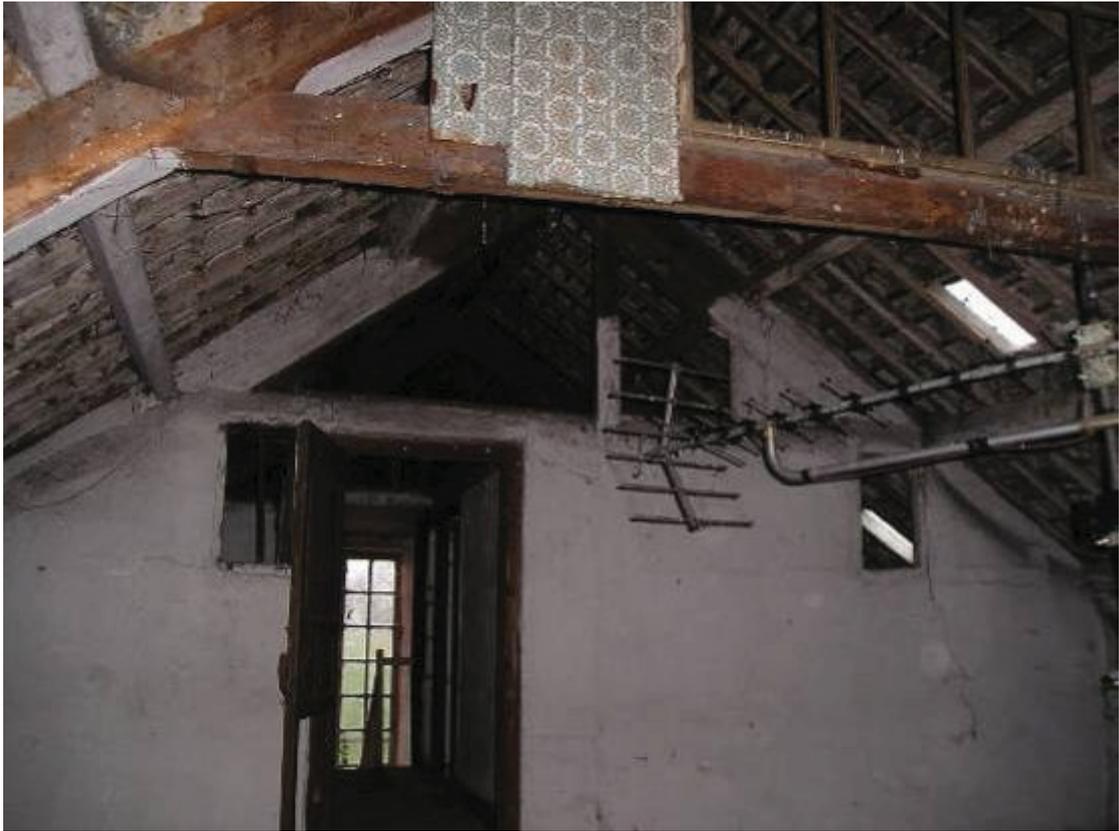
67. Southern end of the attic showing remains of partition decoration to truss in foreground and partition formed along line of truss distant with corridor leading to service stair

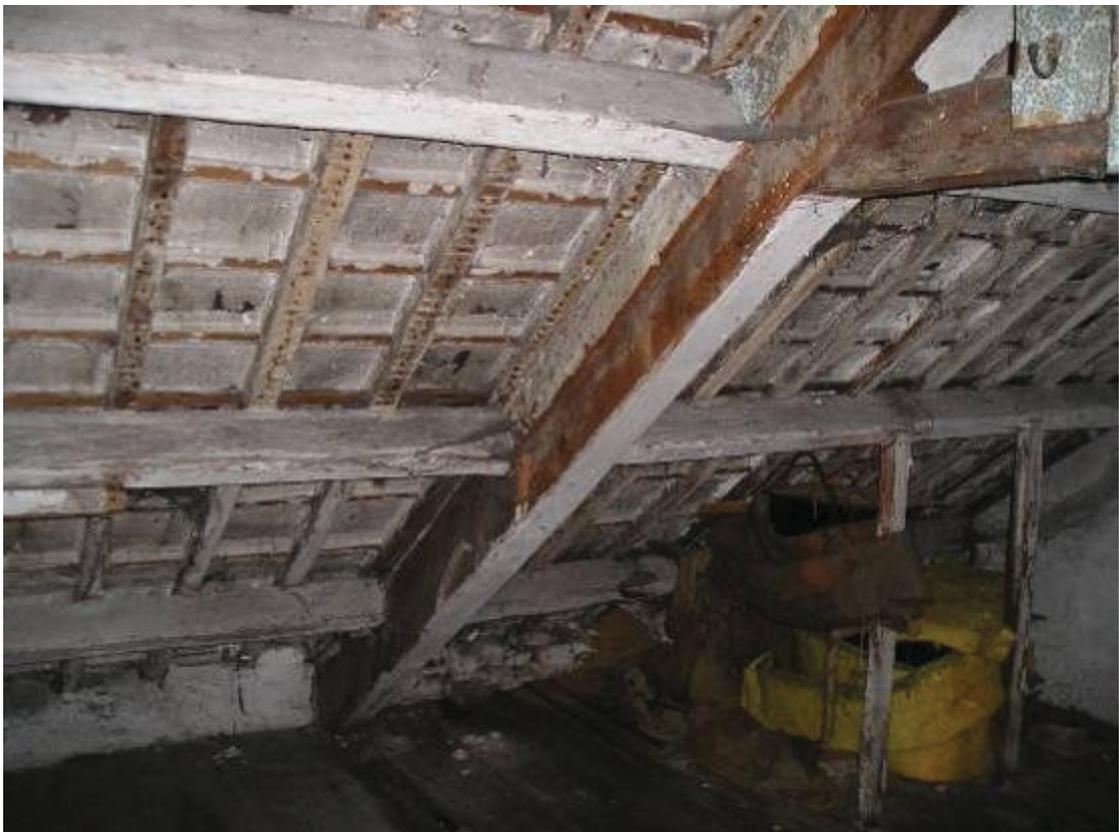
68. Typical view of principal and purlin detail to lower roof voids
