Historic Building Record

**Old Crookhey Farmhouse,
Garstang Road, Cockerham,
Lancaster**

Prepared by
C.J.O'Flaherty MRICS, MSc
January 2009

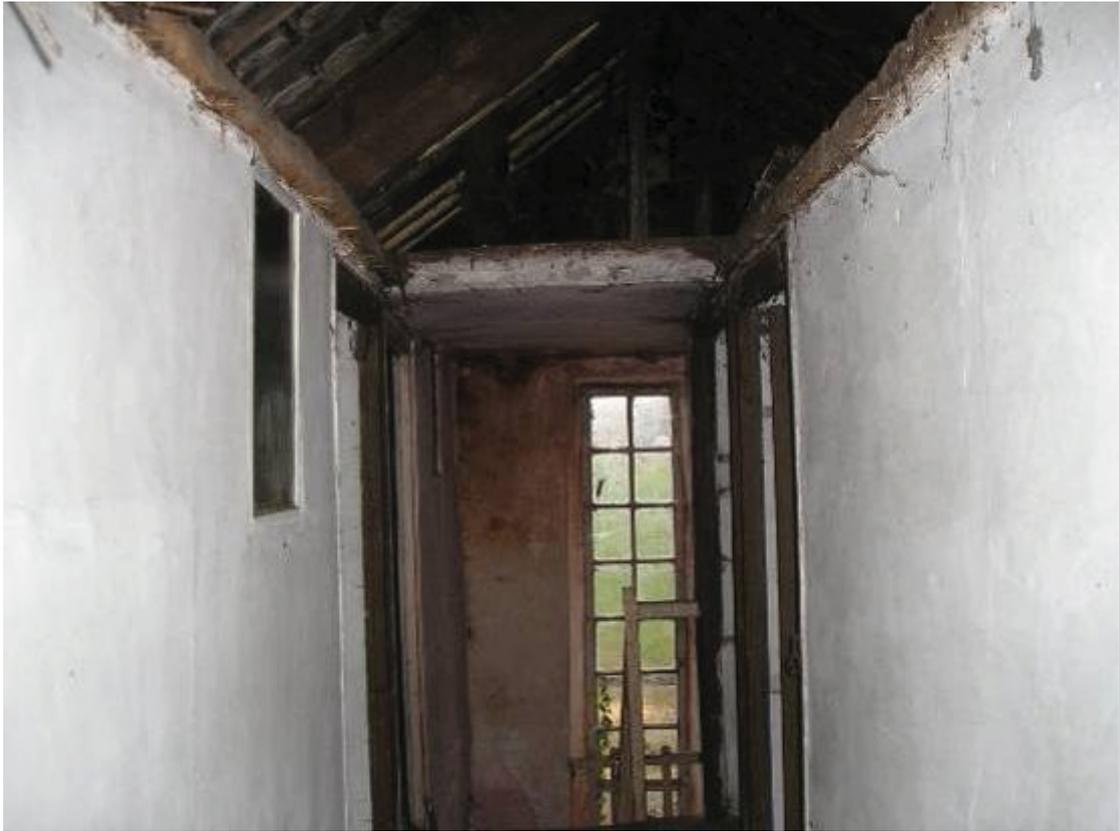
69. View along attic corridor towards service stair (remains of reed ceiling noted head of partitions)

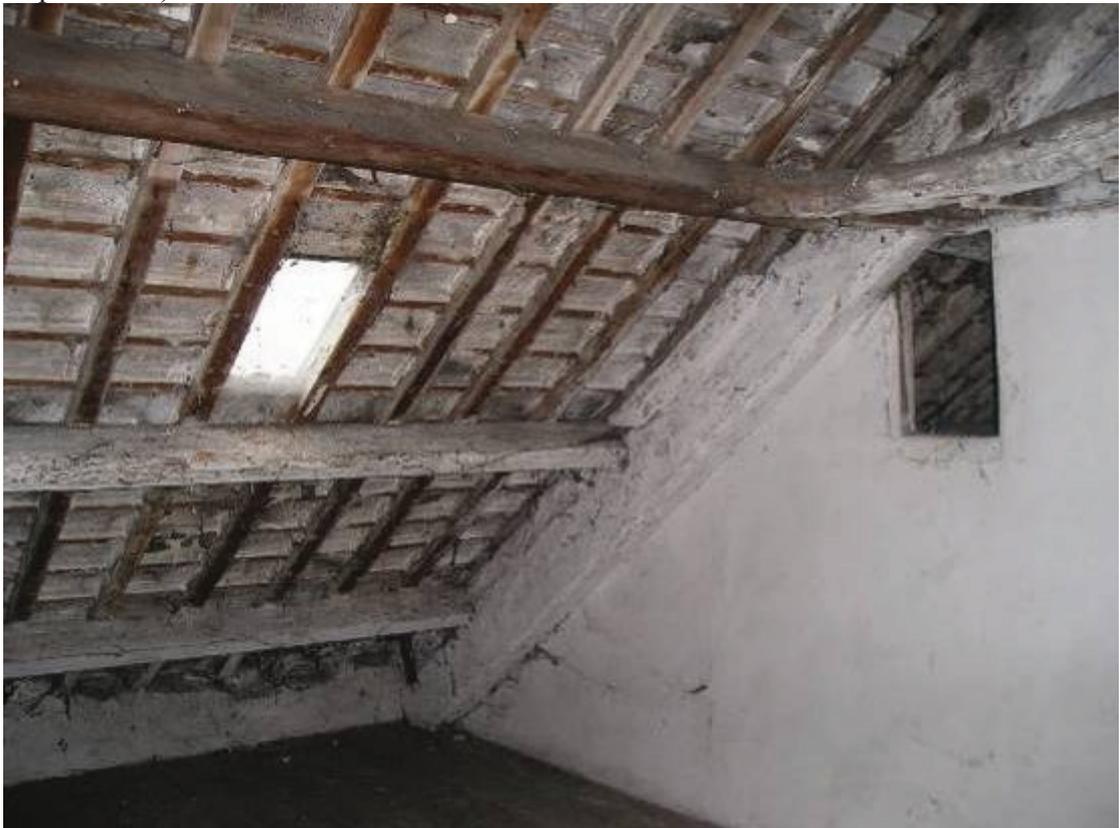
70. Attic room to front right

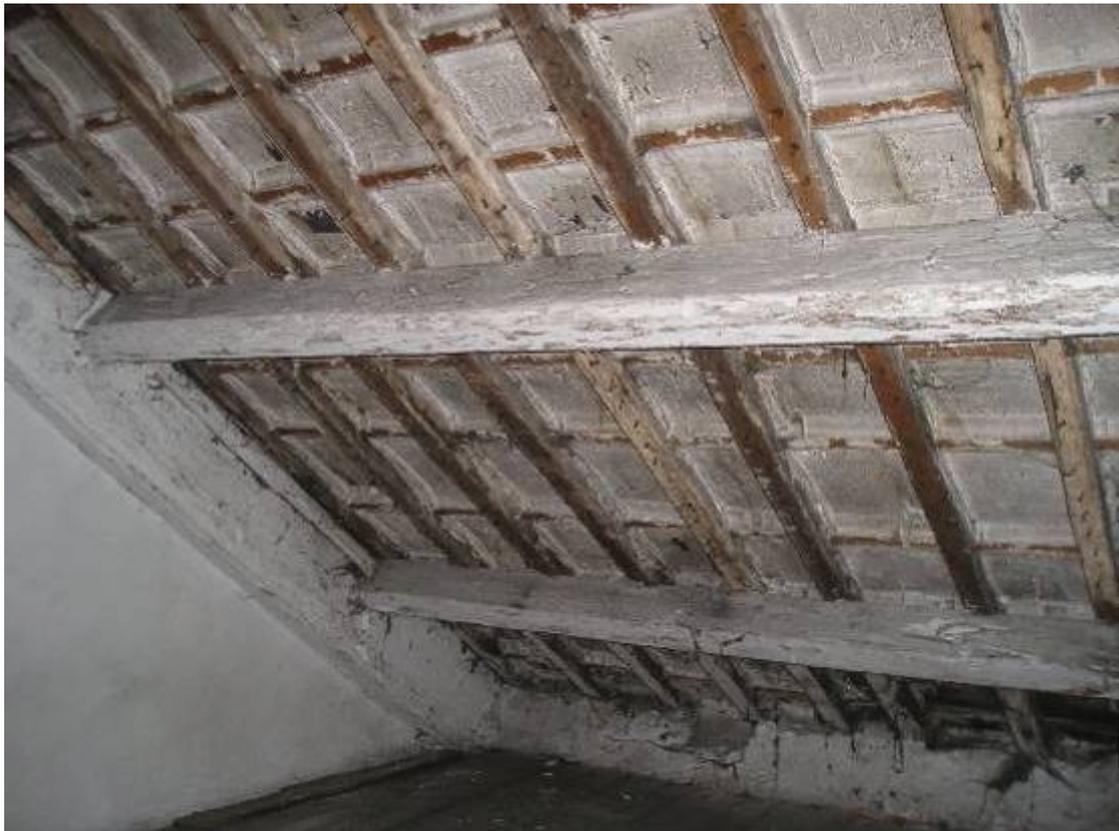
71. As 70, showing general arrangements of roof timbers

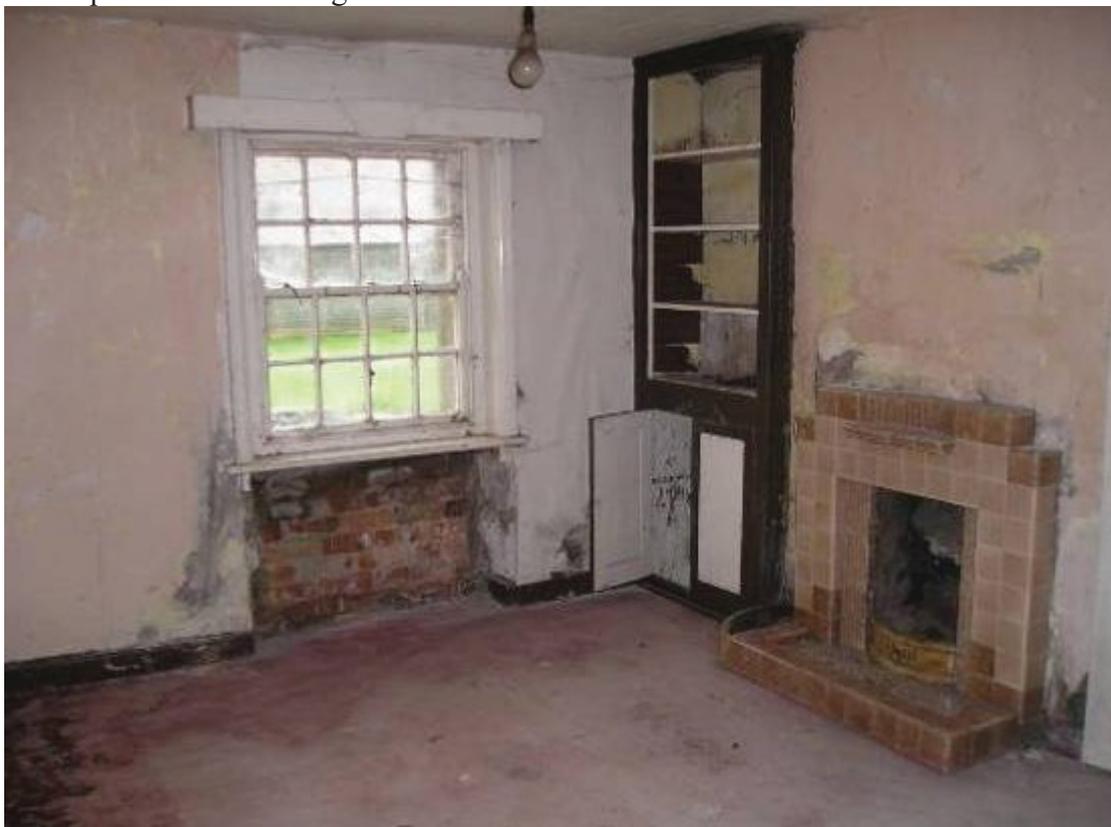
74. Rear ground floor room showing blocked wall beneath cill (former door) and fireplace to the rear wall of the wing (right)

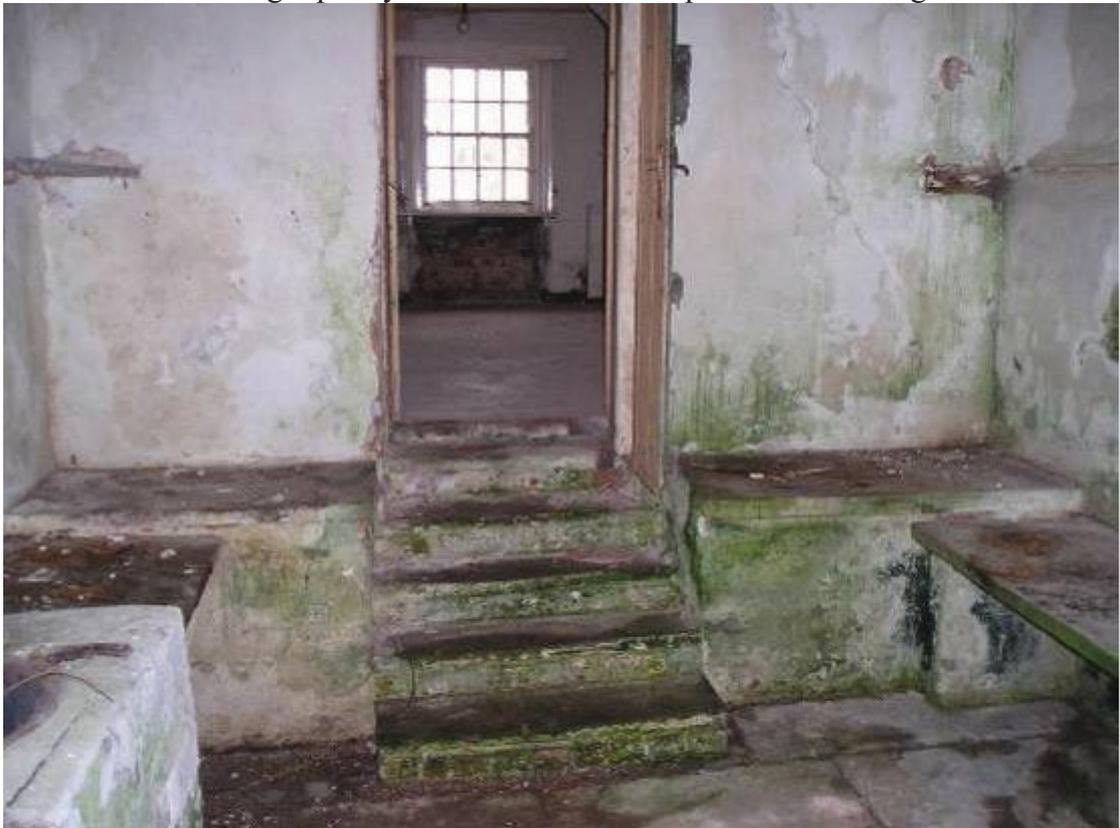
76. View out of cold store, looking up short flight of stone steps to rear room of rear wing

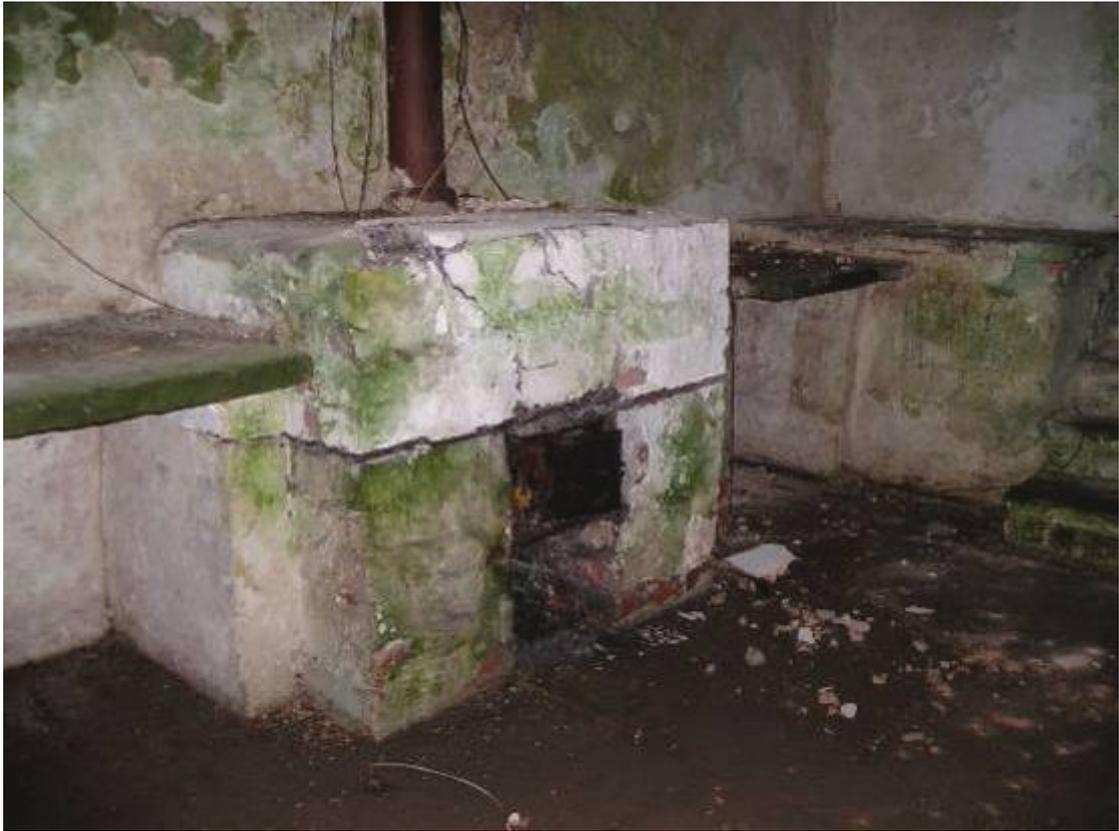
77. Old boiler in rear cold store

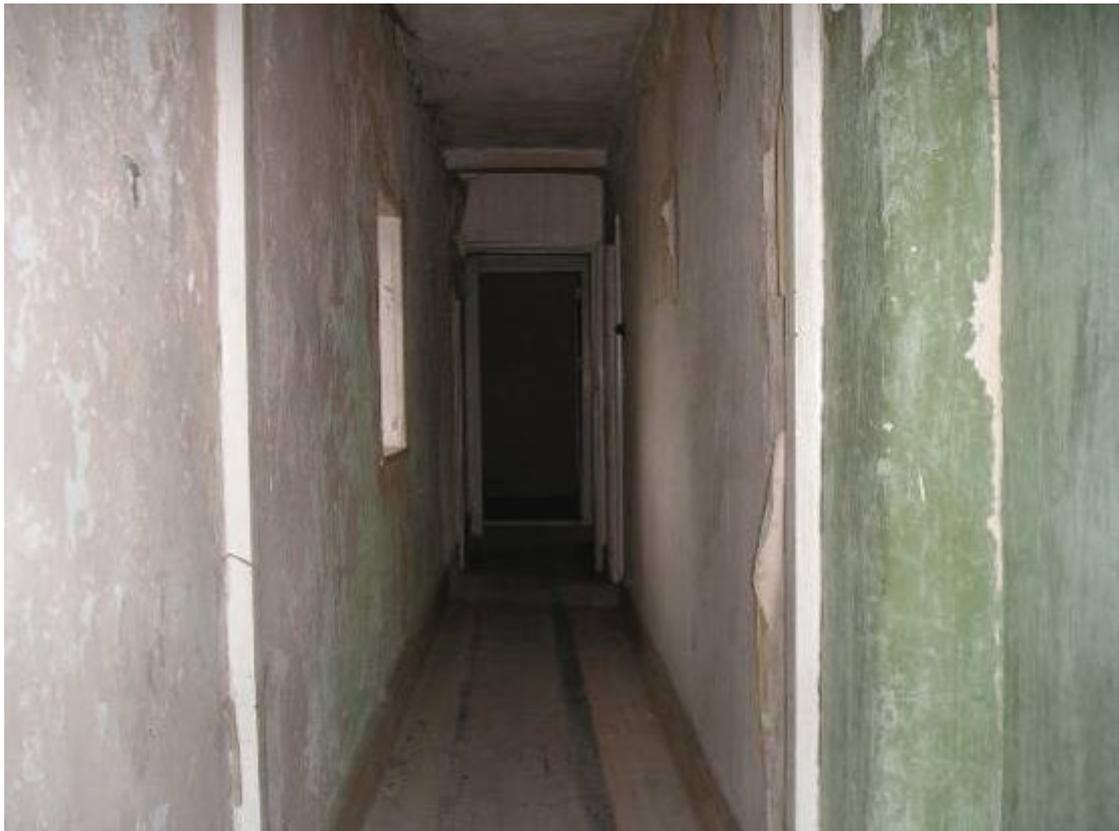
79. First floor landing corridor to rear wing

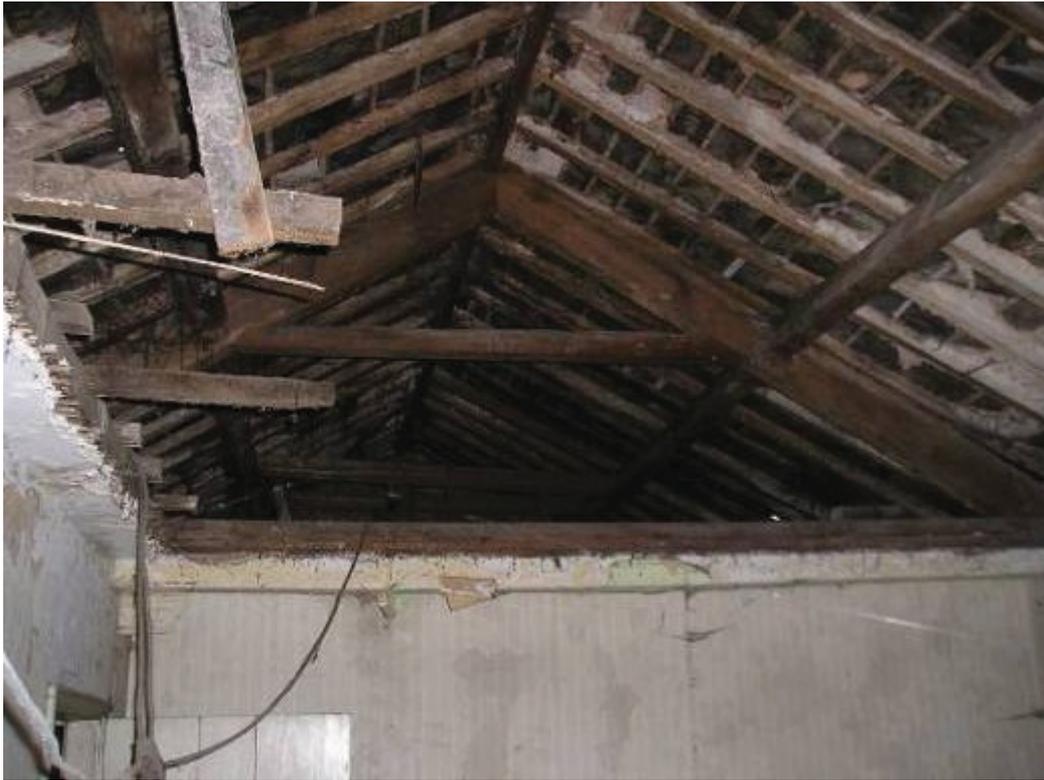
81. Exposed roof where ceiling has collapsed in rear wing showing braced truss with trenced purlins

Re-roofing of dual pitch roof of outrigger, existing slates to be lifted sorted and set aside for re-use, existing battens stripped and all roof timbers inspected for rot and woodworm and treated accordingly or replaced with treated timber of a similar section, sound slates to be relaid on treated timber battens on breathable membrane Tyvek or similar, stone ridges copings and verges to be bedded on and pointed with lime mortar NHL 3.5

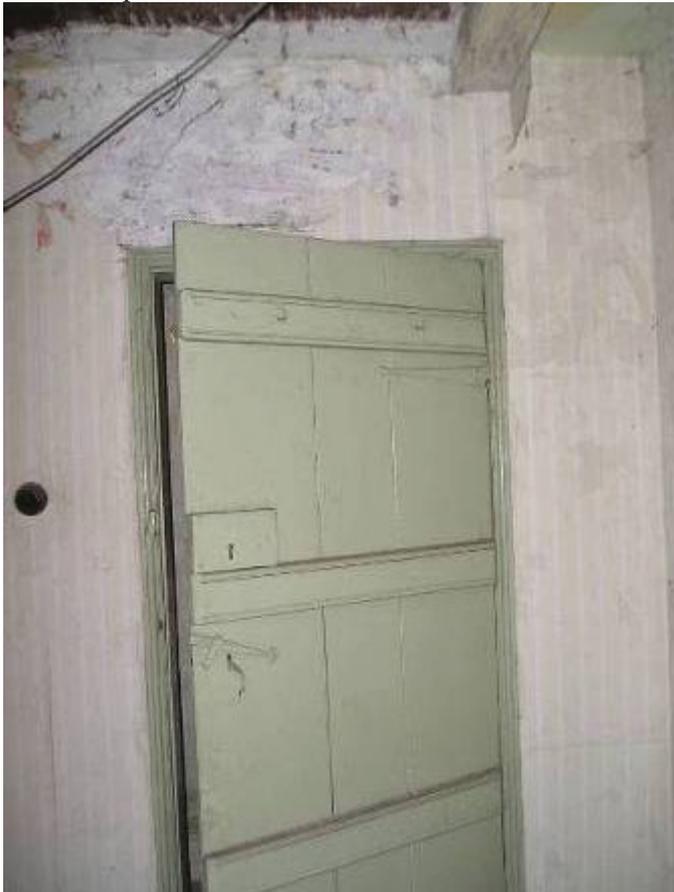
82. Typical first floor ledged board door to rear wing
