CHARLECOTE PARK, WARWICKSHIRE

Woodyard, Service Ranges
and associated Outbuildings

Historic Building Record and Analysis

National Trust

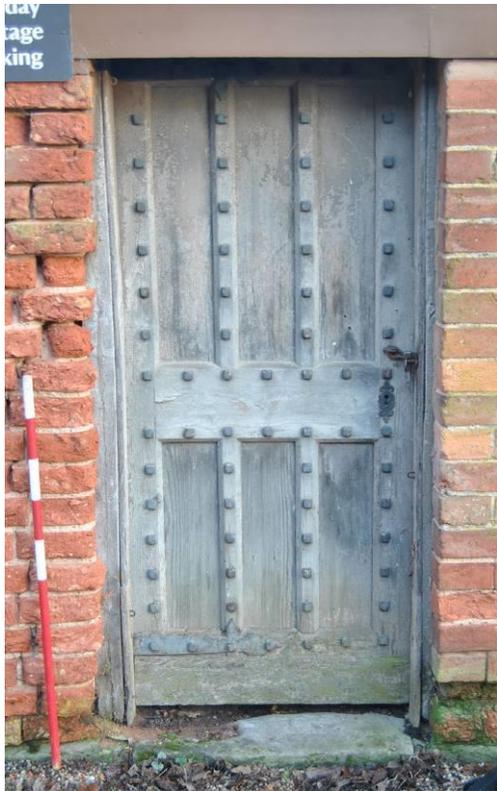
- 7.11.2 To the west end of the range, outhouses **N1-4** (Plate 168) represent four discrete units, fully enclosed and accessed by means of independent timber doors [d41-44] to the south elevation; 3 x 2 recessed panels, bolted and pin-hung on strap hinges (Plate 169); [d43] lost and replaced by simple boarding. Outhouses **N1/2** are larger, measuring at 11½ft. wide (E/W), while **N3/4** are approximately half the size at 5ft. wide. The southern elevation of **N2** and **N3** is in 2½in. brick laid to Flemish bond and is of a very weathered appearance; that to **N1** and **N4** has been rebuilt in 3in. brick (contemporary with the brick piers of **O1-3** to the east), again in Flemish bond with a header course to eaves level. A possible feedrack was noted at the north-east angle of **N2**, while

Plate 168: Outhouses N1-4 looking north-west. NB. weathered brickwork of N2/3.

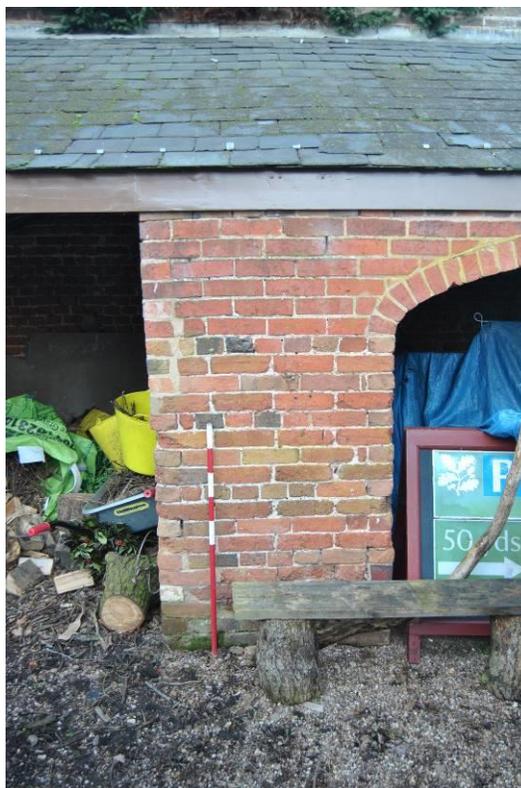
Plate 172: Back of brick pier to outhouse P.

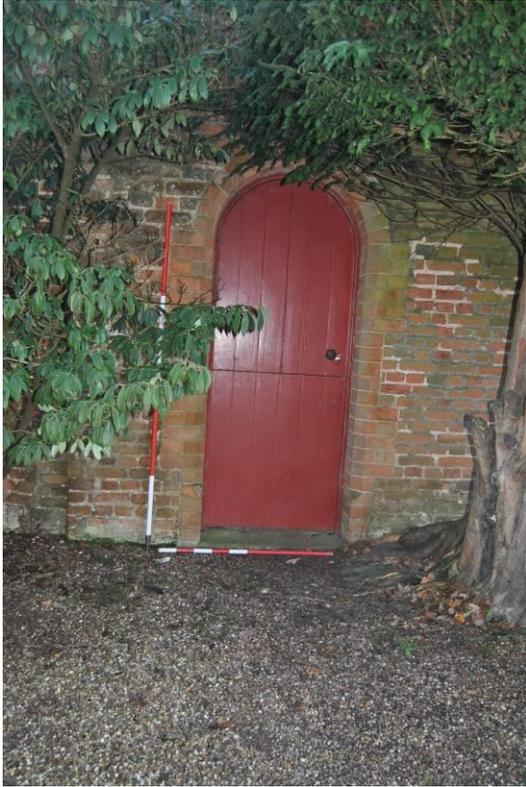
- 7.11.4 To the far east end, the eastern three bay divisions as illustrated on Trepess's plan (outhouses **Q**) have been extensively modified, converted to use as a gents' toilets in accordance with drawings prepared in May 1947 by Maynard H Powell ARIBA of Stratford-upon-Avon (Figure 26a and inset above),¹⁵² shortly after the property came into the hands of the National Trust. Conversion work necessitated the introduction of a series of transverse walls and the blocking off of the south elevation (English bond brickwork; Plate 177) to house urinals and a WC, accessed from the north via an inserted doorway [d45] in the south wall of Greencourt (Plate 178).¹⁵³ The central recess of the south elevation, illustrated on Powell's 1947 drawing, has subsequently been infilled and two matching windows [w44/5] introduced.

Plate 177: Converted outhouses Q looking north-east.
NB. secondary Engl. Bond brickwork

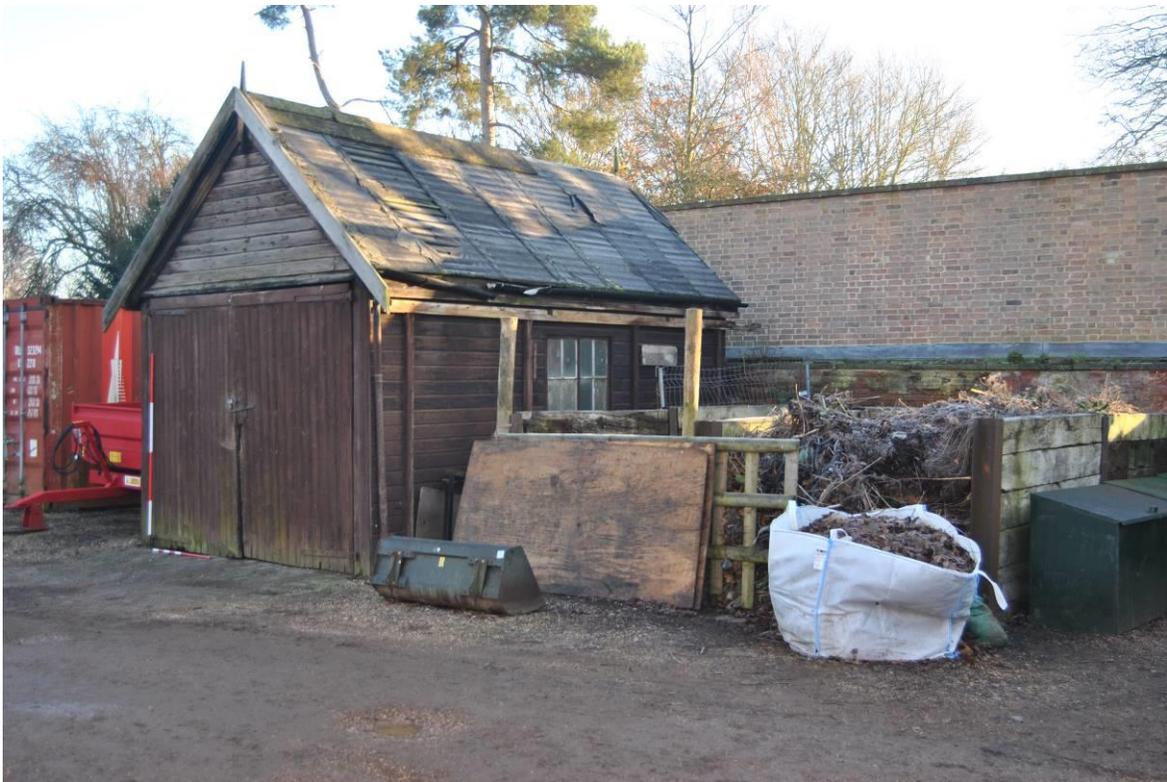
- 7.12.1 **Building R** comprises a simple timber shed (Plates 179/80), believed to be by Boulton and Paul Limited of Norwich (M Glasgow, *pers. comm.*),¹⁵⁴ erected against the raised eastern boundary wall of the woodyard and introduced in the early-mid 20th century as a vehicular garage. It is rectangular in plan, 11ft. wide x 20½ft. long, standing 8ft to eaves with pitched roof rising 12½ft. to ridge, oriented to the west where pin-hung double doors open to the interior. It is of basic, timber stud construction, clad externally in horizontal, tongue-and-groove matchboard cladding with a single, two-light steel casement window set centrally to each of the long elevations. Gables are finished with plain barge-boards with apex finials (secondary barge-boards have been

Plate 179: Building R looking south-east.

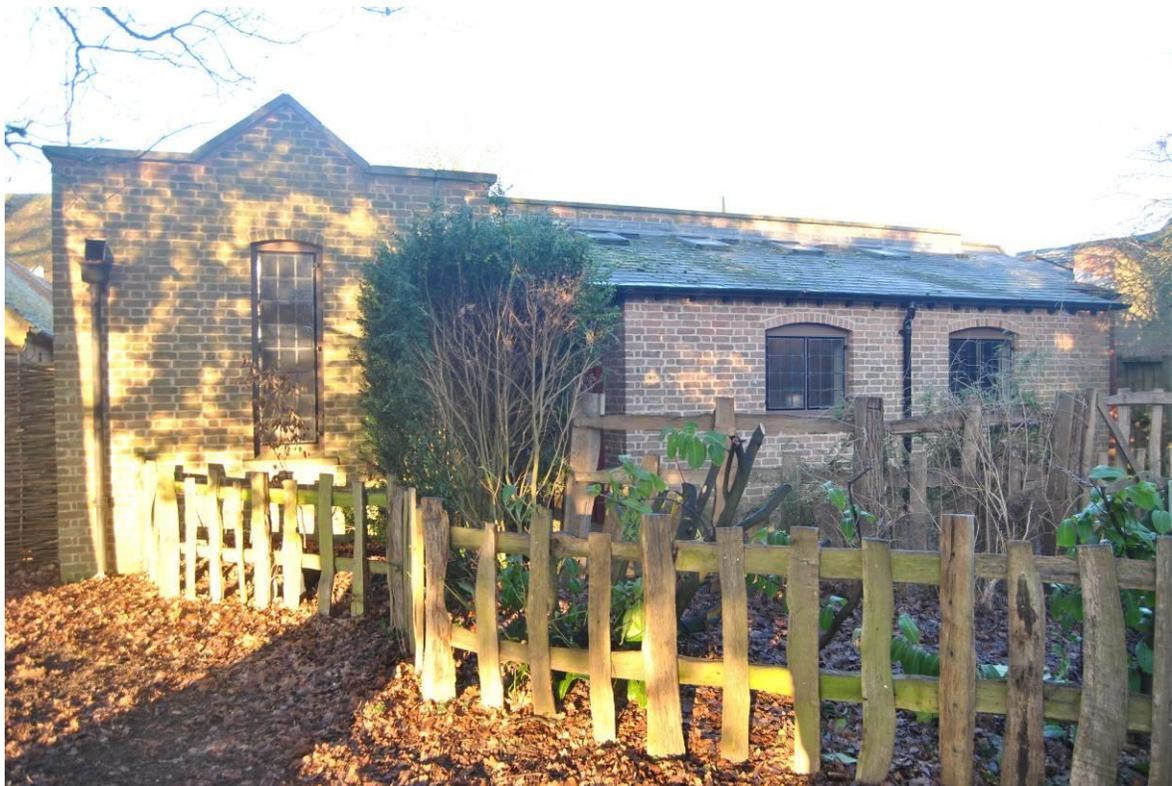
Plate 182: Game Larder S; north elevation.
