PETERBOROUGH CATHEDRAL

ENVIRONMENTAL MONITORING OF THE NAVE CEILING

MARCH 1998 – MAY 2000

Report No: PTB01.1

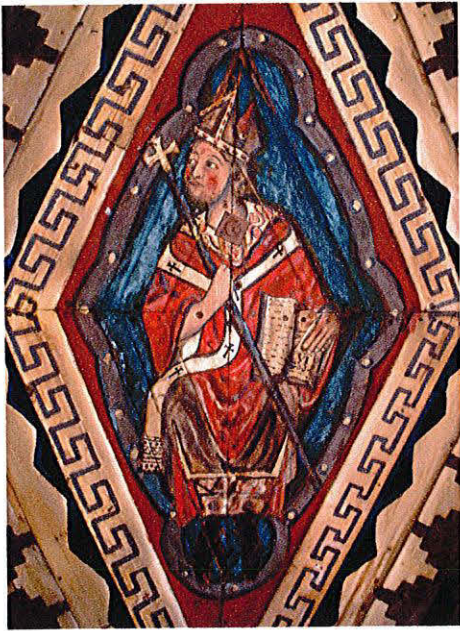
Figure 2. Detail of the painted ceiling. (Photo: TCA 2000)
