PETERBOROUGH CATHEDRAL

ENVIRONMENTAL MONITORING OF THE NAVE CEILING

JUNE 2000 – MAY 2001

Report No: PTB01.2

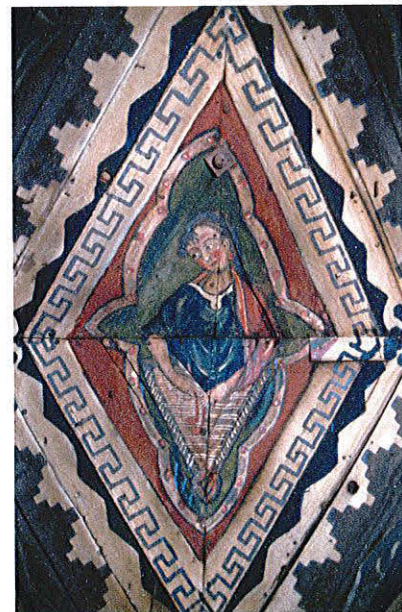
Figure 1. Detail of psalter player in rows 25 and 26 (Photo: PLP 2001)
