A Report prepared for Mr. R. Bailey

HISTORIC BUILDING RECORDING AT DETACHED COACH-HOUSE , THE
OLD RECTORY, CHURCH ROAD, WADDINGHAM, GAINSBOROUGH,
LINCOLNSHIRE (Grade 2 Listed Building)

BBS Report No. : BBS/HBR/RB 1/17.

DETACHED COACH-HOUSE AT THE OLD RECTORY,
CHURCH ROAD, WADDINGHAM, GAINSBOROUGH, LINCOLNSHIRE.

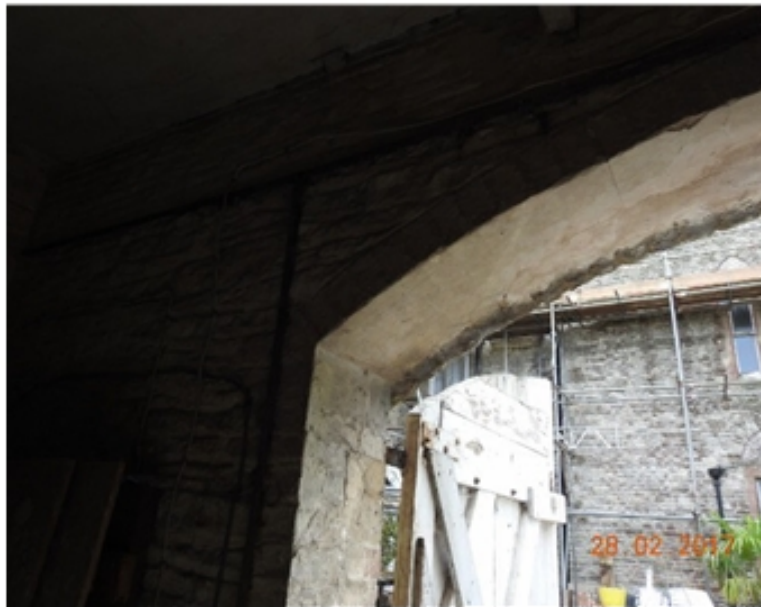
Plate 12 : Inside the Coach house : l.h. side of the double doors...28.02.17.

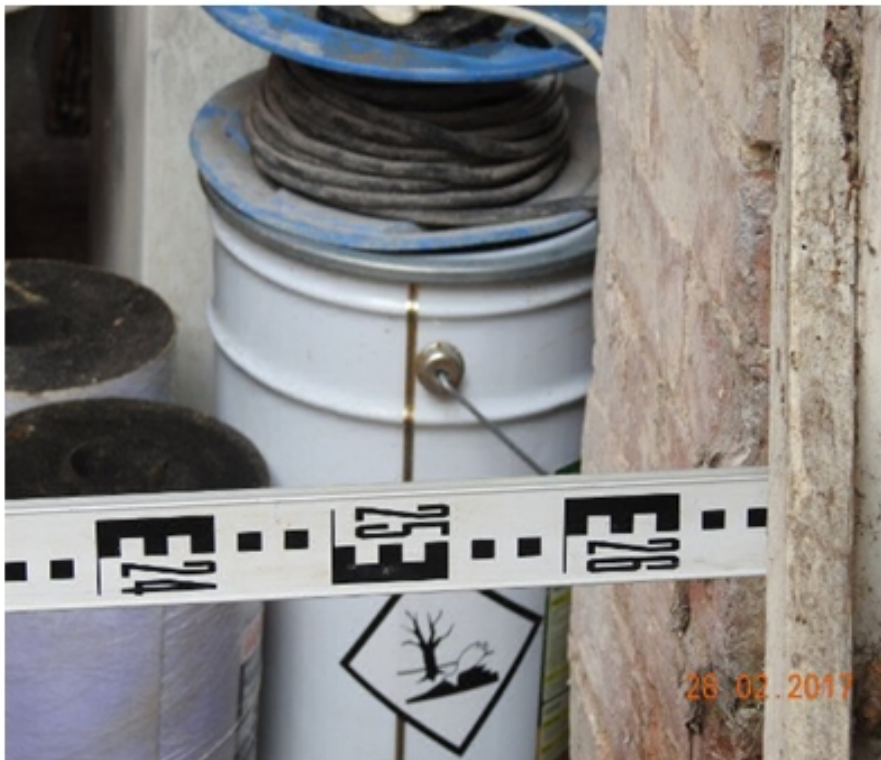
Plate 14 : Coach House double doors width : 28.02.17.

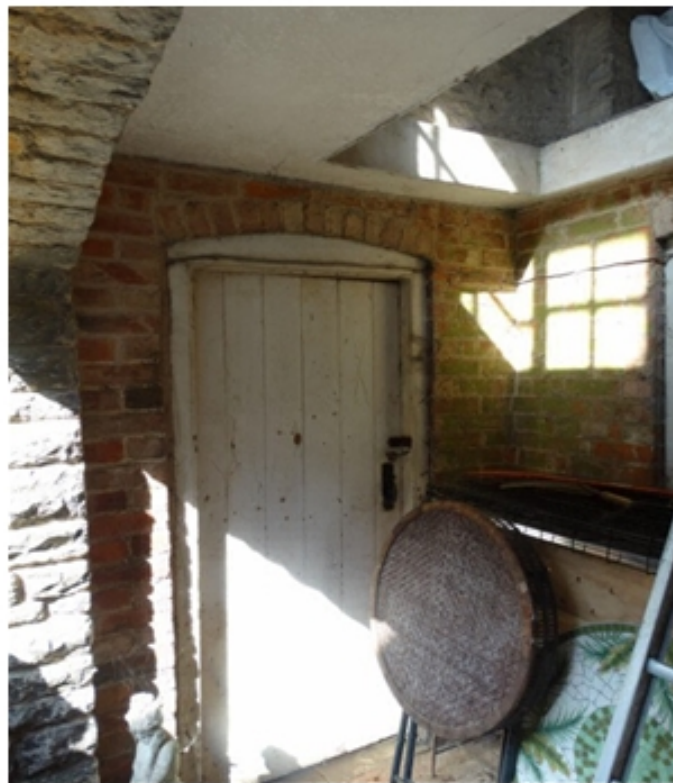
Plate 16 Coach House entrance hand door : 24.08.16.

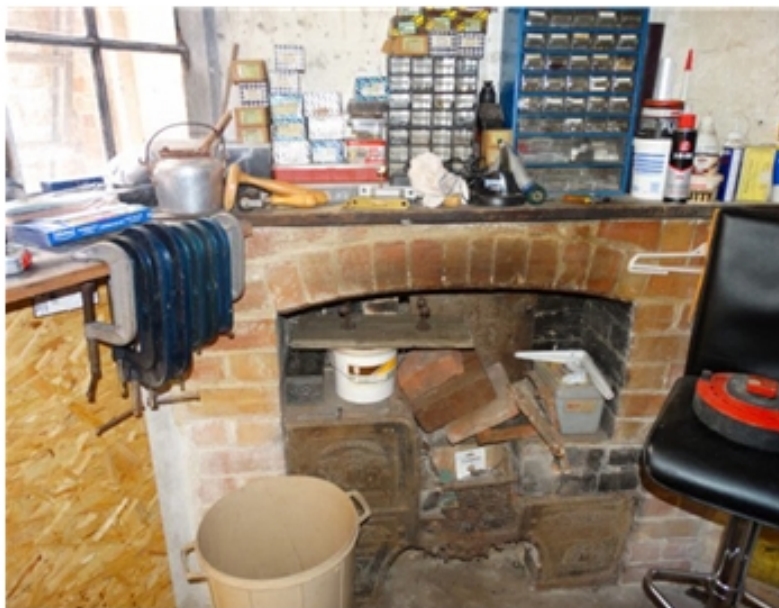
Plate 19 : Inside Saddlery : Fireplace.....01.08.16

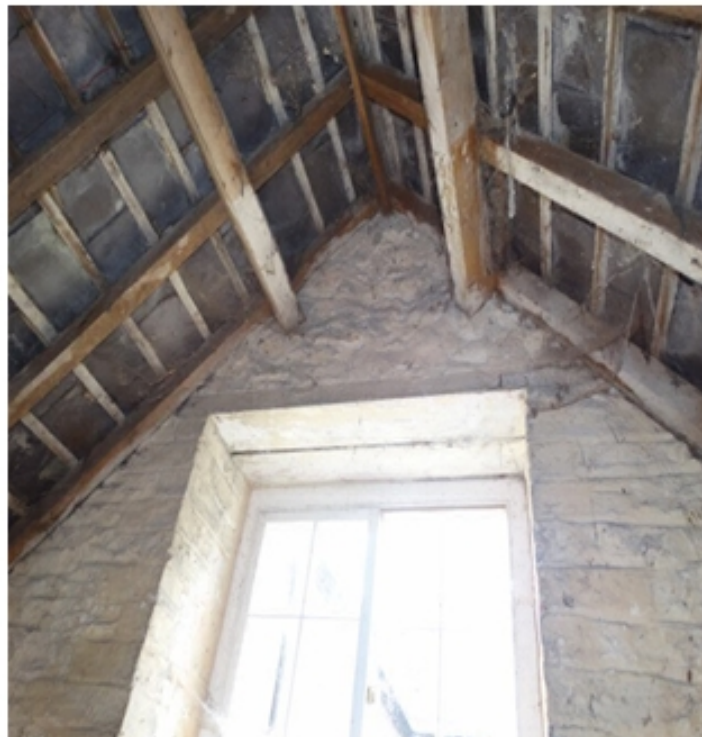
Plate 29 : Inside Hayloft : south facing window : 01.08.16.

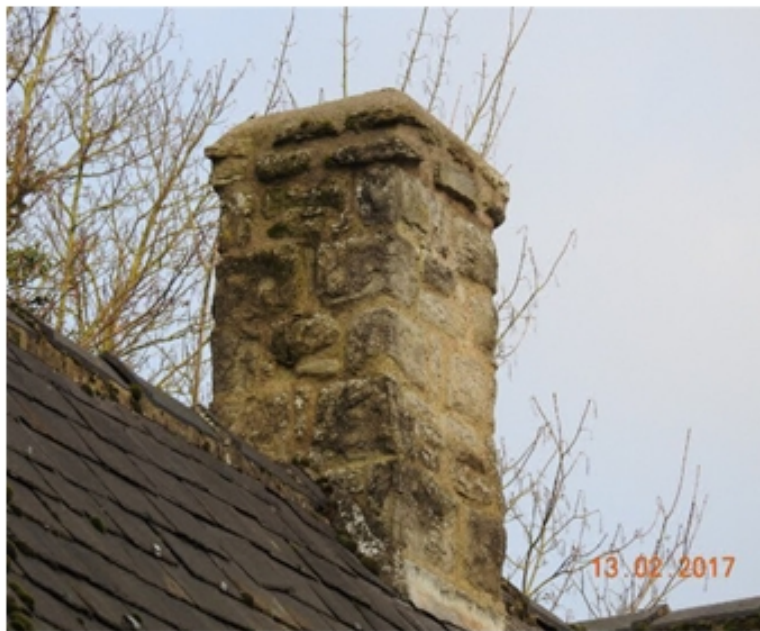
Plate 37 : Hayloft chimney from south-east : 13.02.17.

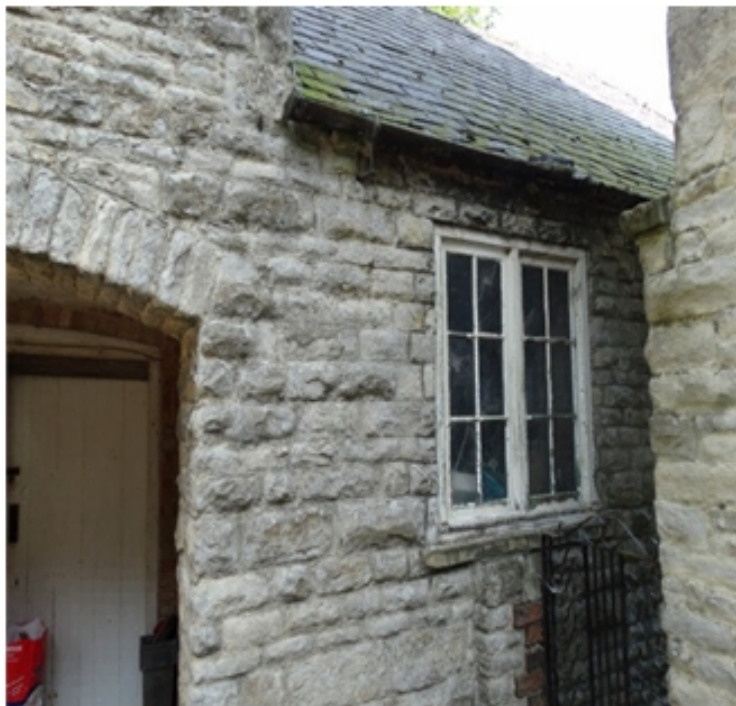
Plate 52 outside the Stables showing the south facing window.....24.08.16.

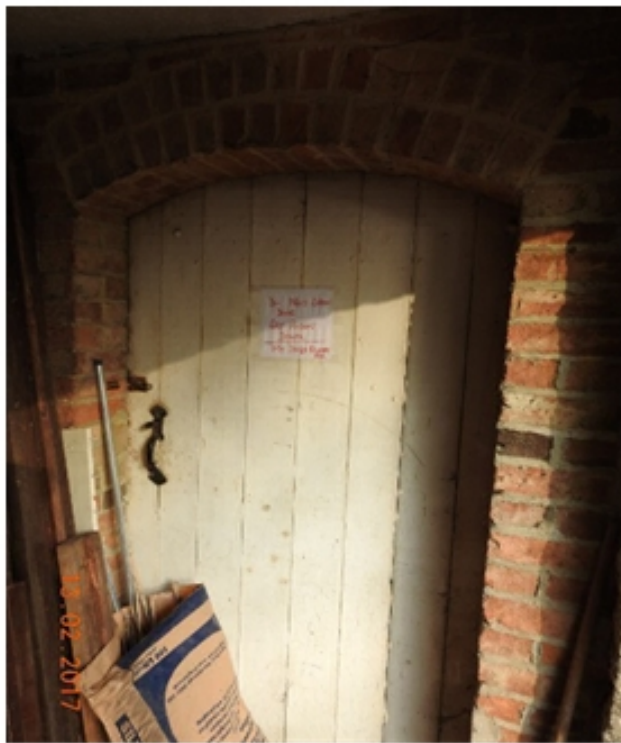
Plate 56 : outside the entrance door to the Stables from the west side...13.02.16.

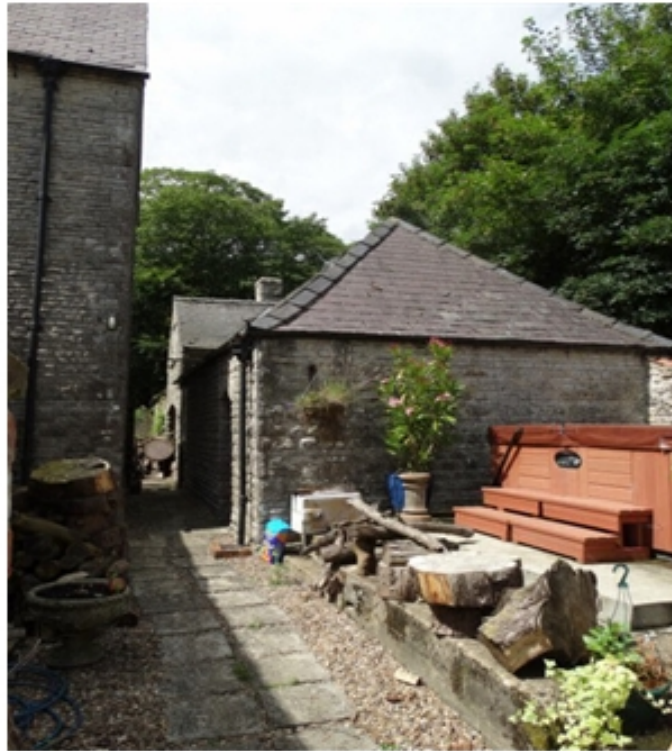
Plate 60 : East side of the Coalhouse....01.08.16.

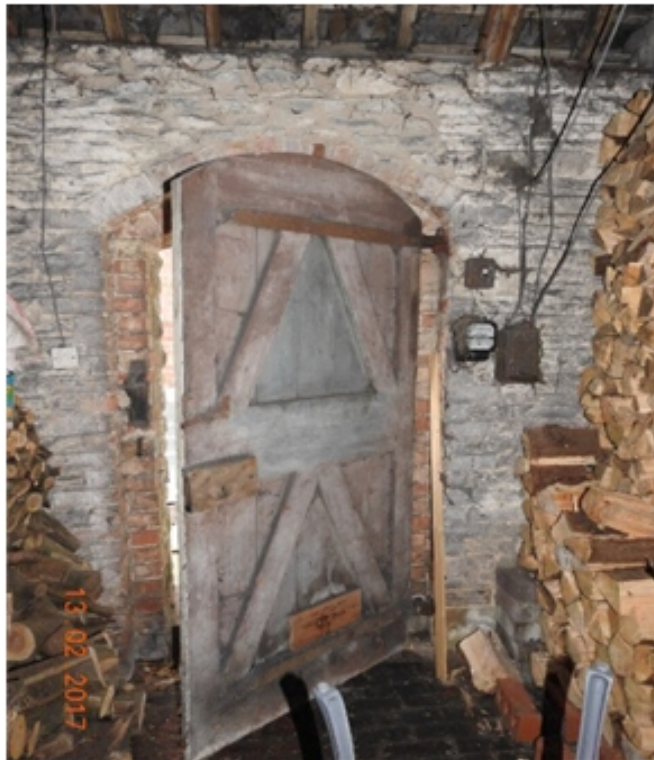
Plate 71 : inside the Coalhouse looking south at the entrance door...13.02.17.

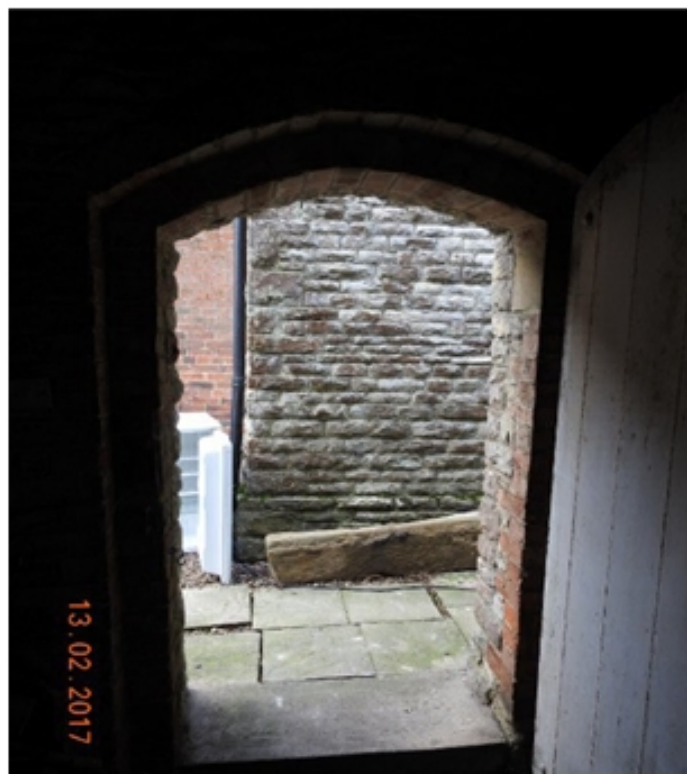
Plate 73 : looking north at the entrance door brick rebate

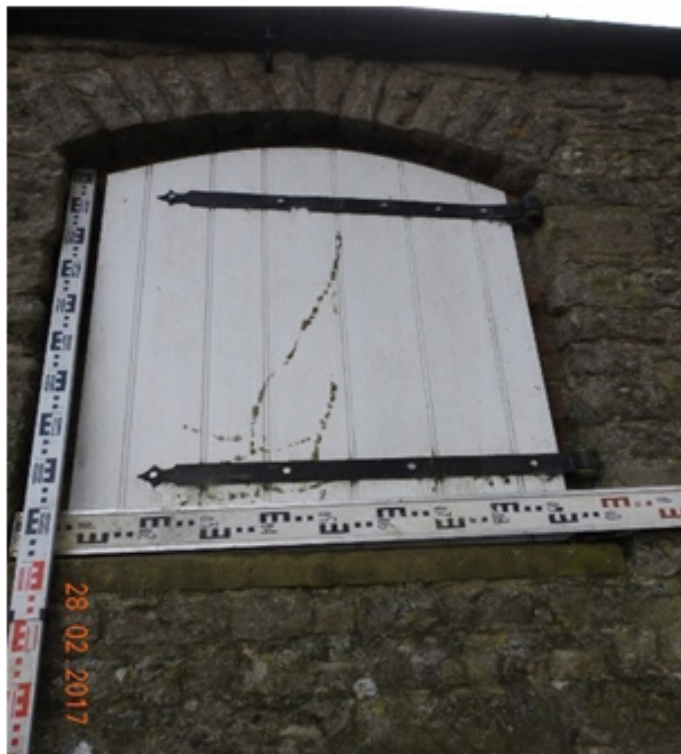
Plate 77 : showing height and width of Coalhouse loading flap door on North side..02.03.17.
