Great Eastern Hotel,
Glasgow

Archaeological Evaluation and
Historic Building Record

Data Structure Report

September 2007

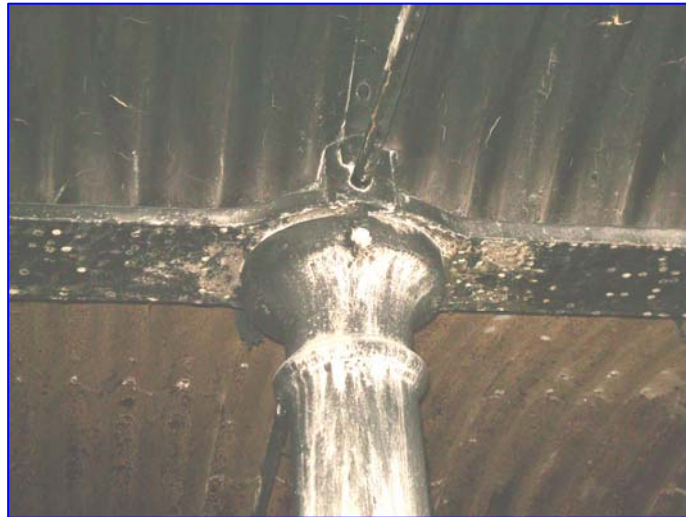
Detail of the top of a cast-iron column on the second floor

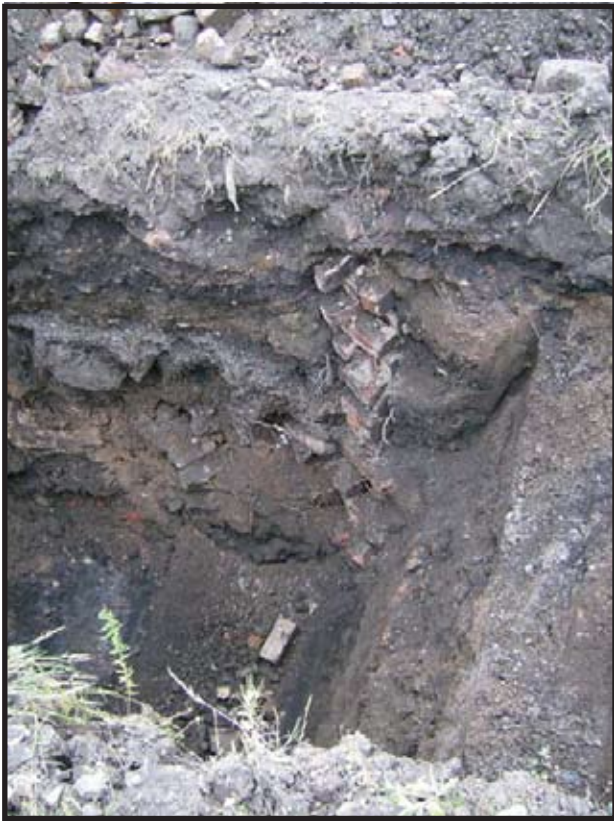
Plate 1: West-facing section at south end of Trench 1

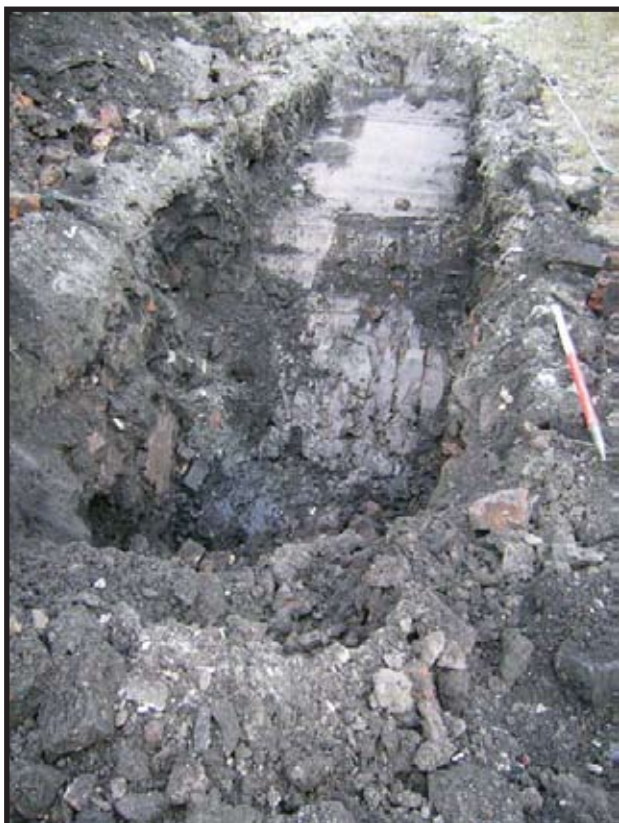
Plate 3: General view of Trench 3 from the south

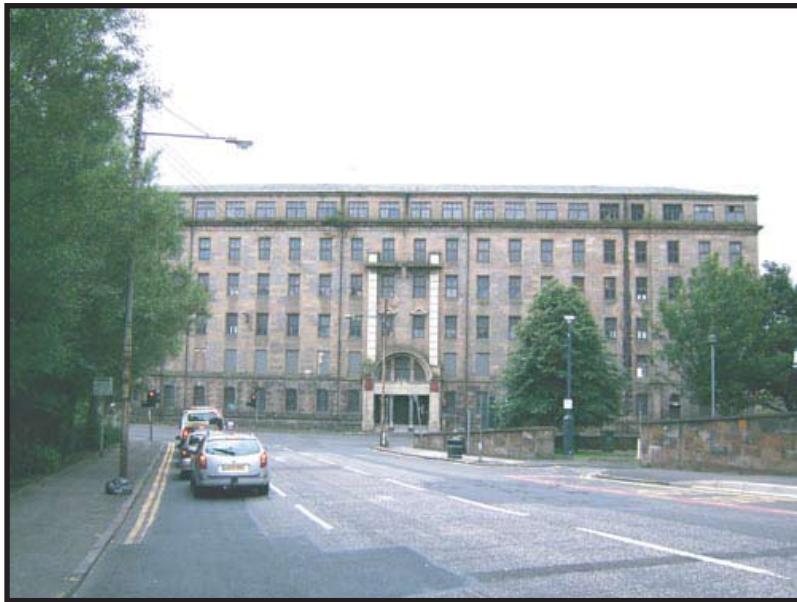
Plate 4: View of the front of the Hotel from the north

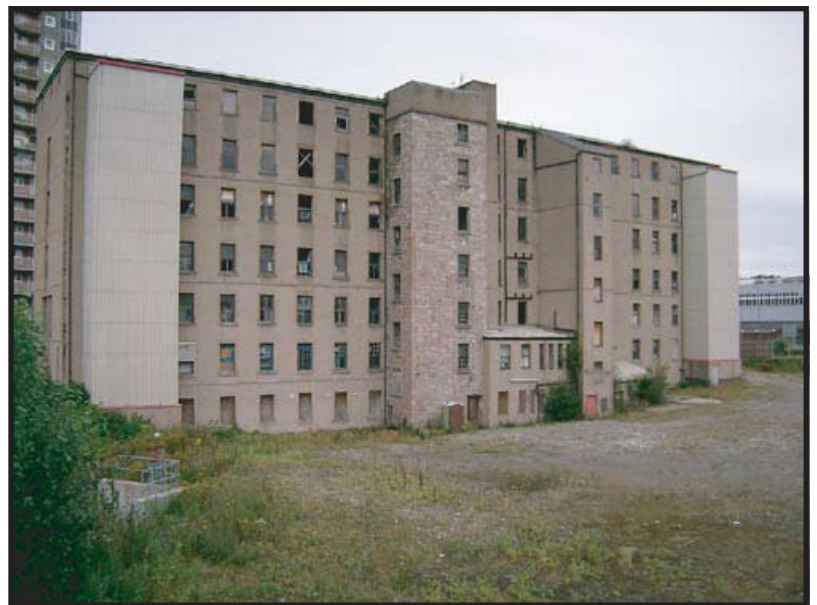
Plate 5: View of the south (rear) elevation of the Hotel

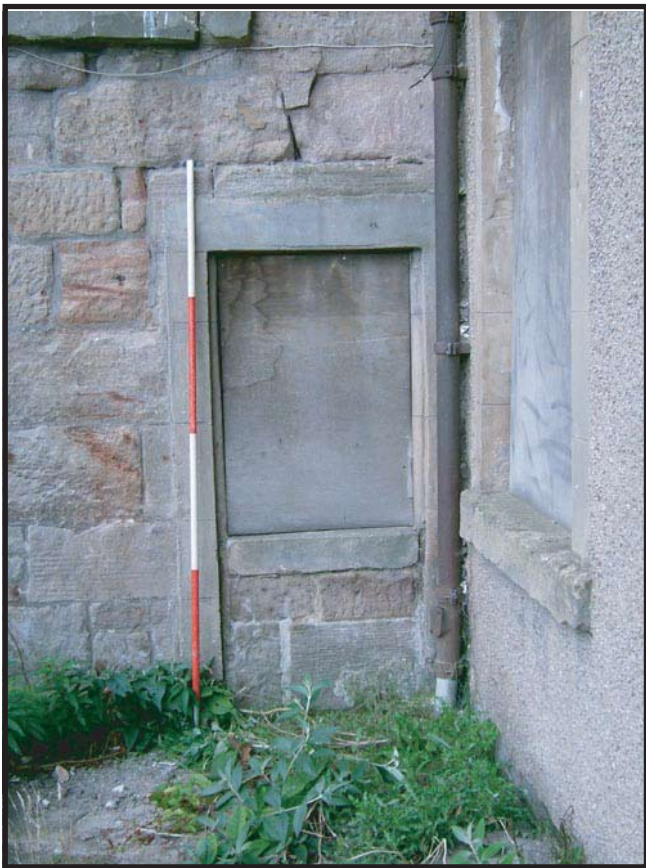
Plate 7: Detail of the modified window on the west side of the main staircase

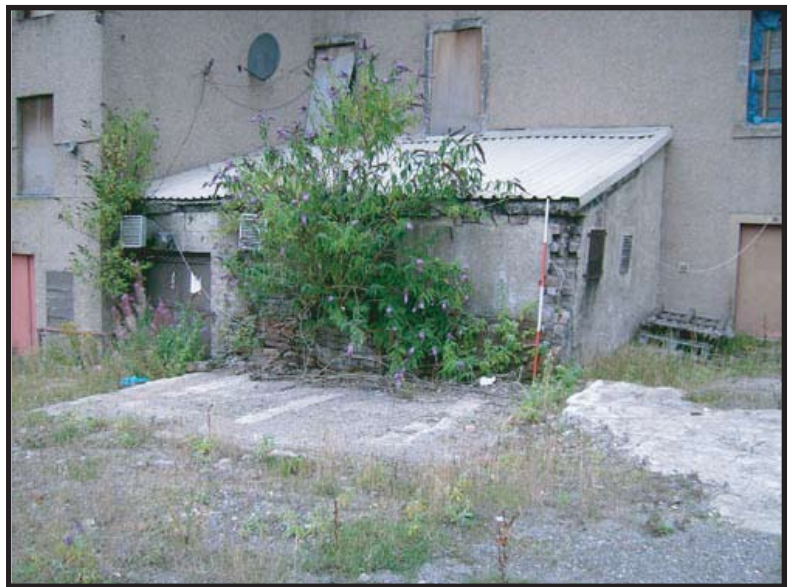
Plate 8: Detail of the later phase generator room (H) to the rear of the building

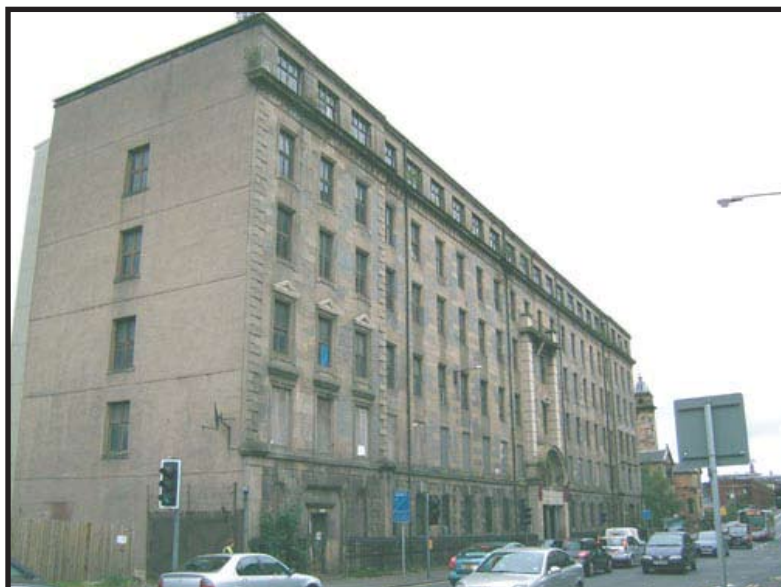
Plate 9: General view of the north elevation of the hotel from the north-east
