Greenhow Hill Lead Mines Survey

September 2003

Surveyed by Martin Roe on behalf of the Northern Mine Research Society

Commissioned by the Nidderdale AONB

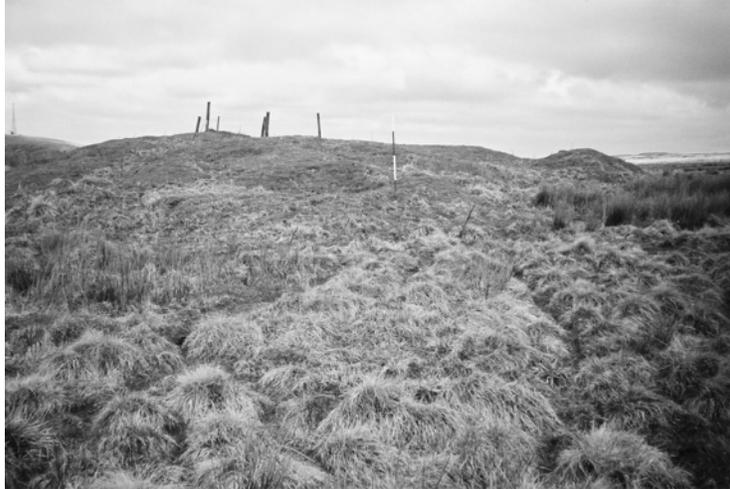
Fig.10 East Engine Shaft (feature 2)

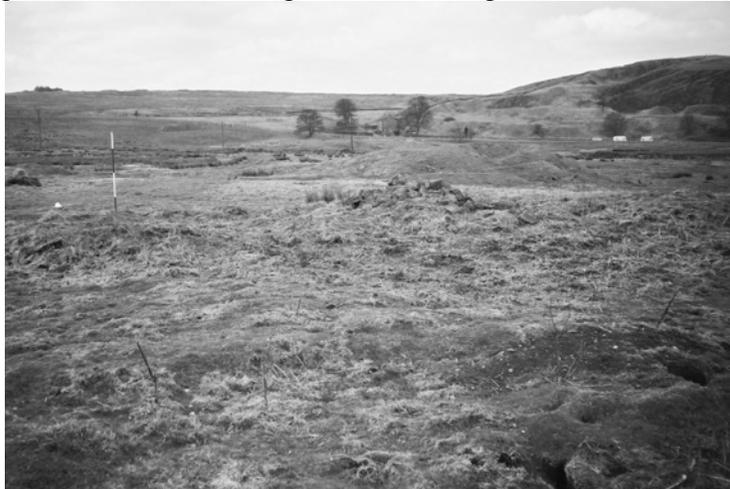
Only one building has been identified in this area (19) and the presence of blacksmiths waste nearby suggests that it was a smithy.

Fig.12 Smithy (feature 19)

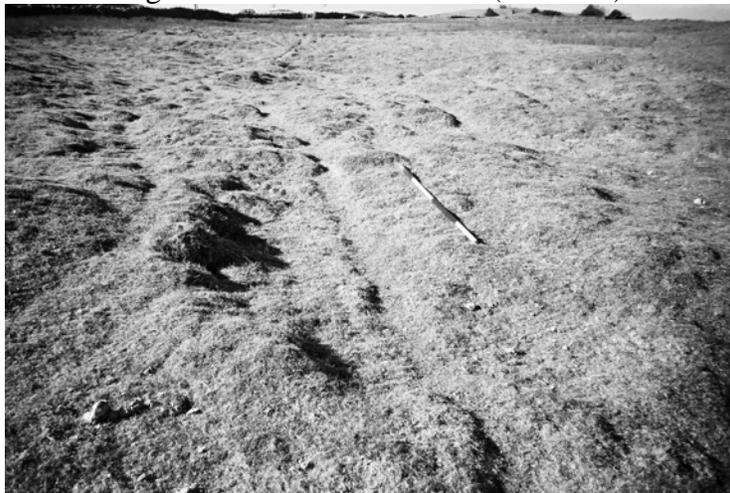
Fig.21 Buddle on water leat (feature 11)

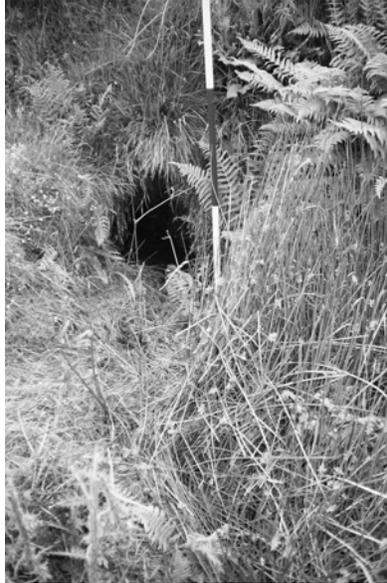
Fig.27 Entrance to Sam Oon Level (feature 40)

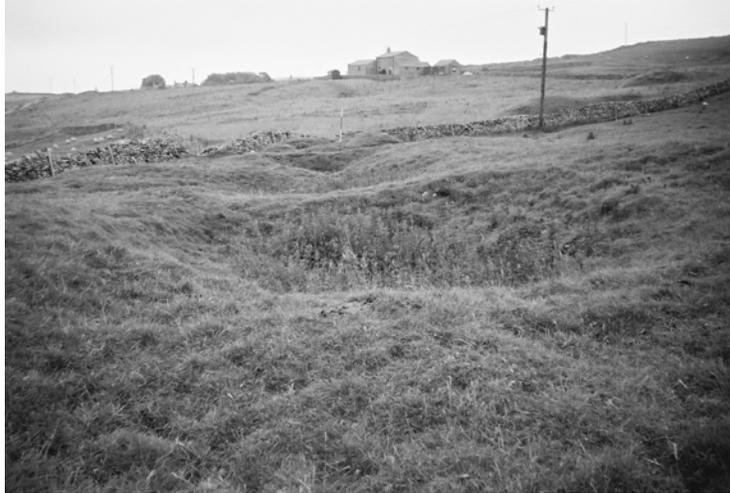
Fig.30 Shaft mounds The Virgins Vein (feature 1)

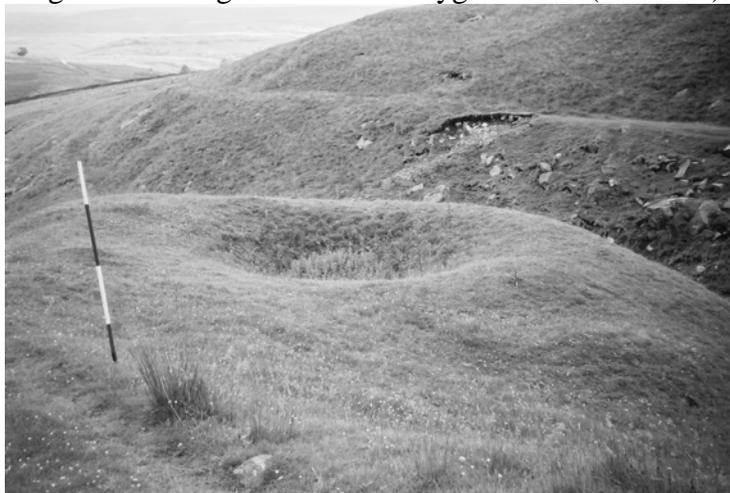
Fig.32 Possible shaft onto Jackass Level (feature 63)

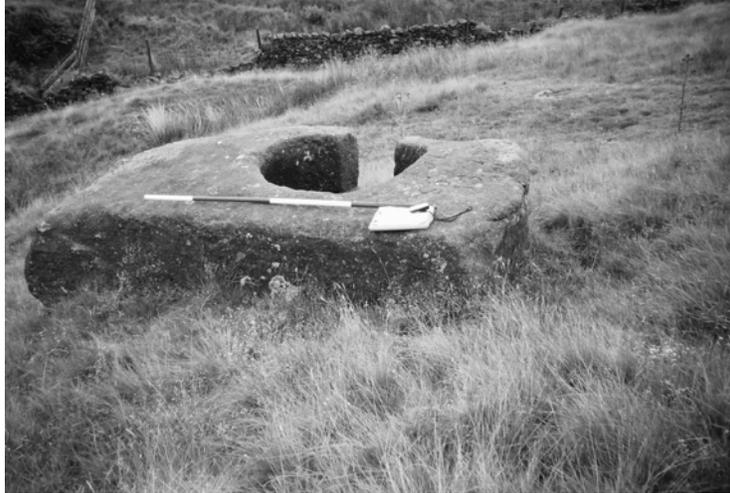
Fig.33 Panty Oon Stone (feature 39)

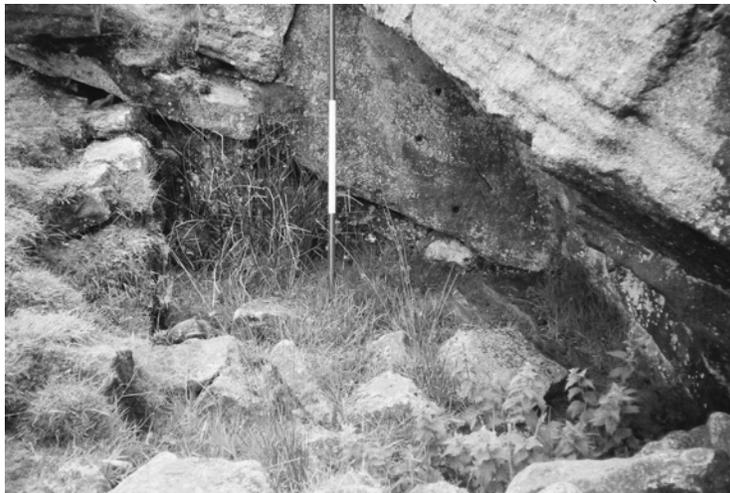
Fig.35 Quarryman's shelter (feature 64)

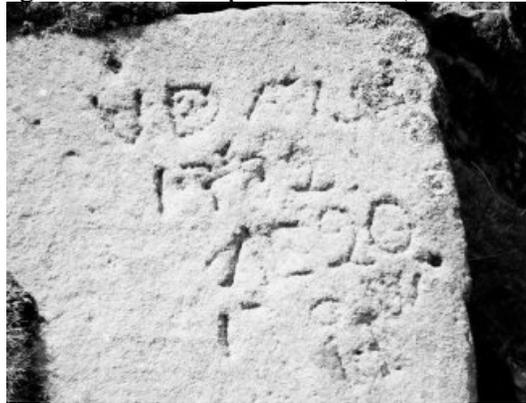
Fig.47 Possible explosive store (feature 29)

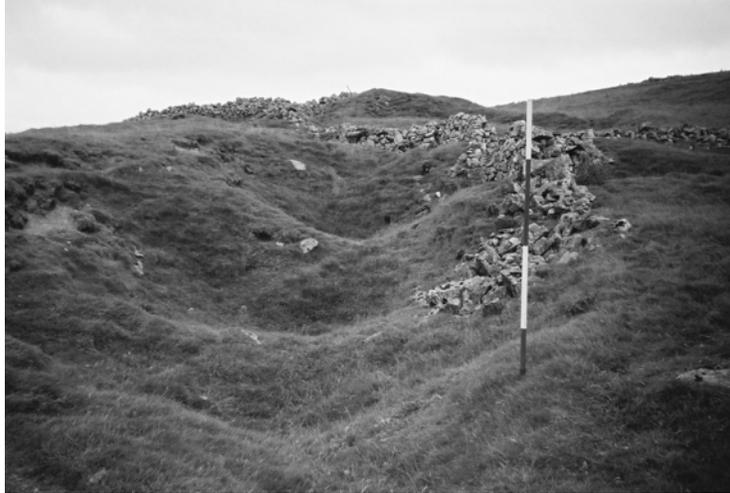
Fig.55 Opencut Greenhow Rake Vein (feature 204)

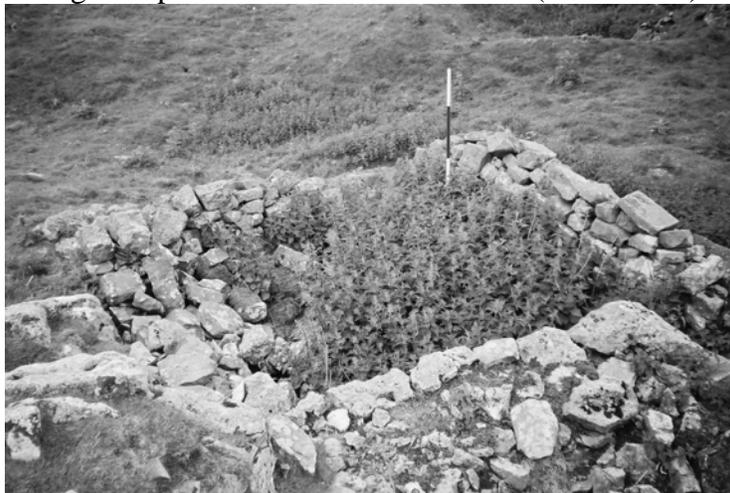
Only two mining related buildings have been identified. Both are small square buildings in the style of a miner's coe. Feature 189 is partly buried in the spoil from the Greenhow Rake opencut and if the vein has been worked by the meer system would be located within the quarter cord. This suggests that the coe could be contemporary with meer working. The second 121 has a similar relationship to a fracture off the Prim Gap Vein.

Fig.57 Coe near PrimGap Vein (feature 121)

The remains of nineteen mining related buildings have been found, of which eleven are located in the Cockhill area. Two buildings (fig.51 features 121 & 189) are in the style of a traditional miners coe which are usually associated with meer working. Such buildings are unusual in the Yorkshire Dales and therefore highly significant.

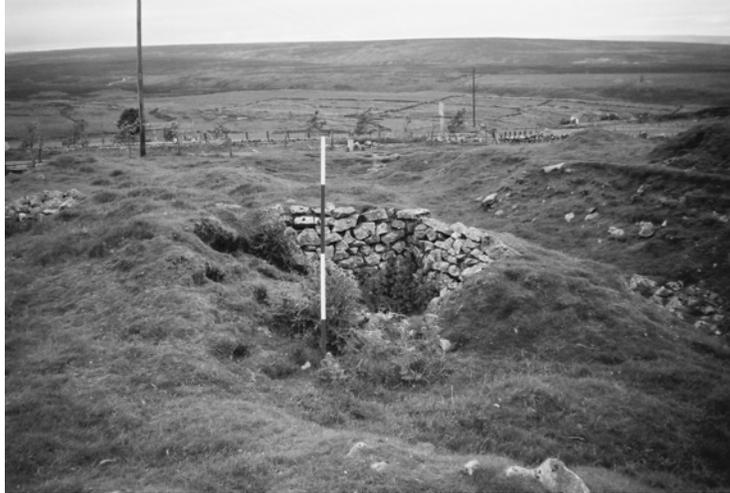
Fig.58 Coe on the side of Greenhow Rake Vein (feature 189)

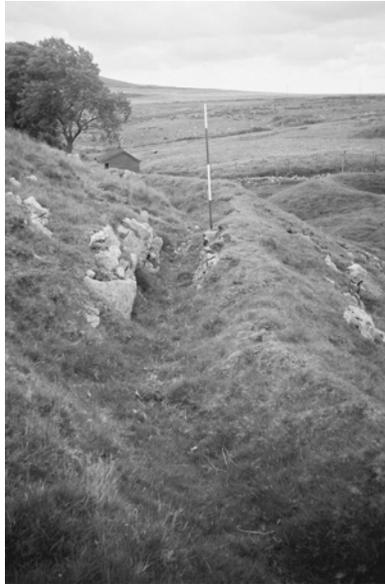
Fig.59 Rock cut water leat (feature 11)

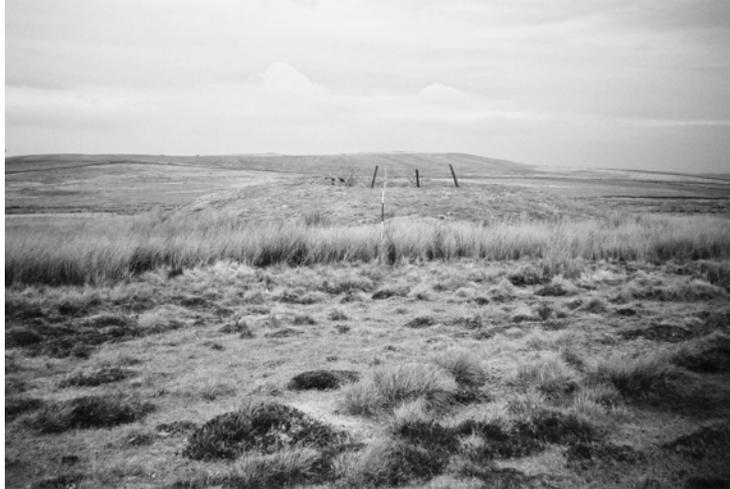
Fig.68 Engine Shaft (feature143)

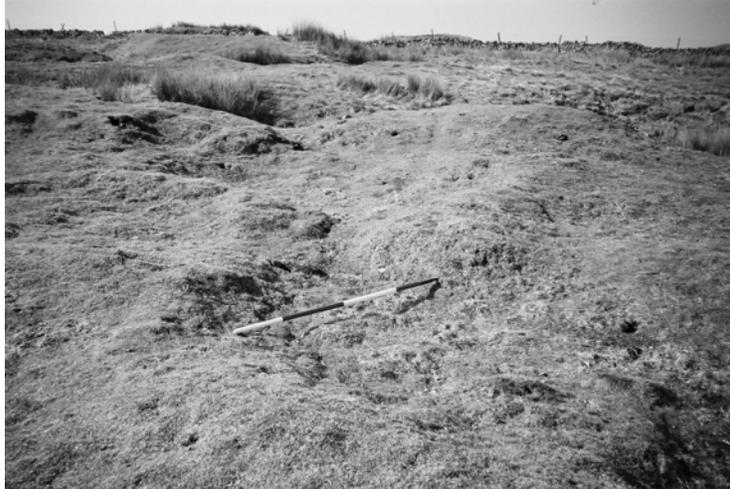
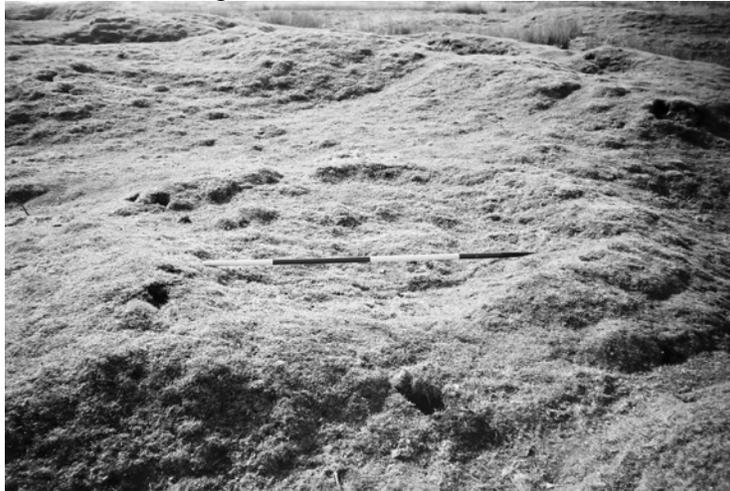
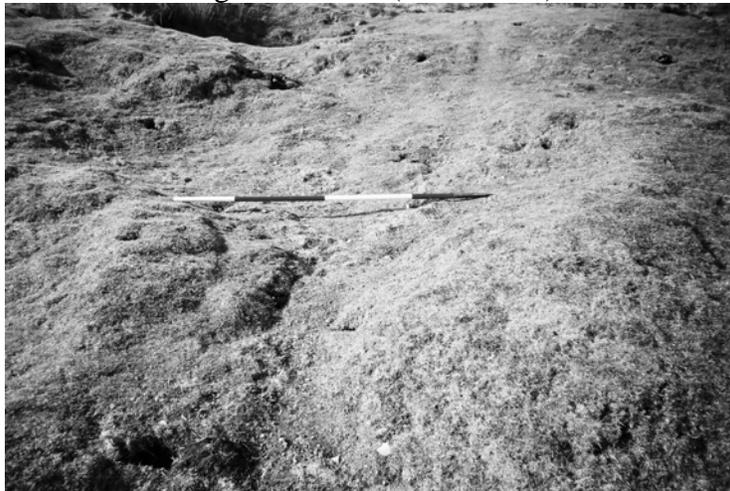
Fig.71 Buddles (feature 263)

Fig.72 Buddles (feature 263)

Fig.73 Buddles (feature 263)

The disturbance of ore dressing areas throughout the village is indicative of operations to recover discarded lead ore, fluorspar and barites. The recovery of lead ore at Greenhow is documented from the later part of the 18th century when waste redressing was leased separately to mining. These operations appear to have left considerable remains particularly at North Coldstones (fig.17 & 18) where waste dressers were active in the 1780. These activities led to damage to various watercourses plus the construction of new leats and dams. Sludge from these operations was allowed to run into several shafts and causing them to collapse, disrupting the miners working in Gillfield Level (Gill 1998). These areas, which are not associated with shafts or levels, are represented by low-lying complex earthworks, usually served by leats and close to dams. Very little identifiable structure is present in these areas but at a number of locations simple buddles have been found (e.g. fig.18 feature 11, fig.36 feature 43, fig.67 feature 263). These are commonly sets of small-interconnected sub-rectangular tanks up to 2m across, usually closely associated with water leats. These buddles are very rare survivors and as such should be considered as suitable for statutory protection.

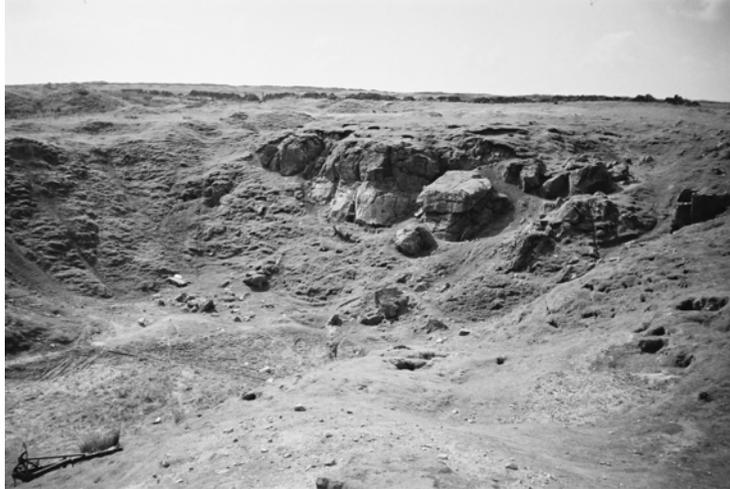
Fig.74 Galloway Gulf (feature 54)

Both Cockhill and Gillfield levels were used during twentieth century fluorspar mining operations, but as this activity took place underground it has had little discernable affect on the surface archaeology. The situation is different on Greenhow Hill and Galloway Pasture. Greenhow Rake Vein, which runs over the summit of Greenhow Hill has been worked by both shafts and open cuts (fig.51). The form of the open cuts strongly suggests 20th century working both on the north side of the hill and where the vein crosses Duck Street Quarry. On Galloway Pasture, Galloway Gulf (fig.65 feature 54) represents a shakehole excavated in the early 1960s (Gill 1998).

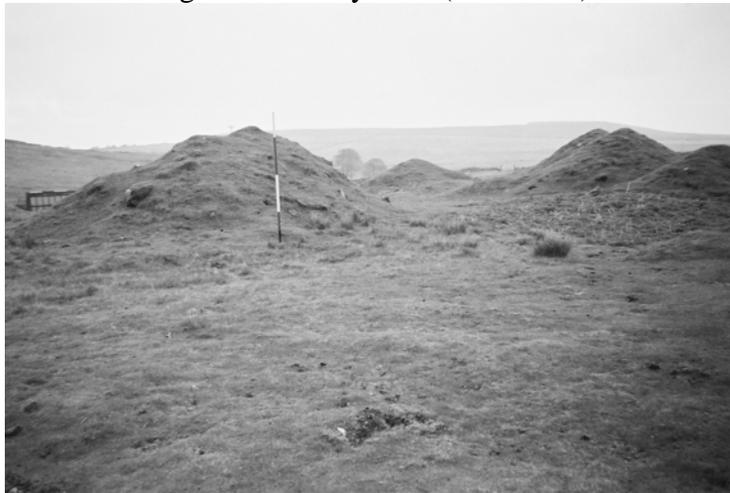
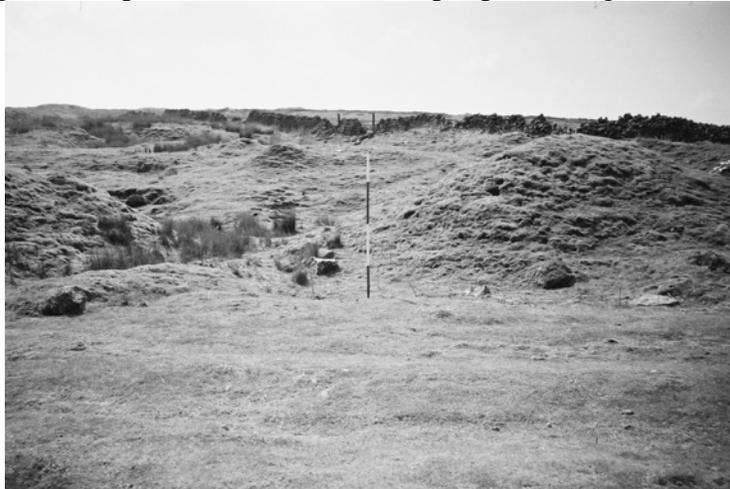
Fig.75 Dumped material from fluorspar processing (feature 53)

Fig.76 Dumped material from fluorspar processing (feature 53)

The mining and recovery of gangue minerals such as fluorspar and barites began in the 1920s and continued at a small scale for around 50 years. Close to Galloway Gulf are numerous piles of waste from the processing of fluorspar and barites (fig.65 feature 53). This waste was not produced at Greenhow but at the Dales Chemical Company plant at Grassington which operated between 1957 and 1964, and was supplied with material from Greenhow from 1962 (Gill 1998). The Duke of Devonshire was not happy about waste produced from the processing of the Greenhow mineral being dumped at Grassington and so returning wagons brought it back to Galloway Pasture (pers com Mr Colin Shepherd). Each pile of material therefore represents one lorry load. Further dumps of fine clay spoil are found on Galloway Moss and these mark the location of small scale reprocessing operations (fig.9 feature 35). Very little remains, other than a concrete engine mounting and a fragment of wall, of a gravity mill (fig.40 feature 15) built close to the Cockhill Smelt Mill around 1933 by the Caldbeck Mining Company who worked underground in both Cockhill and Gillfield levels.
