BLACK BECK HALL, AYSIDE, CUMBRIA

Archaeological Building Recording

Client: Laing O'Rourke Infrastructure
NGR: SD 3956 8362

© Greenlane Archaeology Ltd
October 2006

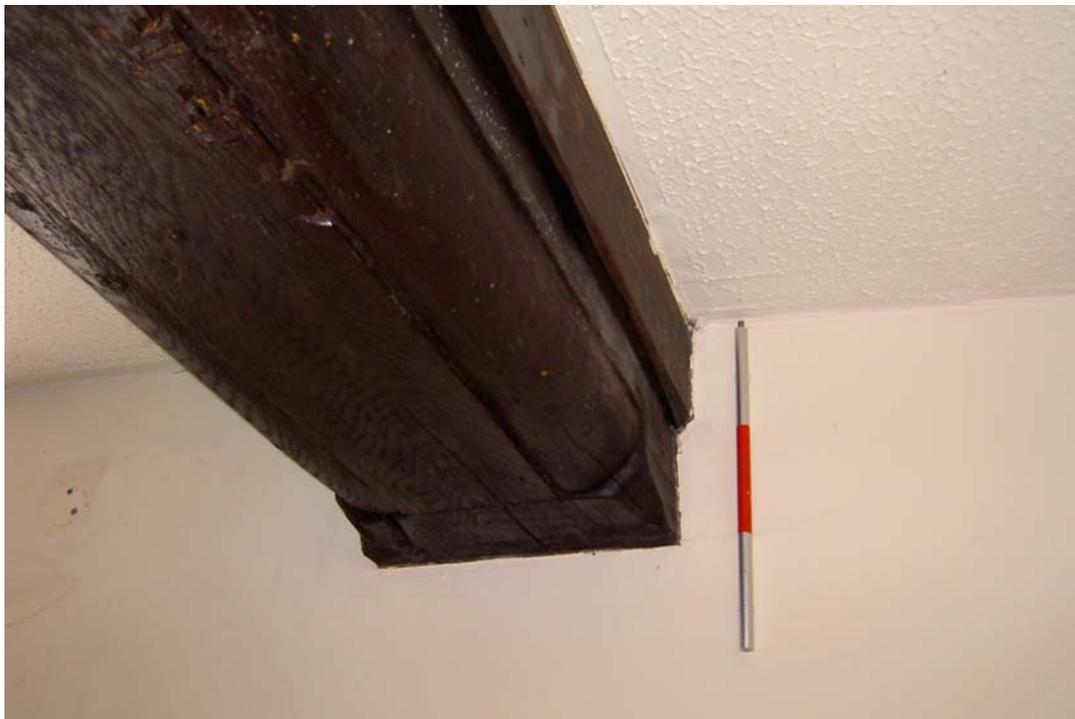
Plate 86: Relict joist slots in the east and upper faces (south end) of beam **135**, facing west (film refs. **10_6/11+12_5-6**)

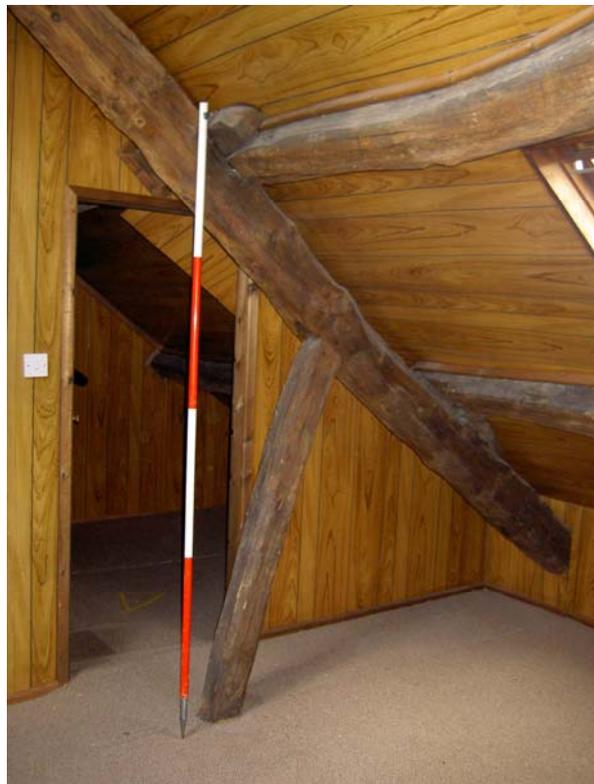
Plate 96: Angled brace **177**, part of truss **176** in room S1, facing south-west (film refs. **10_45/16_11-12/17_11-12a**)

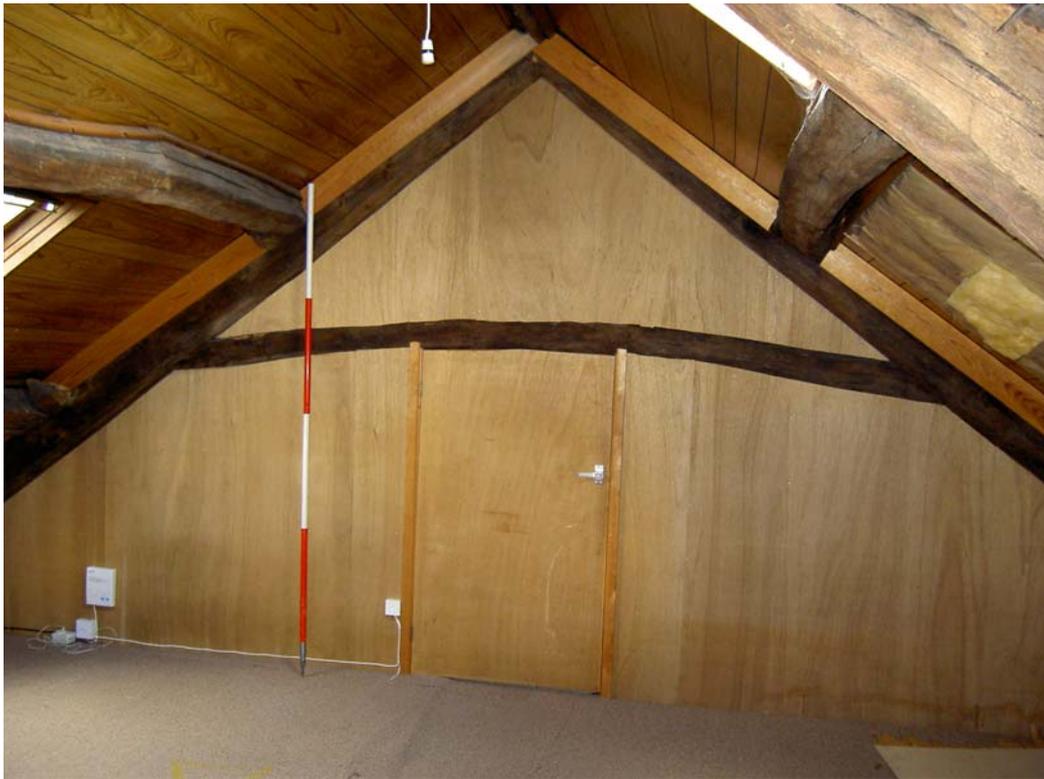
Plate 97: Angled brace **178**, part of truss **176** in room S1, facing north-west (film refs. **10_46/16+17_13-14**)
