Orford House, Ugley, Essex

Historic Buildings Recording

November 2009

OA East Report No: 1068
OASIS No: oxfodar3-52941
NGR: TL 5155 2705

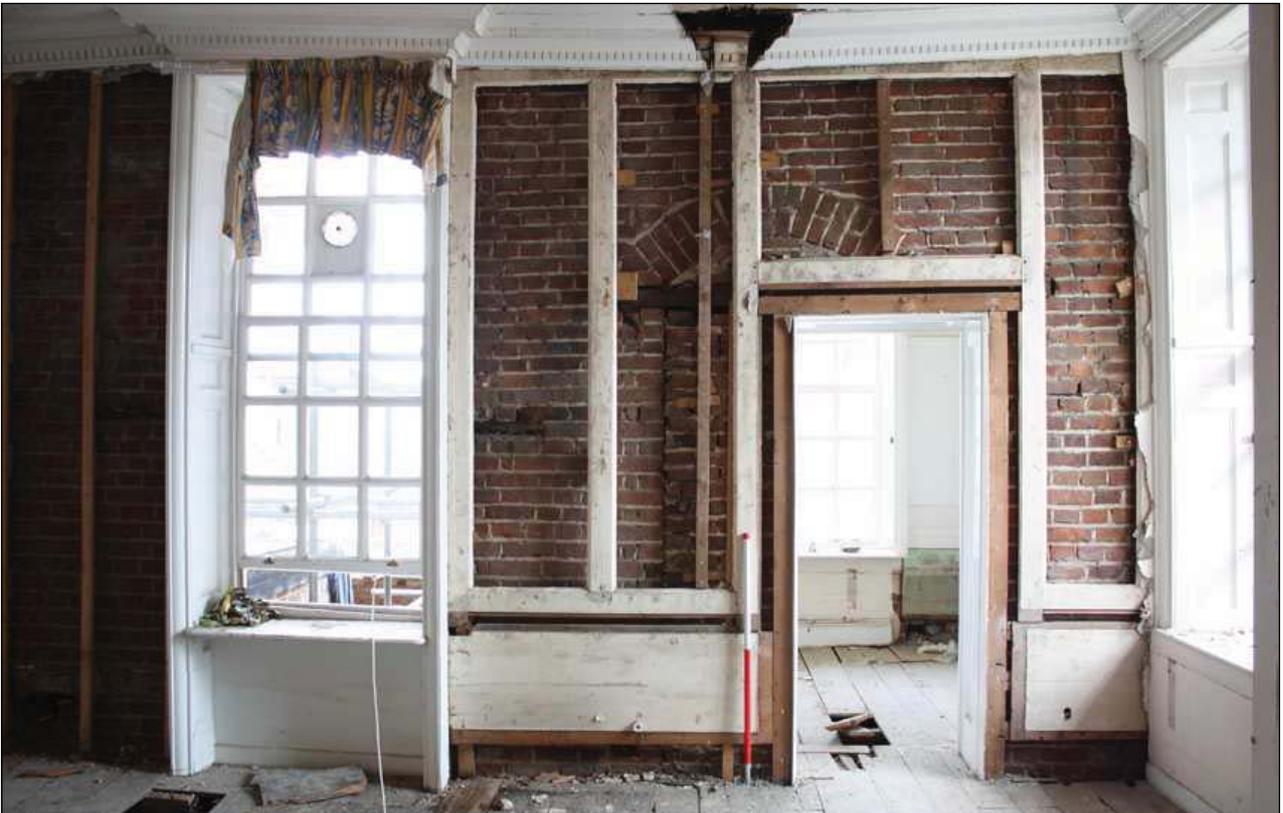
Plate 53: General room shot, F10

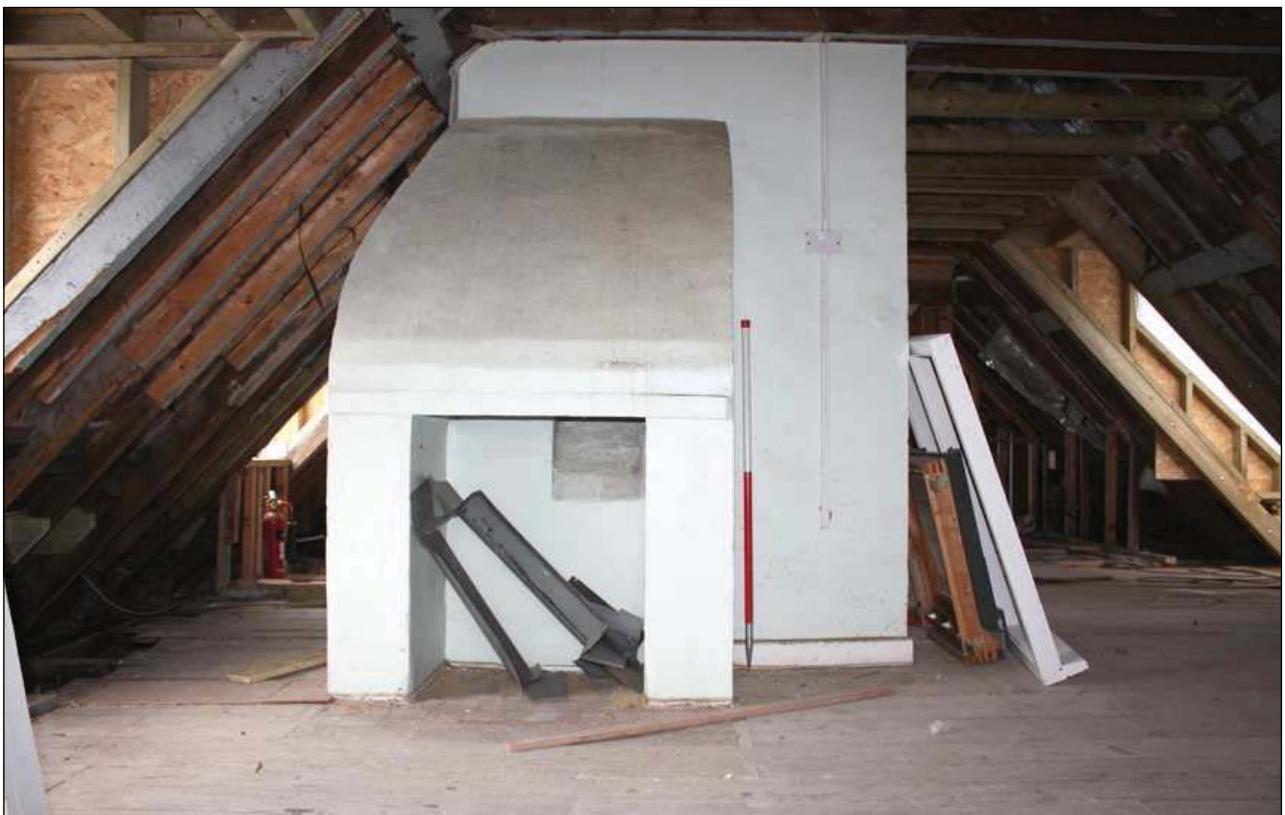
Plate 57: General room shot, F13

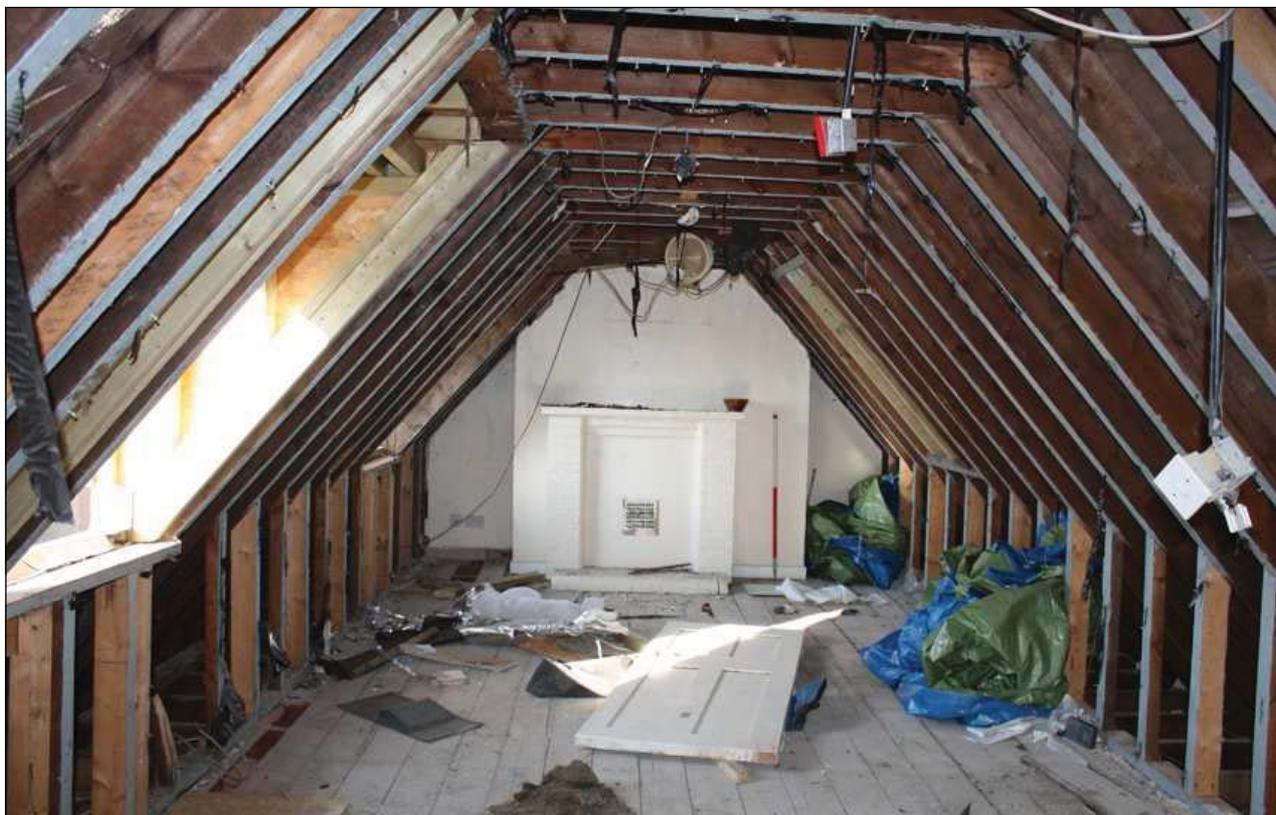
Plate 59: General room shot, S5/6

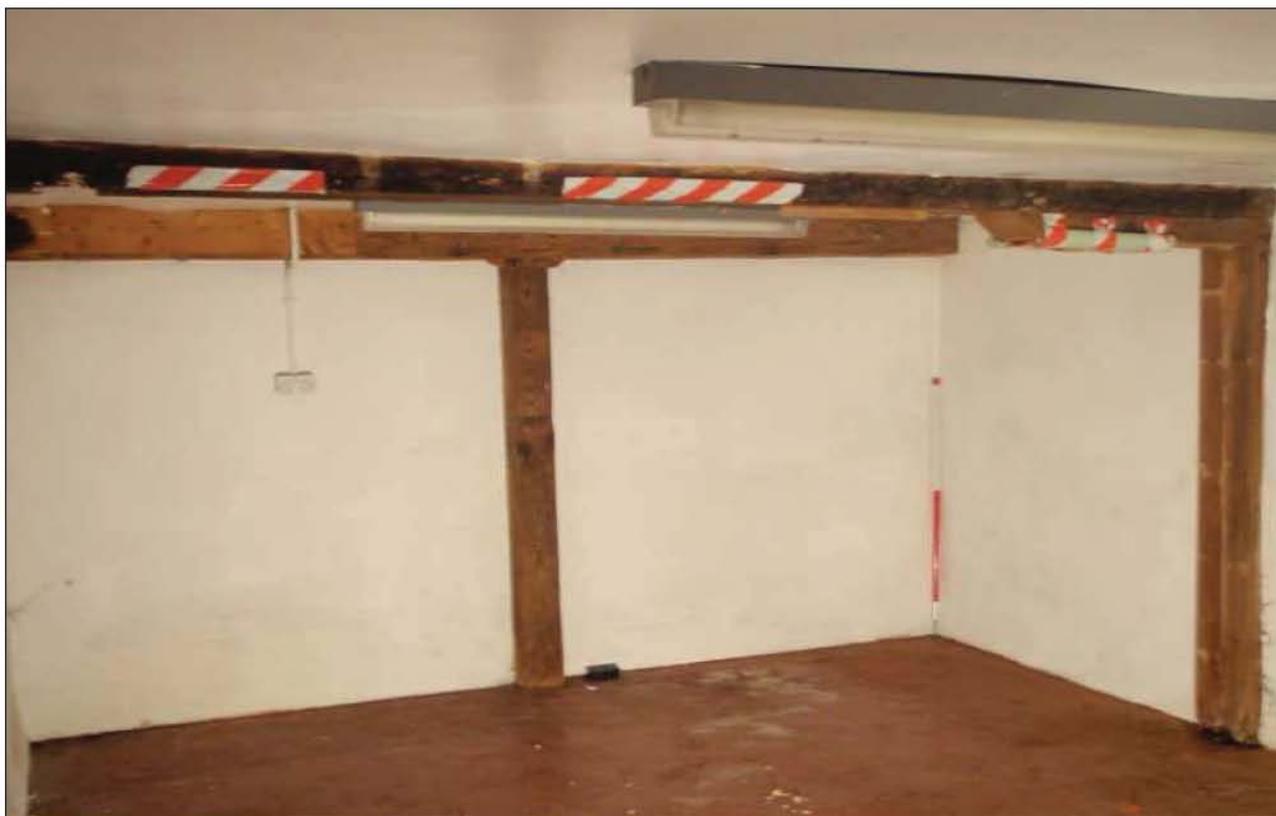
Plate 60: General room shot, S3

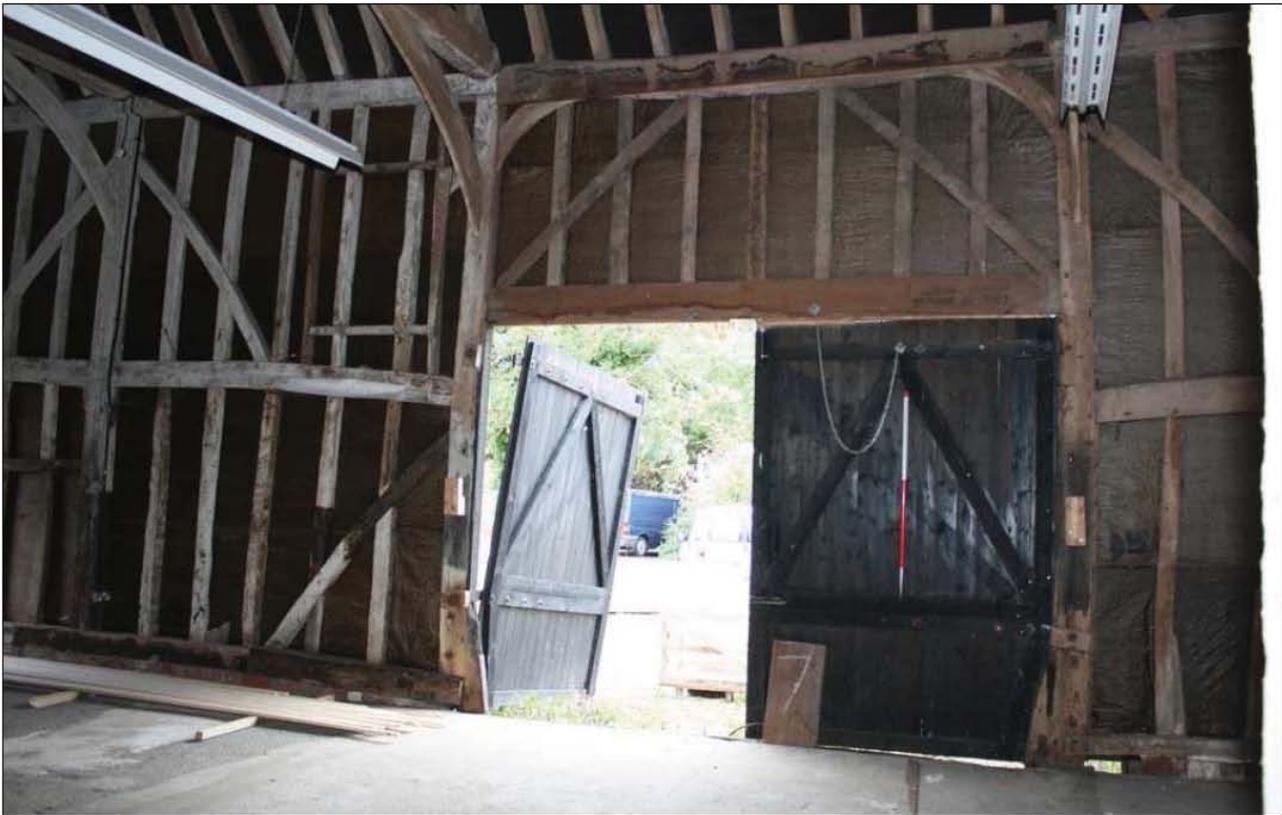
Plate 74: East facing gable end of barn

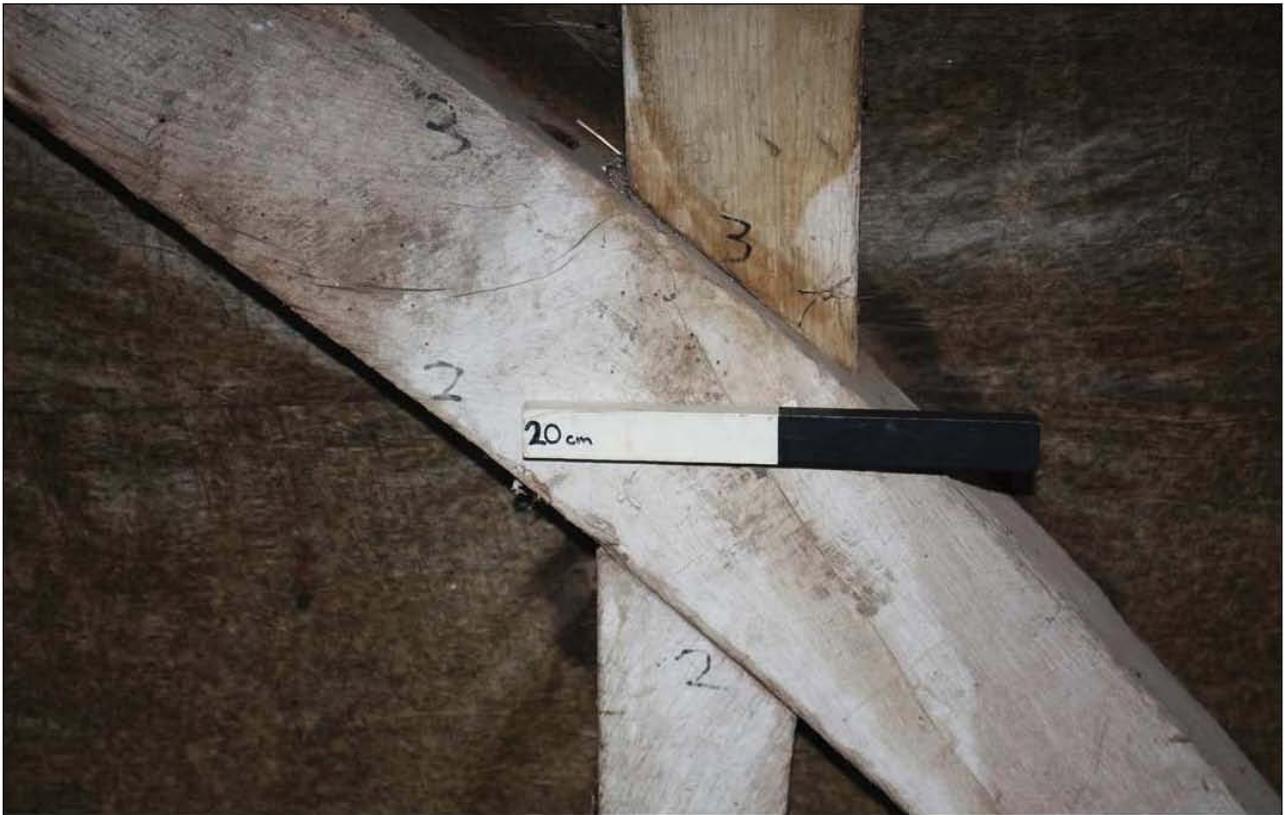
Plate 76: Scissor bracing on rear elevation, phase 2 barn
