# HOUSE AT SLACKWOOD FARM, SILVERDALE, LANCASHIRE

## Archaeological Building Recording

Client: Adrian Waddingham

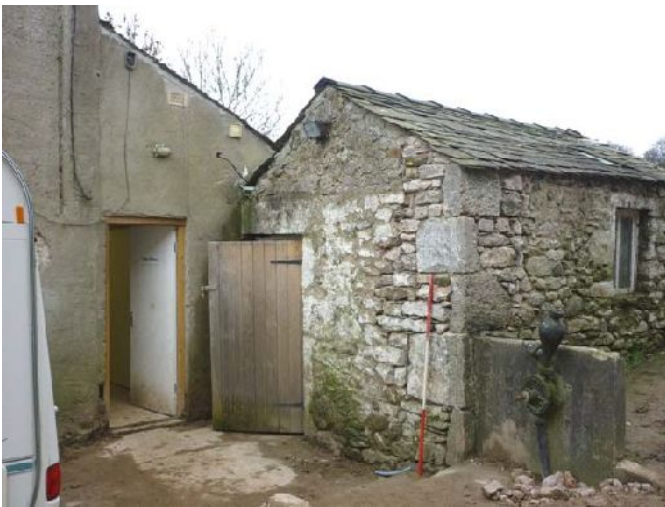
Plate 6 (left): North elevation of Outshut 1 and north and east external elevations of Outshut 2

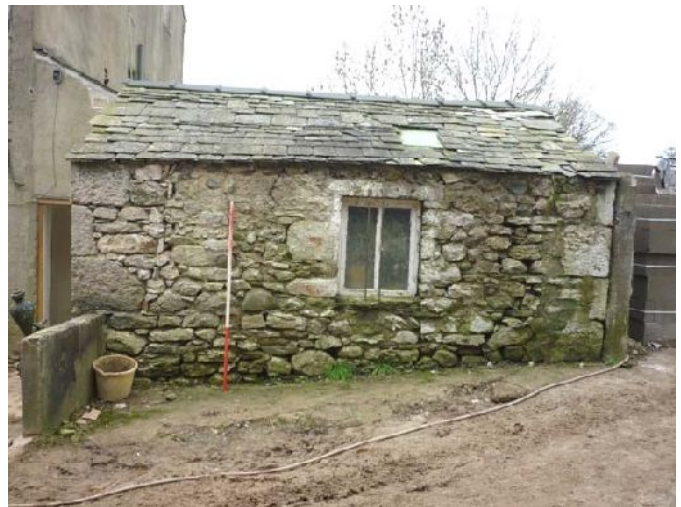
Plate 7 (right): North external elevation of Outshut 2

4.2.4 **Farmhouse – west elevation:** the north end of the west elevation was extended by the gable of Outshut 2 and there were large quoins behind the gatepost on the north side (see Plate 7). The west wall of Outshut 2 butted against a tall retaining wall on the south side (Plate 10), which formed part of a general retaining wall. The retaining wall returned to the east and within this section there was a low opening with a limestone lintel, and was butted by Outshut 1, which had a mono-pitch roof (Plate 11). The west elevation of this outshut was plain except for a ceramic vent and some concrete re-pointing. There was a timber barge board attached and quoins at the south-west corner. To the south of where the wall of Outshut 1 butted against the main wall of the house the house had a small one-light window, with a chamfered stone surround, and below this there was a plinth along the length of the wall (Figure 3). The first floor of the house had a central tall narrow three-light modern casement window, which was probably inserted, the surround for which was concreted over. The second floor had two two-part mullion windows, each with a later single or two-light casement in each part. There was a further blocked single-light window on the south side at the level of the attic, which had a chamfered surround. There were scrolled kneelers at either end of the elevation and a central chimney stack with three ceramic pots and the remains of a drip course.

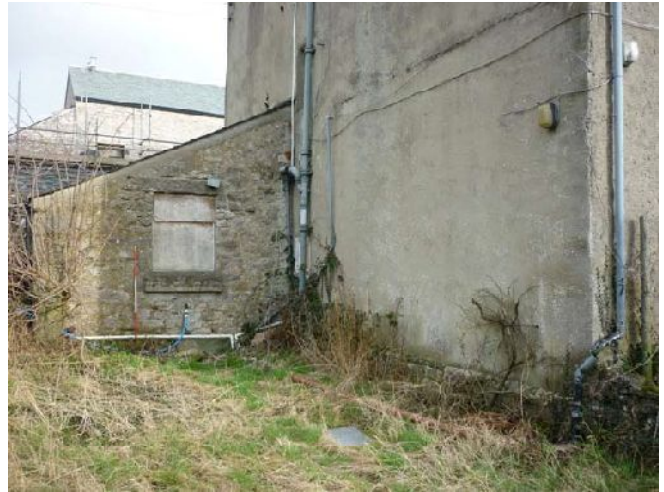
Plate 9 (right): South elevation of Outshut 1

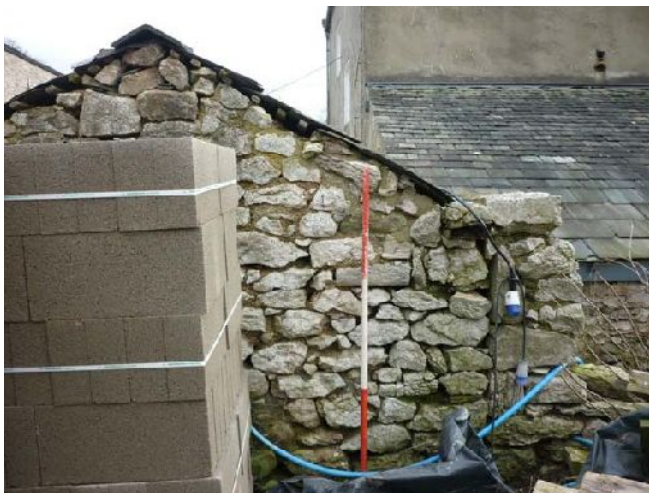
Plate 10 (left): Retaining wall at the south end of the west external elevation of Outshut 2

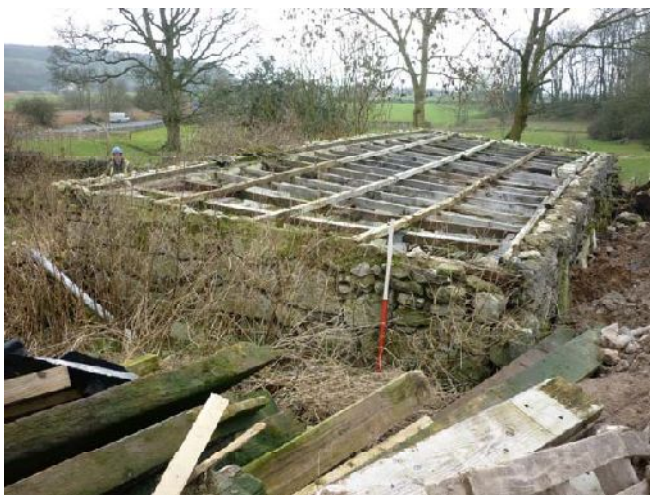
**Plate 12 (left): North external elevation of the ruined outbuilding**

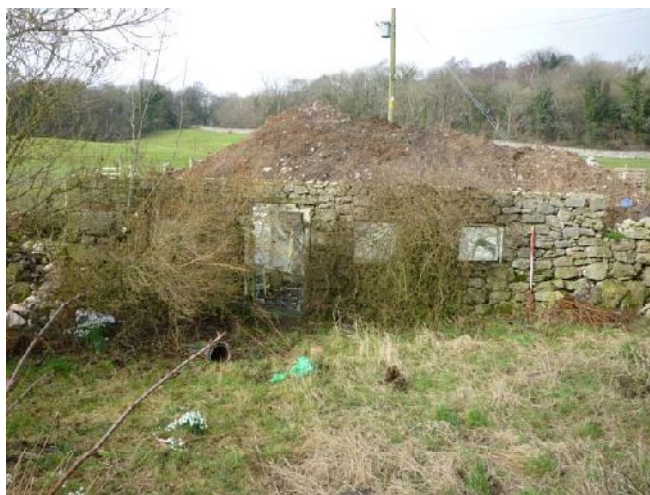
**Plate 13 (right): East external elevation of the ruined outbuilding**

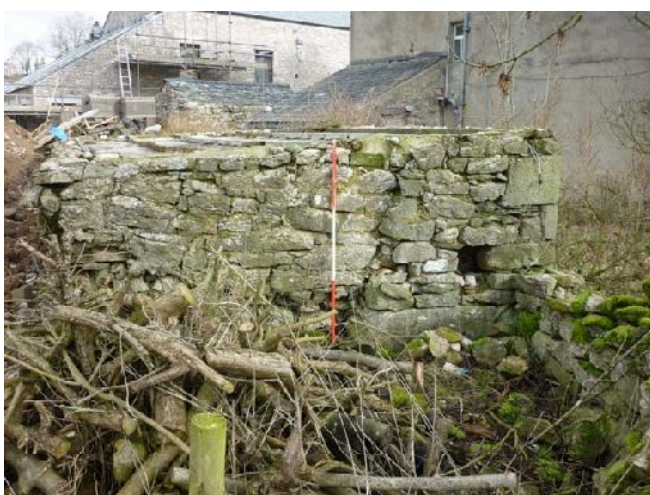
**4.2.7 Ruined outbuilding – south elevation:** this elevation was plain (Plate 14). It was stepped out at the east end and had been rebuilt to the west. There were quoins at the east end and the possible remains of similar quoins at the west end, albeit largely collapsed. There was a large low-level aperture at the east end with a heavy stone lintel, effectively below ground level.

**Plate 14 (left): South external elevation of the ruined outbuilding**

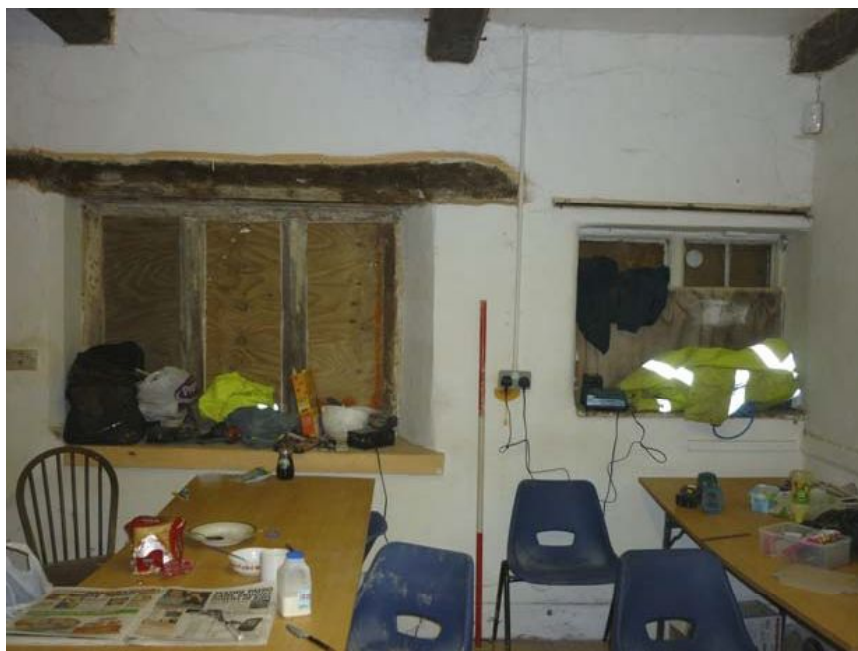
**Plate 22 (left): North elevation of Ground Floor Room 3**

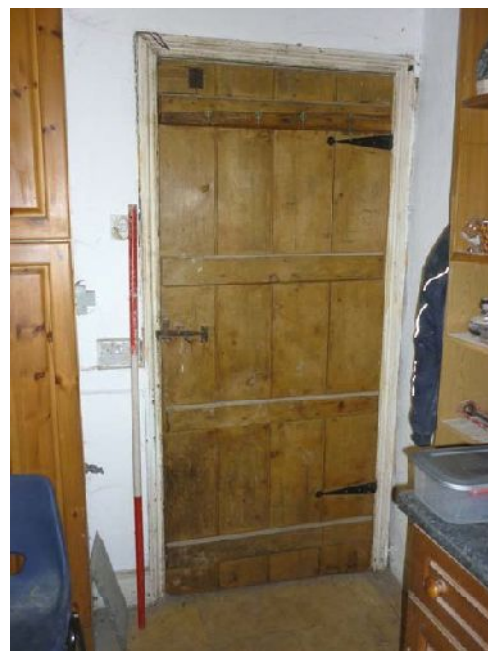
**4.3.5 Ground Floor – Room 3:** this room had a polished concrete floor and was finished with vinyl tiles. It had a plastered ceiling with three hand-finished and stained north/south beams. The beams had some stop chamfer and the centre one had meat hooks attached. The walls were plastered and painted. The south elevation and the south side of the west elevation were covered by kitchen units and were partially tiled. The north elevation had concrete skirting and two windows (Plate 22). The west one was a three-part mullion window and it had a long hand-finished timber lintel and a concrete sill. The east window was boarded over and was a more plain ovolo-moulded timber mullion with a timber sill. The east elevation had a beaded rail at mid height and a doorway on the south side, with a moulded surround, which housed a beaded plank and batten door (Plate 23). The door had early hinges and a

**Plate 23 (right): Doorway at the south end of the east elevation of Ground Floor Room 3**

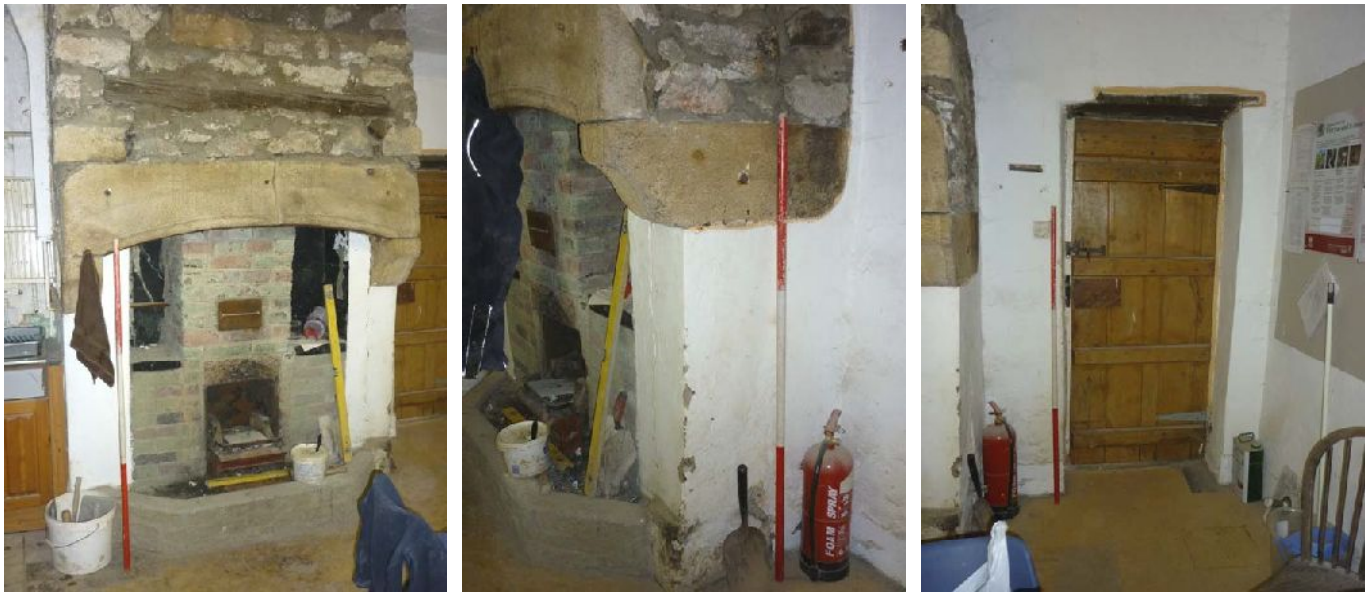
latch and a small hinged section in the top left corner. This elevation was a stud wall and had beaded skirting. The south elevation had concrete skirting to the east and was covered by modern fittings. It was recessed at the west end where it was a stud wall and there was a kitchen sink and other attached fittings in this corner of the room (Plate 24). There was a small window with splayed jambs and a stone surround above the sink. The chimney breast projected fairly centrally on the west elevation and was exposed stone at the top and there was an exposed timber lintel (Plate 25). The fireplace had a dressed stone lintel with a slight arch (Figure 8) and beaded moulding on corbels over the hearth and there were bolts in the north side of the corbel possibly for an earlier crane (Plate 26). The hearth itself had been in-filled with modern stone-effect brick to form a smaller fireplace and there was a brick fender round the base. The doorway to the north of the chimney breast had a beaded plank and batten door with early strap hinges and a modern lock and an ornate latch (Plate 27).

**Plate 25 (left): Chimney breast on the east elevation of Ground Floor Room 3**

**Plate 26 (centre): Bolts in the north corbel of the fireplace, possibly for a crane**

**Plate 27 (right): Doorway on the east elevation of Ground Floor Room 3**

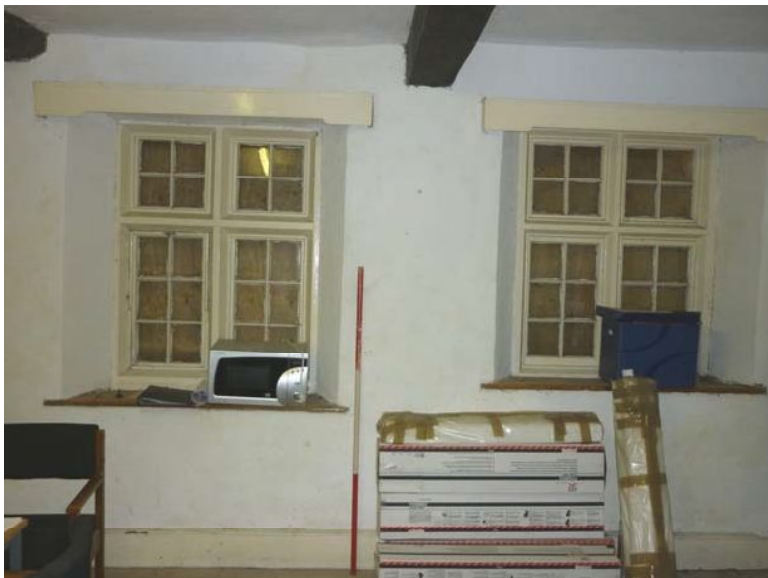
Plate 30 (left): Windows in the south elevation of Ground Floor Room 4

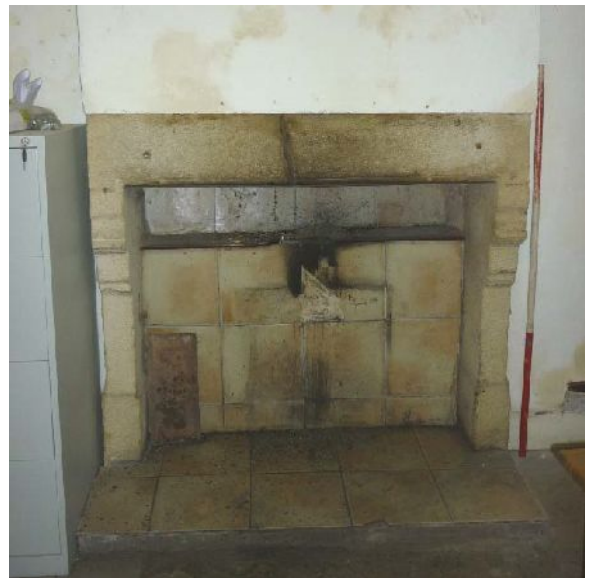
Plate 31 (right): Fireplace in the east elevation of Ground Floor Room 4

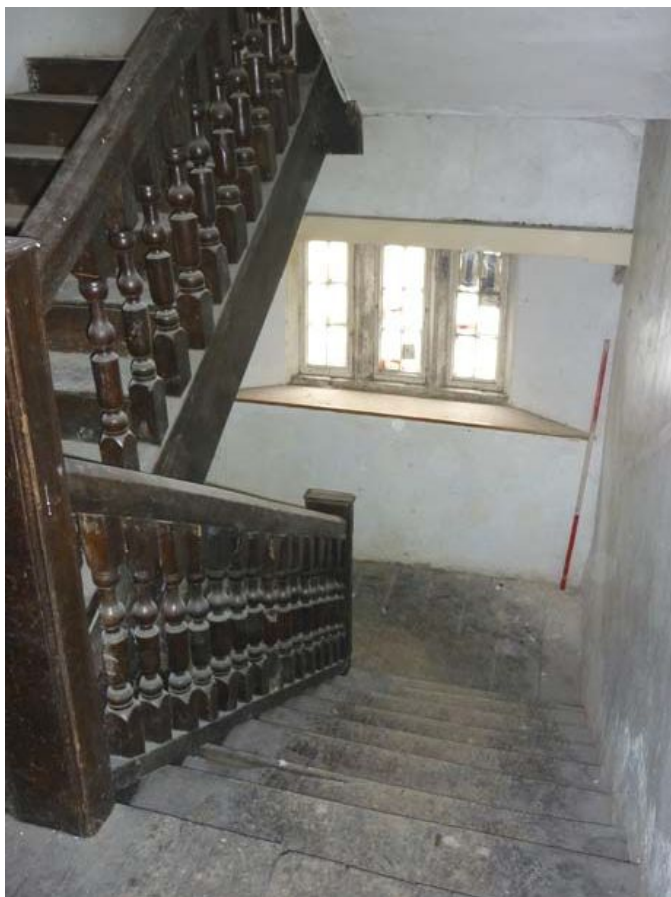
three-part mullion window, with widely splayed jambs, each with six lights (Plate 33). There was a doorway on the lower level to the east of the stairs, which had a plain surround and housed a beaded plank and batten door, with modern “Gothic” strap hinges and possibly the original sliding timber lock (Plate 32). The east elevation was plain except for the beaded plank and batten door on the south side, which had an early latch and a plain surround that was pegged together. The south elevation had two doorways to the east and west of a dividing wall (Figure 9). The east doorway had a plain surround, the tongue and groove plank and batten door for which was loose in Ground Floor Room 5. This door had a later latch and hinges. The west door had a stop chamfered surround and pegged joints and was a beaded plank and batten type with a modern latch.

**Plate 33: Window above the landing between ground and first floor level**

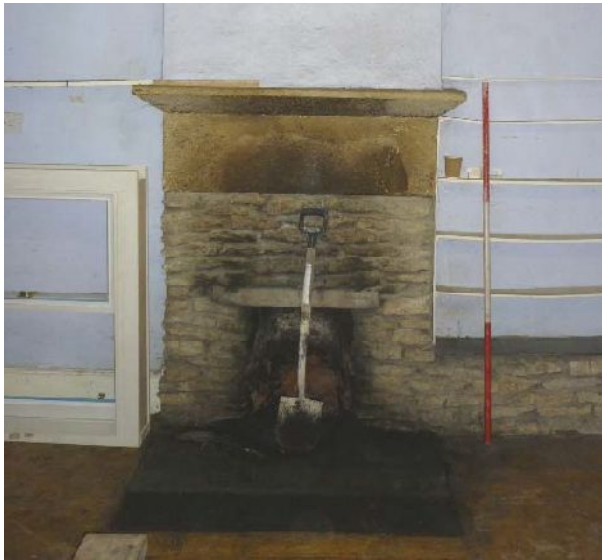
**Plate 34 (left): Fireplace in the east elevation of Ground Floor Room 6**

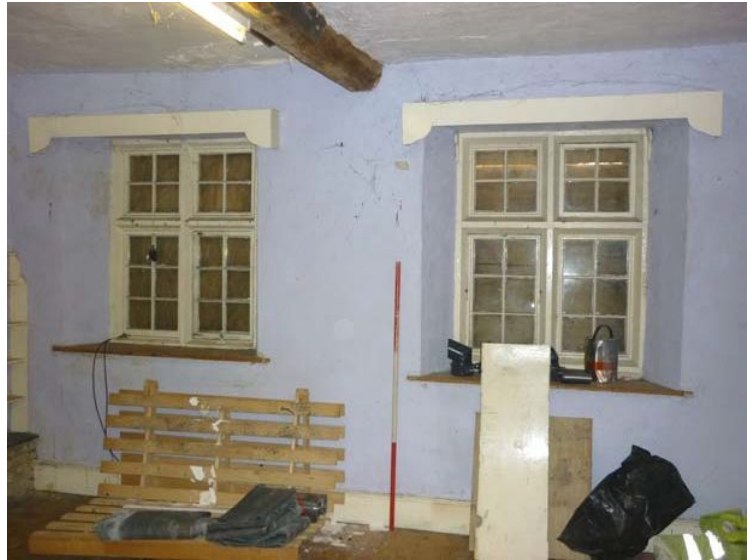
**Plate 35 (right): South elevation of Ground Floor Room 6**

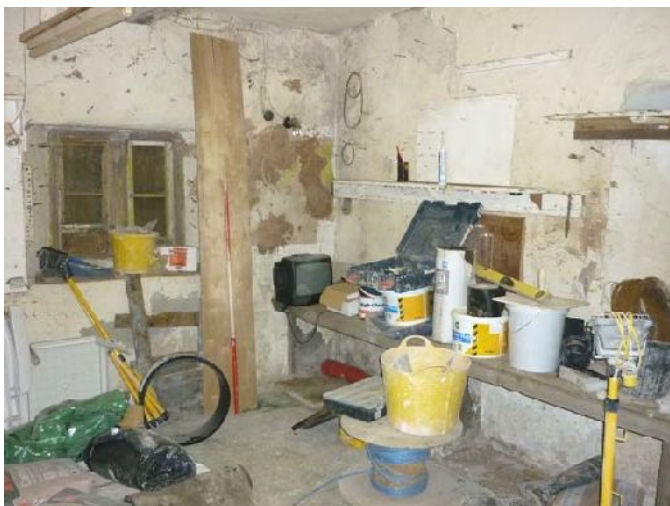
**Plate 37 (left): North and east elevation of Ground Floor Room 7**

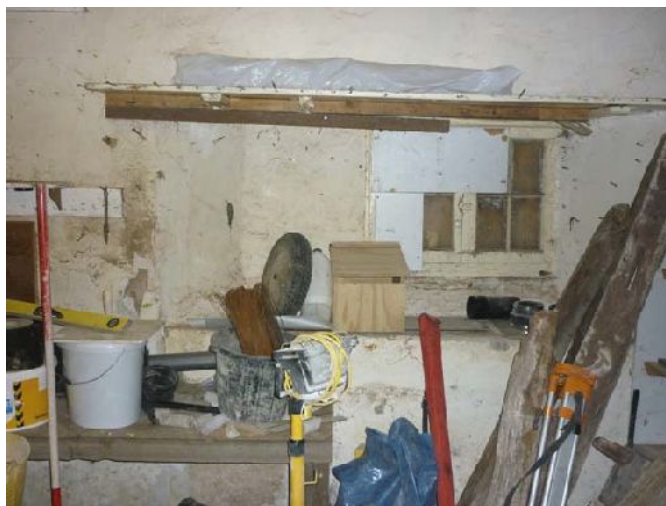
**Plate 38 (right): Window in the east elevation of Ground Floor Room 7**

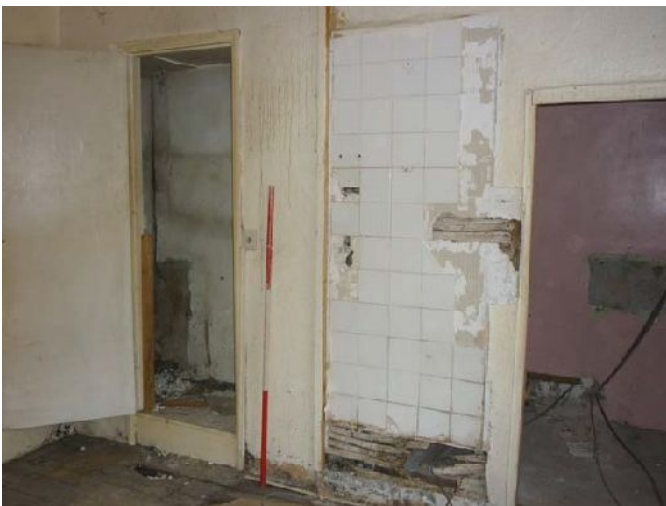
**Plate 42 (left): Smaller room and cupboard to the west side of First Floor Room 1**

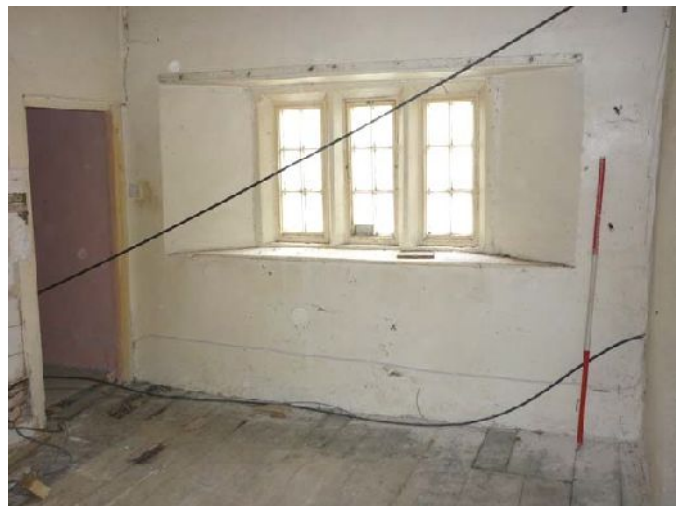
**Plate 43 (right): The north elevation of First Floor Room 1**
