JUNCTION OF HINDPOOL ROAD AND CORNMILL CROSSING, BARROW-IN- FURNESS, CUMBRIA

Archaeological Building Recording

Client: Positive Location
Properties Ltd
Planning Ap. Ref.: 6/05/1530
NGR: SD 1955 6905

© Greenlane Archaeology Ltd
June 2007

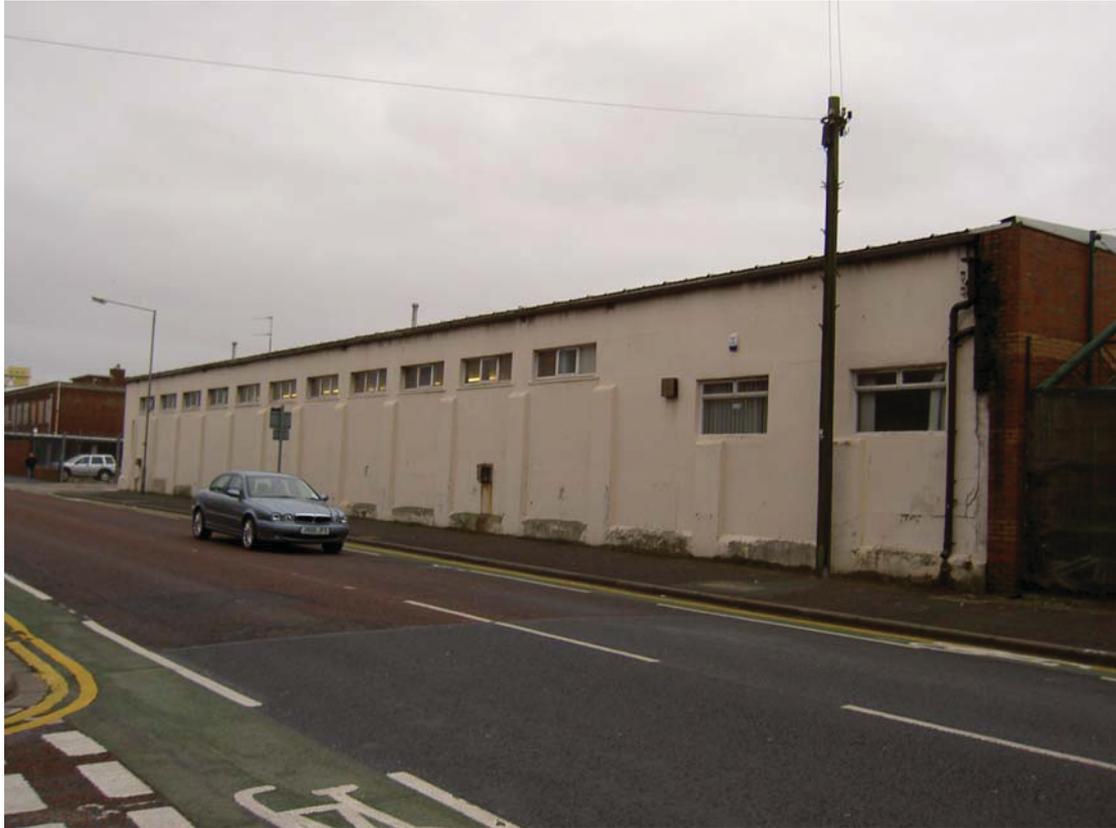
Plate 12: North-east wall of gasworks Building 1

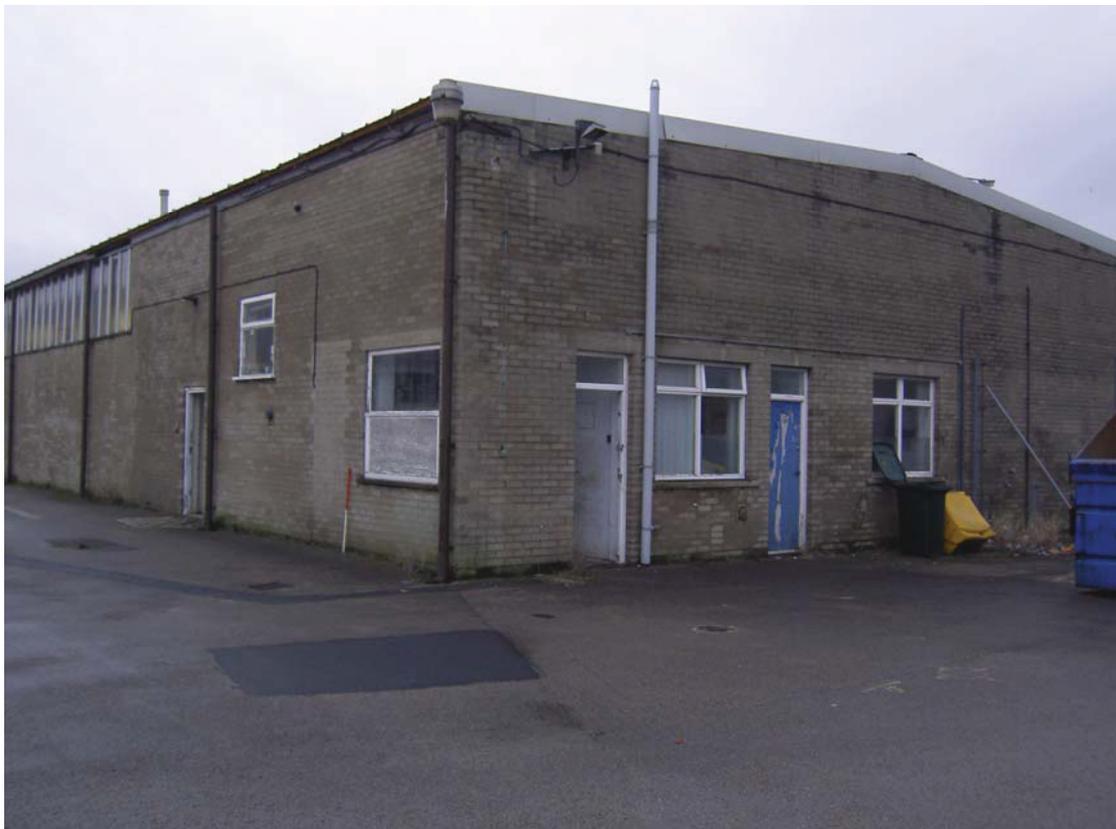
Plate 13: South-east end of gasworks Building 1

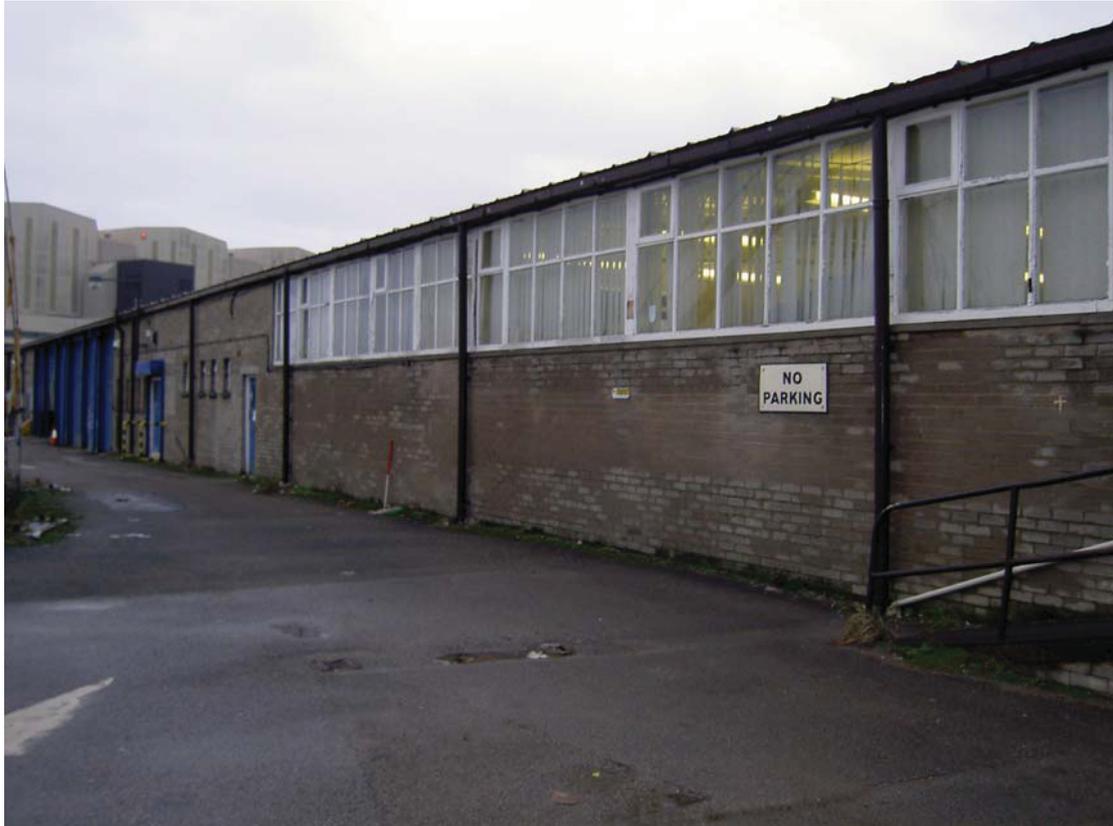
Plate 14: North-east end, south-east elevation of gasworks Building 2

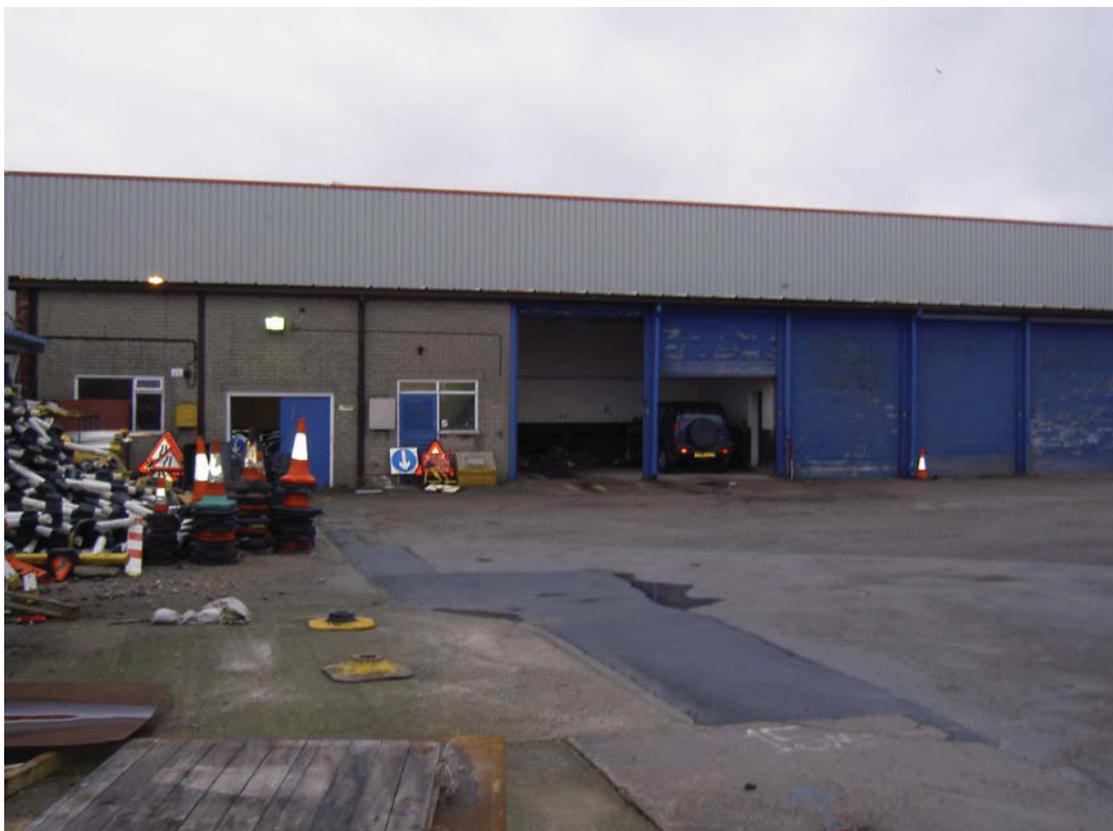
Plate 15: South-west end, south-east elevation of gasworks Building 2

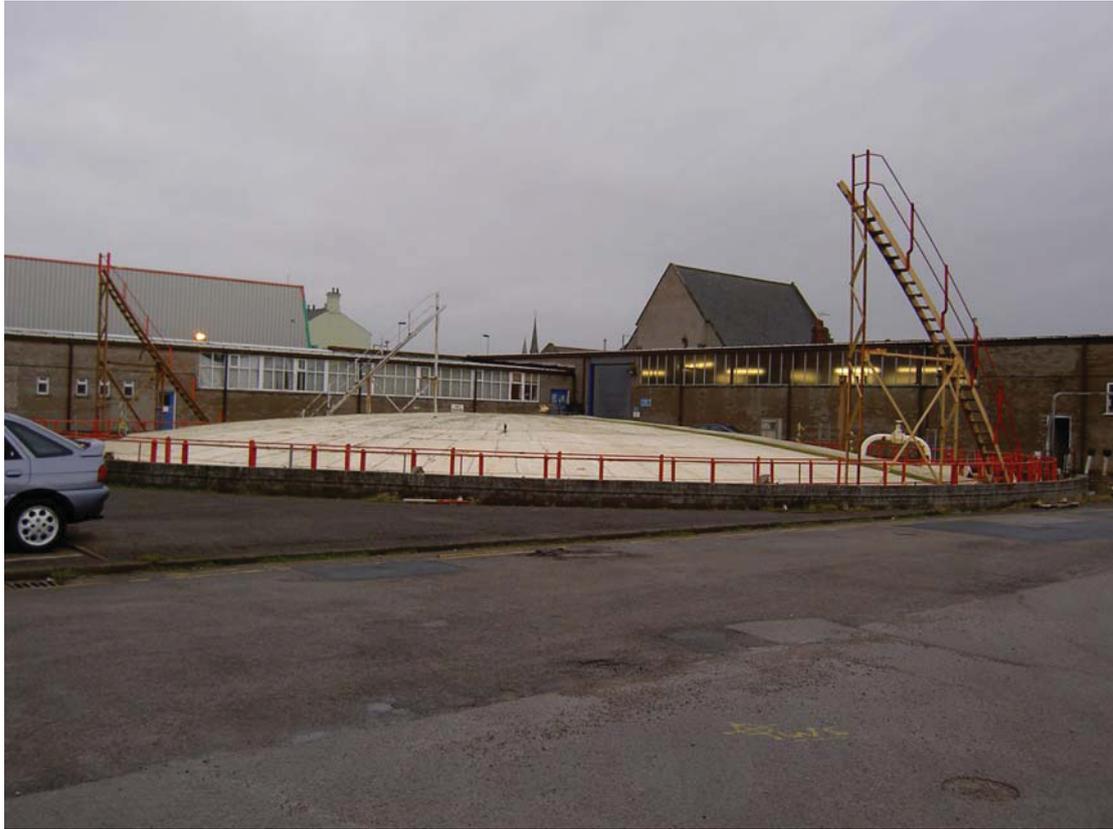
Plate 16: North-western gasholder, gasworks Building 3

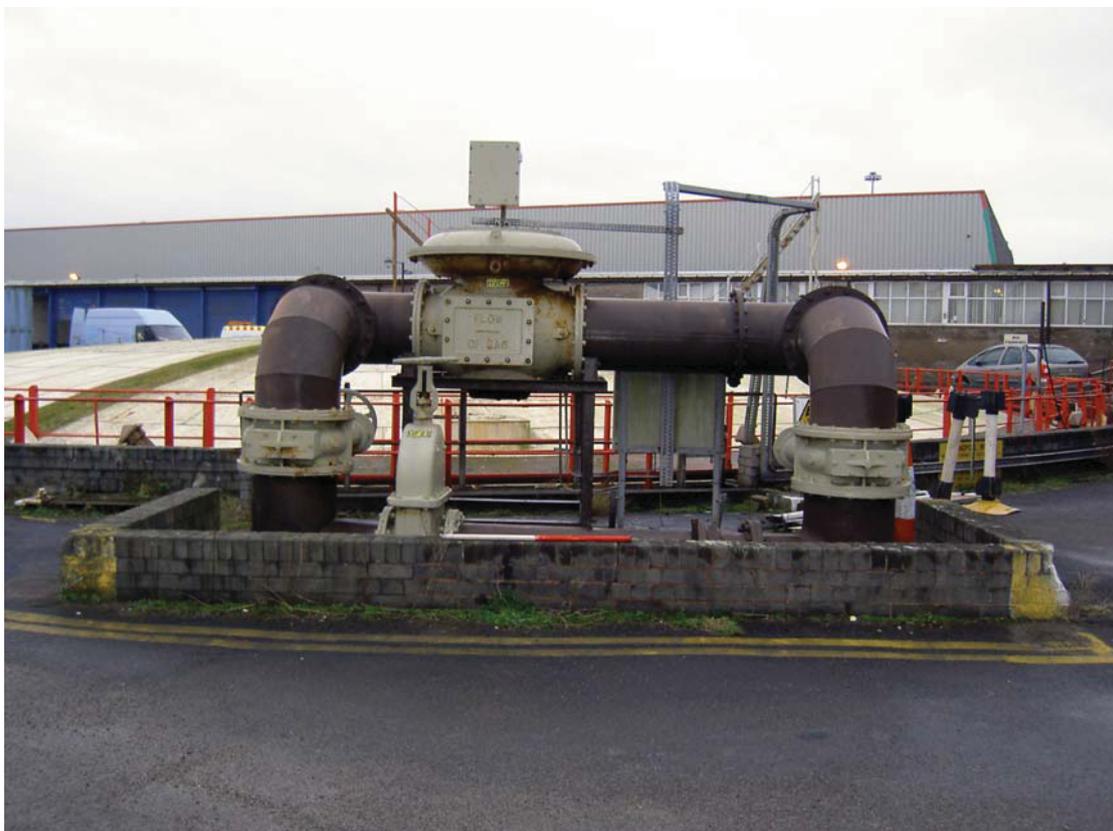
Plate 17: Large valve associated with gasworks Building 3

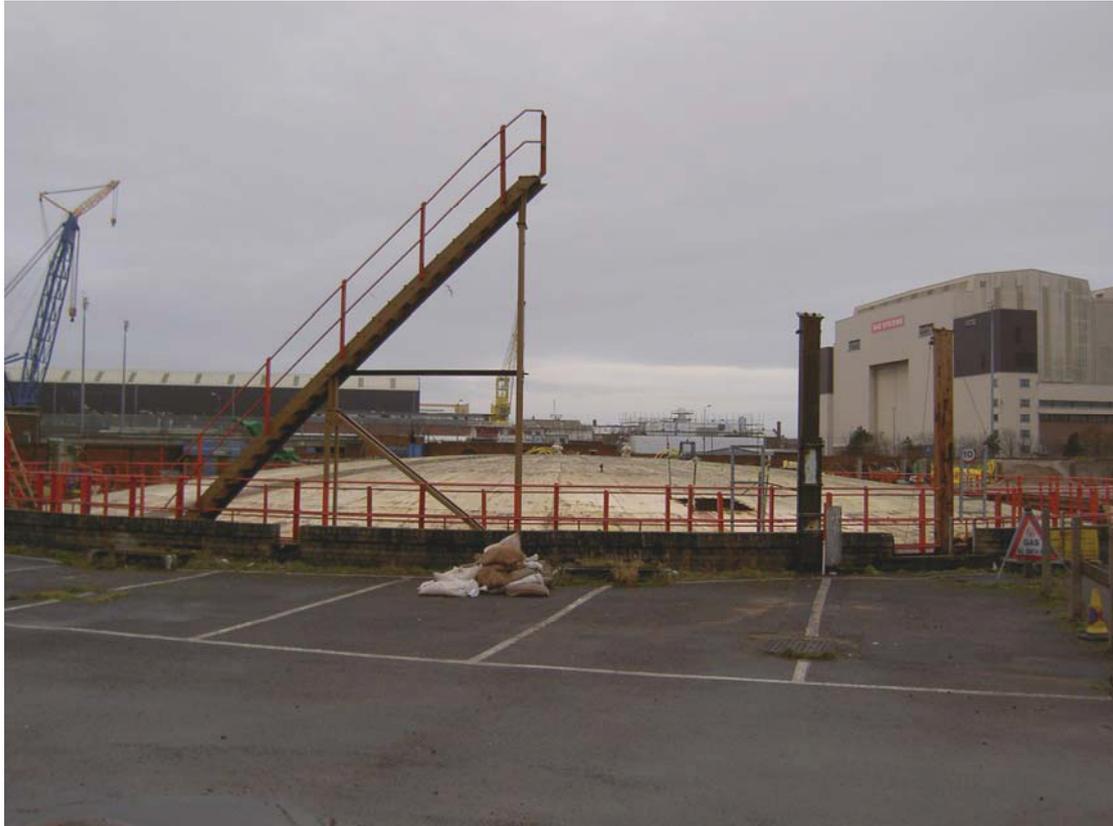
Plate 18: South-east gasholder, gasworks Building 4

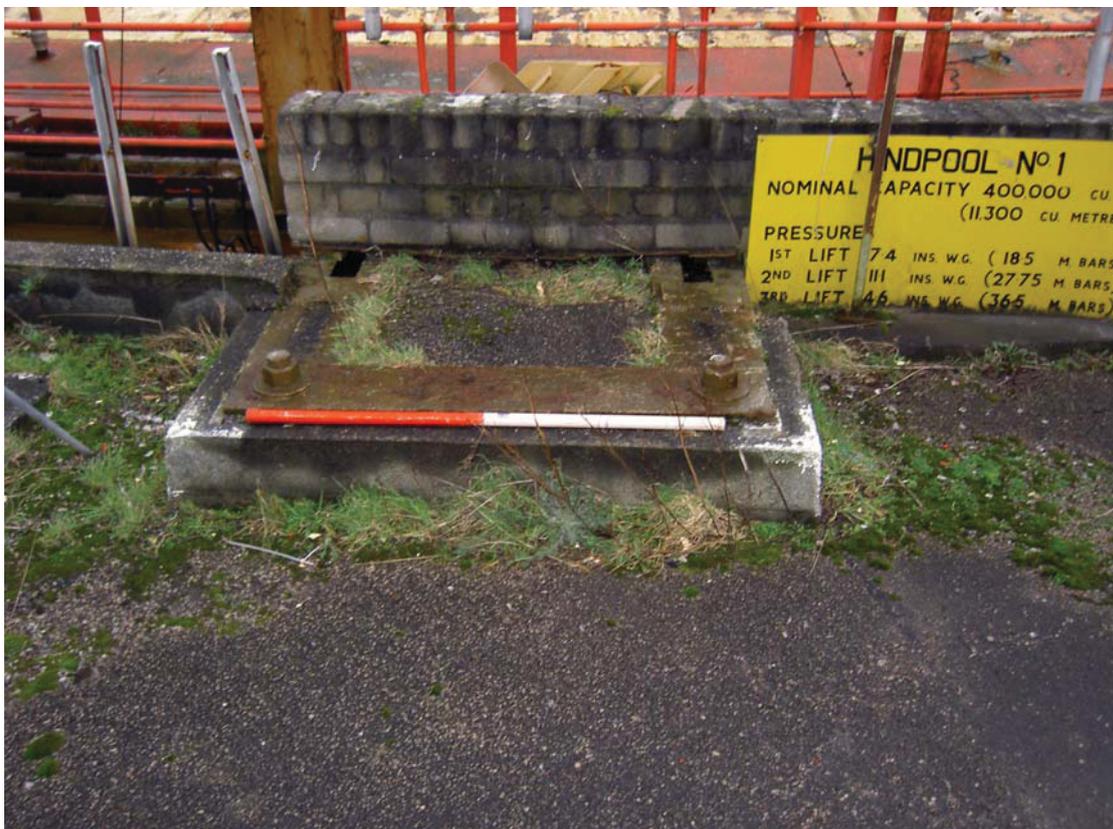
Plate 19: Detail of stanchion on gasworks Building 4

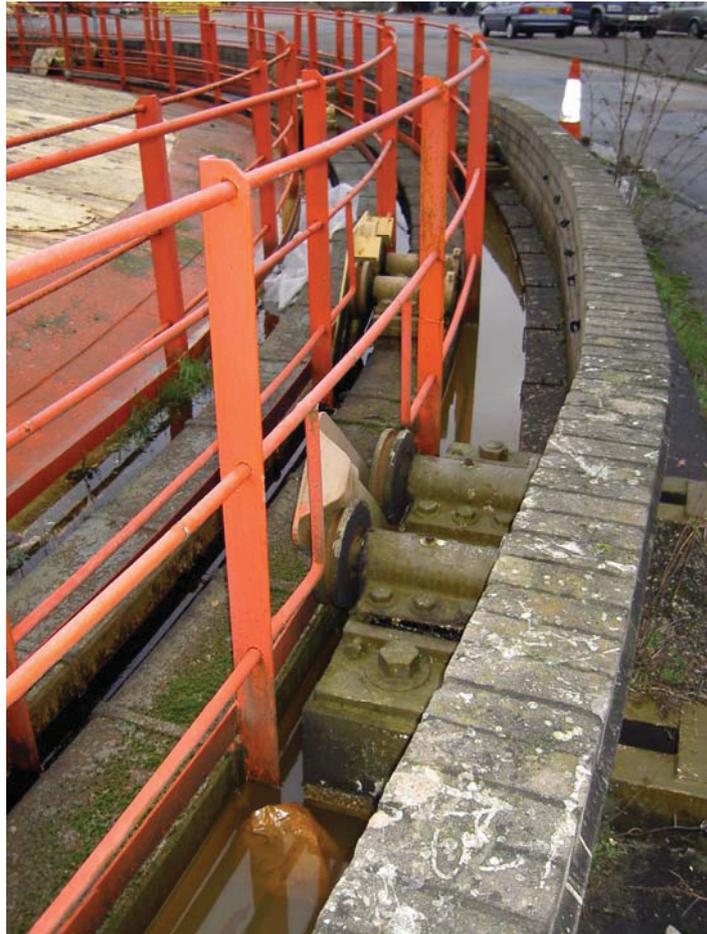
Plate 20: Detail of rolling mechanism, gasworks Building 4

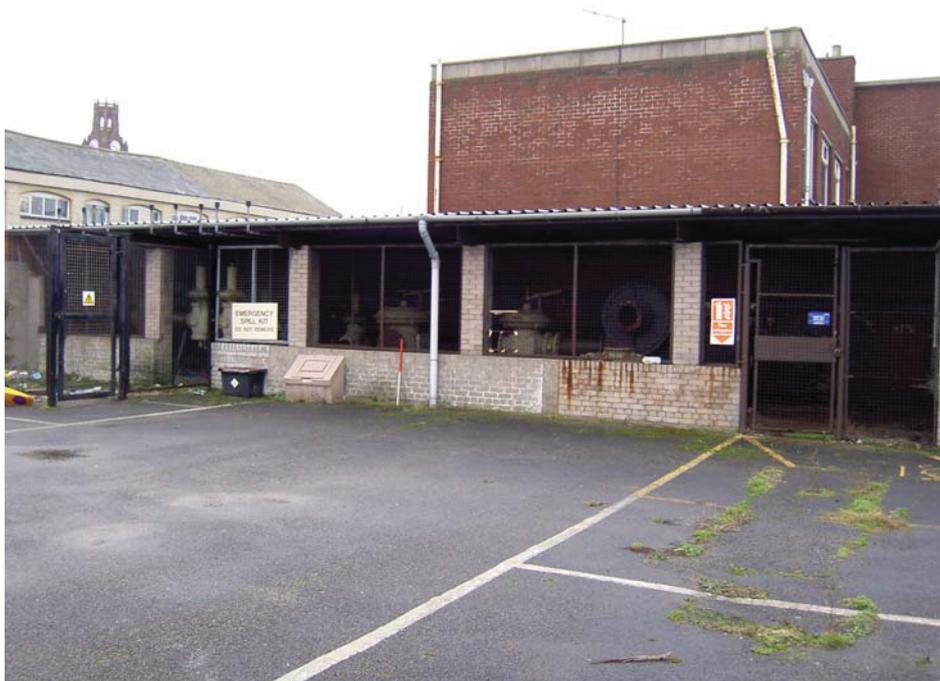
Plate 21: The gas governor, gasworks Building 5

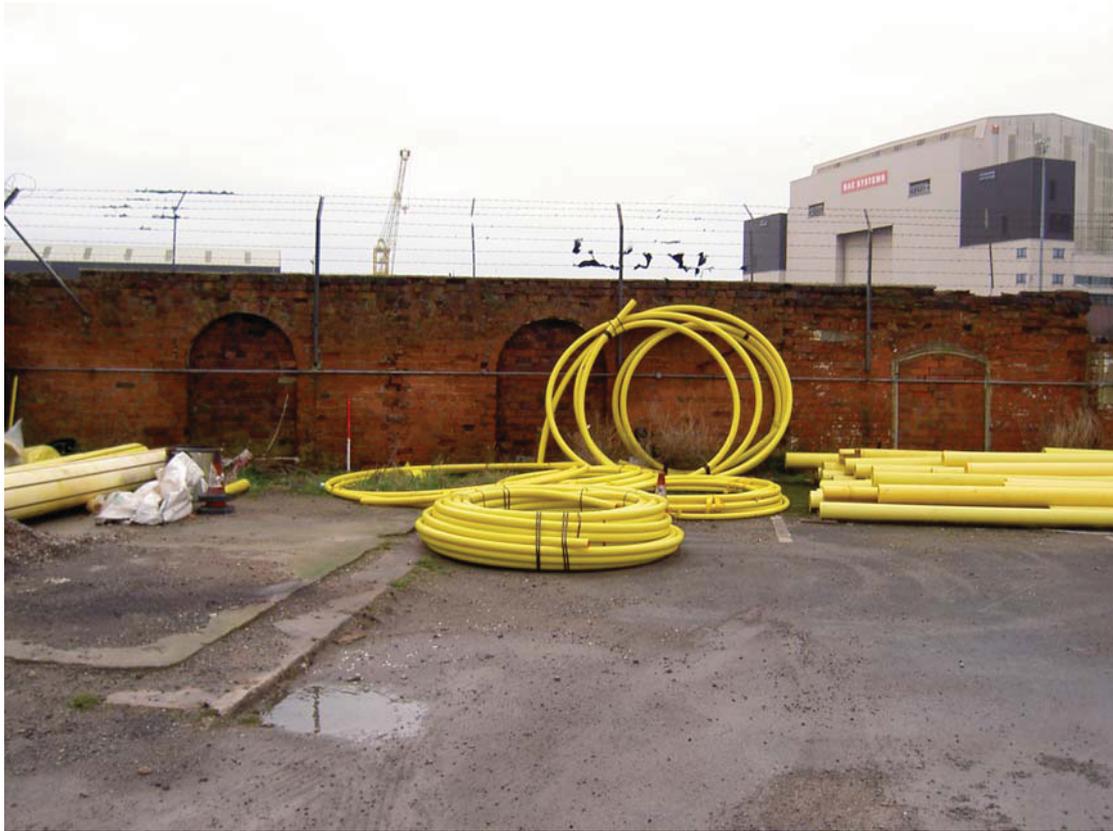
Plate 22: North-east face of the gasworks boundary wall

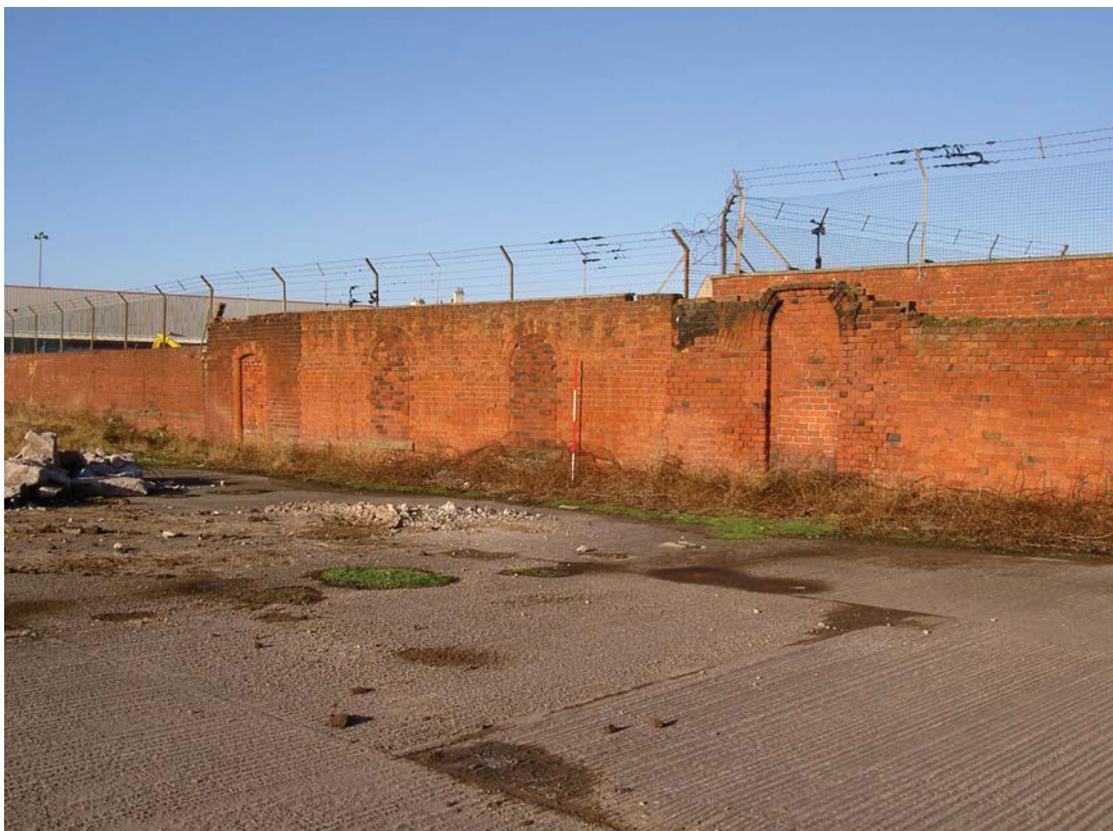
Plate 23: South-west face of the gasworks boundary wall

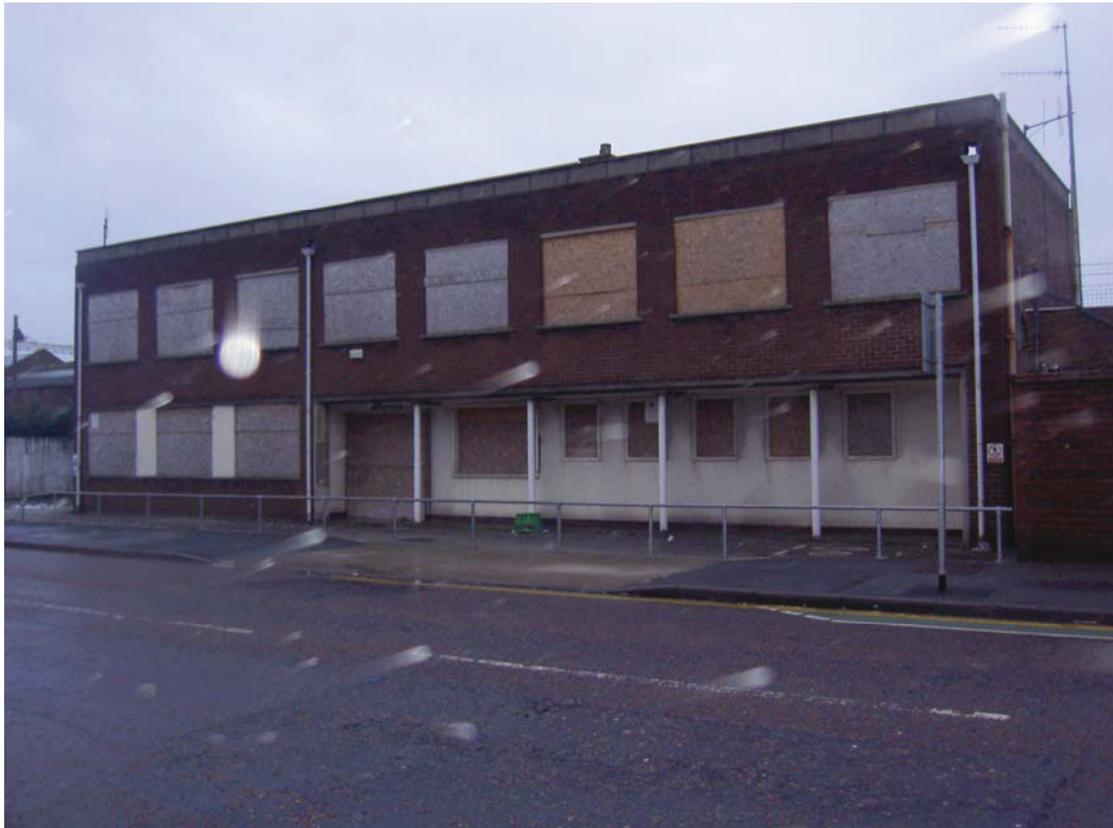
Plate 24: Front (north-east) elevation of gasworks Building 6

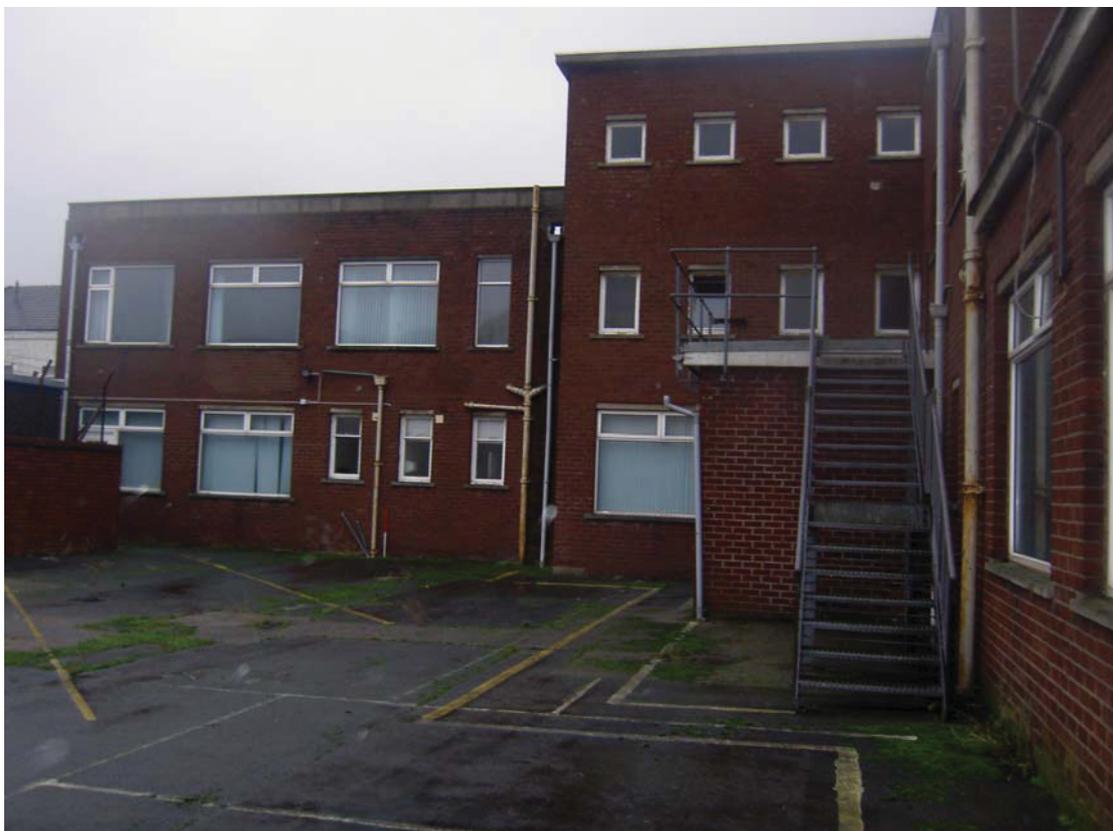
Plate 25: Rear (south-west) elevation of gasworks Building 6

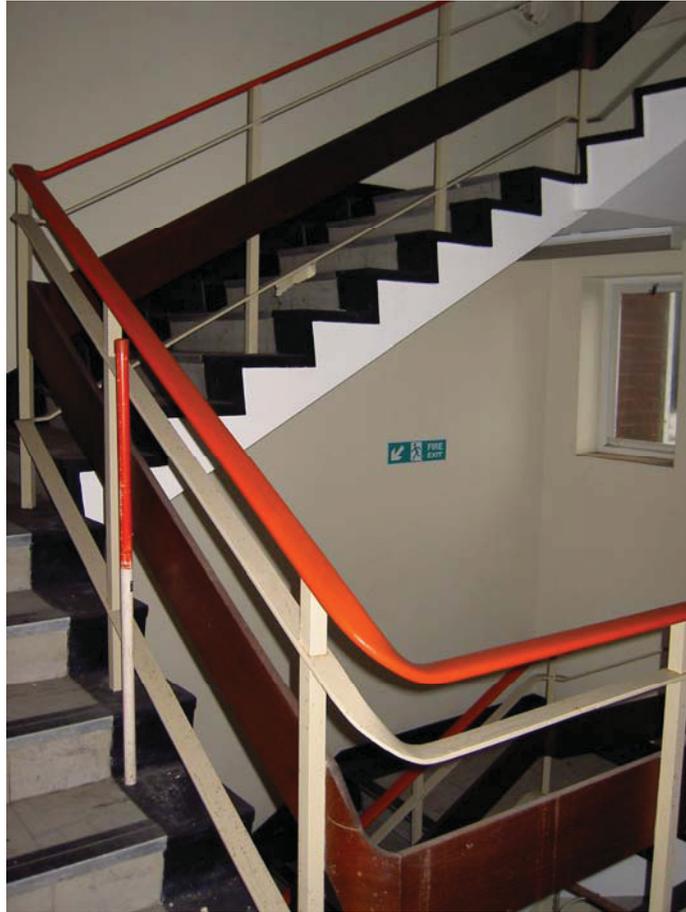
Plate 26: Staircase within gasworks Building 6

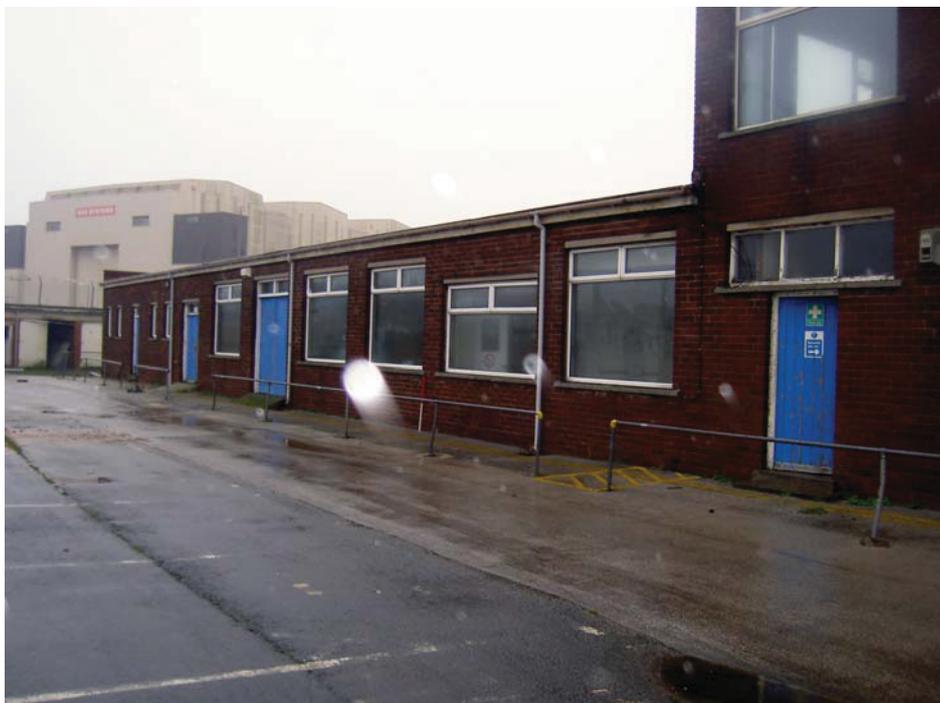
Plate 26: South-east elevation, gasworks Building 7

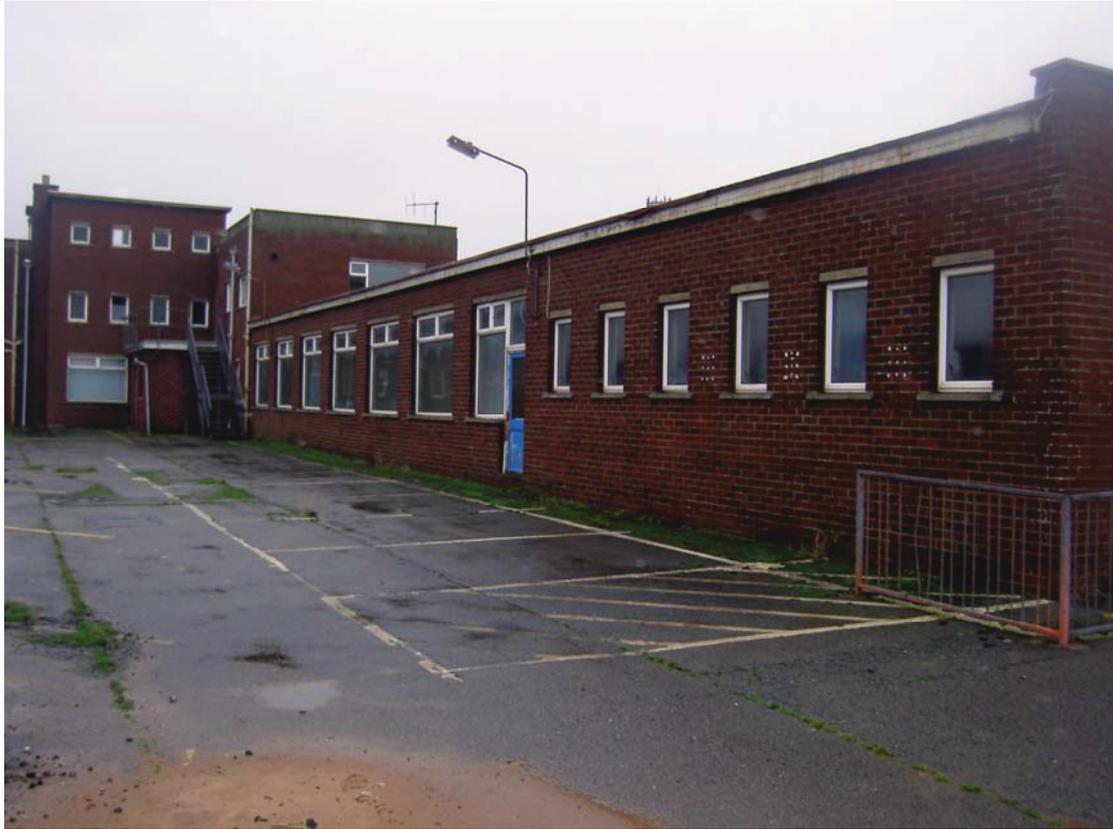
Plate 27: North-west elevation, gasworks Building 7

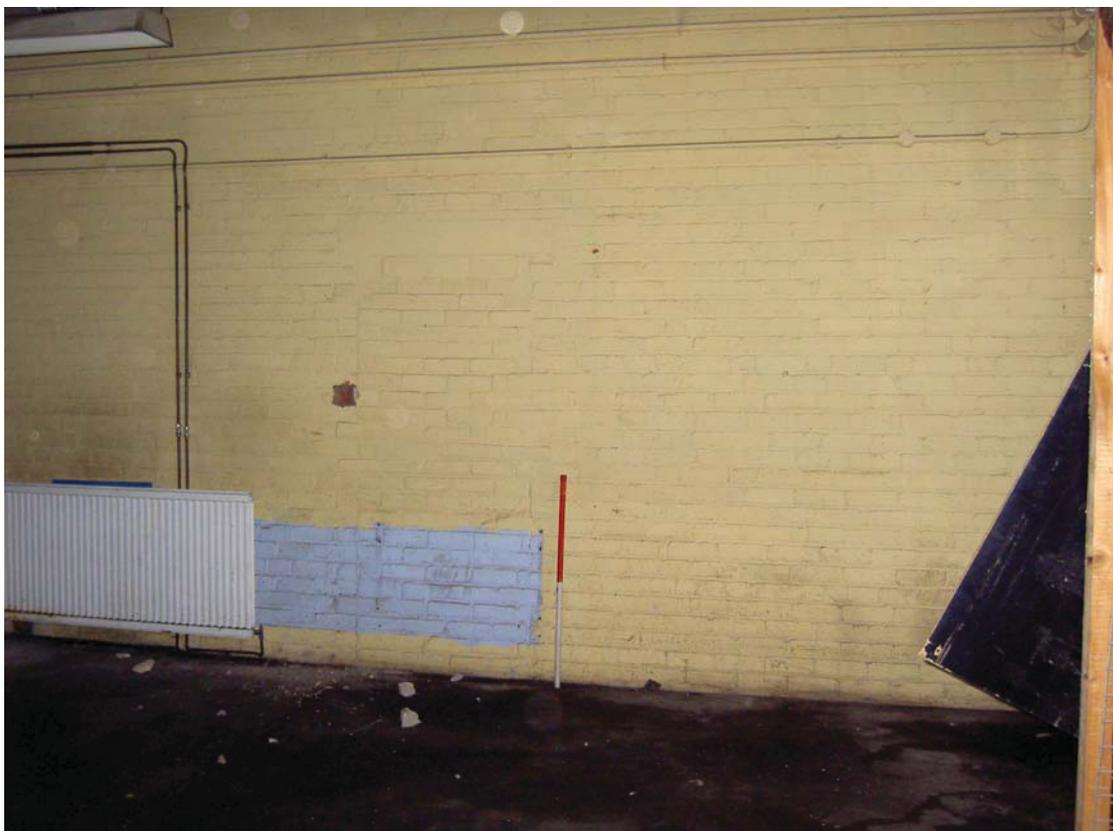
Plate 28: Blocked doorway, south-west end, gasworks Building 7

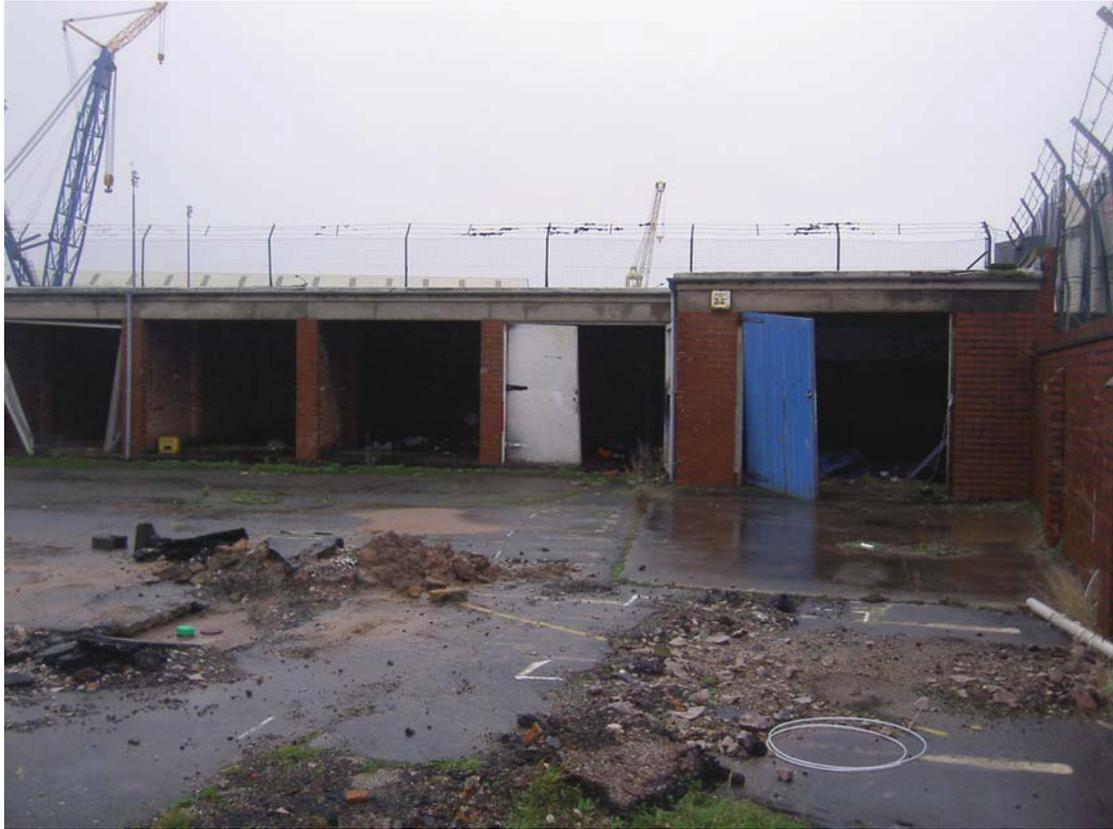
Plate 29: North-east elevation, north-west end, gasworks Building 8

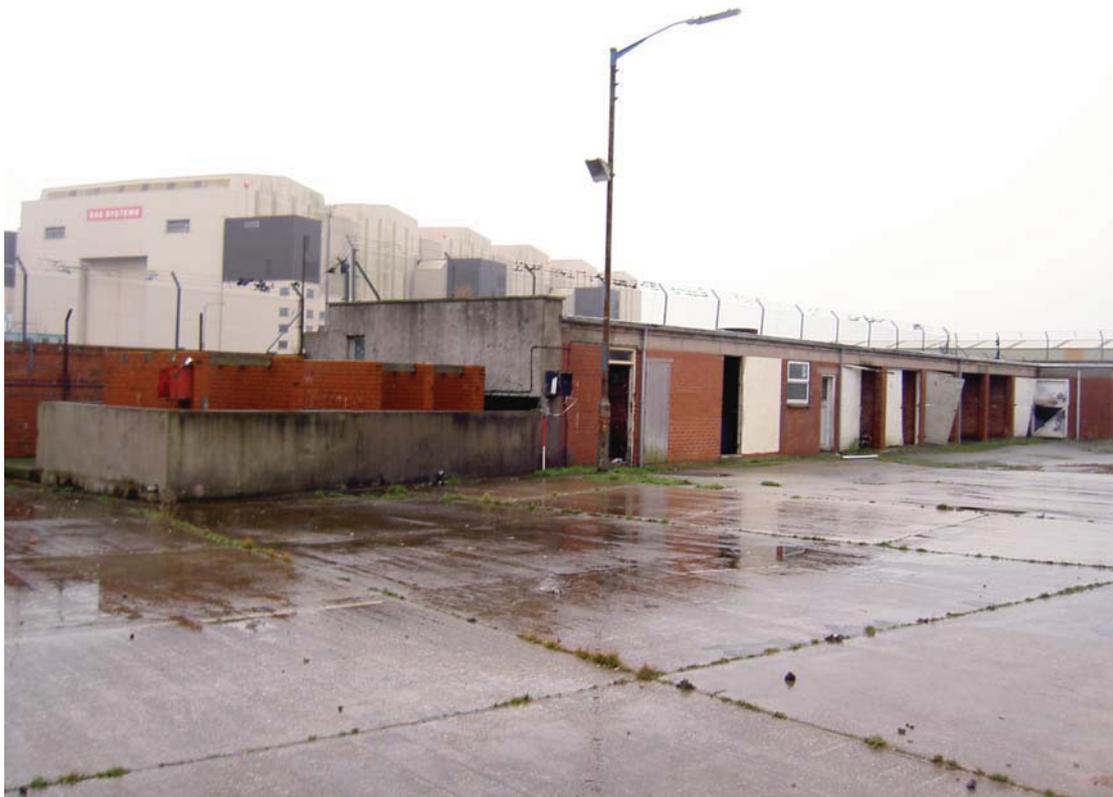
Plate 30: North-east elevation, south-east end, gasworks Building 8

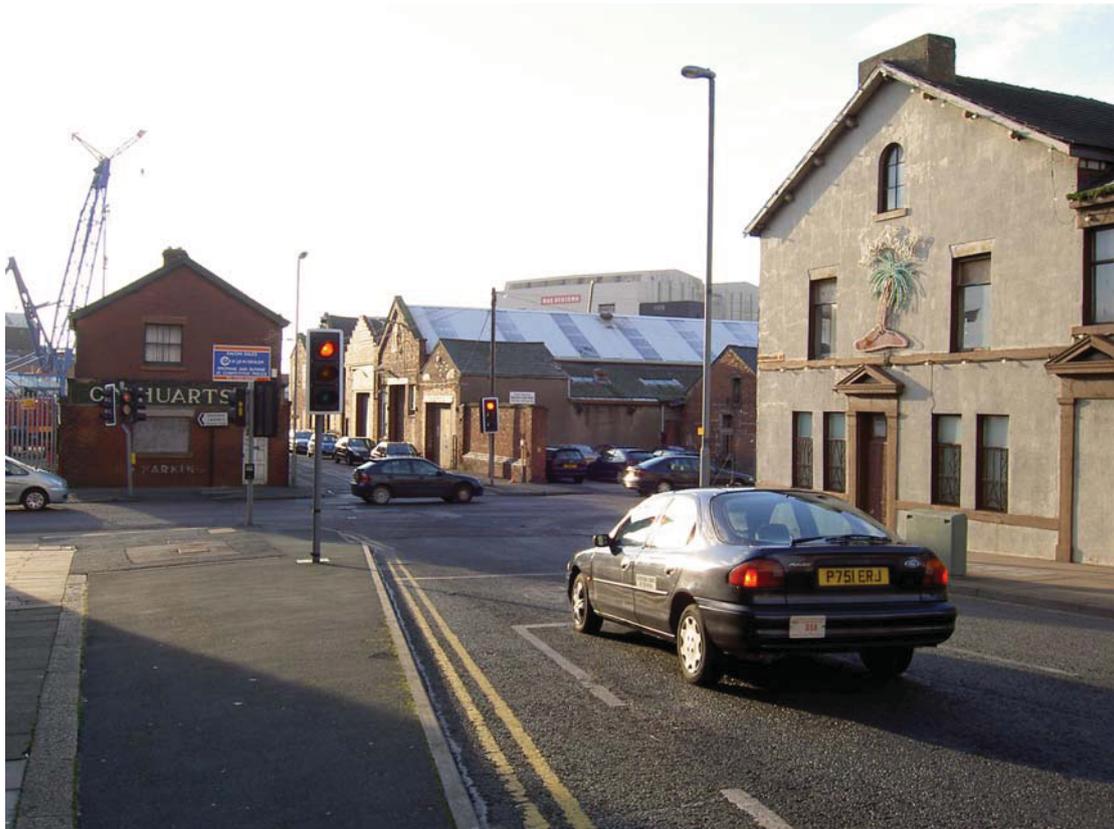
Plate 31: General view of foundry buildings and environs, from east

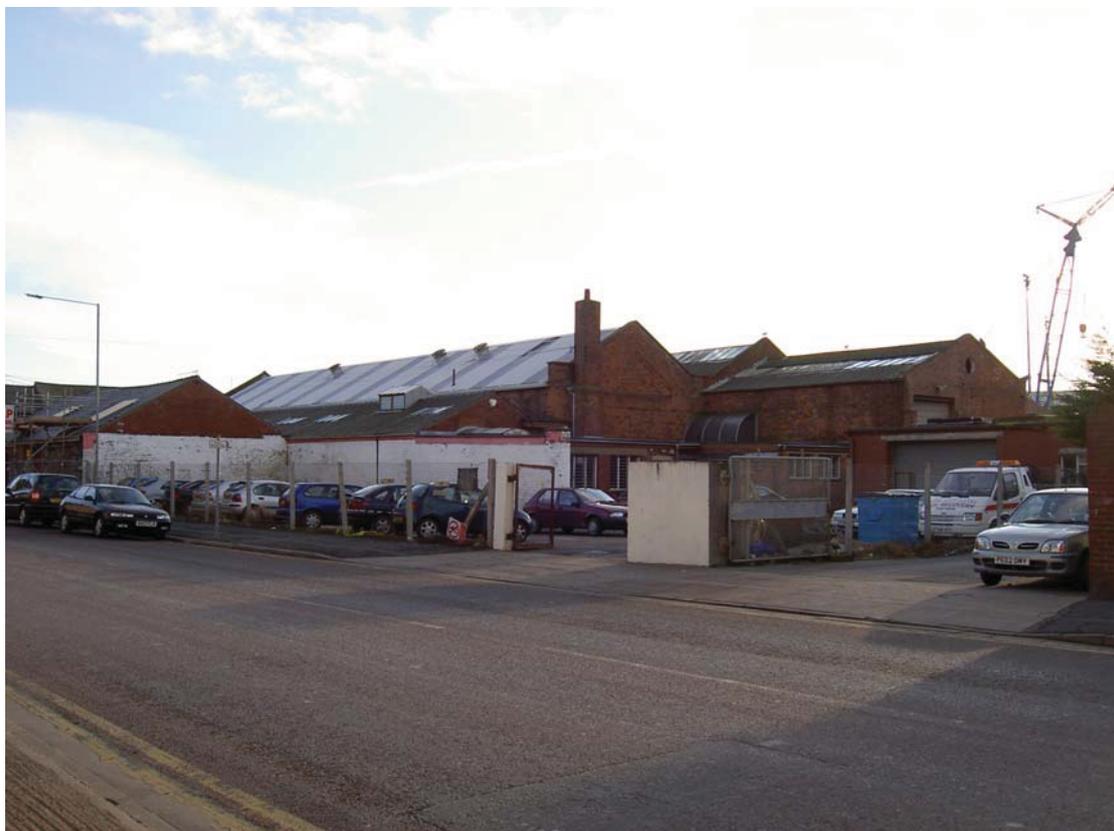
Plate 32: General view of foundry and environs from north

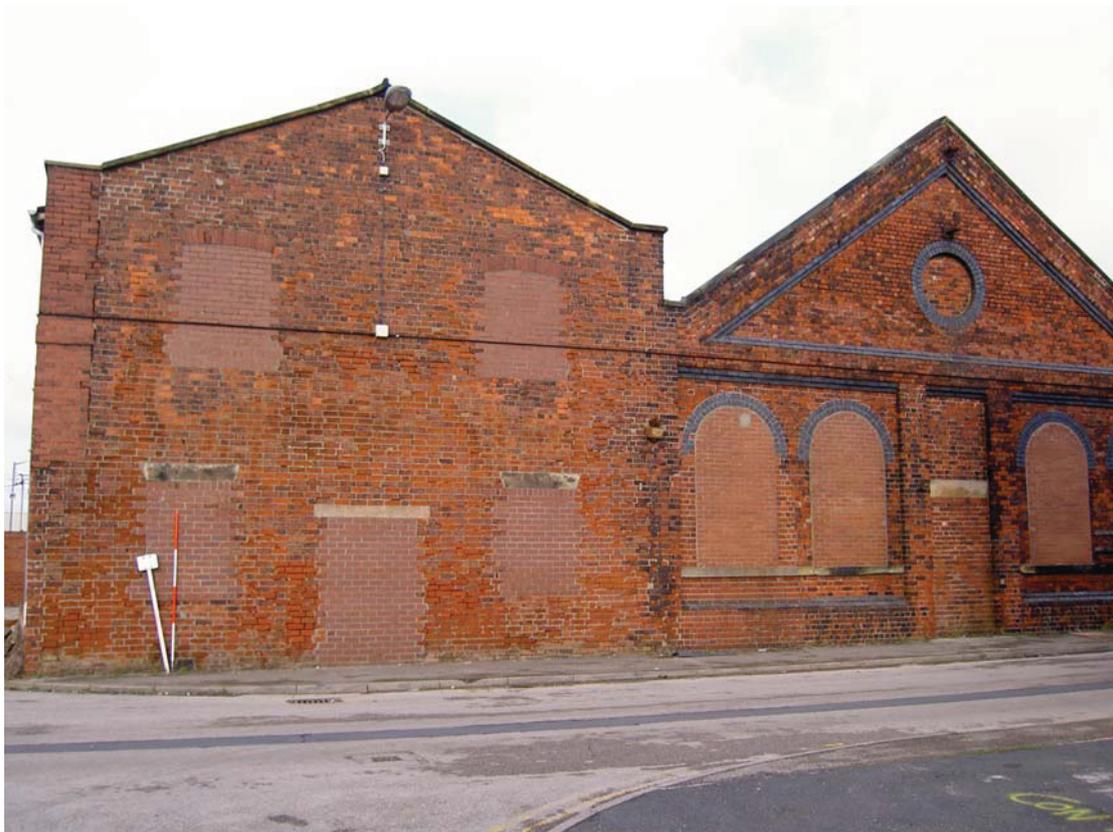
Plate 34: South-east elevation, foundry Buildings 1 and 2

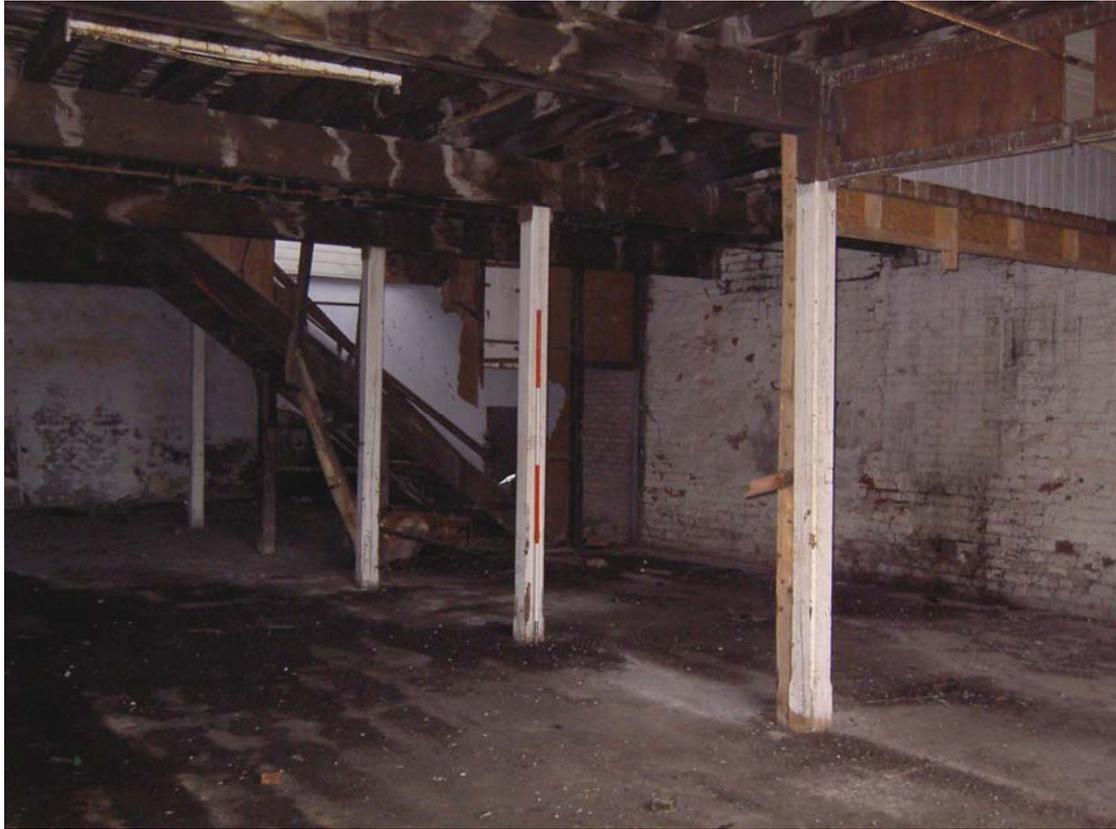
Plate 35: Internal view, ground floor foundry Building 1
