Tavistock Canal, Devon

Archaeological impact and recording report

Tavistock Canal – Impact assessment and archaeological recording during a program of repair works

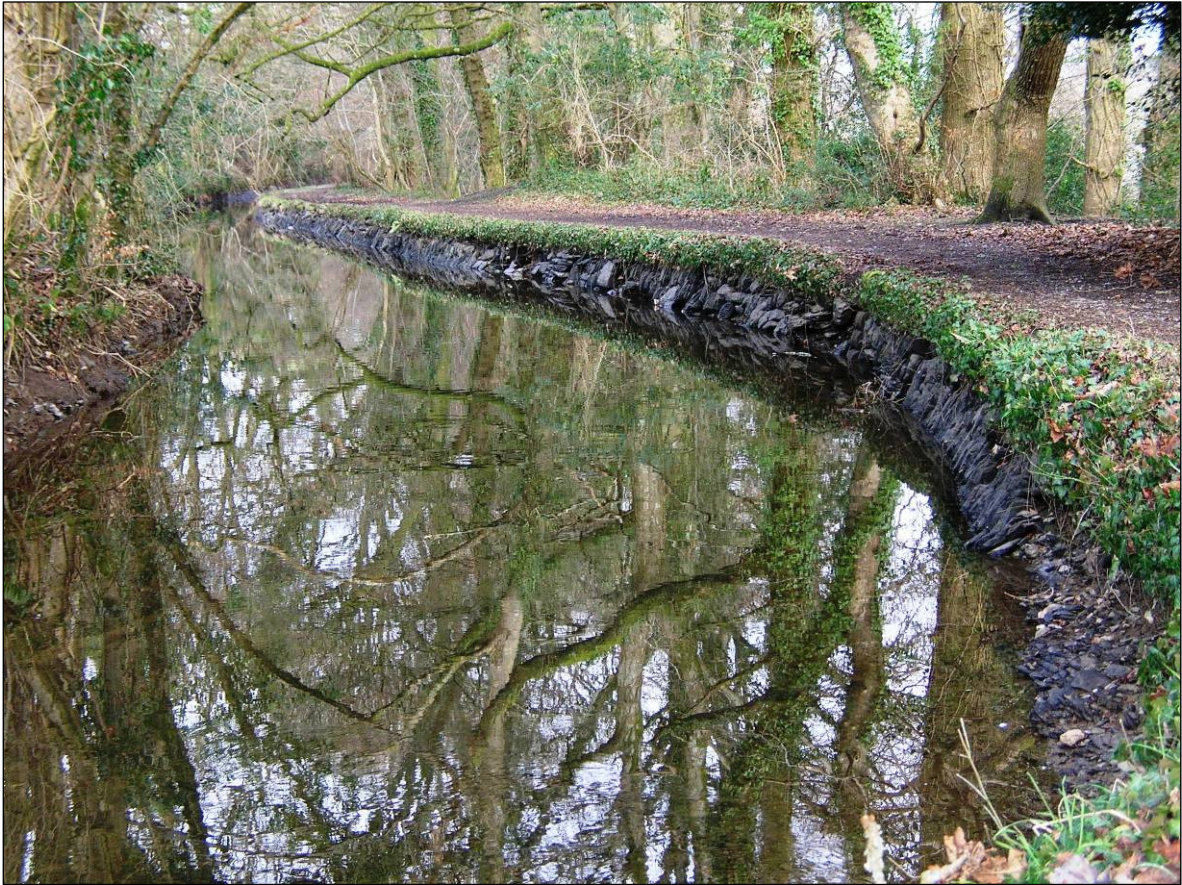
Repair works to the canal's east side (and towpath) has been undertaken in the past, sometimes inappropriately using cement and concrete formwork. The 2009 repair work to both sides of the canal and re-surfacing parts of the towpath continued with this theme of patching the damaged sections (Fig 11).

Figure 7 A view of the Tavistock Canal east bank before works © CC HE Projects

The repair works relate to identifying areas of the canal sides that needed to be patched with new (similar specification) stone within the section of canal identified above. This should immediately stop progressive damage to the canal sides and help to support the well used canal towpath. There is no site plan showing each small repair section, rather a canal bank repair work schedule (Appendix 1).

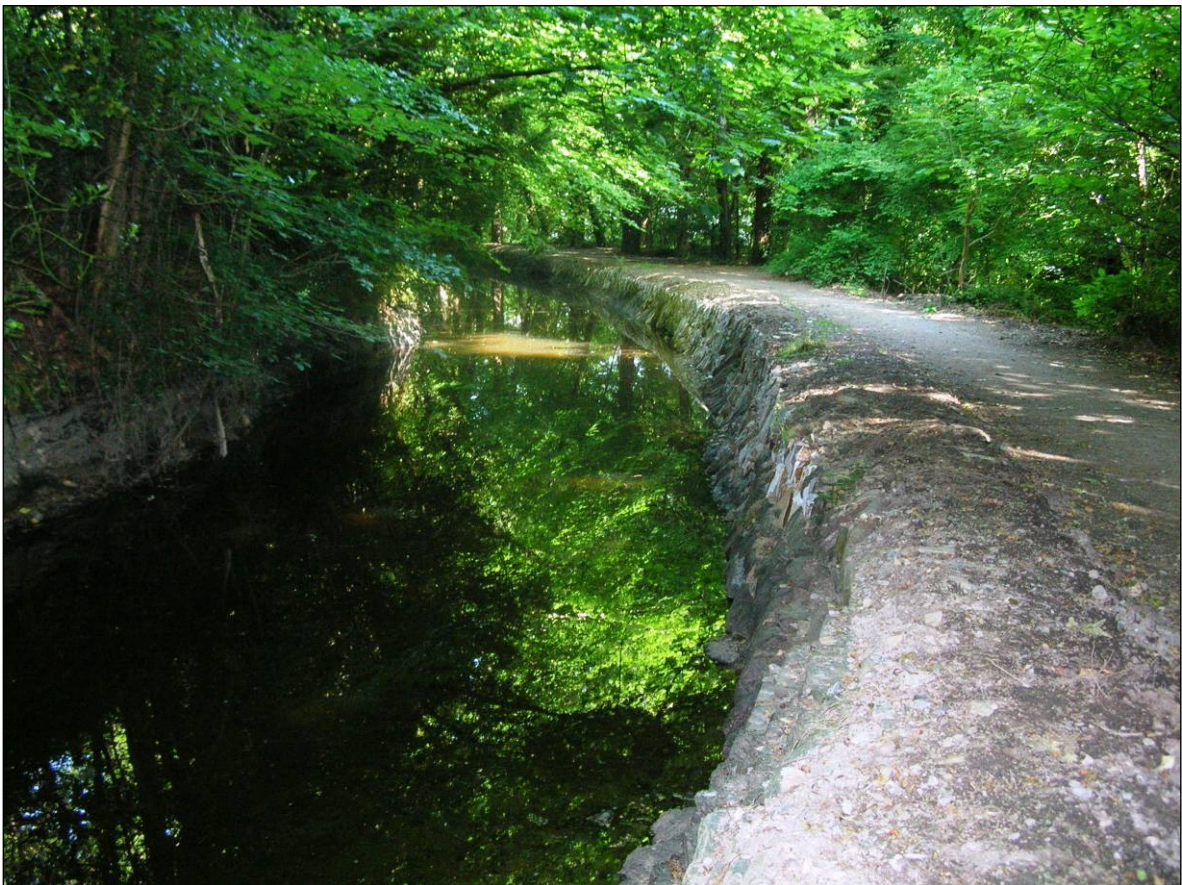
Figure 8 A view of the Tavistock Canal east bank after works © CC HE Projects

The canal bank repair works (see Appendix 1), were finished on 28/05/09, including an additional element of work totalling 87 metres, which the contractors identified whilst on site. A total of 337 linear metres of canal bank was repaired (only on the south/west side), using a total of 86 tons of additional Trebarwith stone. The canal repair works were funded by South West Water.

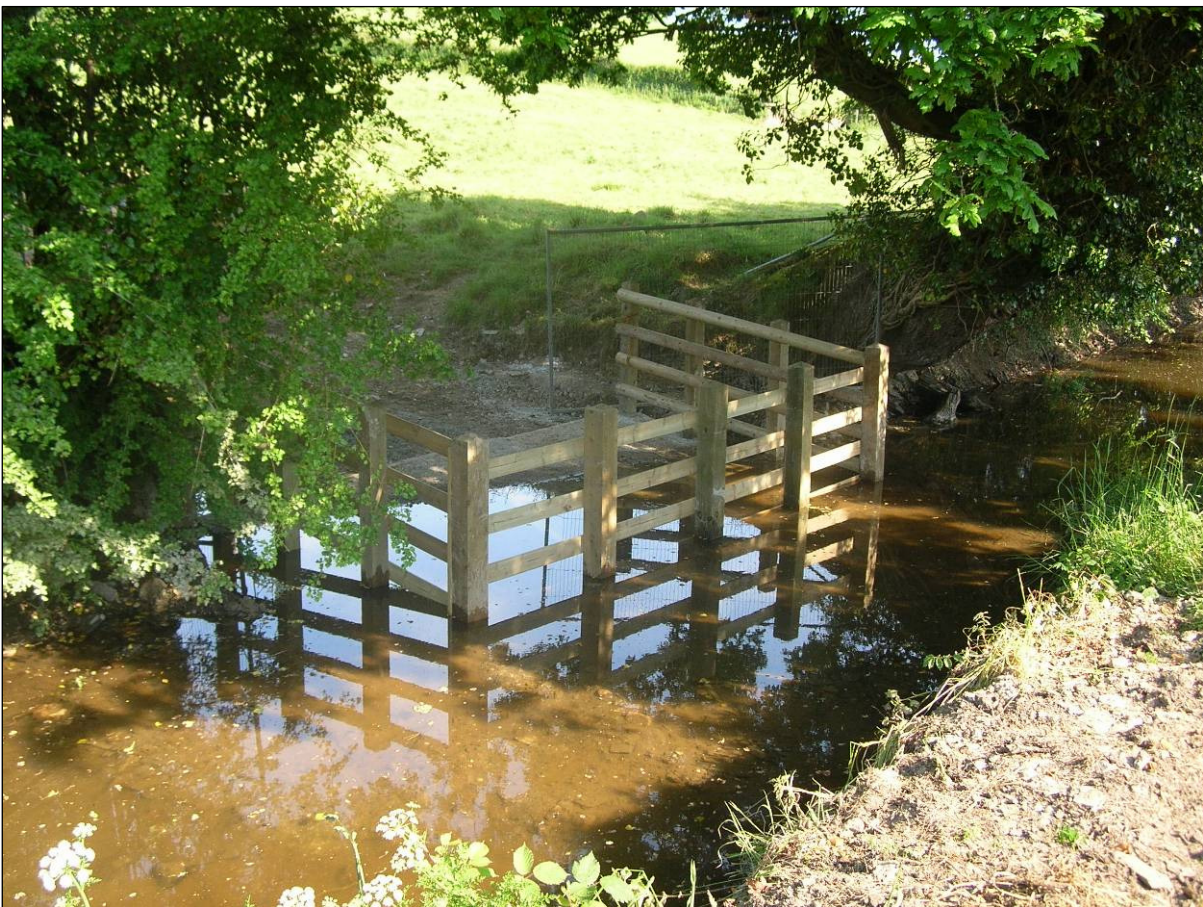
Figure 10 A view of the same Cattle Drinking site after works © CC HE Projects

Figure 5 is a site plan and specification document for the installation of timber post and wire stock fencing along the west/north side of the canal and construction of three cattle drinking areas to minimise any future erosion of the opposite (north/west) side of the canal bed. The cattle drinking sites are located at SX 47384 73064, SX 47257 72705, and SX 47078 72415. A concrete pad (min 0.3m thick), varying from 3m to 4m wide and approximately 5m long, has been created to at each of these sites to form the post and rail fenced cattle drinking areas that should minimise further damage to the banks (on either side). An additional cattle drinking area was constructed on bedrock immediately on the west side of the Shillamill Viaduct (see Fig 6). Figures 9 and 10 show before and after views of a cattle drinking site (SX 47384 73064).

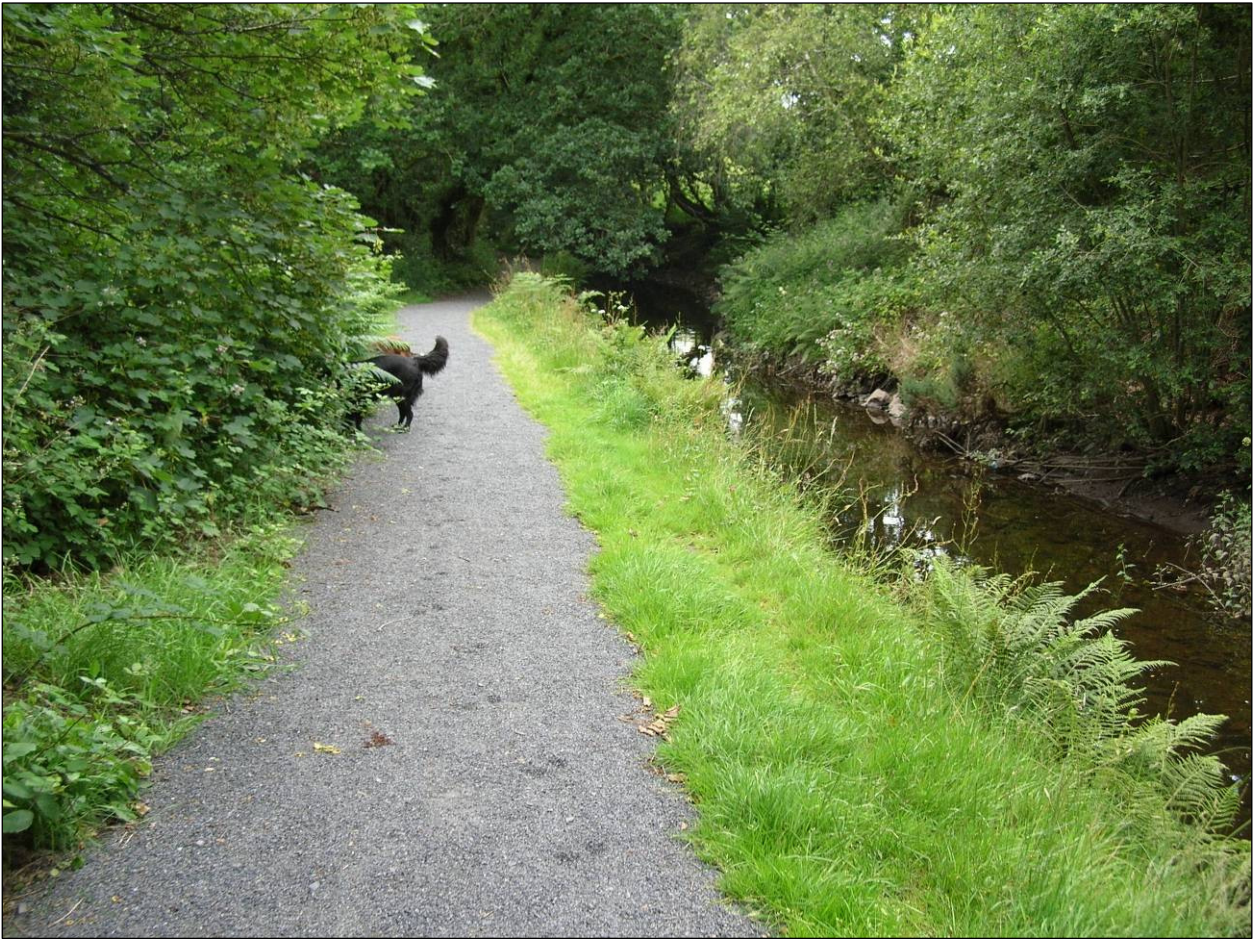
Figure 11 A view of the canal towpath after re-surfacing works © CC HE Projects

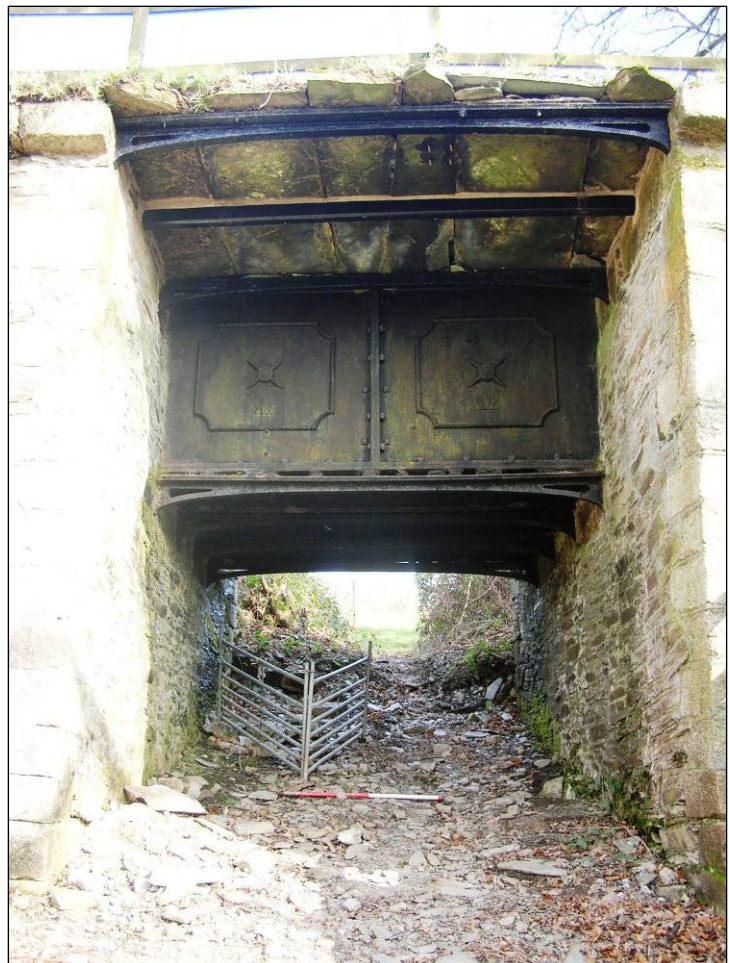
Figure 14 A view of the canal aqueduct bridge after works
© CC HE Projects

After dialogue with the TVMHP manager, the structural engineer, the landowner of Shillamill Farm, the Devon County Archaeologist and consulting project archaeologist; the TVMHP agreed to fund replacement of the centrally located rusty wrought iron lintel, and to undertake limited lime mortar repointing where structural stability of the adjacent walling could be compromised.

Site impact of the replacement lintel was minimised by matching most of the original profile of the replacement item as far as could be possible from an 'off the shelf' steel equivalent (in order for the project to be cost-effective), with the original wrought iron lintel.

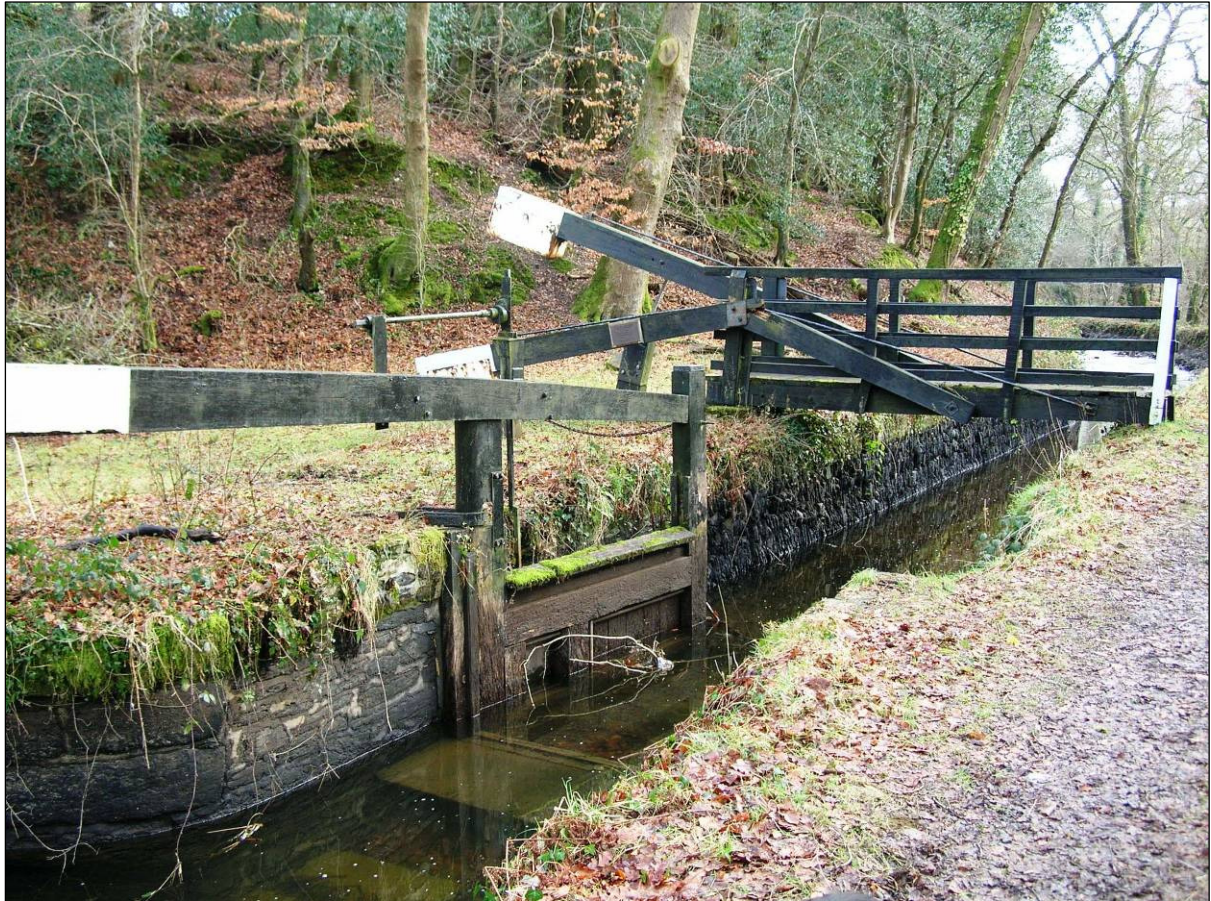
Figure 15 A view of the canal lock gate and bridge before works © CC HE Projects

The TVMHP agreed to fund replacement of the timber components that were rotted or had broken or snapped off. This includes the large timbers to open the bridge and the Lock gate. The TVMHP tendered for experienced Carpenters to assess both features and to price for the production of making and erecting replacements.

Site impact for the replacement timbers was minimised by specifying exact replacements with the existing timbers (previously replaced in 1998).

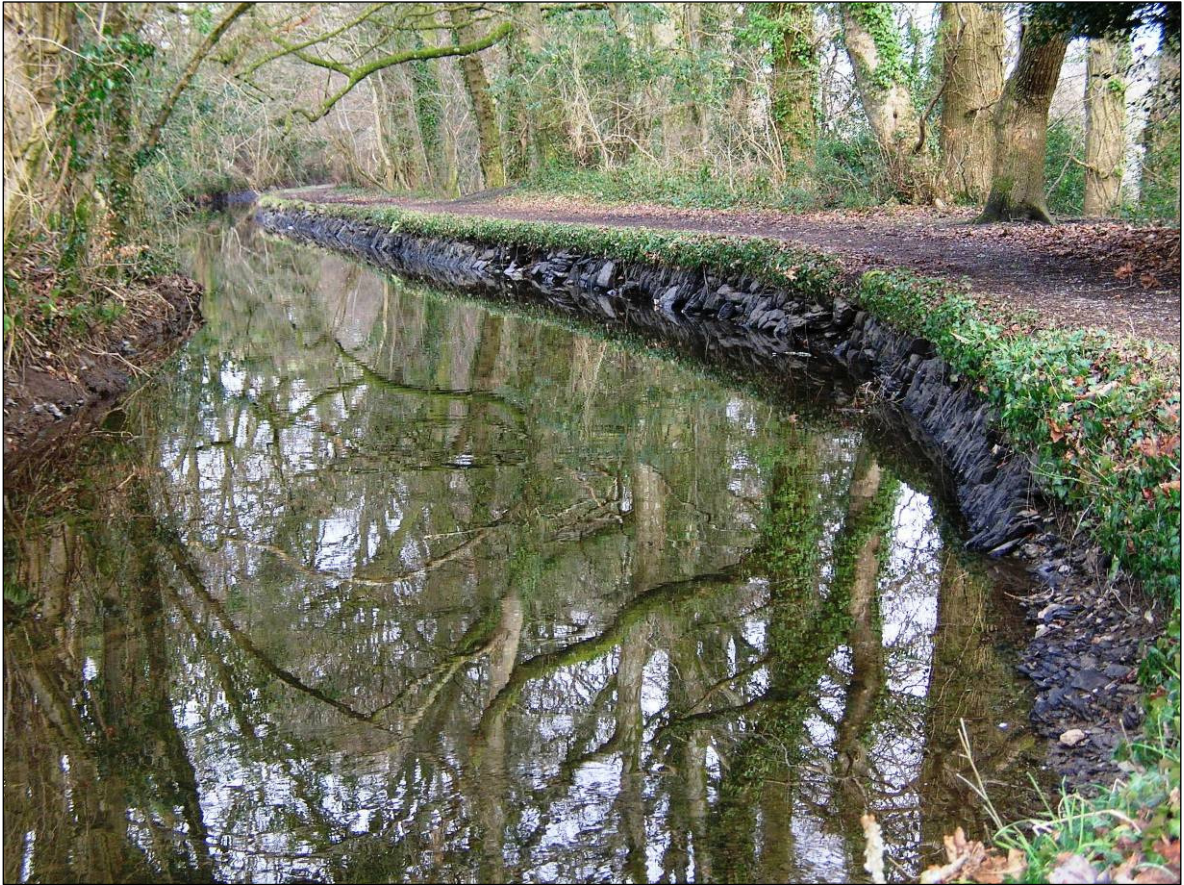
Figure 7 A view of the Tavistock Canal east bank before works © CC HE Projects

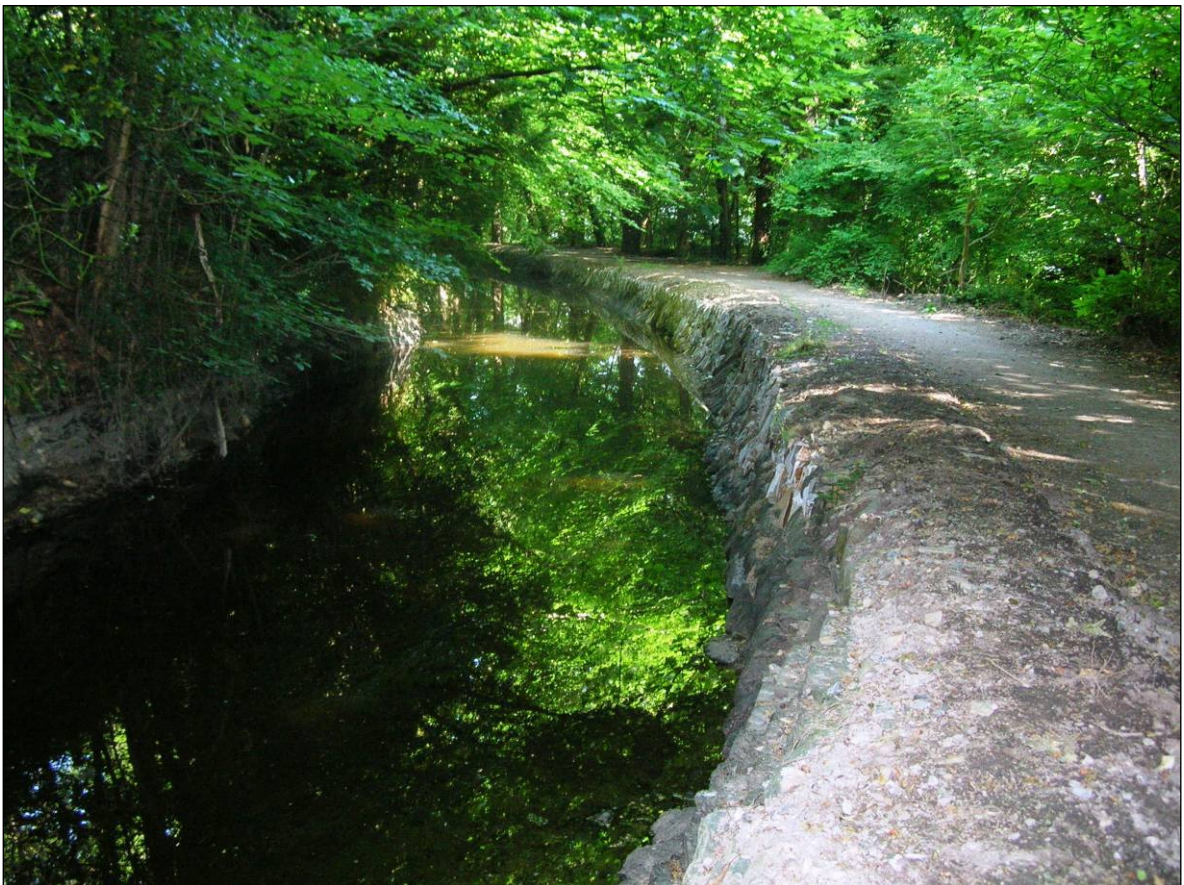
Figure 8 A view of the Tavistock Canal east bank after works © CC HE Projects
