Poltesco Mill House, Cornwall Historic building record

2015R036

The National Trust

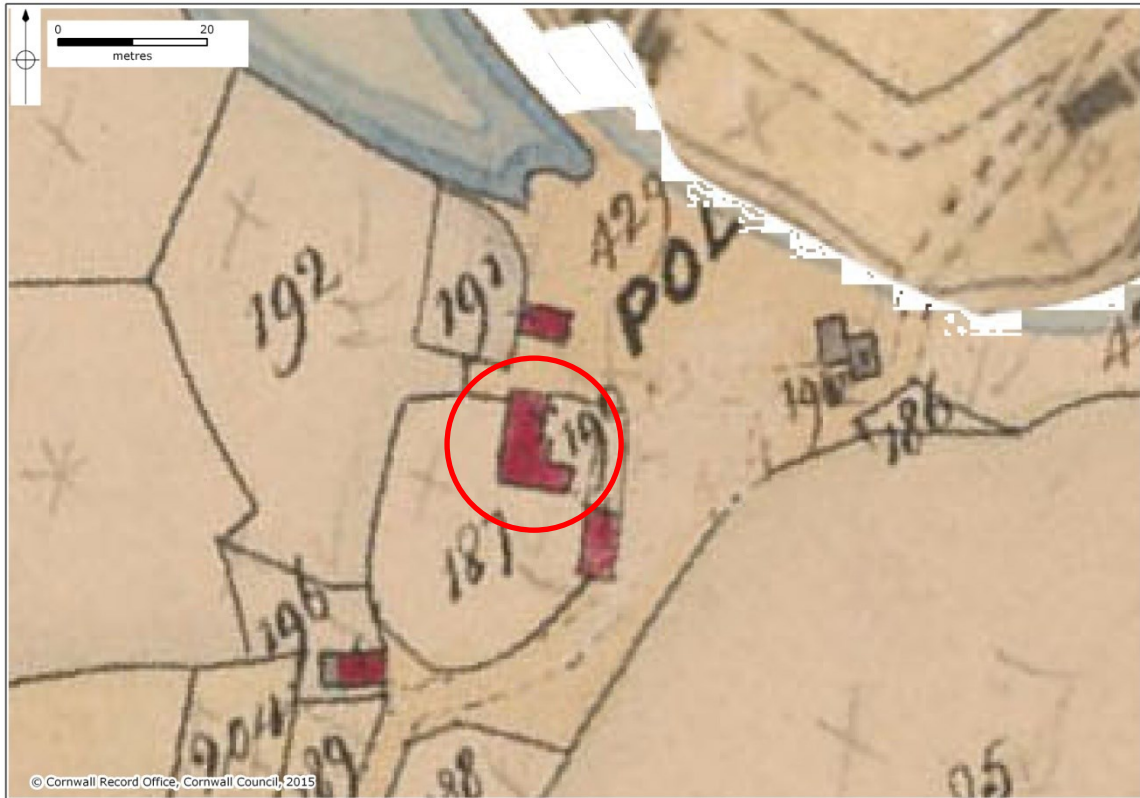
By 1842, as shown on the Tithe map (Fig 7), a narrow wing (approximately 3.5m wide) had been added to the southern end of the front elevation extending 4m eastwards.

Fig 7: Tithe map (the parish of Ruan Minor) 1842

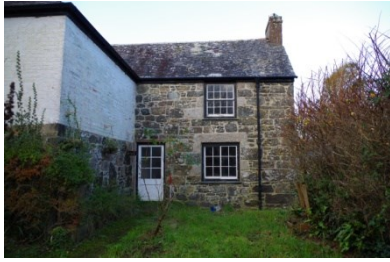
Much of the front (east) wall of the original building was removed when the first east wing was added during phase 2. The southern half of the original wall was replaced with the present narrow brick wall (Fig 54) that divides the study from the living room. In the south-east corner of the study the remains of the truncated earlier front wall are visible at ground level (see Figs 55 and 56). The north half of the original front (east) wall has also undergone major remodelling in the 19th century with the insertion of two large windows and possible re-facing of the external surface. These windows have granite lintels and blocks of granite used in the jambs, which was not a material utilised in the original build (Fig 20).

Fig 20 East (front) elevation
