Miners' Dry, South Wheal Frances,
Piece, Cornwall
Historic Building Record

Report No: 2022R010

Client	Cormac Solutions Ltd
Report Number	2022R010
Date	24/03/22
Status	Final
Report author(s)	Connor Motley and Jo Sturgess
Checked by	Jo Sturgess
Approved by	Andy Jones
Project number	147146
Data location	\\CAU\Archive\Sites\R\Redruth Miners Dry South Wheal Frances HBR 2021
Historic England / ADS OASIS online reference	cornwall2-504956
Planning reference	PA20/09145

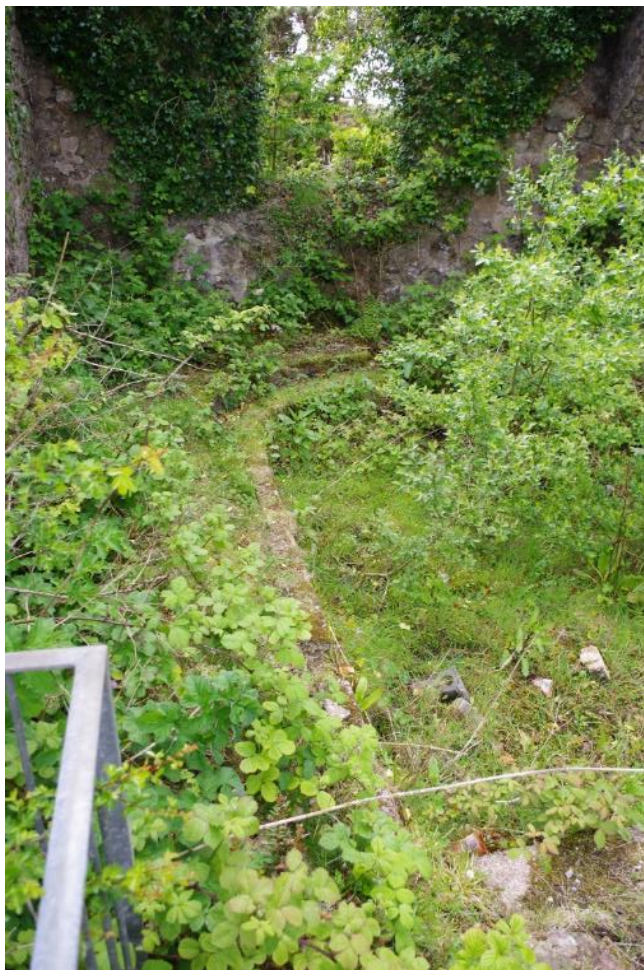
Fig 67 Room 6 cement rendered communal bath built into the floor.
