Pascoe's Shaft Pumping and Winding
Engine Houses, South Wheal Frances,
Piece, Cornwall
Historic Building Record

Cornwall Archaeological Unit

Report No: 2022R022

Historic Building Record

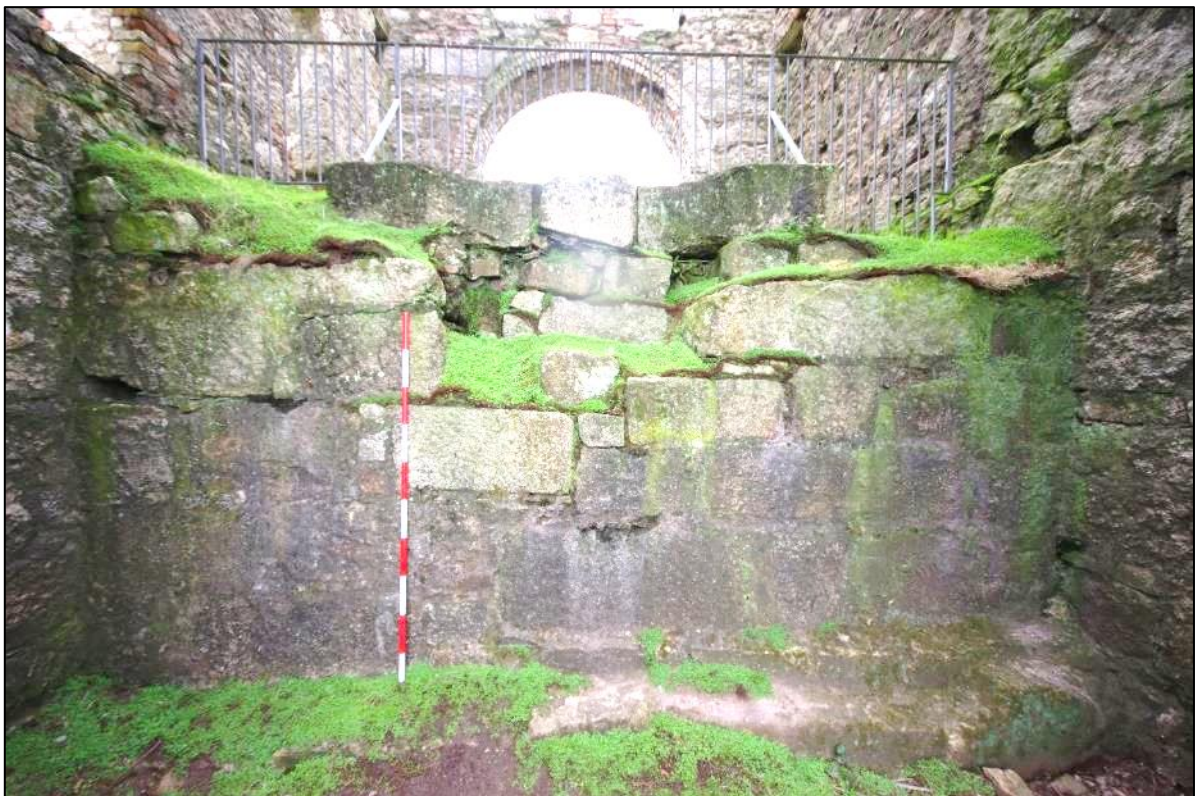
Fig 96 South-east wall of cataract pit (cylinder bed).

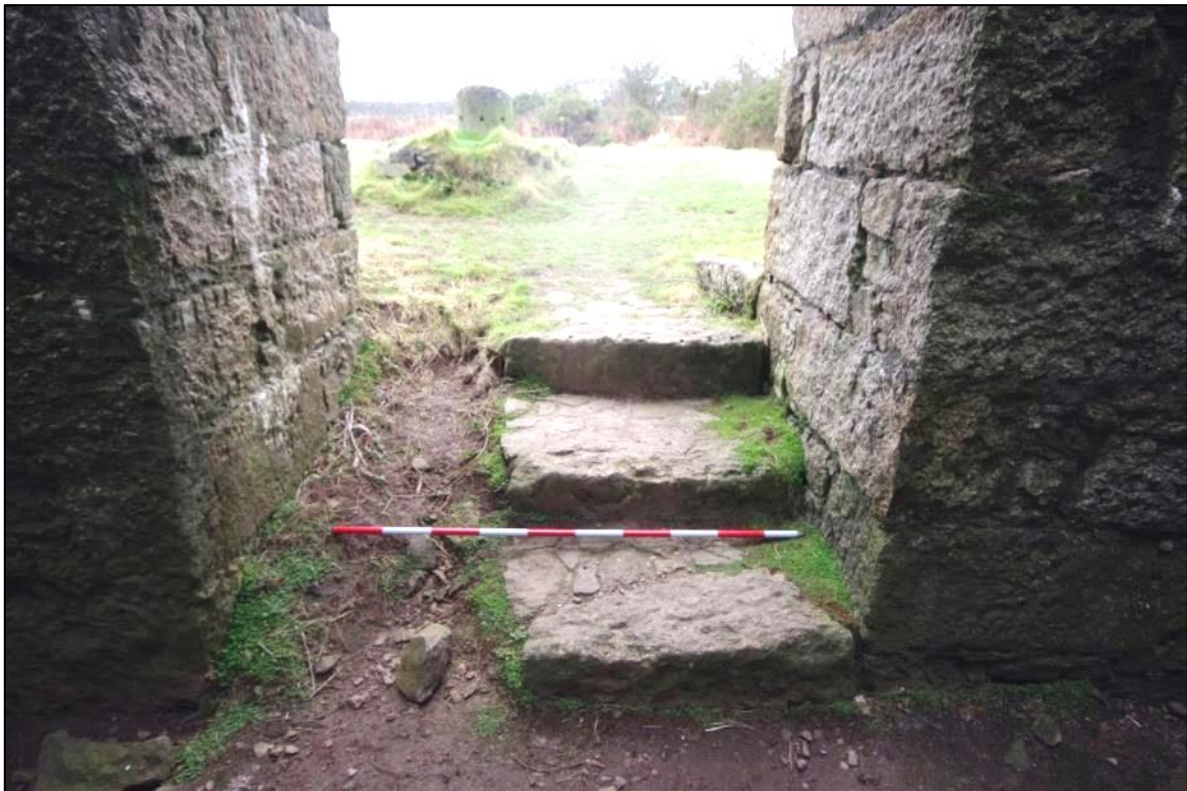
Fig 108 Steps leading in to cataract pit inserted in the 1990s.
