Hallgarden Farm outbuildings, Otterham, Cornwall

Historic building record

Client	Mr and Mrs D Thompson
Report Number	2011R024
Date	February 2011
Status	Draft/2nd draft/Final
Report author(s)	Eric Berry
Contributions from	Jo Sturgess and Nigel Thomas
Checked by	
Approved by

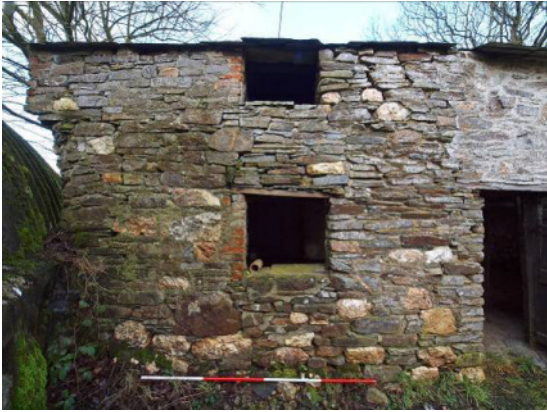
Fig 16 Building 1: front left (4 building phases)
