BARNS AT PARK HOUSE, GOREFIELD ROAD LEVERINGTON, CAMBRIDGESHIRE

Historic Building Recording

BARNS AT PARK HOUSE, GOREFIELD ROAD, LEVERINGTON, CAMBRIDGESHIRE

CHER Event No. ECB3841
Museum Accession No.: TBC
OASIS ID.: withamar1-189800
Planning Application Nos.: F/YR11/0259/LB & F/YR110258/F
NGR: TF 4352 1199

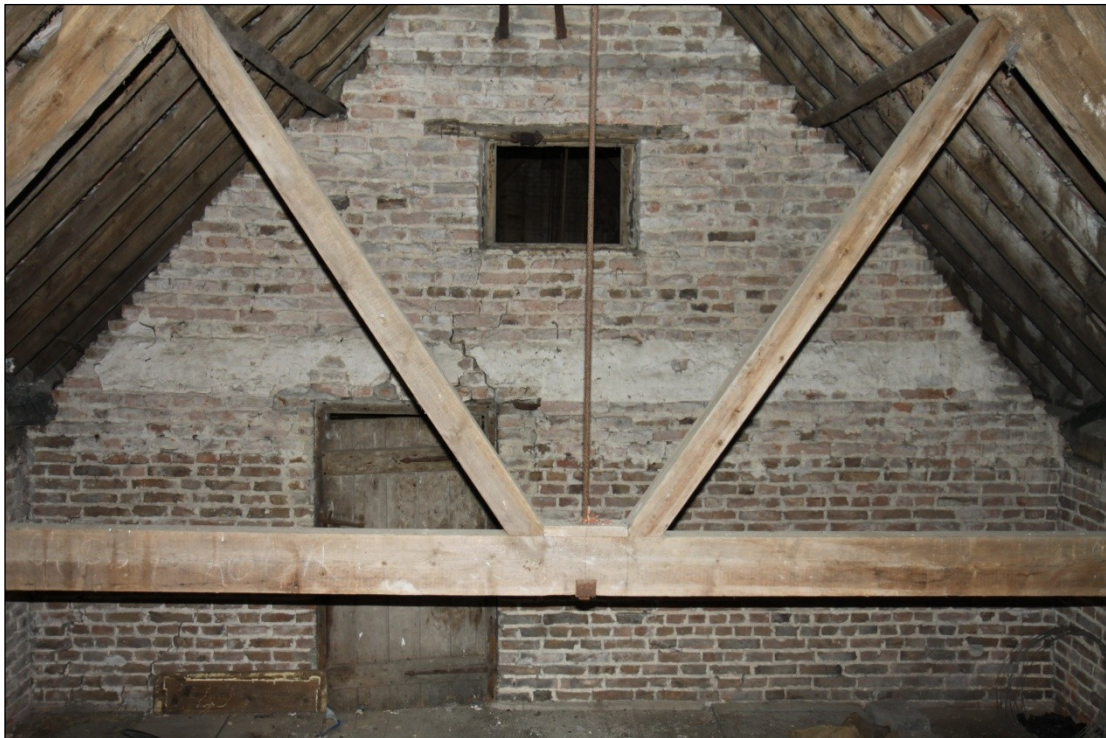
Plate 38: Bricked up opening (probable pitching door) in the south wall of Barn 1, looking southwest

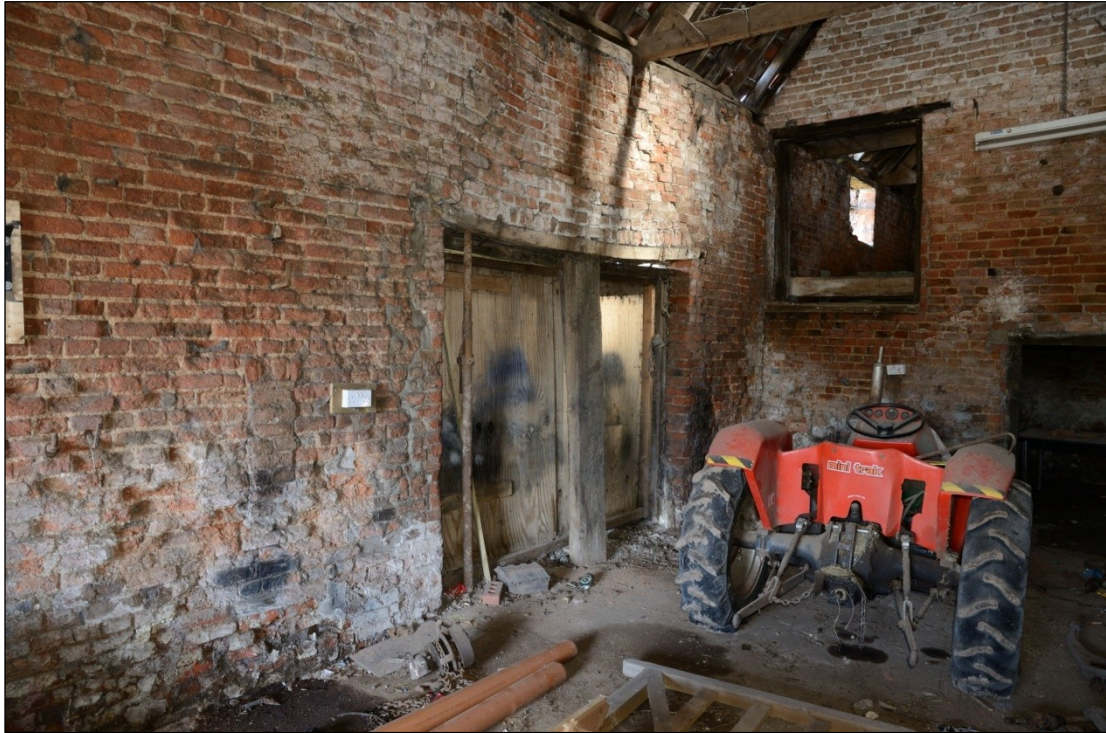
The western part of the structure originated as a traditional threshing barn, open to the roof with large opposing doors in the long walls (*Plate 67*), located immediately west of the partition wall. The south door (*Plate 70*) is the larger of the two, extending to the full height of the wall, with a timber lintel at eaves level. The lintel is supported by a substantial post, with planks panelling the areas to either side. The north door (*Plate 71*) is smaller, with a post supporting the wooden lintel and panels of ply blocking the opening.

Three ventilation slots are visible in the south wall (*Plate 68* and *Plate 69*), two above and one below, corresponding to the easternmost of the features seen externally in *Plate 51*. Five more slots (all bricked up) are visible at low level in the north wall (*Plate 71* and *Plate 72*), corresponding to features seen externally in *Plate 65*.

Plate 71: Interior of the north door in Barn 2, looking northeast
