# Wollaton Park Walled Garden

## Structural Recording and Condition Survey

For Nottingham City Council Museums & Galleries

TPA Report code: 144/2014

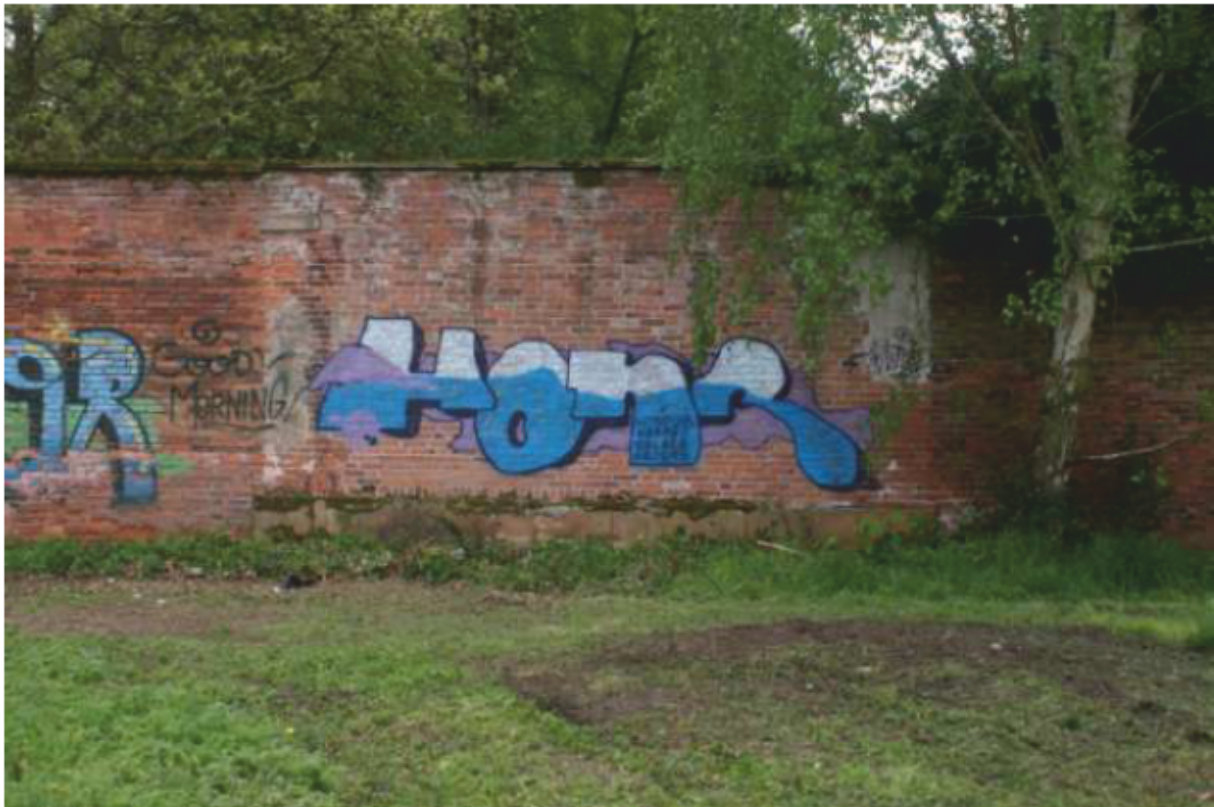
Plate 1: Wall face 1, showing remains of demolished exterior glasshouse or possible infilled entrance. Looking west.

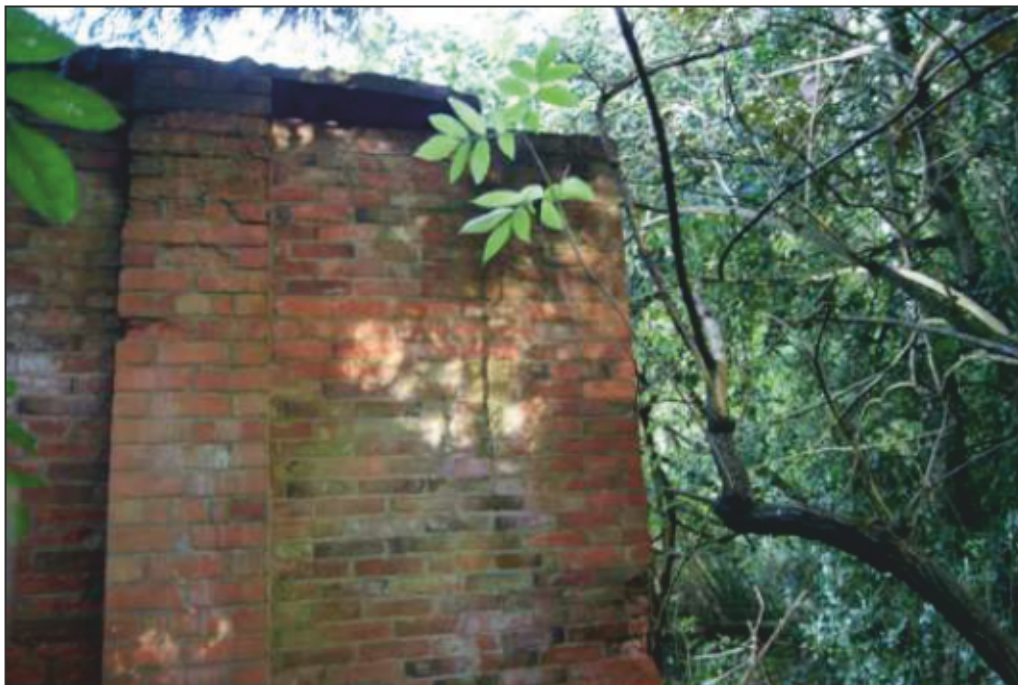
Plate 4: Wall face 2, looking west.

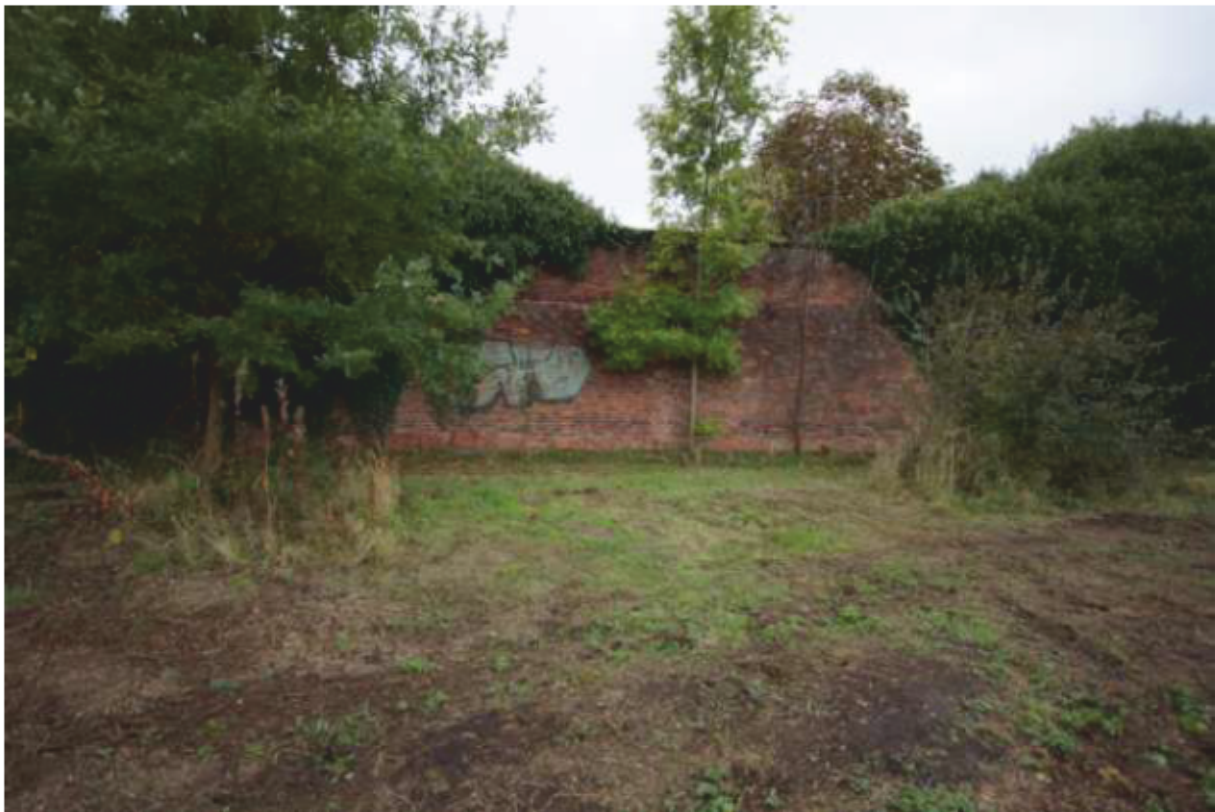
Plate 22: Wall face 13, showing graffiti. Looking west.

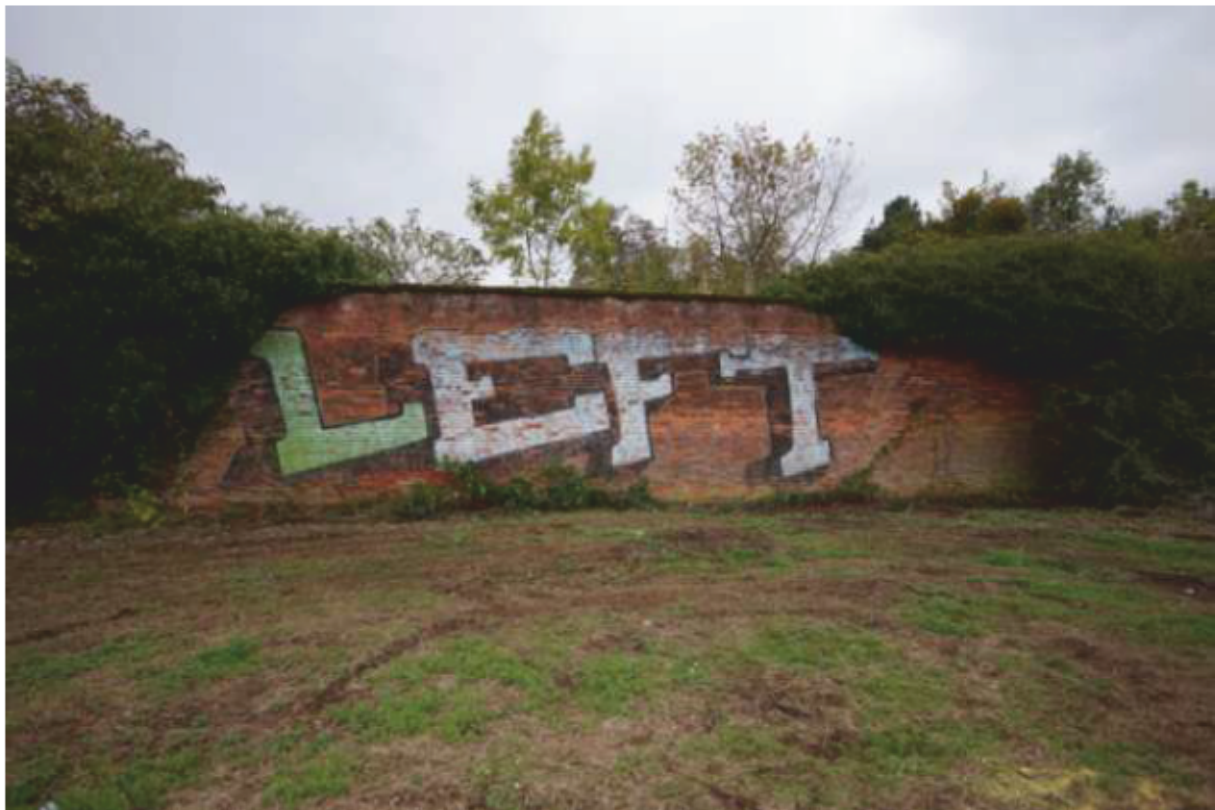
Plate 23: Wall face 13, showing graffiti. Looking west.

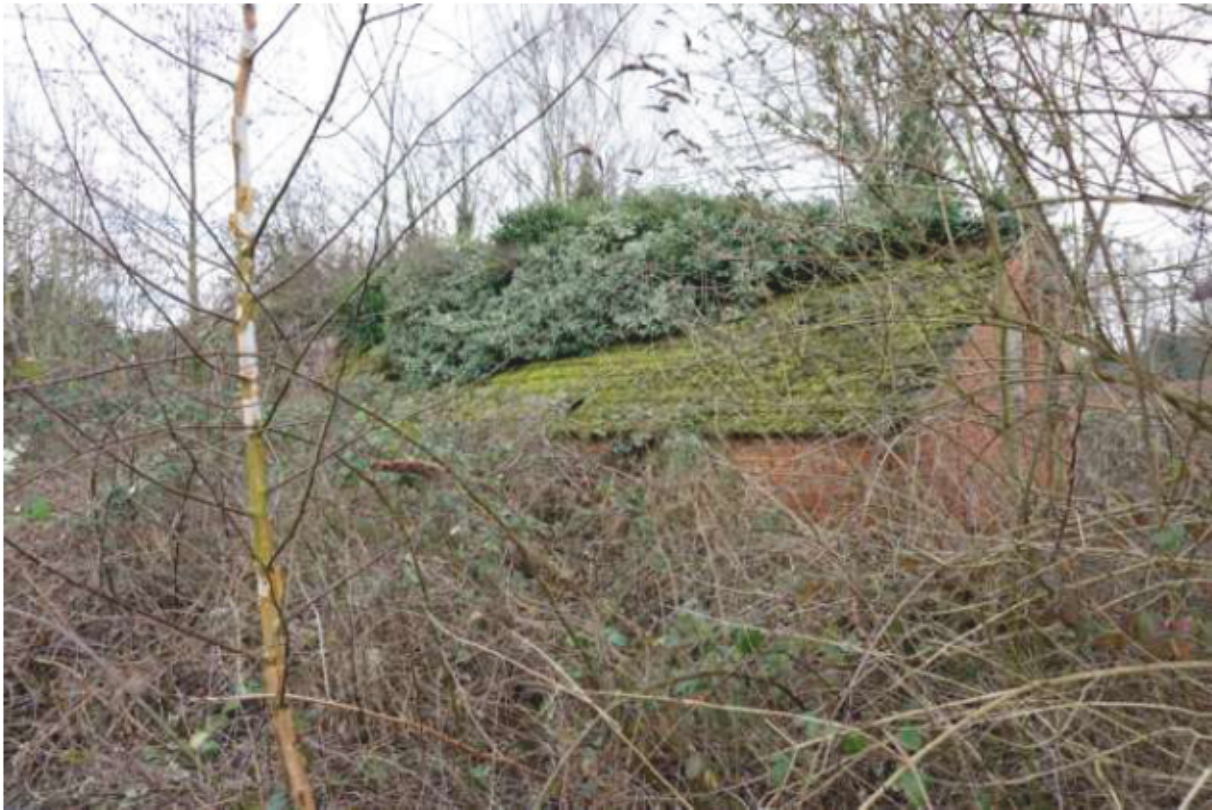
Plate 40: Shed Phase 4, inaccessible behind heavy vegetation. Looking south-east.

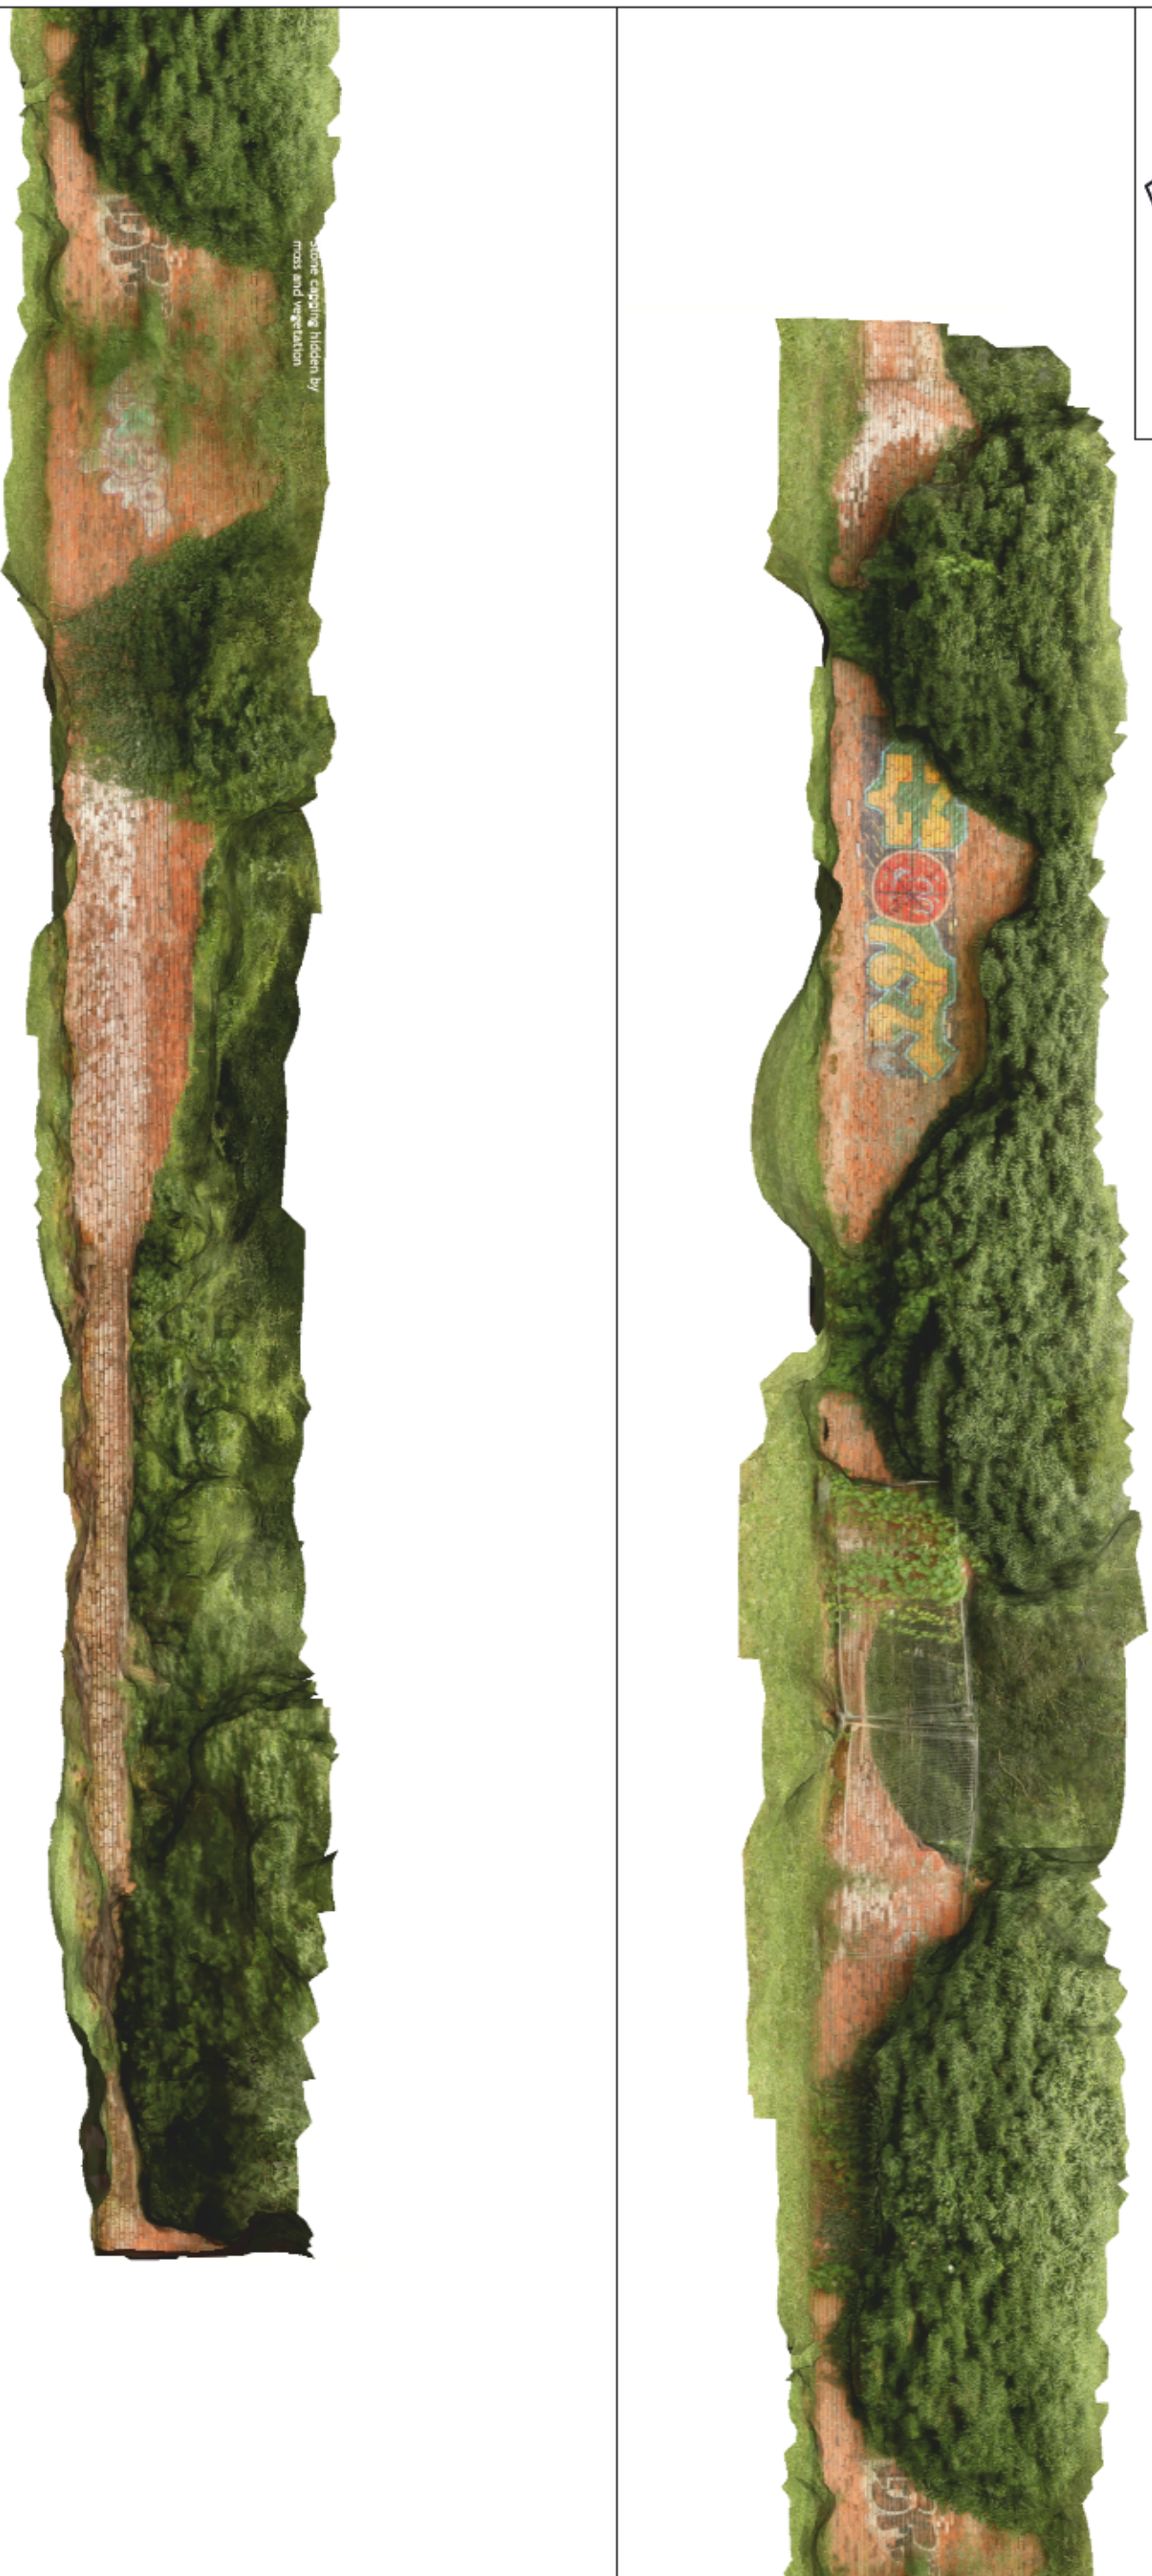
stone capping hidden by  
moss and vegetation
