**AN ARCHAEOLOGICAL WATCHING BRIEF AT  
16 SOUTH BAILEY, DURHAM,  
COUNTY DURHAM**

**ASSESSMENT REPORT**

**SEPTEMBER 2013**

Pre-Construct Archaeology Limited Quality Control	
<i>Project Number</i>	K3020
<i>Site Code</i>	SBD 13
<i>Report Number</i>	RN11028

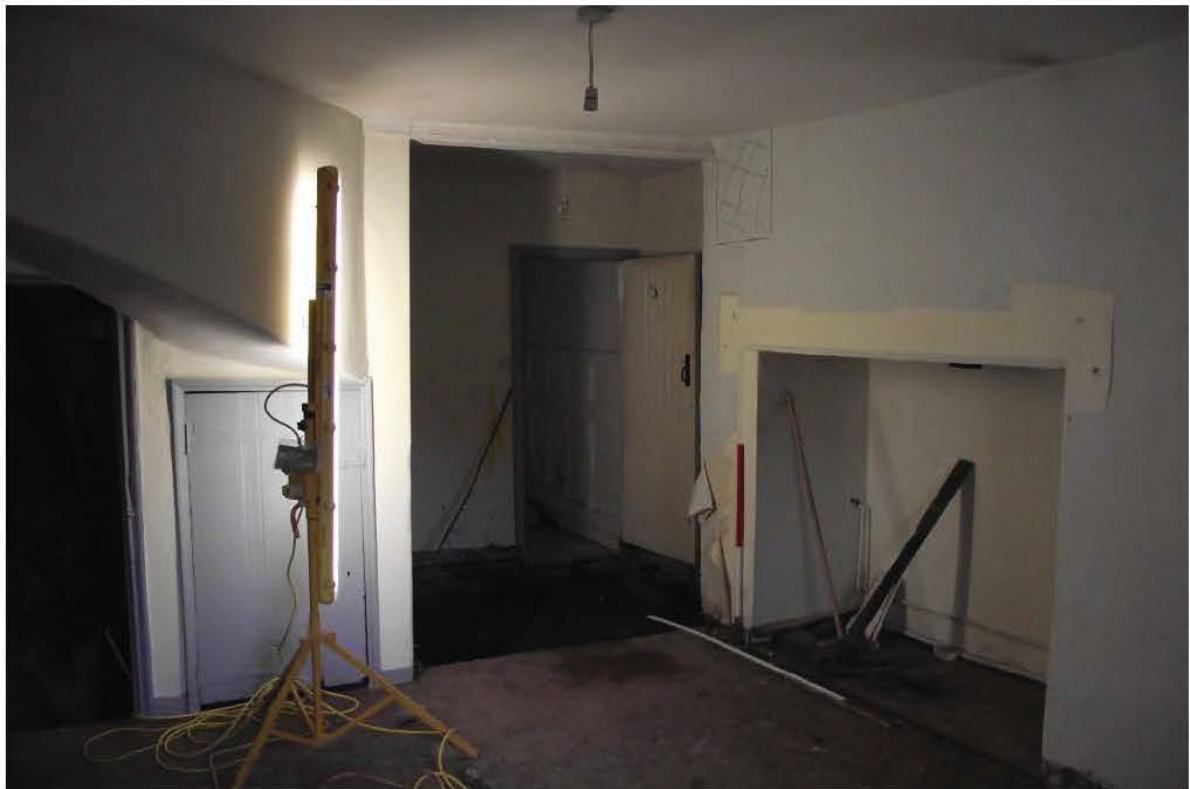
Plate 39: Southern rear element, ground floor, Reception Room 2, eastern part (1m scale)

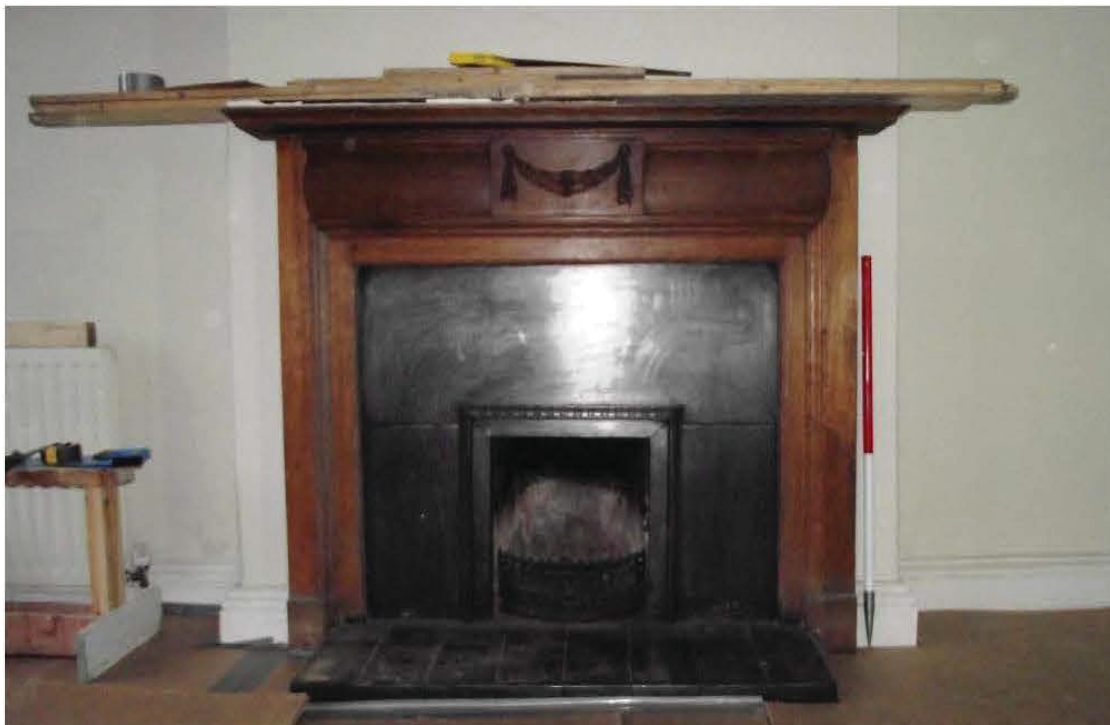
Plate 44: Reception Room 1, fireplace in north wall (1m scale)

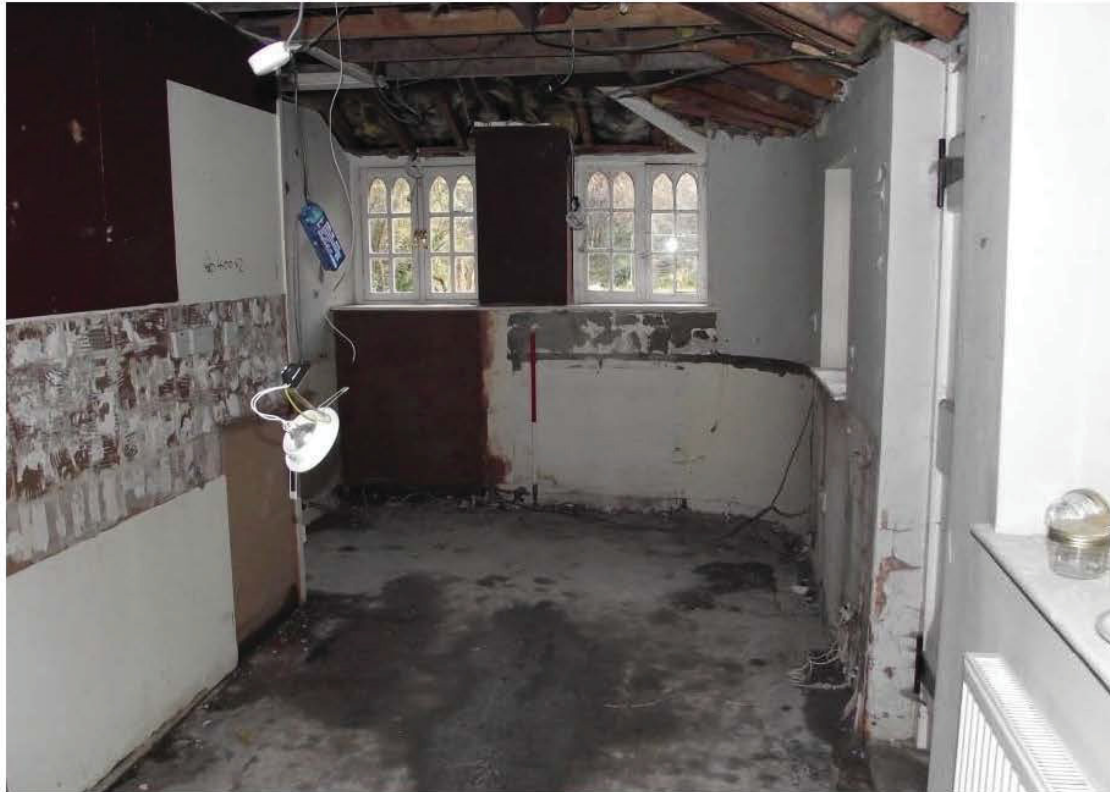
Plate 49: S-shaped rear extension, kitchen range (1m scale)

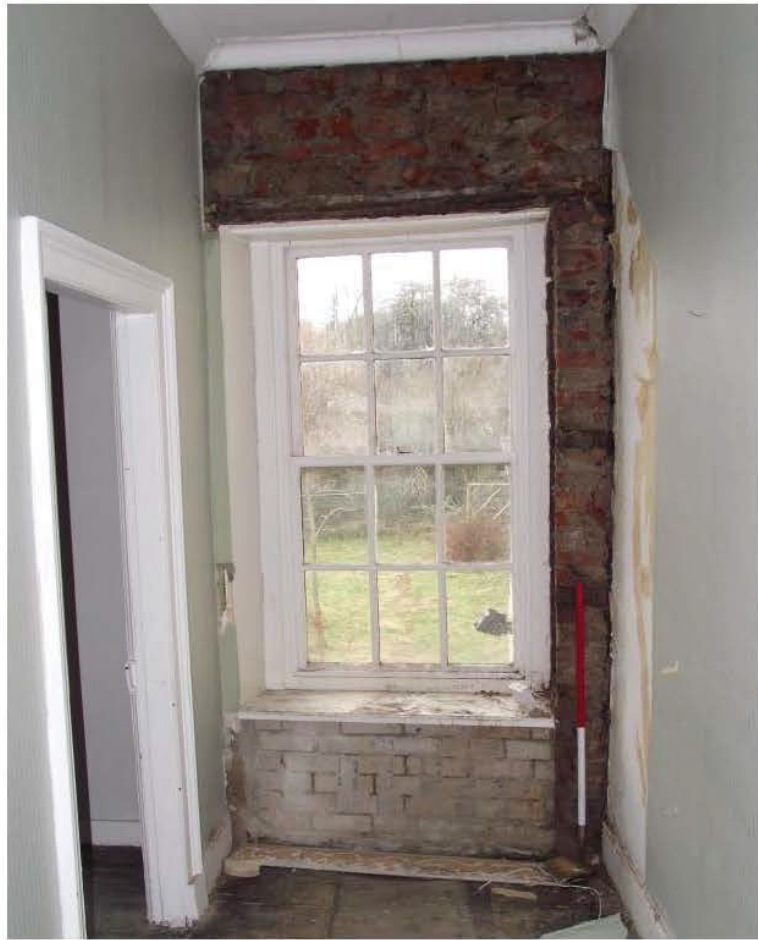
Plate 59: Southern rear element, first floor landing window (1m scale)

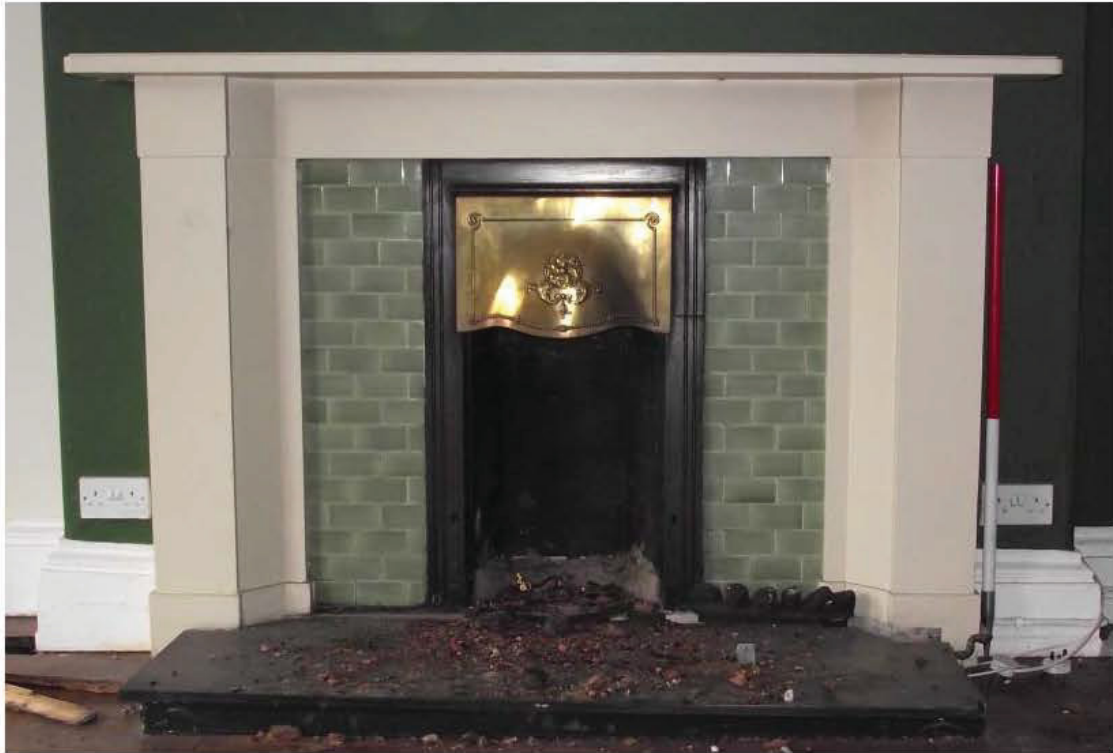
Plate 61: Northern rear element, first floor, Bedroom 1, fireplace (1m scale)

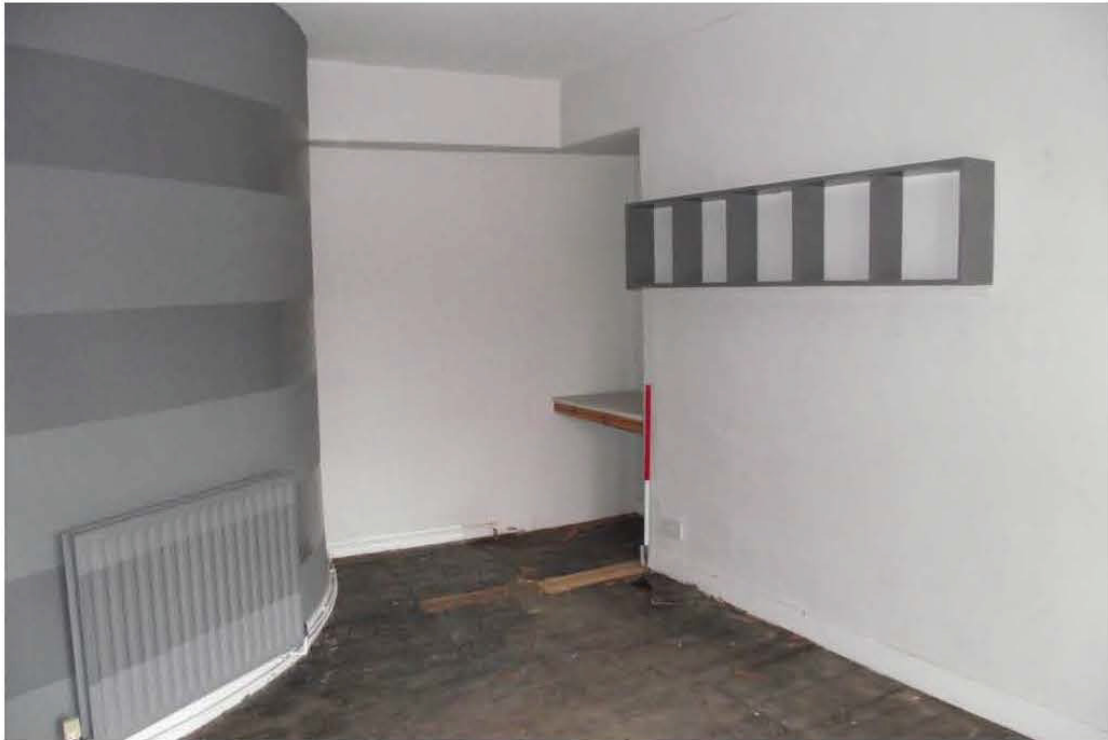
Plate 63: Southern rear element, first floor, Bedroom 2, eastern part (1m scale)

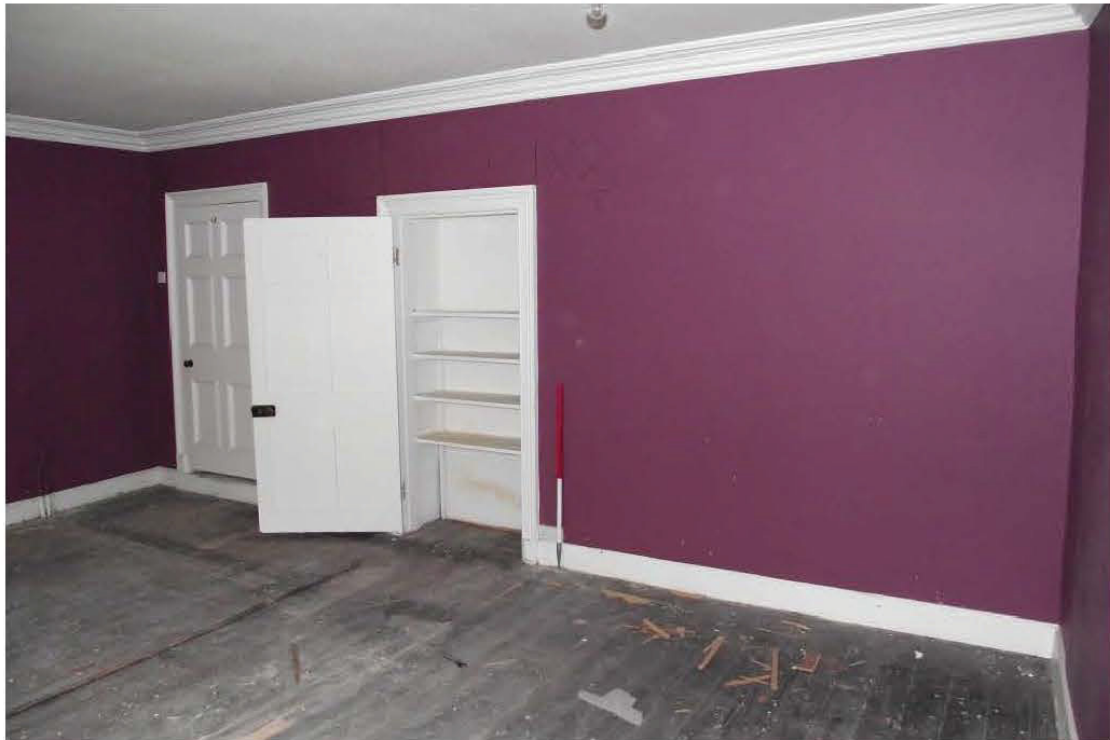
Plate 66: Front element, first floor, Bedroom 3, western part (1m scale)

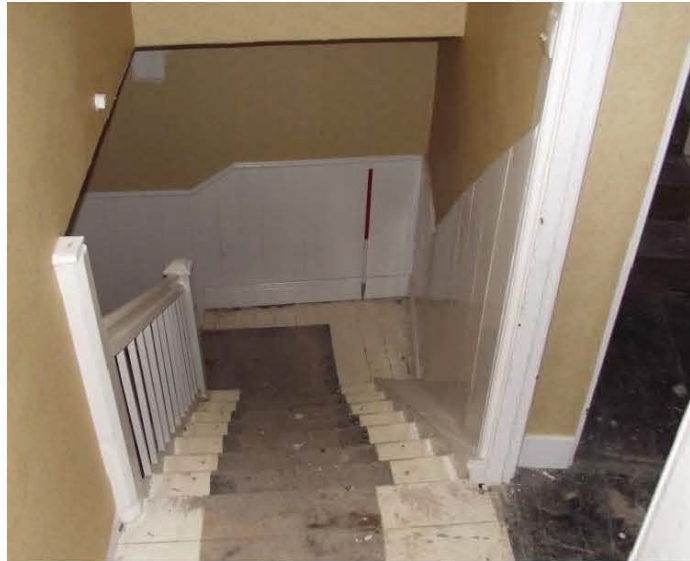
Plate 73: Northern rear element, staircase, from second floor landing (1m scale)
