**ARCHAEOLOGICAL
BUILDING RECORDING AND
WATCHING BRIEF OF
THE ROOF LANTERNS AND
LEADED FLAT ROOFS AT
KENSINGTON PALACE,
PALACE AVENUE,
ROYAL BOROUGH OF
KENSINGTON AND
CHELSEA,
W8 4PU**

SITE CODE: KEN29

PCA REPORT NO. R12405

MARCH 2016

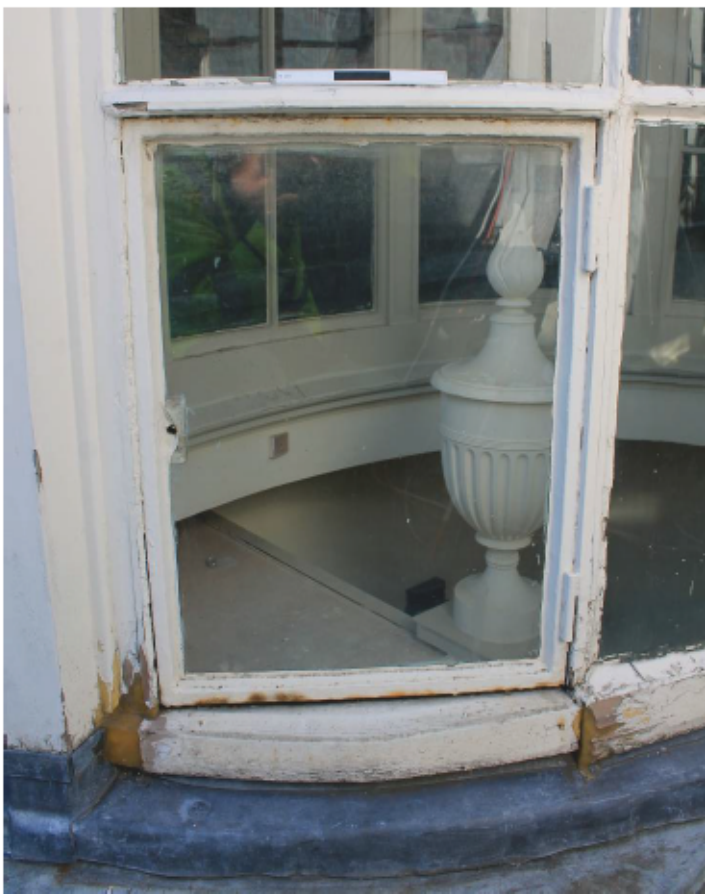
Plate 8 Lantern A: Casement 5

- 5.2.4 External Repair 4: Repair to sill (Plate 7): Similar insertion of a new section of modern softwood timber sill into the base of the easternmost light. As with (ER3) the inserted sill is much cruder than the original and includes evidence of resin repairs.
- 5.2.5 Casement 5 (Plate 8): Replacement and alteration of glazing bars and insertion of window frame to facilitate introduction of new side hung iron-framed casement window. This also includes the addition of a heavier glazing bar to the top of the casement, which over-sails the window opening to provide a rain drip.
- 5.2.6 External Repair 6: Repair to sill (Plate 9): Resin repair to the sill the window within the central bay/light of the northern elevation, used to consolidate the frame and replace areas of decay within sill.

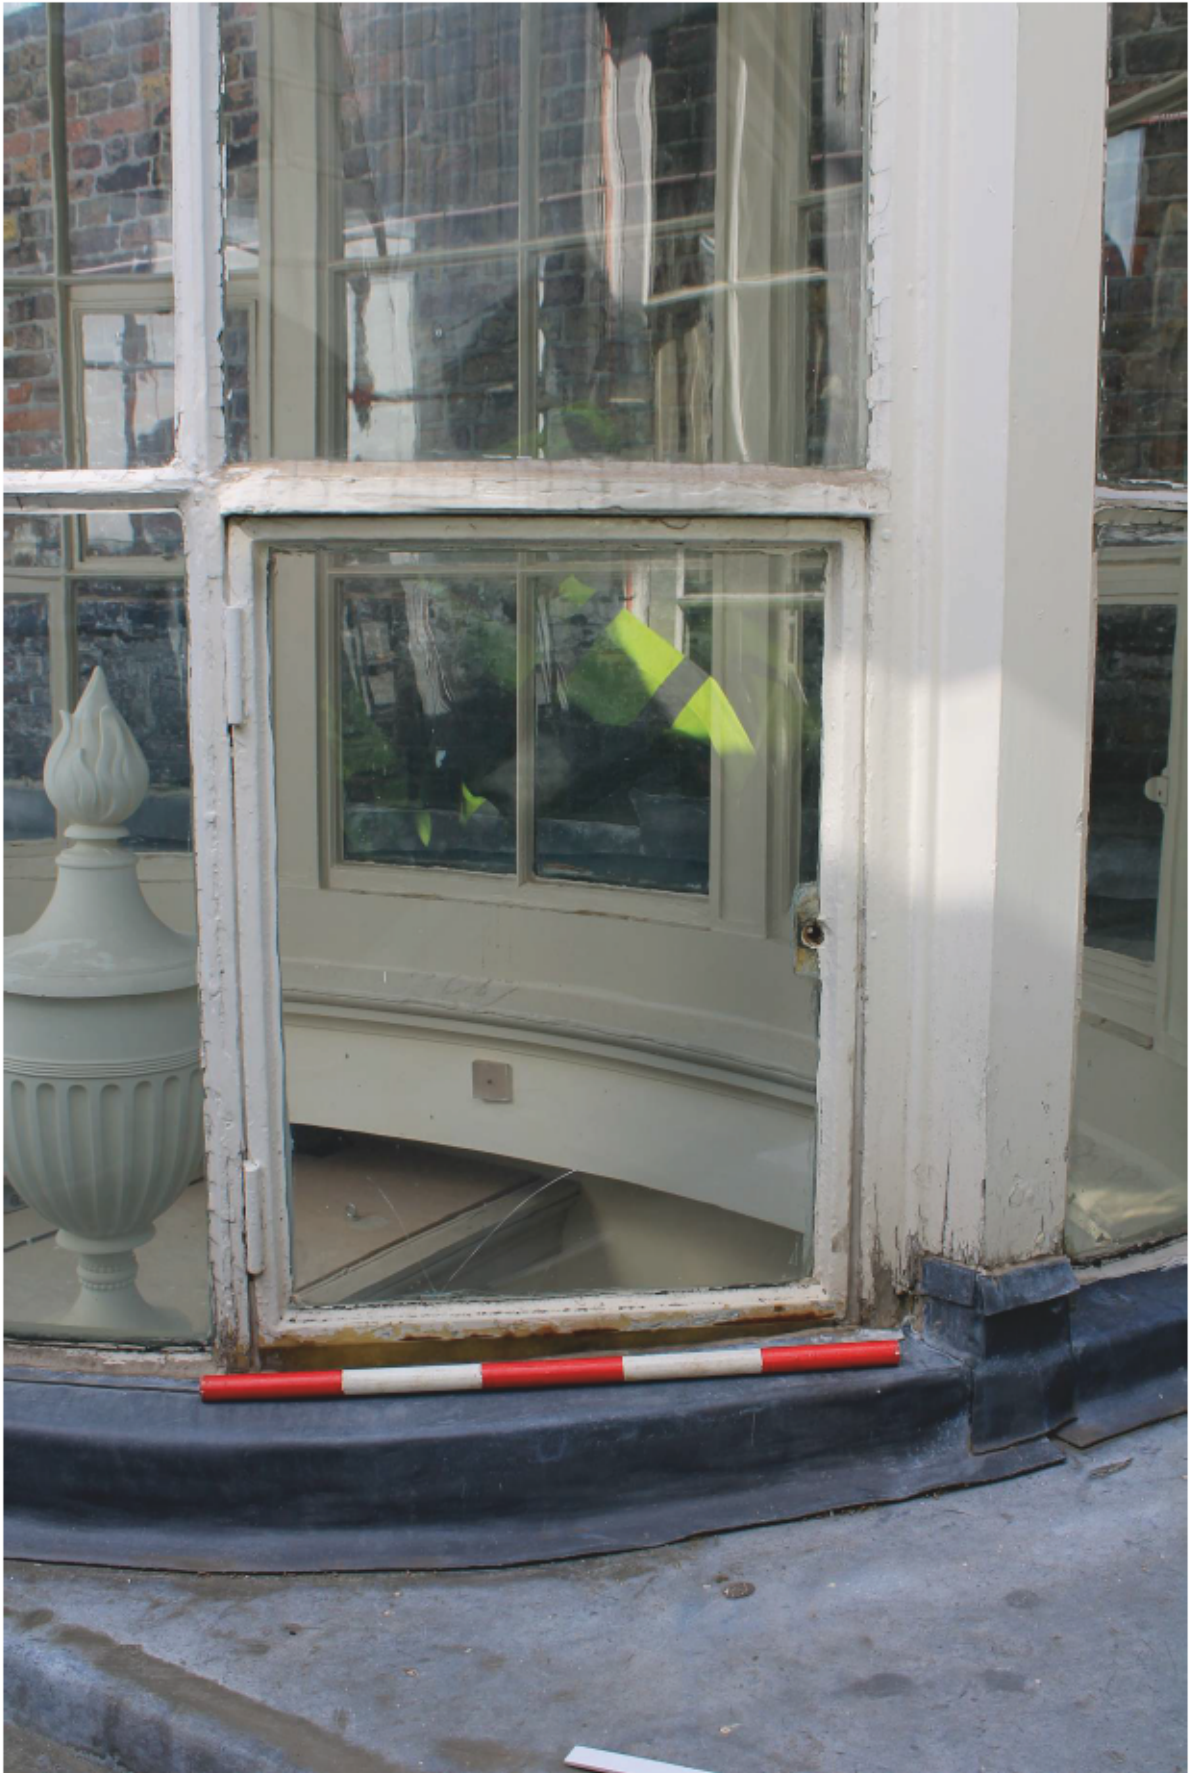
Plate 11 Lantern A: Casement 8

- 5.2.8 Casement 8 (Plate 11): Insertion of a metal framed casement window involving (like 5) the addition of a timber frame to accommodate the introduced window and an over-sailing hood to act as a rain drip, added to the upper glazing bar.

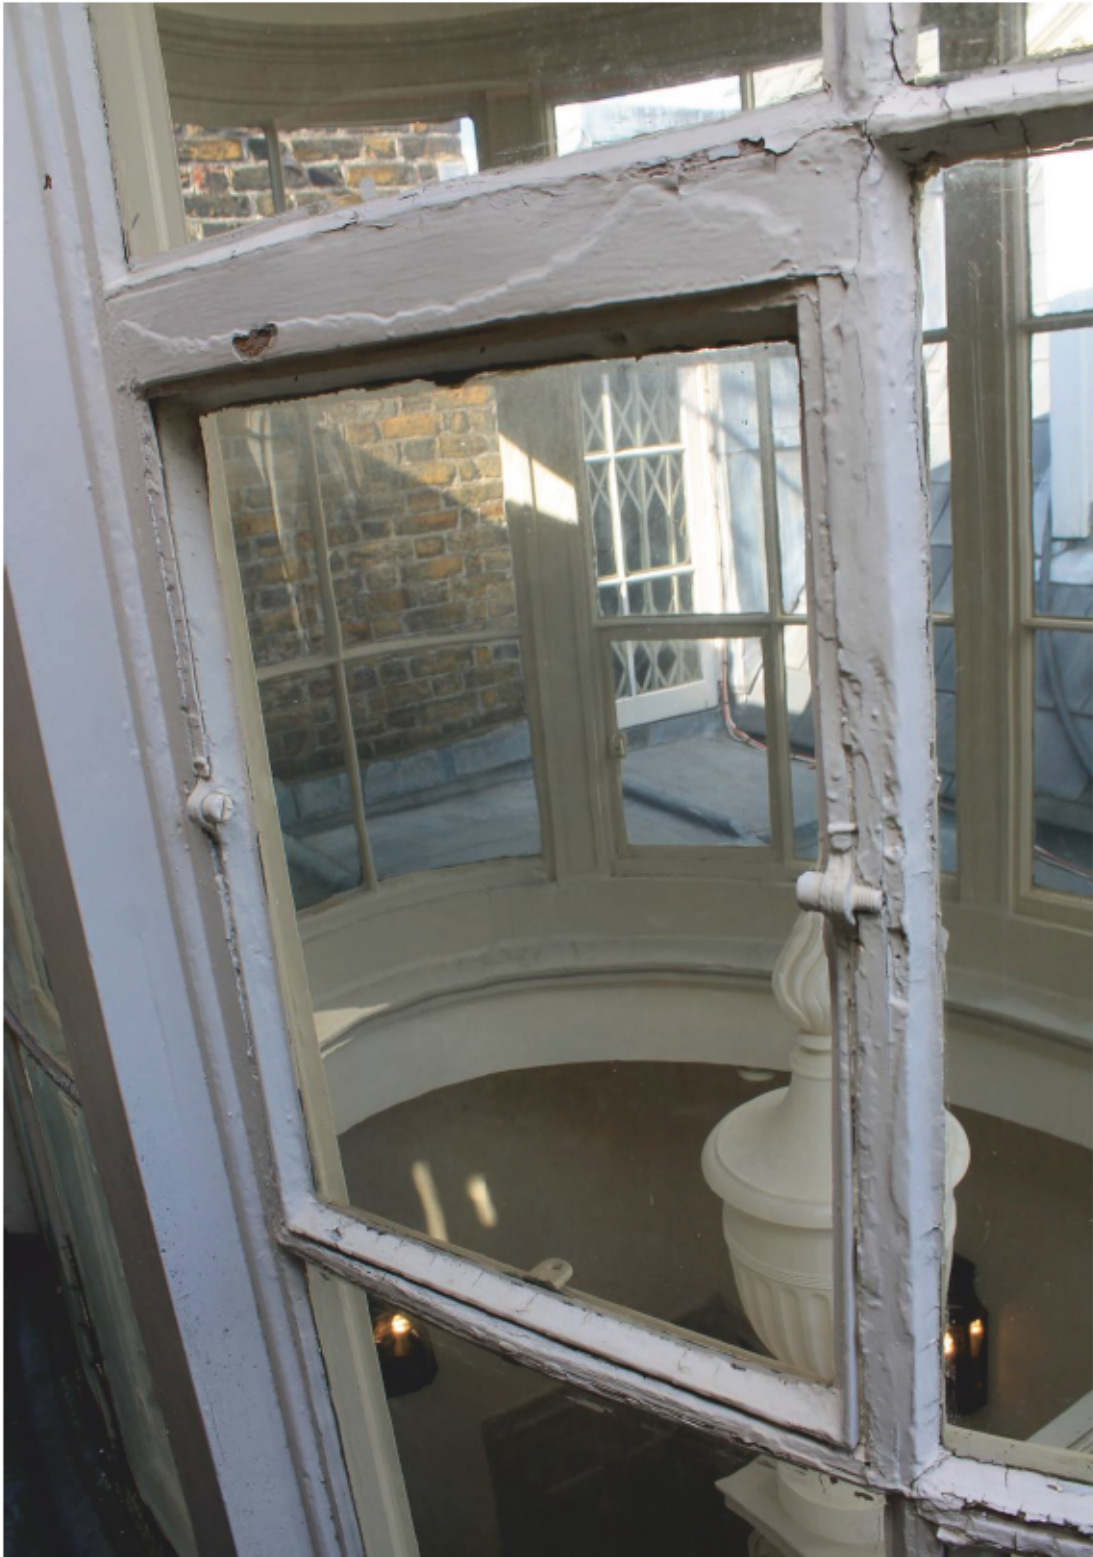
Plate 16 Lantern A: Casement 13

- 5.2.13 Casement 13 (Plate 16): The insertion of a bronze centre pivoting casement window, above, but in the adjacent pane to casement 12. The insertion of the casement typically also entailed the addition of a supporting timber frame for the metal framed casement to be seated into, but, unlike windows 12 and 10, did not incorporate an over-sailing hood.

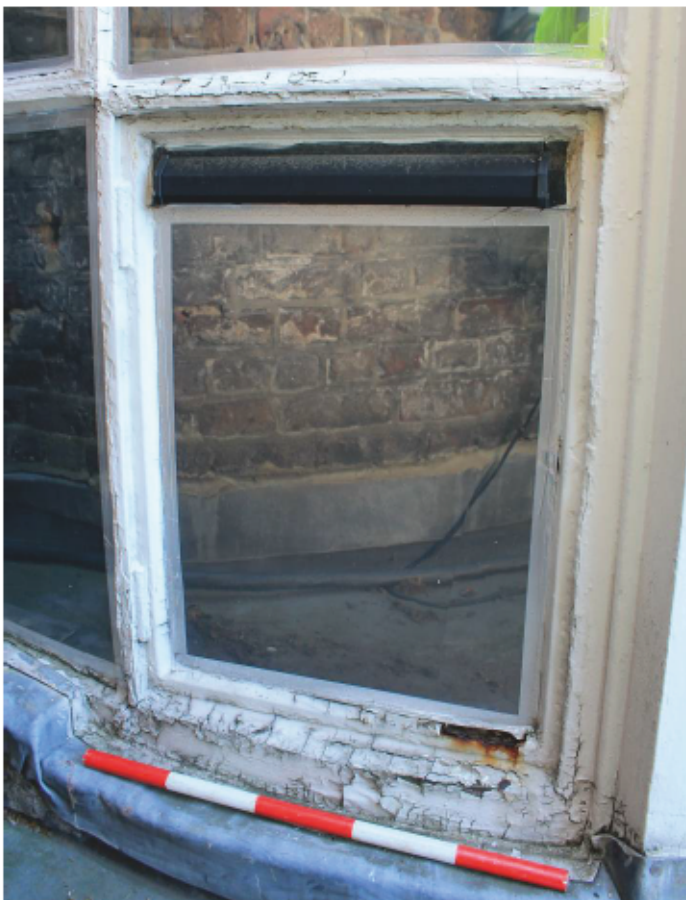
Plate 41 Lantern B: Casement 24

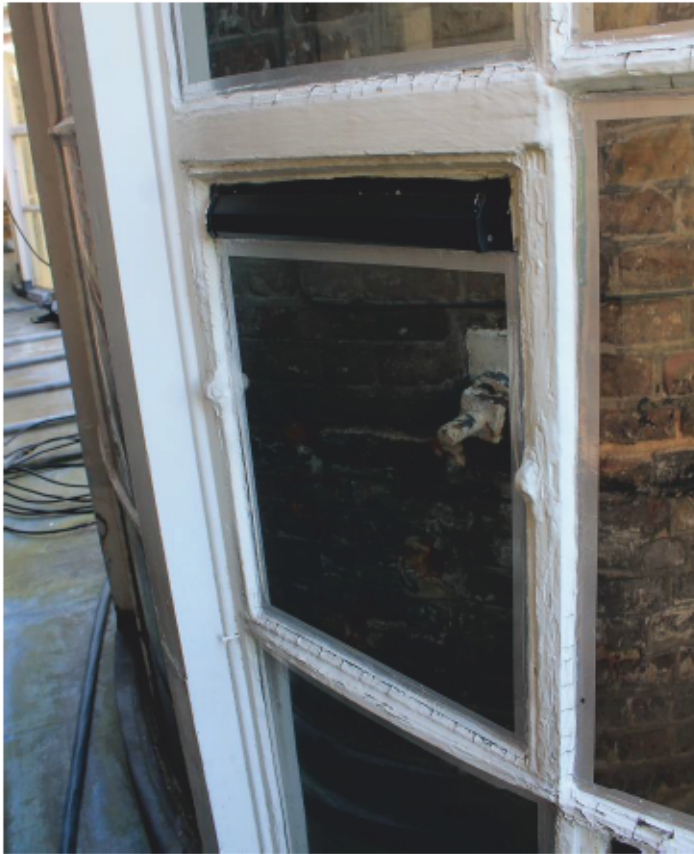
Plate 42 Lantern B: Casement 25

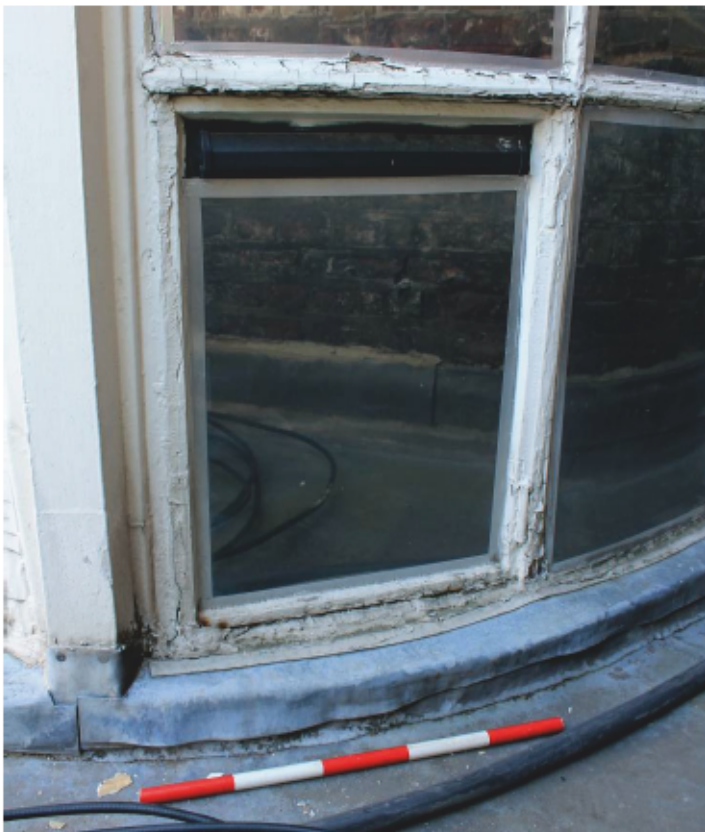
Plate 43 Lantern B: Casement 26

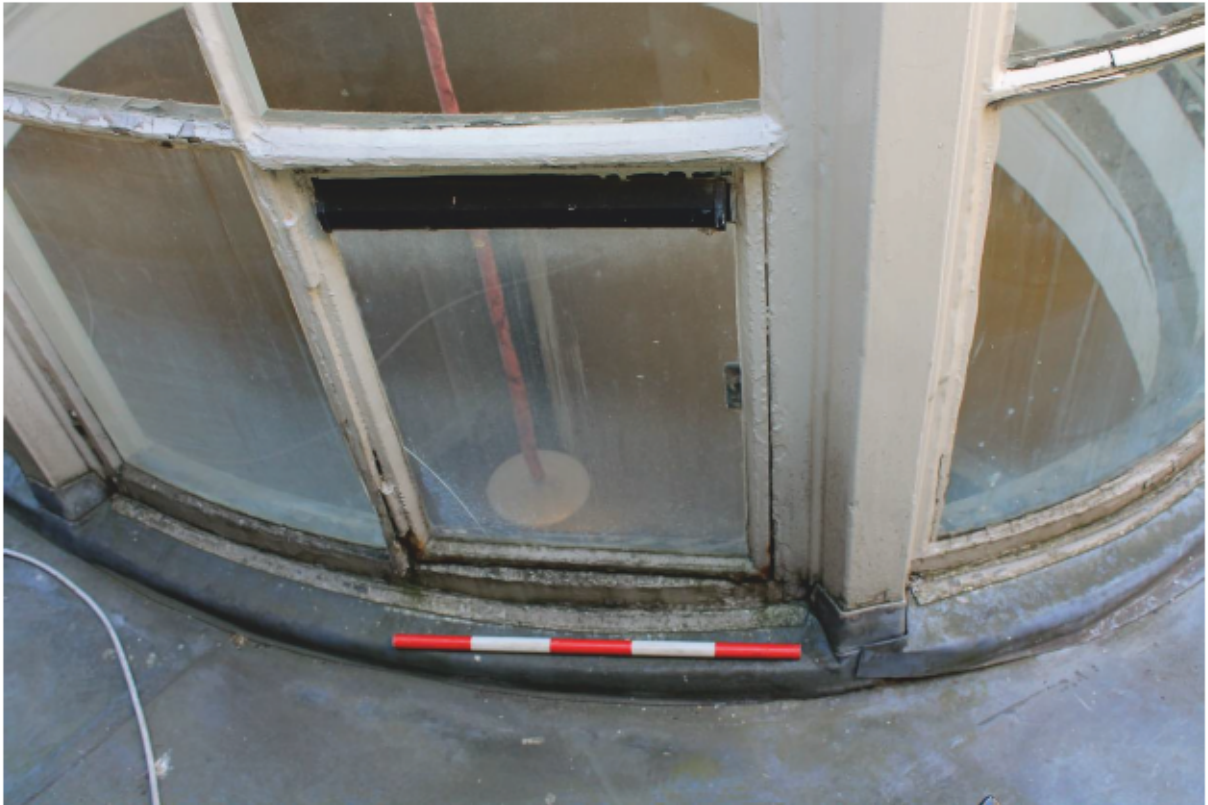
Plate 56 Lantern C: Casement 30

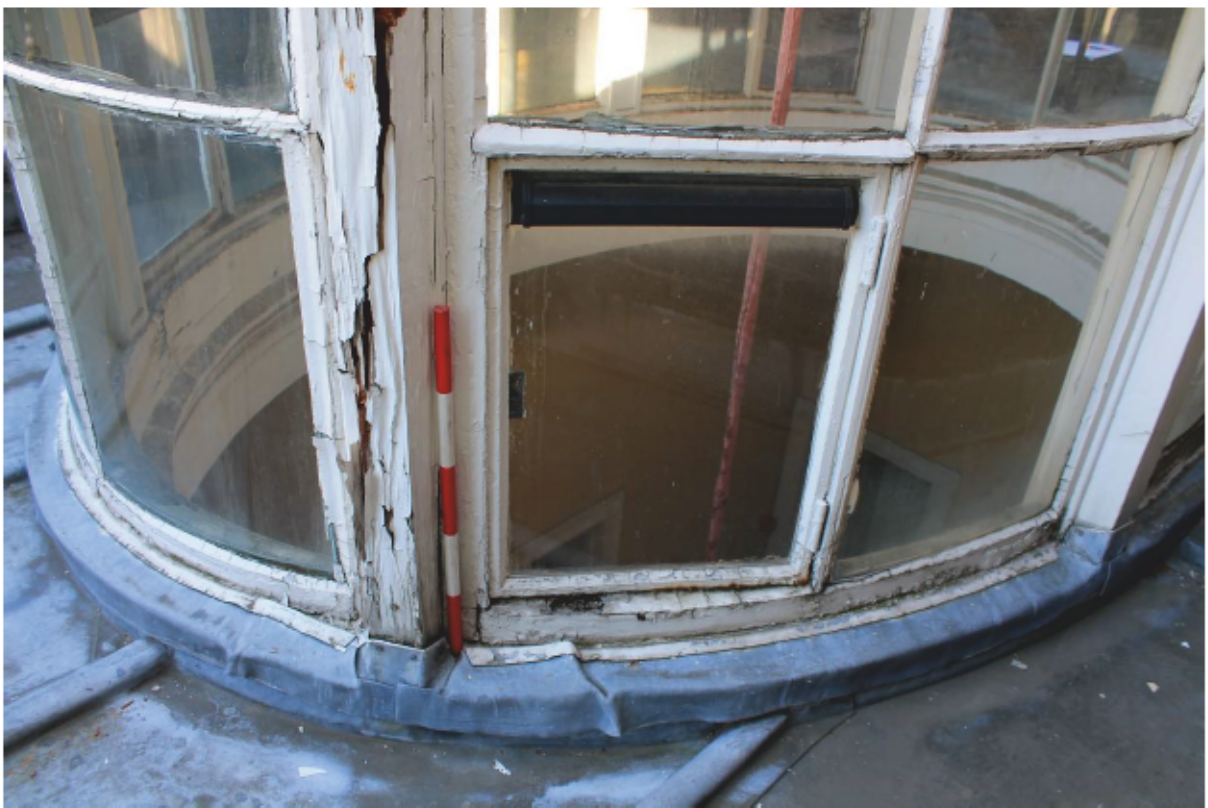
Plate 57 Lantern C: Casement 31

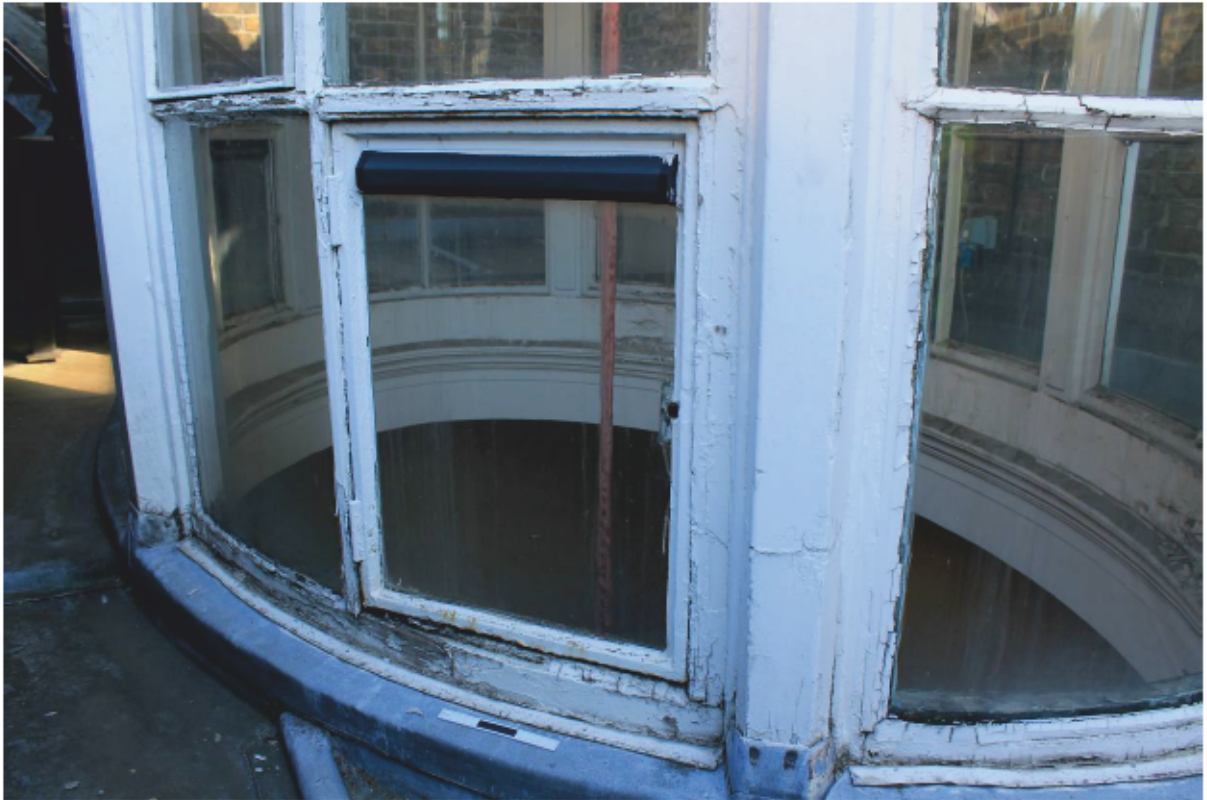
Plate 58 Lantern C: Casement 32

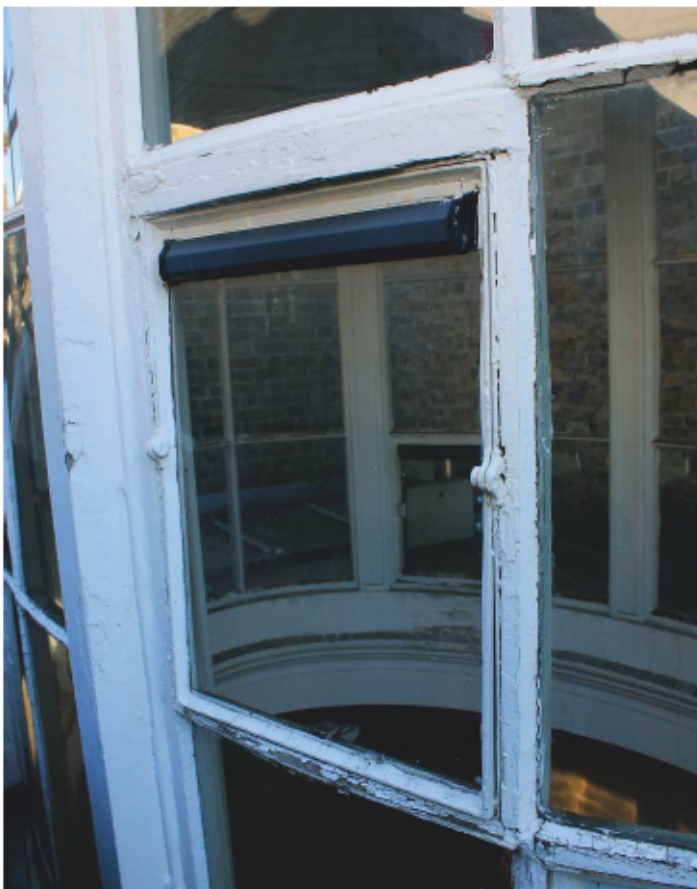
Plate 59 Lantern C: Casement 33

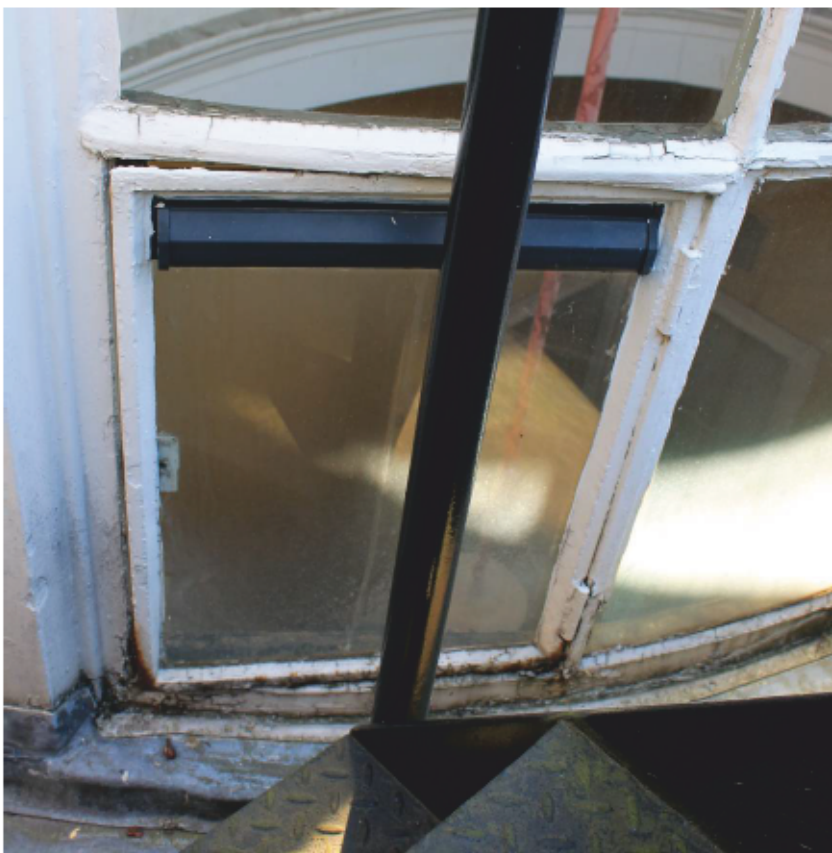
Plate 61 Lantern C: Casement 35

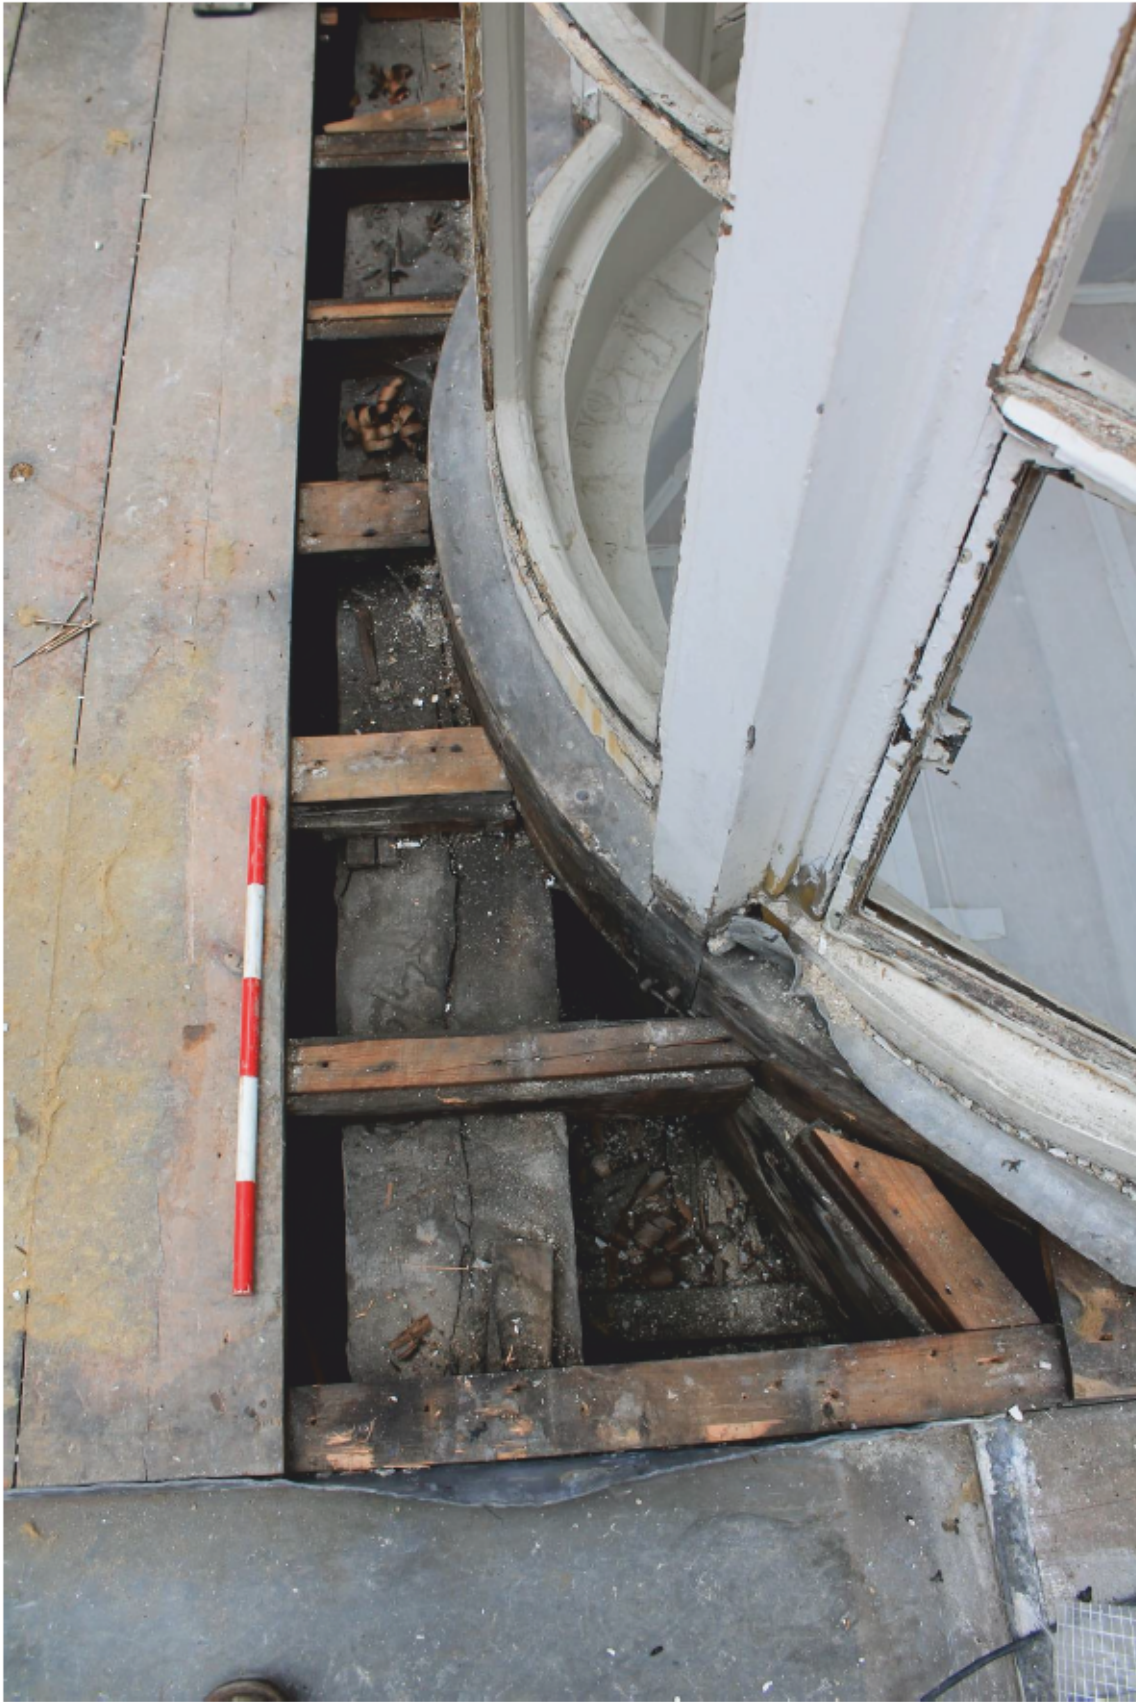
5.9.1 Opening A1 entailed the removal of a 'quadrant' of the roof covering located along the north-eastern side of Lantern A (Figure 10; Plates 73 and 74). This involved the initial removal of the leadwork to the flat roof within this quadrant and the subsequent removal of the underlying softwood boards. The latter, 9 inch boards, butted up against the lantern base/ring beam and were laid north-south, closely cut to follow the curve of the lantern. This was covered in fibrous matting fixed in place using copper nails.

Plate 73 Lantern A: Opening A1 looking south

Plate 74 Opening A1: Detail of sectional sill and supporting sub-structure looking south-west

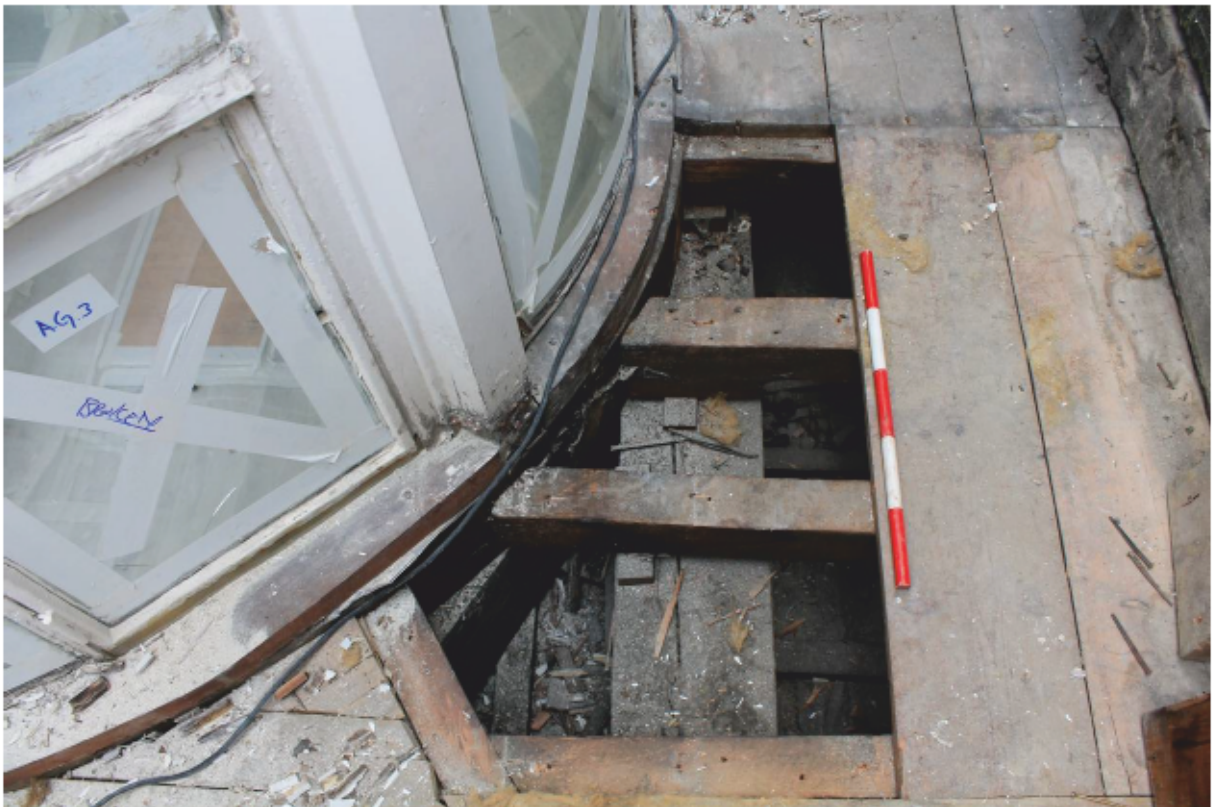
5.10.1 Opening A2 entailed the removal of a corresponding 'quadrant' of the roof located along the north-western side of Lantern A (Figure 10; Plate 75). This involved the removal of the same sequence of leadwork, fibre matting and softwood boards.

Plate 75 Lantern A: Opening A2 looking south

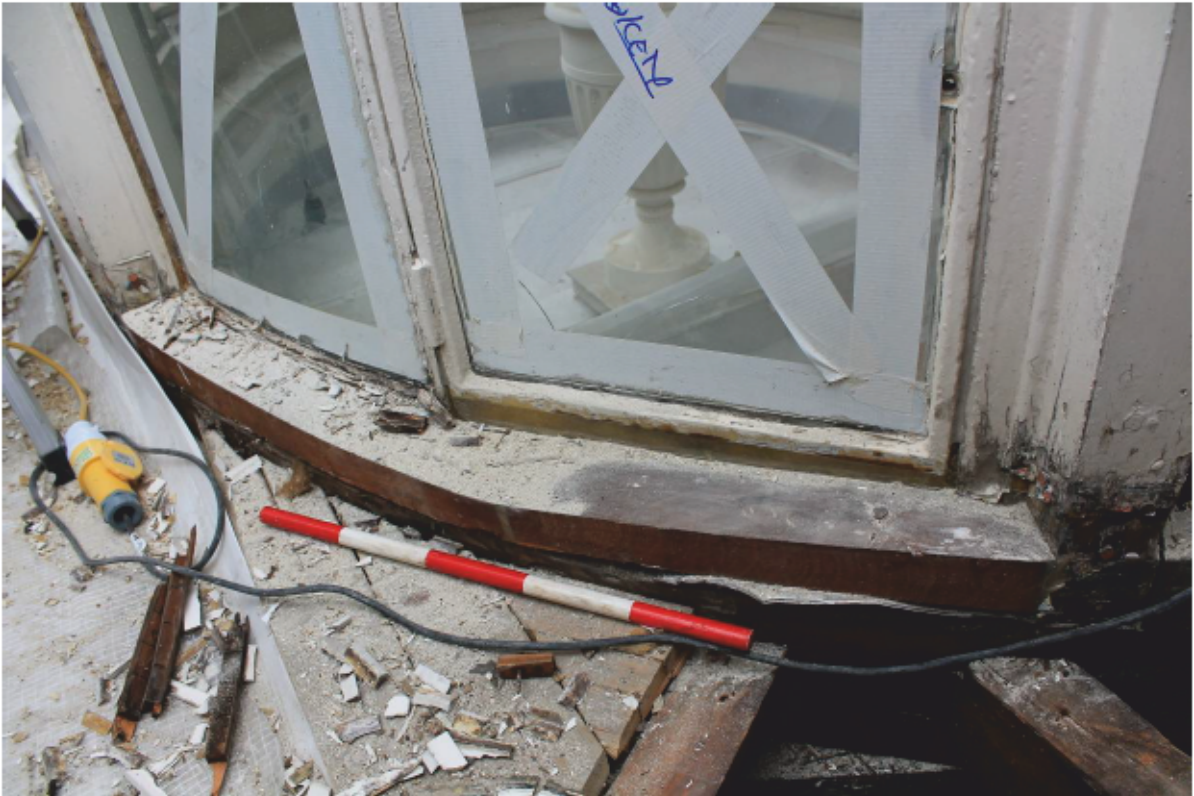
- 5.10.3 Both sections of the sill beam had been heightened in this area of the roof by the addition of timber inserts overlaying the sill beam and either side of the north-western mullion (formerly visibly obscured by lead flashings). That to the east of the mullion was a recent replacement fabricated from non-native hardwood (**Plate 76**) and other insert, an earlier softwood section nailed into place. The sill beam, as seen in opening A1, was diagonal nailed into the base of the mullion.

Plate 76 Lantern A: Modern heightening to sill

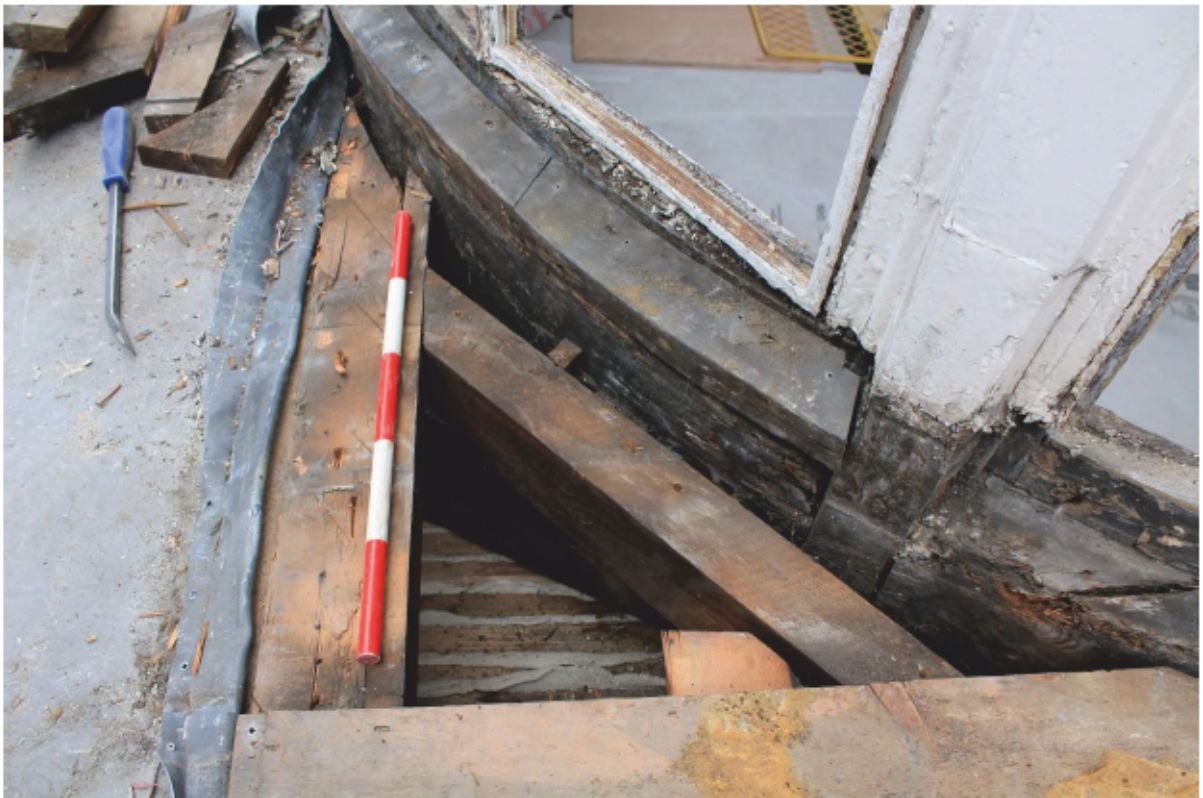
- 5.11.1 Opening B1 entailed the removal of a 'quadrant' of the roof located along the north-western side of Lantern B and south of the central valley (**Figure 11; Plate 77**). The same sequence of lead-work, fibre matting and softwood boards were encountered. The boards were nailed into softwood joists, either aligned east-west and forming the southern edge to the central valley, or diagonally set following the line of the original trimmer beam below. They represent a later reworking and heightening of the flat roof. The sectional sill (or ring beam) to the lantern typically measured 7 inches in depth and in conjunction with the adjoining mullions were supported by a diagonally set trimmer beam/dragon tie. This is an arrangement consistently recorded within the other roof openings and more fully exposed when the lanterns were lifted. The roof void in this area is less than that recorded in A1 and A2, with the laths for the ceiling below tacked directly into the soffit of the trimmer. The present ceiling void measures 16 inches.

Plate 77 Lantern B: Opening B1

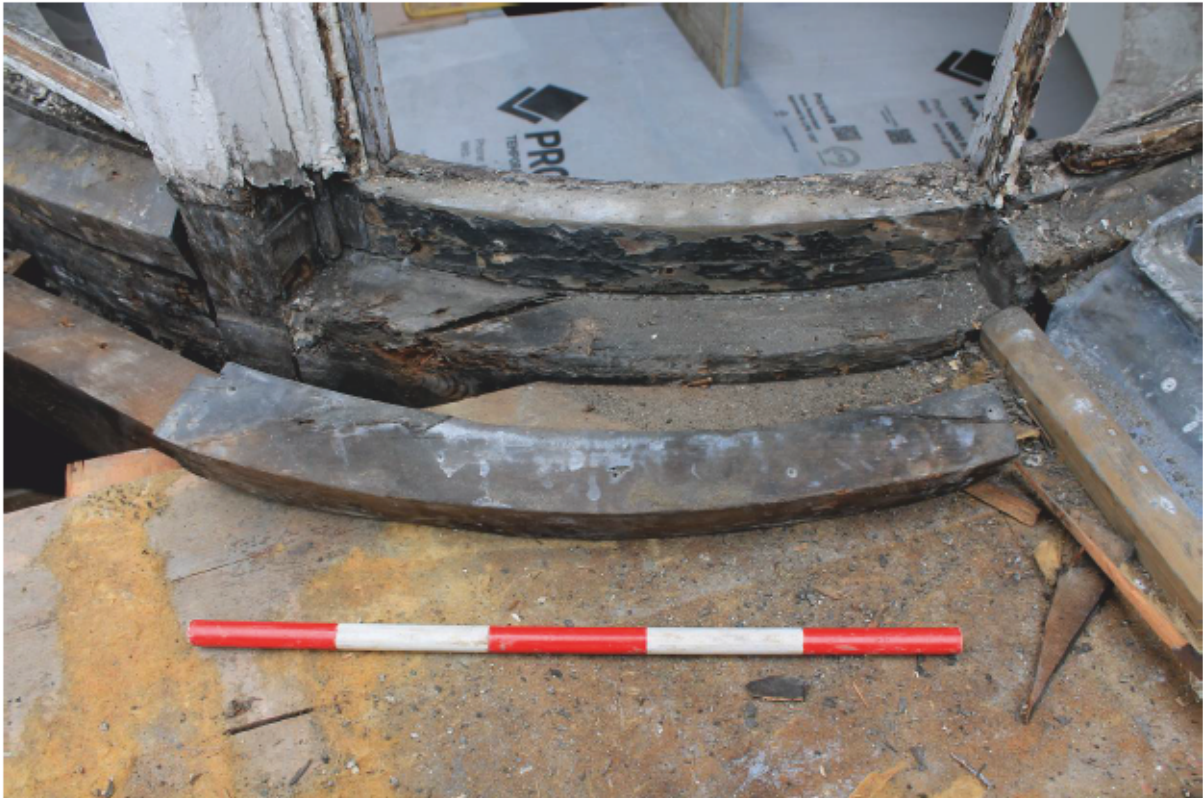
- 5.11.2 The sill was typically formed of sections, each shaped at the ends to match the slightly chamfered outer profile of the mullion foot. No evidence of pegging between the mullion and sill beam sections was observed. The height of the sill at the western end of the lantern had (as also seen in A2) been heightened with the addition of curving softwood timber inserts nailed onto the top of the existing sill beam (**Plate 78**). In this area their addition was carried out in conjunction with the raising of the roof height (to maintain a lip above the level of the roof) and the creation of a central, recessed valley.

Plate 78 Lantern B: Later sill heightening (removed)

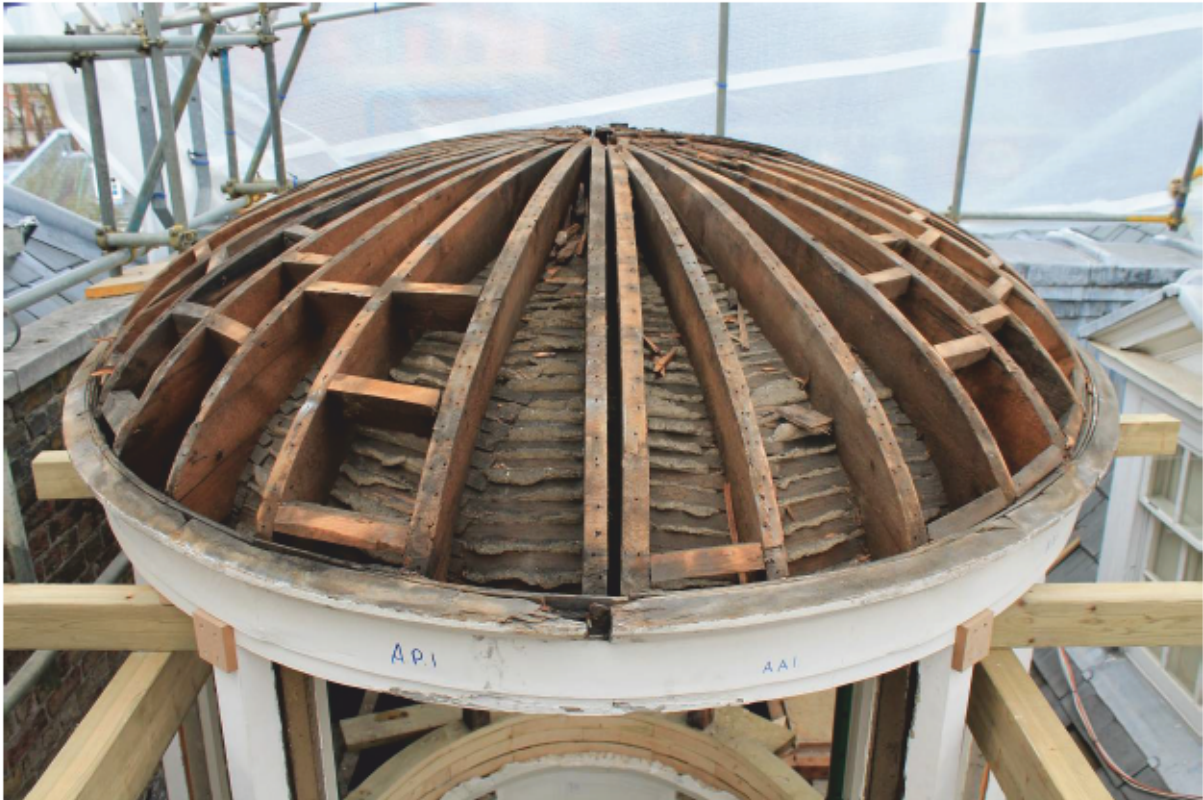
- 5.13.2 Removal of the sarking boards revealed the rafter detail (**Plate 83**). The softwood unplaned rafters, measuring 5 inches deep and 1¼ inches wide, and shaped to the curvature of the dome (in the vertical plain) reduced to gradually, tapering in width, so each rafter butted against its neighbour where they converged at the apex. The rafters sat onto an outer sill or plate and were strengthened in elevation by small sections of timber used as cross-bracing between the rafters. These rafters converged at the apex to pinch an elliptical timber boss (similar to that used for the leading detail) using a simple notch cut out of the end of the rafter and were fixed to the rear of the fascia. Consequently the dome structure was held in tension by the weight of the overlying leading. The laths for the domed plaster ceiling were nailed directly into the soffits of these rafters.

Plate 83 Lantern A: Following removal of sarking boards, looking west

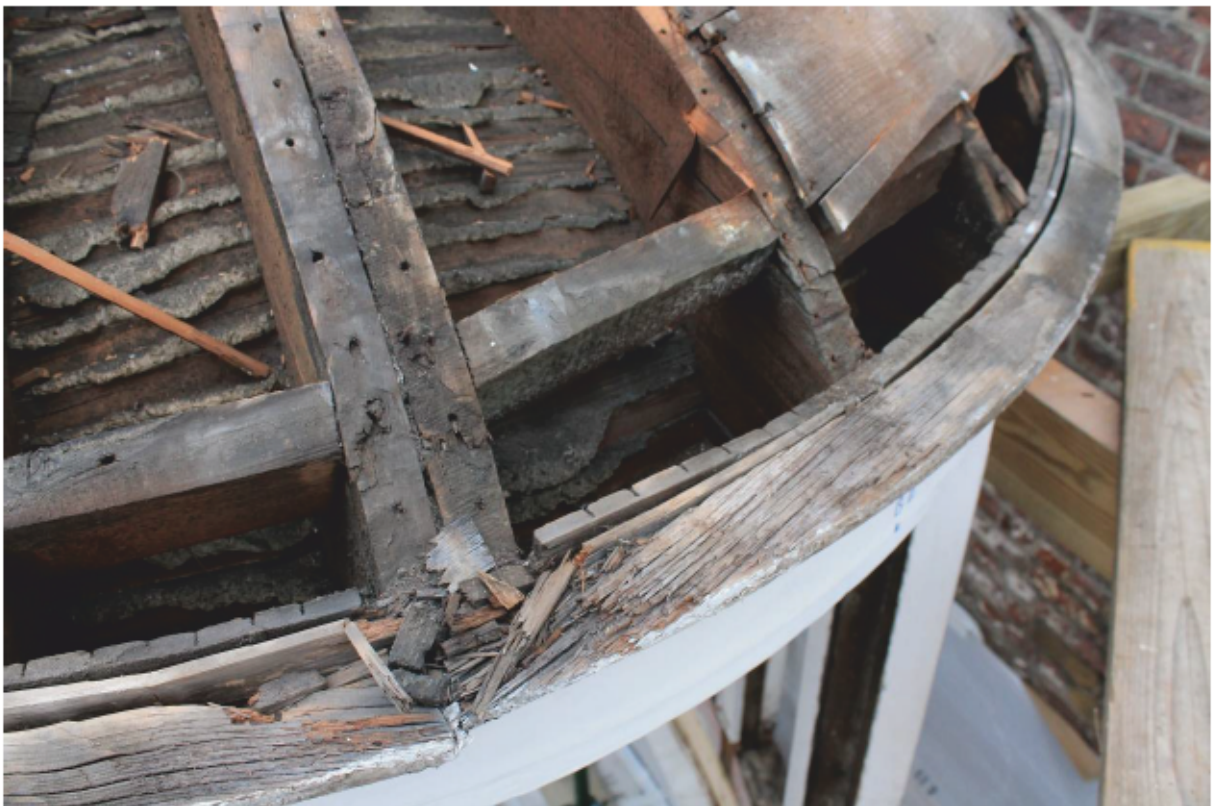
- 5.14 Domed Roof over Lantern B (Plates 84 to 86)**
- 5.14.1 The covering to the roof structure over lantern B was similarly revealed. It was also covered in individual lengths of softwood boards, of a form similar to that present on the eastern side of lantern A (**Plates 84 and 85**). The boards were not a uniform size, with boards spanning three rafters and others, only two. The boards reduced in width as they progressed toward the summit of the dome, at which point they were laid perpendicular (north-south) to the lower boards and within a geometric shaped upper section. The boards are overlain by the same elliptical cap and radiating softwood ribs, located at the junctions of the sections of leadwork covering the dome. Removal of the softwood boards revealed an identical roof structure as present over lantern A (**Plate 86**).

Plate 84 Lantern B: Following removal of lead flashings, looking south-east

Plate 85 Lantern B: Detail of sarking boards and central boss for leadwork

Plate 86 Lantern B: Detail of rafters and eaves

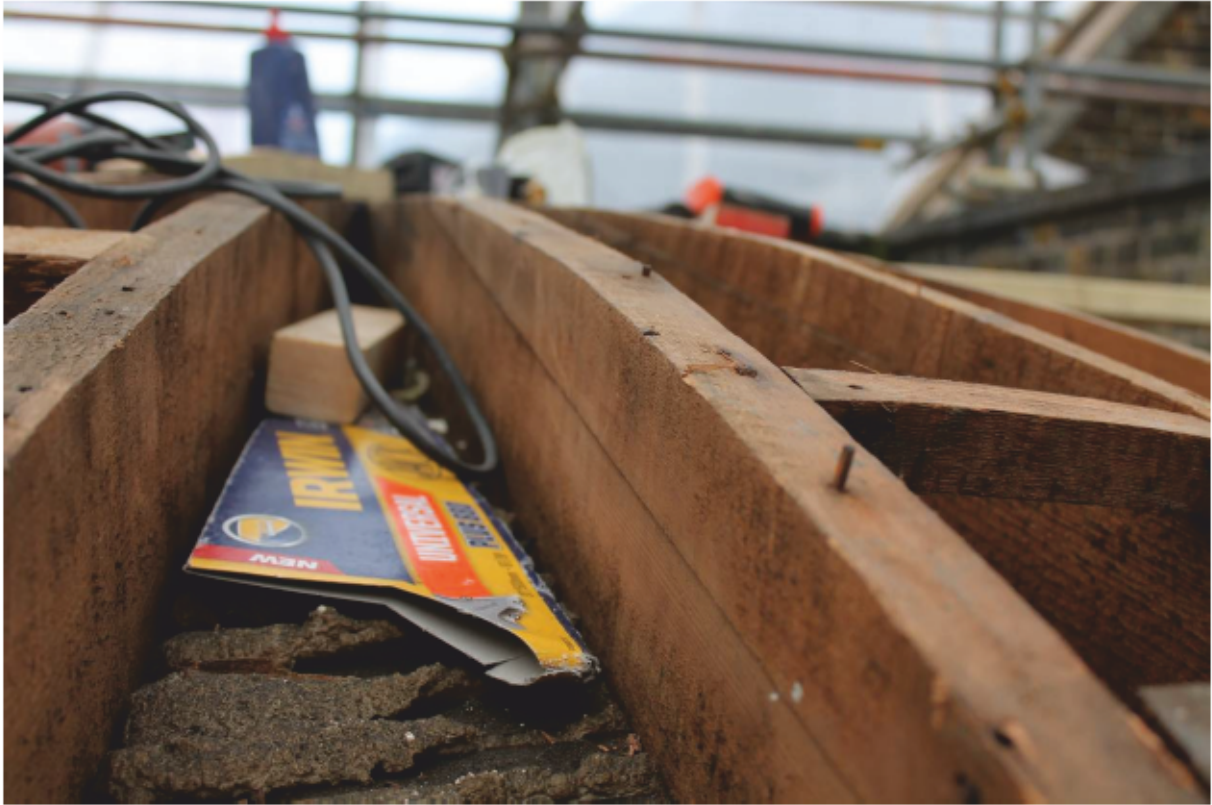
Plate 89 Lantern C: Composite rafter

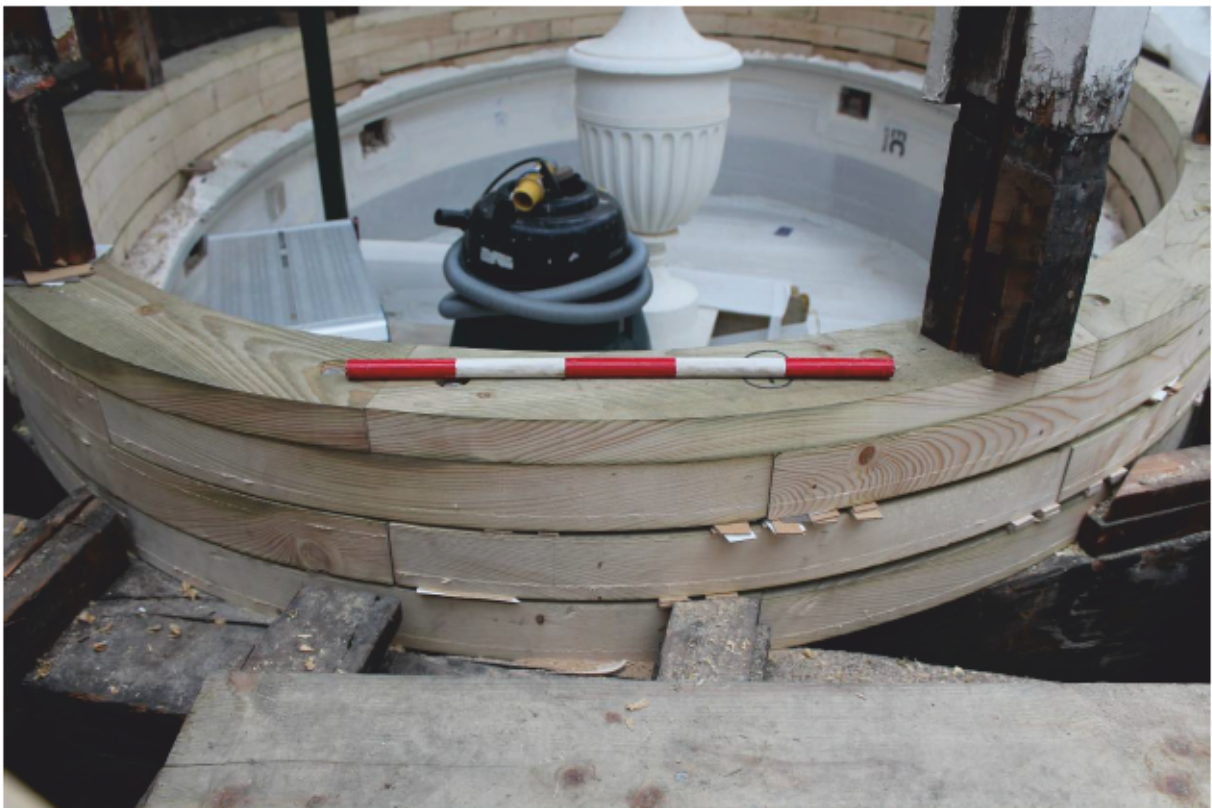
Plate 90 Lantern A: Insertion of new softwood composite sill
