**ARCHAEOLOGICAL
BUILDING RECORDING AND
WATCHING BRIEF OF
THE ROOF LANTERNS AND
LEADED FLAT ROOFS AT
KENSINGTON PALACE,
PALACE AVENUE,
ROYAL BOROUGH OF
KENSINGTON AND
CHELSEA,
W8 4PU**

SITE CODE: KEN29

PCA REPORT NO. R12405

MARCH 2016

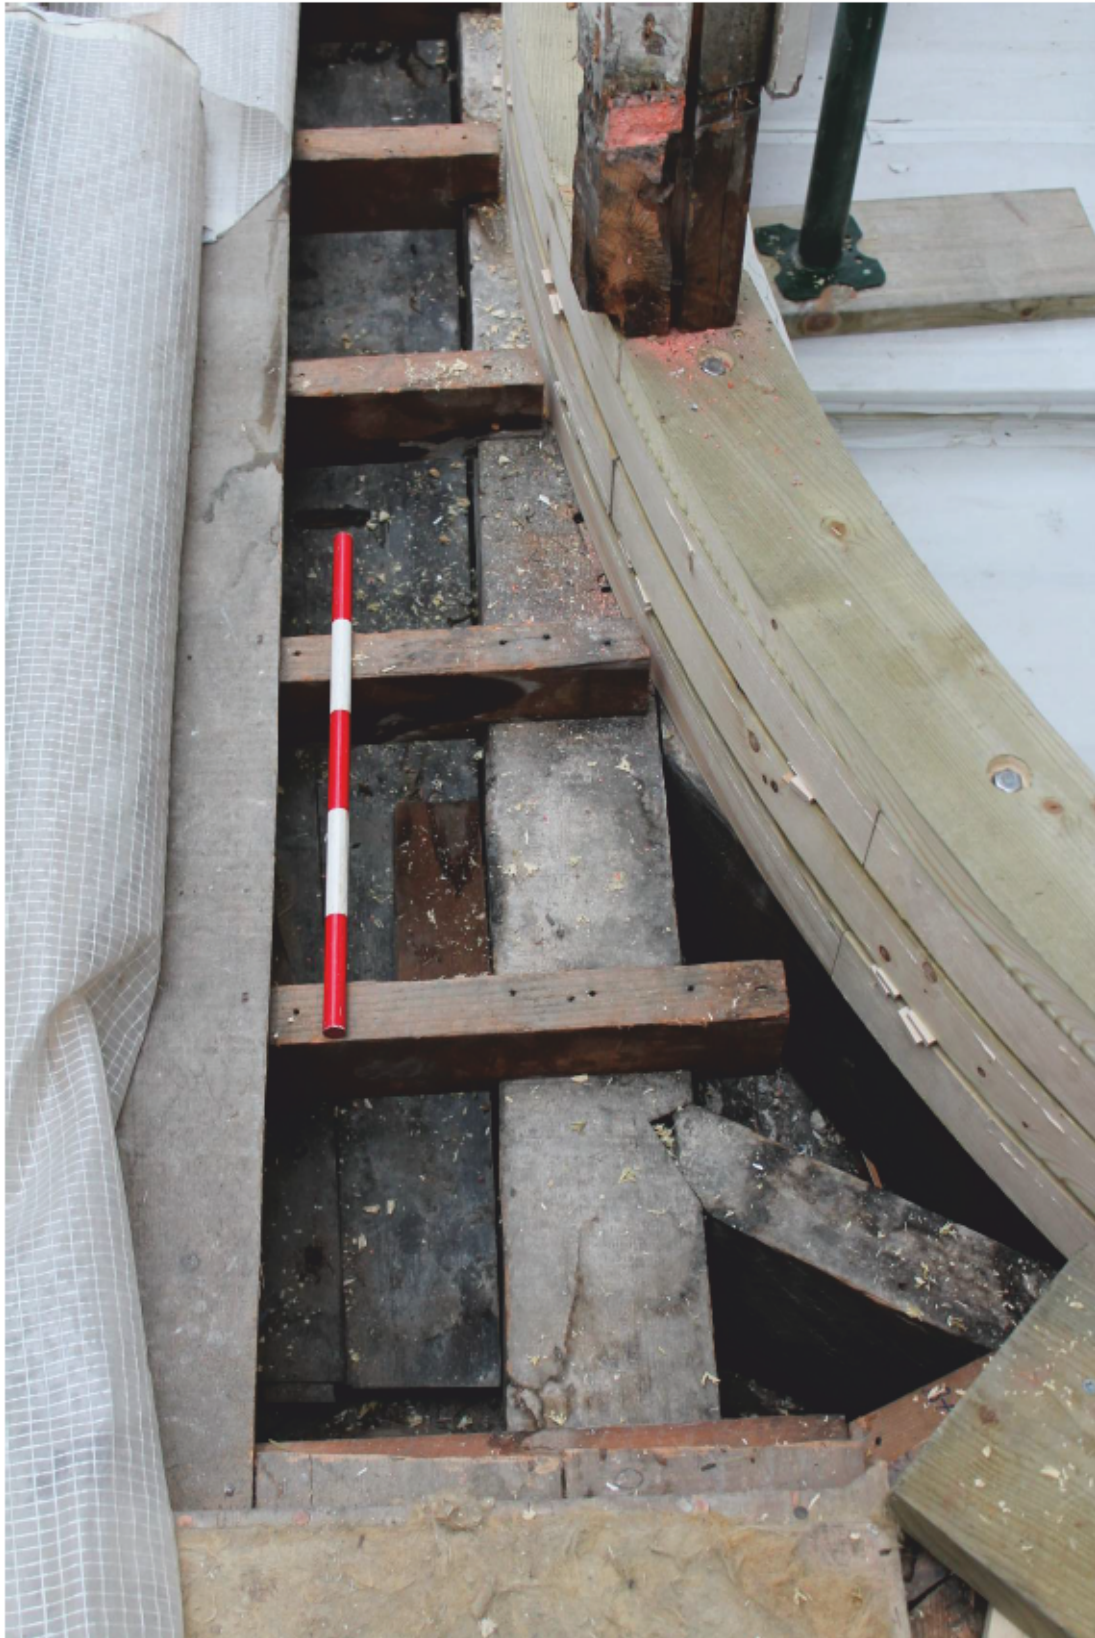
Plate 92 Lantern A: Sub-structure looking east

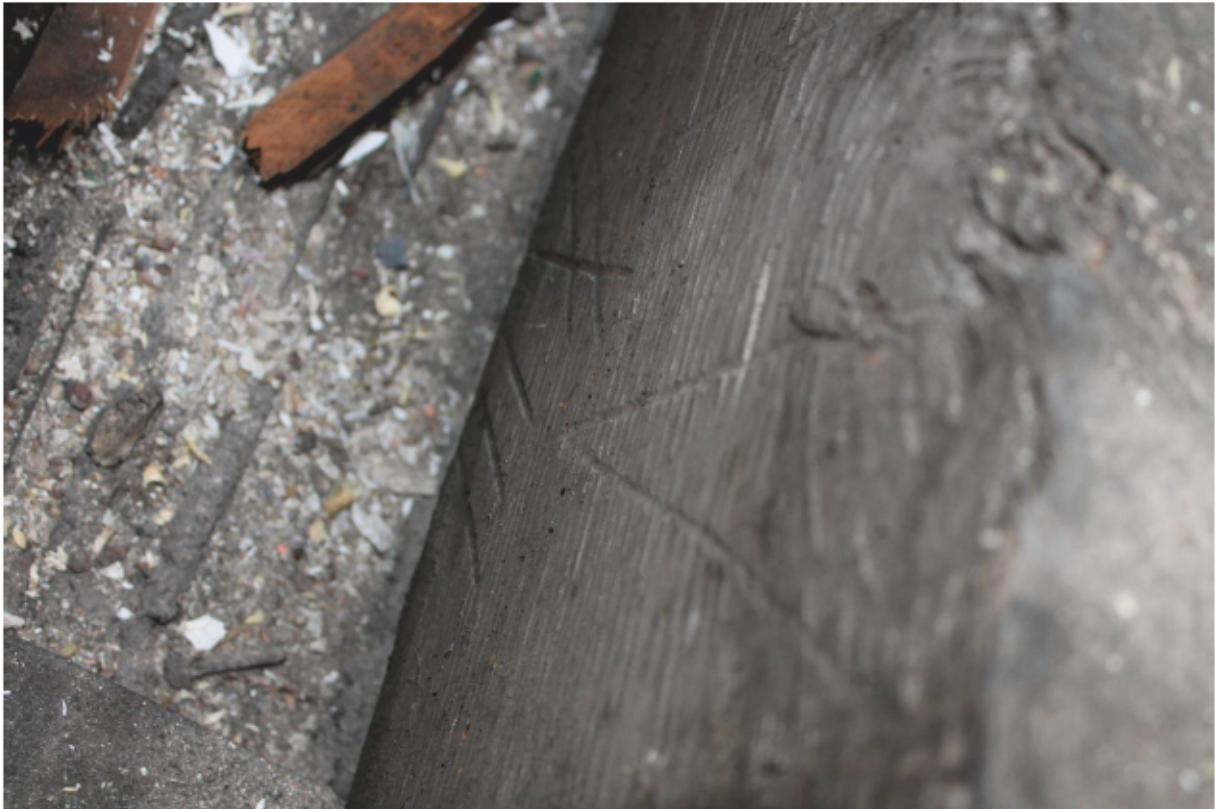
Plate 93 Lantern A: Scribed Baltic marks

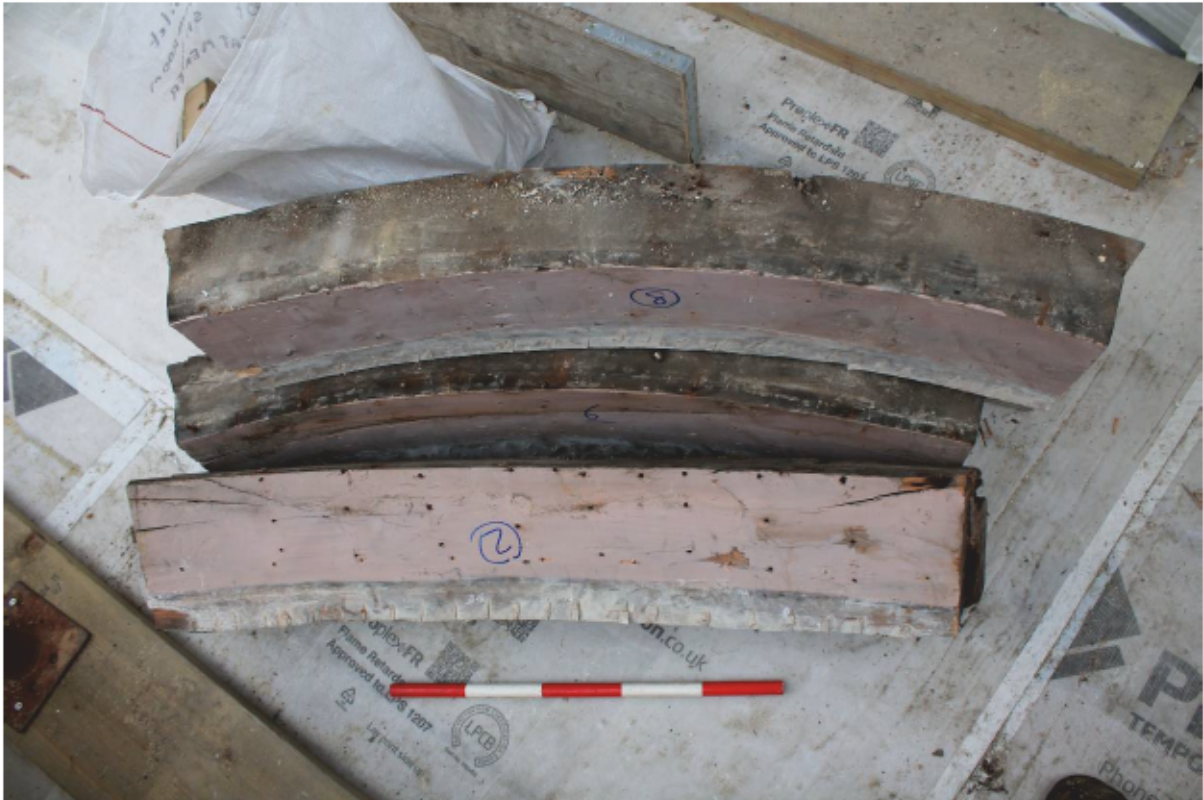
- 5.17.5 Each pair of mullions, as described above, retained individual sections of curving sill (to the casements), nailed into the base of the post (Plate 99). Therefore, eight mullions and eight intermediate sill sections. No evidence of carpentry joints fixing the sills to the posts were observed, and they were simply 'pinched' and nailed into the posts. The mullions were slightly chamfered to the outside (close to the line of the glazing) and incorporated a vertical rebate cut into the window facing side to locate the side rails or jambs of the casement windows. This rail was plain externally, using a bead edging against the mullion, and a more intricate ovolo detail to the interior. The bottom rail to the casement was also formed from a separate section, overlying the heavy sill and located within a notch cut into the base of the side rails.

Plate 99 Lantern B: Original sill sections

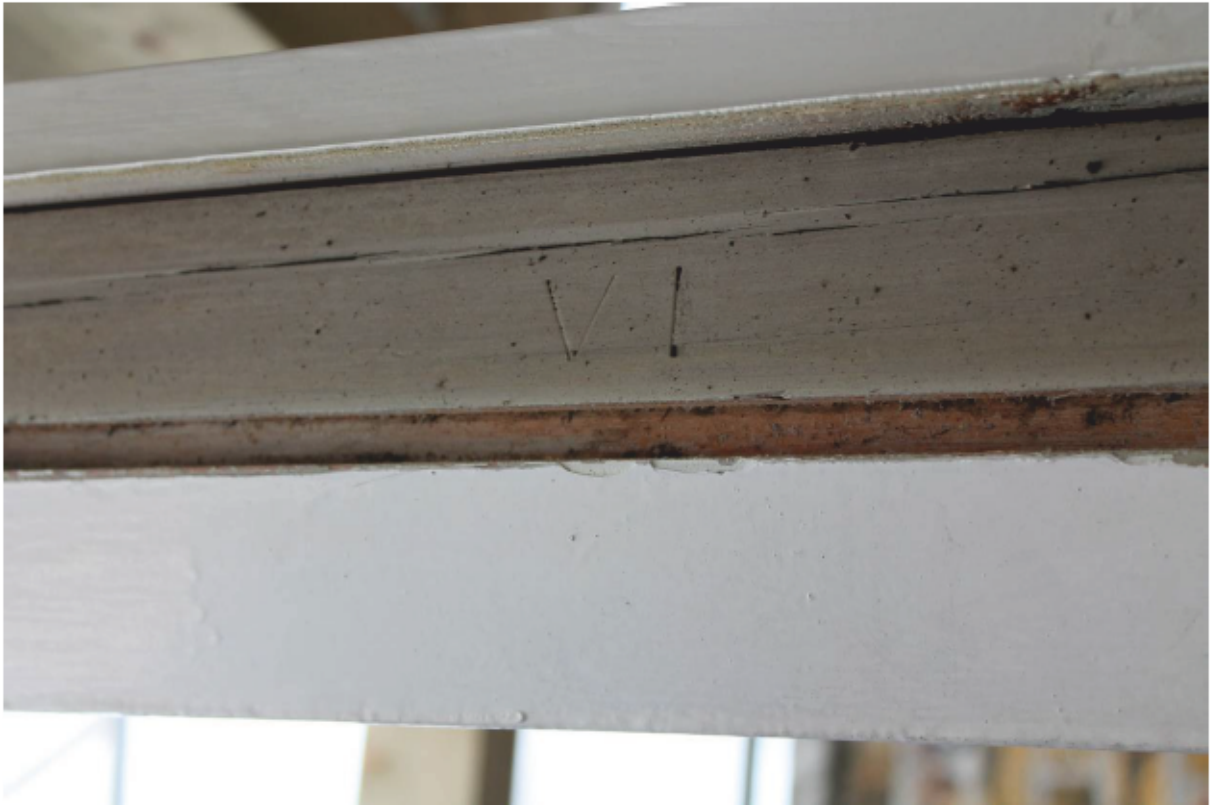
- 5.19.1 Two sets of carpenters marks, in the form of chiselled or scribed Roman numerals, were revealed during the conservation works. These were observed, in two different locations, marked onto the inner face (**Plates 101 and 102**) or alternatively the foot of the mullion posts of lanterns A and B (**Plates 103 and 104**). The former (mid-post) was seen following the removal (for repair) of each complete window casement, rebated into the flanking mullions and the latter (formerly hidden below the flat roof) seen when the lanterns were raised. The numerical sequence ranged from I-VIII (1-8) equivalent to the number of posts, although the numbering was by no means consistent.

- 5.19.2 The numerical markings on Lantern A were located either mid-height of the post (**Plate 101**) or at the foot (**Plate 103**). The former was consistently seen on the right-hand inner face of each mullion post, starting as (I) on the western post north side, progressing in a clockwise direction (II), (III) etc, to the east. This numerical sequence was consistent apart from the post that should have been scribed (VII), which was unmarked. The Roman marking to the foot of the posts did not coincide numerically or characteristically with that described above, being chiselled marks which commenced (as I) on the eastern post, south side (a mirror image of the casement markings). Again the sequence progressed in a clockwise direction, although inexplicably the post between (III) and (V) was marked (VII), while the post which should have been (VII) was unmarked. Possibly this post (VII) was relocated during the construction of the lantern structure. The base of the post to (VIII) was replaced (as part of these conservation works) using Sapele hardwood, scarfed into the mullion foot.

Plate 101 Lantern A: Roman marking to mullion (mid-post)

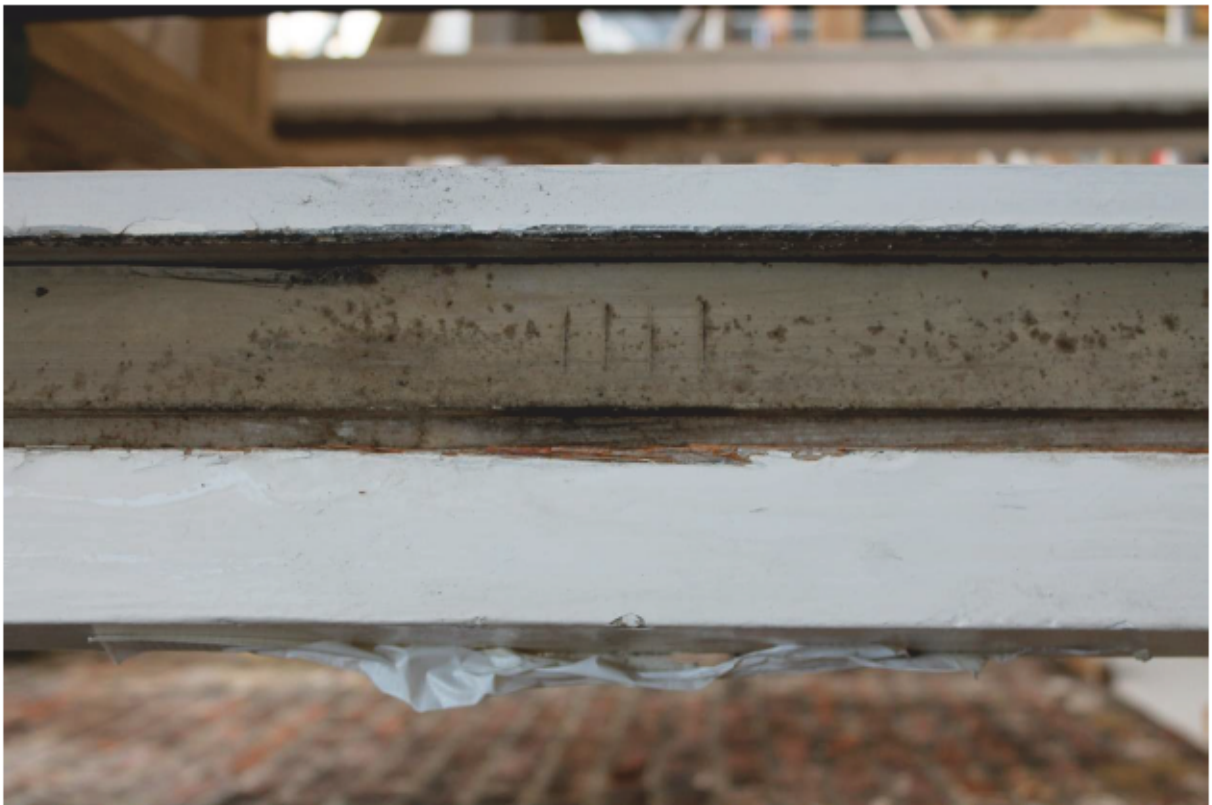
- 5.19.3 The numerical markings on Lantern B also occurred at mid-post (**Plate 102**) and at the mullion foot (**Plate 104**) and, with regard to the former, in the same right-hand locations. As the first marking (II) occurred on the north post east side, and the numbering progressed clock-wise, logically, the eastern post, north side, should have been marked (I), although no marking was evident. This was also the case for post which should have been marked (VI). Interestingly posts seven and eight were mirror marked with seven (IV) and eight

Plate 102 Lantern B: Roman marking to mullion (mid post)

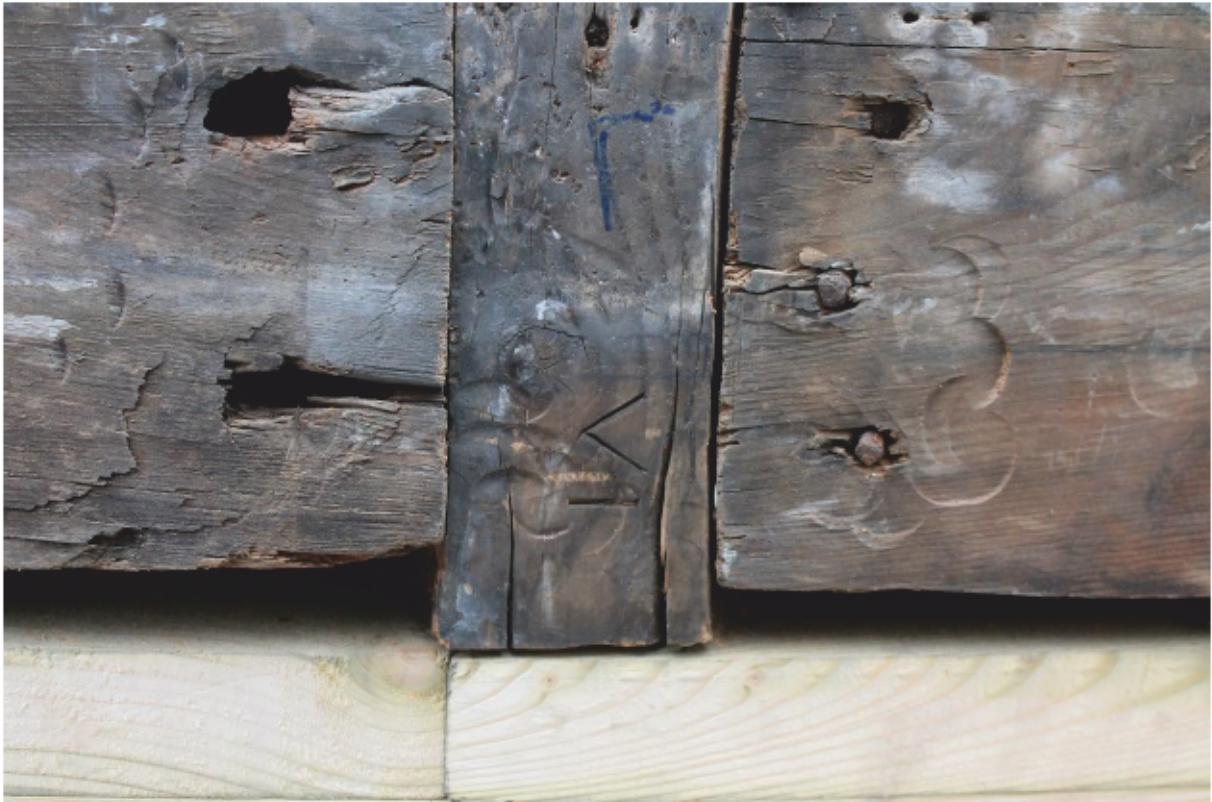
Plate 103 Lantern A: Roman marking to mullion foot
