BENTHALL HALL FARM

Benthall, Broseley, Shropshire

Historic Building Record and Assessment, 2017
(Vernacular Building Survey)

Report Ref.: 2017_001.v2.FINAL

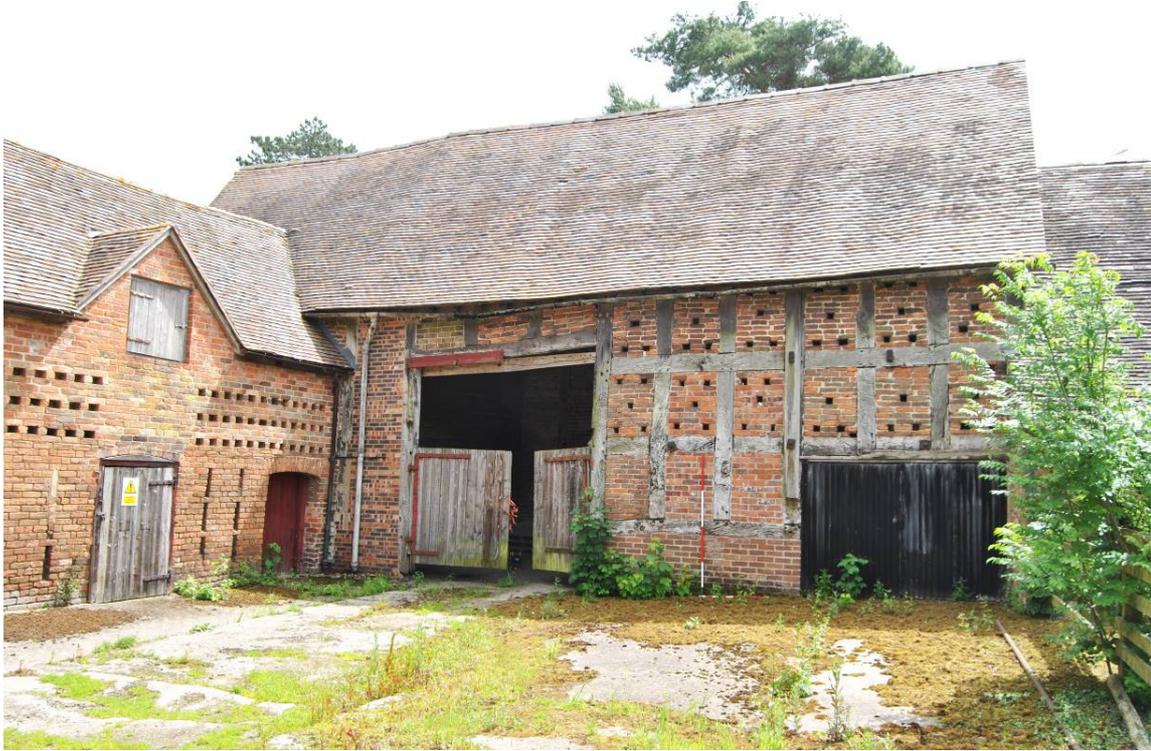
Plate 1: Barn A, general view (oblique) of north (yard) elevation, looking south-east (Bldg. C to left).

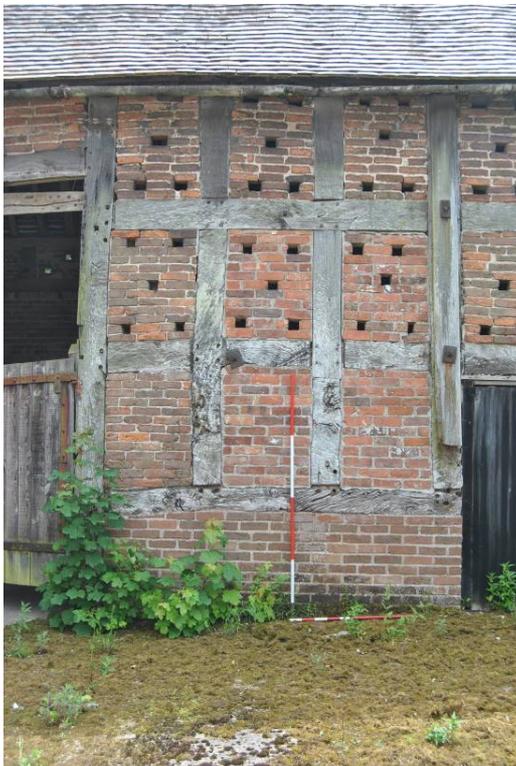
Plate 2: Representative bay of timber-framing atop (under-built) brick plinth (Bay 4, north elevation).

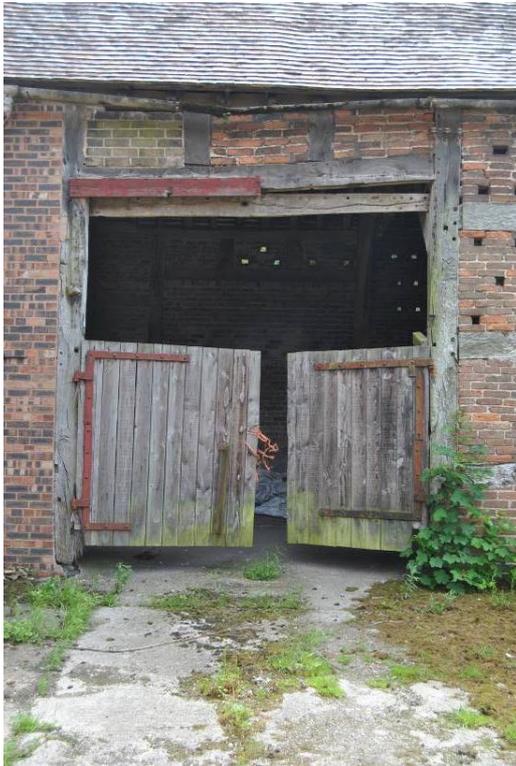
Plate 4: Extant threshing doors to Bay 3 (N).

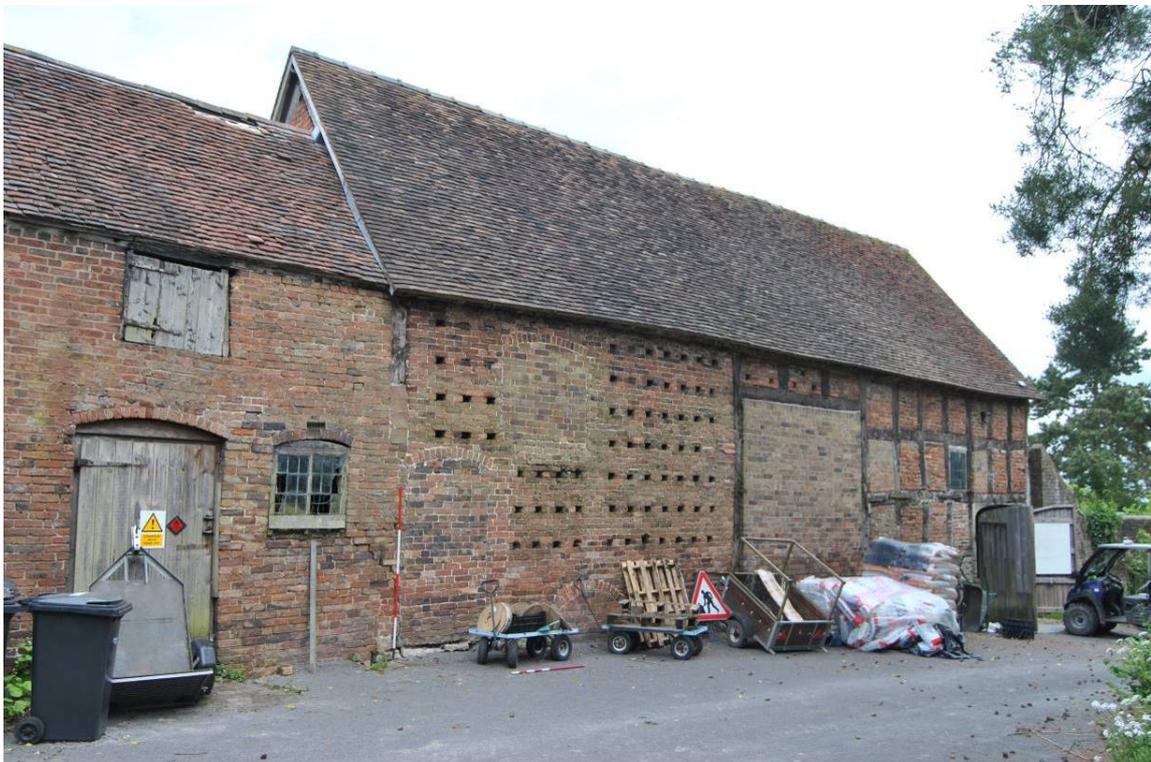
Plate 6: Barn A, general view (oblique) of south elevation, looking north-east (stables F to left).

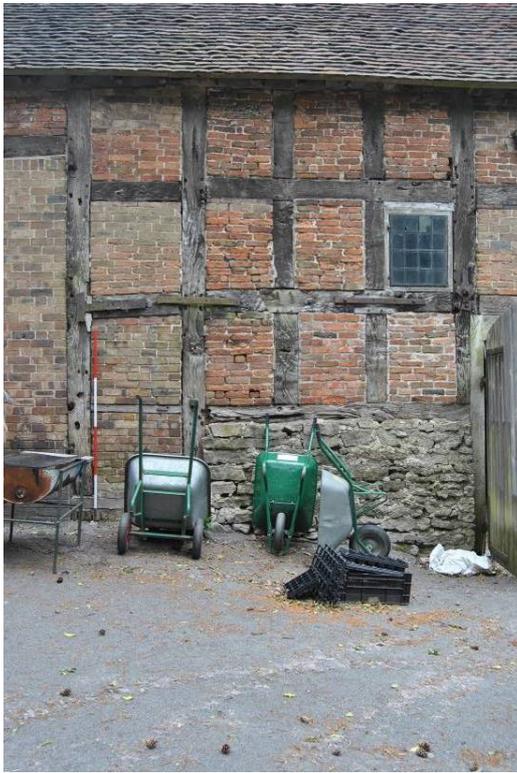
Plate 7: Representative bay of timber-framing atop stone plinth (Bay 2, south elevation).

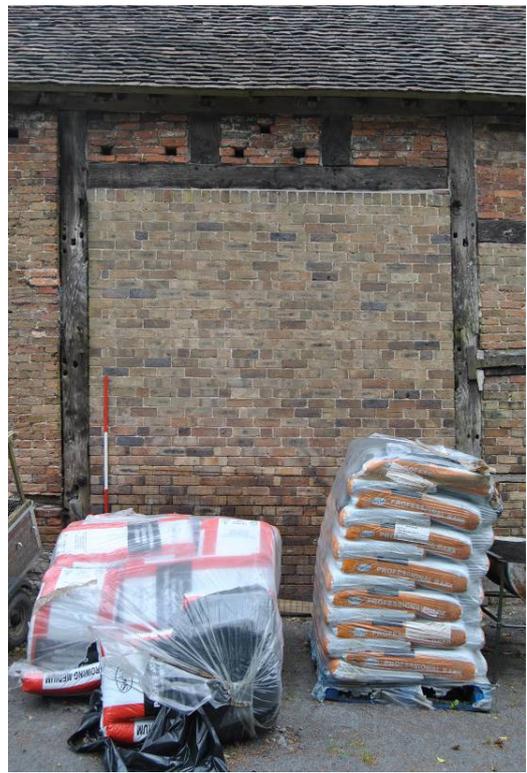
Plate 8: Blocked threshing door to Bay 3 (S).

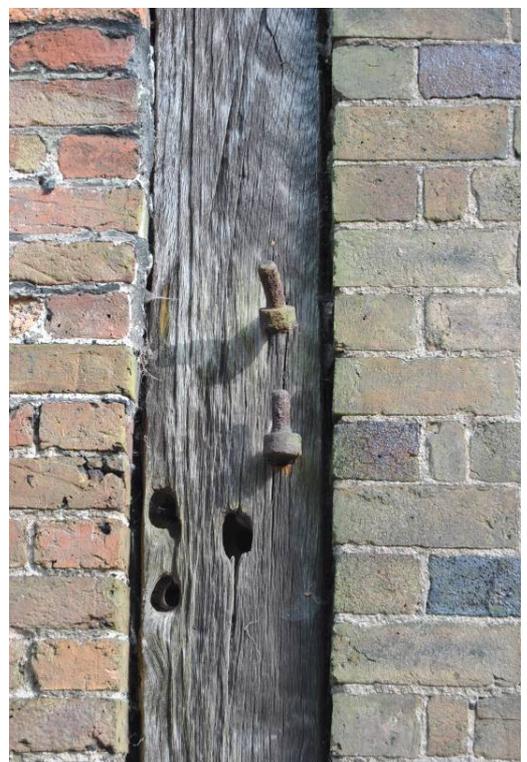
Plate 10: Iron pintles indicating bi-partite doors.

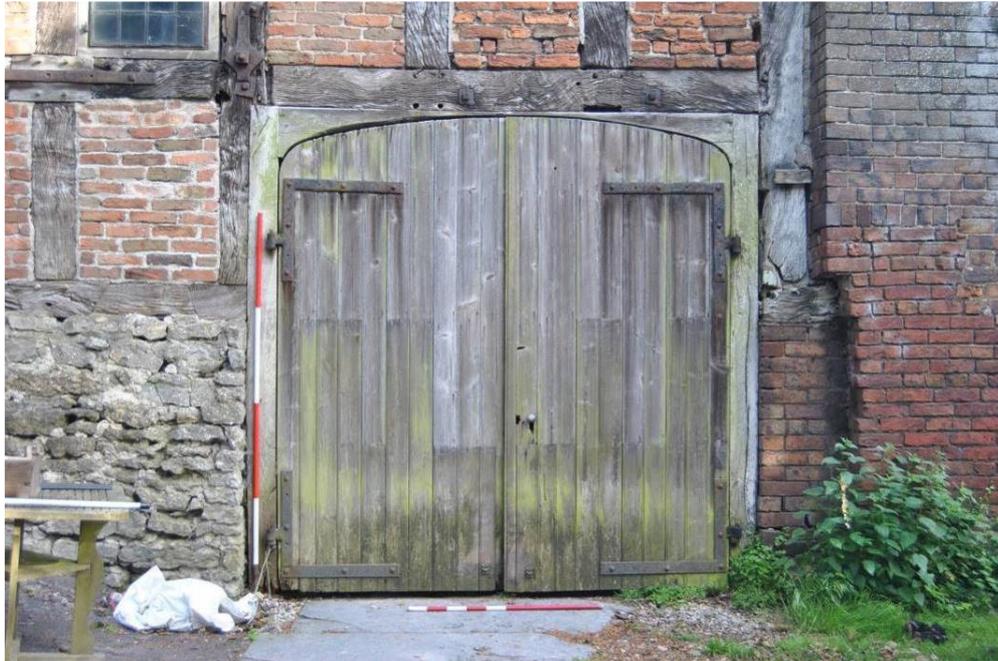
Plate 11: Double doors inserted to Bay 1 of south elevation (?late C19th/early C20th), **NB.** peg holes for former studs to rail.

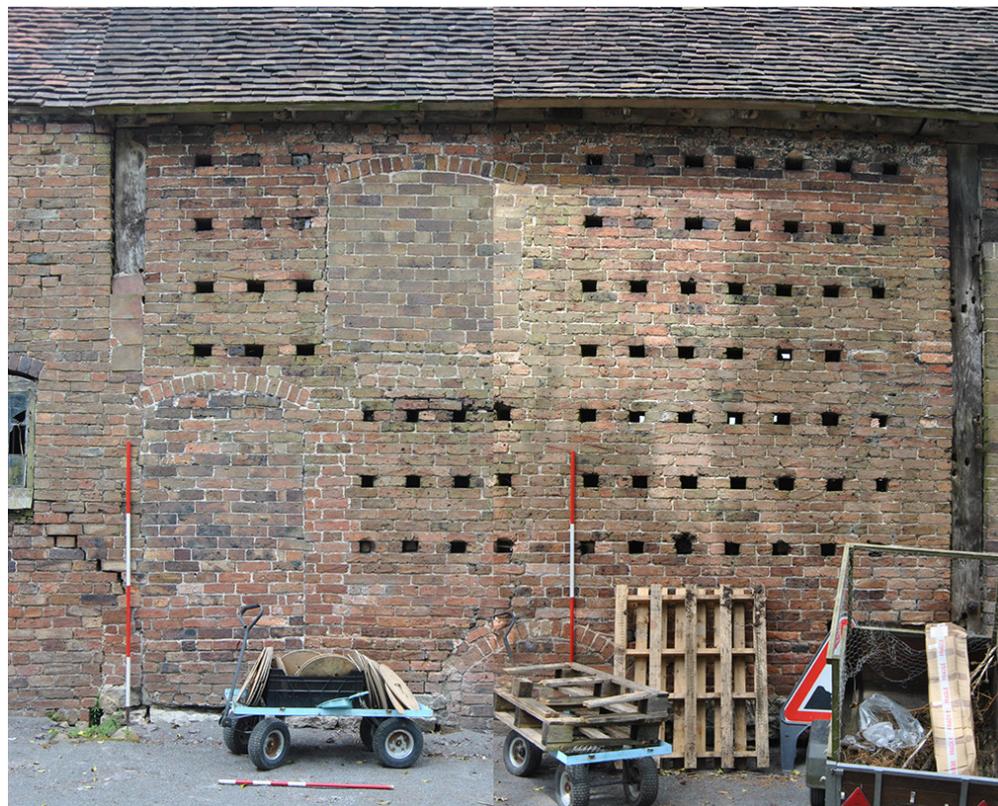
Plate 12: Brick under-build of Bays 4/5 of south elevation, with vent holes, GF door and 1F pitching hatch (both evidently inserted, blocked in C19th); **NB.** tie beam with pegging for studs and recessed primary angle-post to left, partly obscured by tiles.

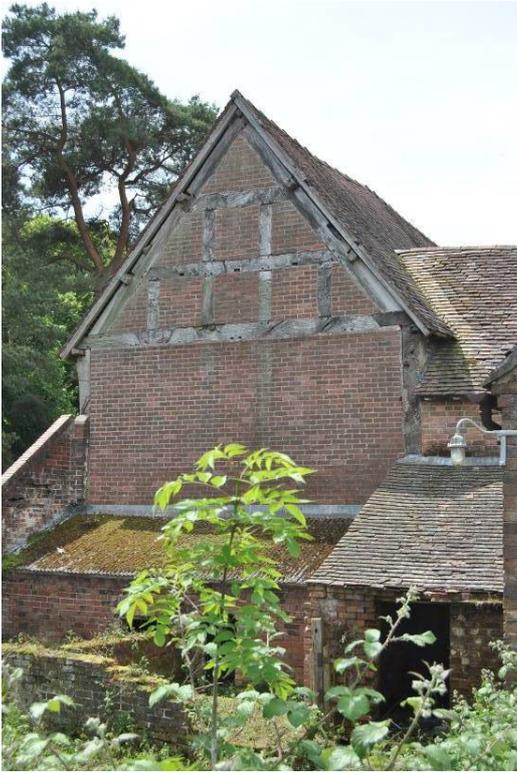
⁵⁵ Pattern of framing survives to west (Plate 13).

Plate 13: Barn A, east gable end, underbuilt beneath tie and with renewed nogging panels above.

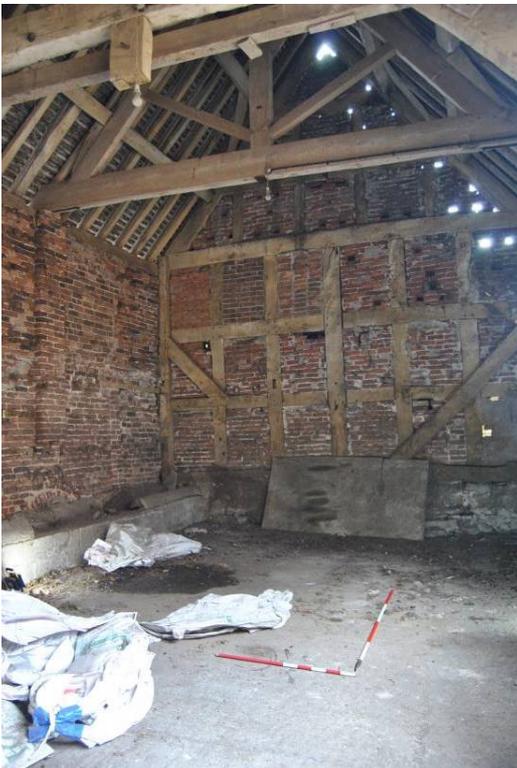
Plate 15: Bays 4/5 looking south-west.

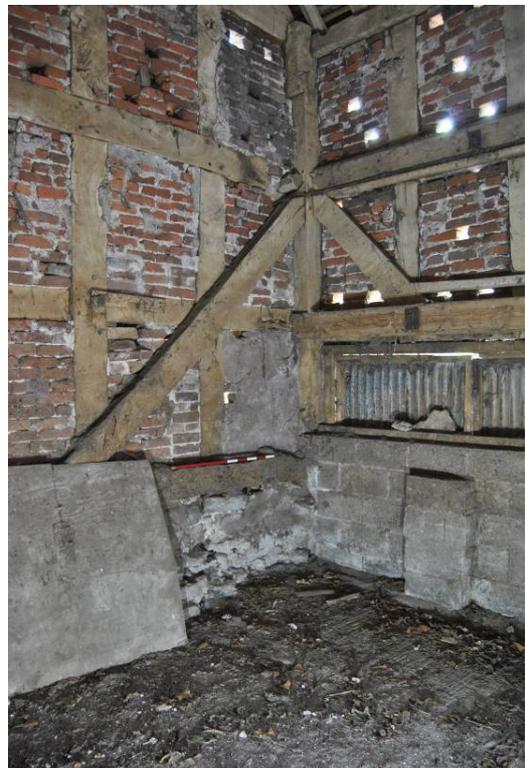
Plate 16: Detail of passing braces at NW angle (Bay 5).

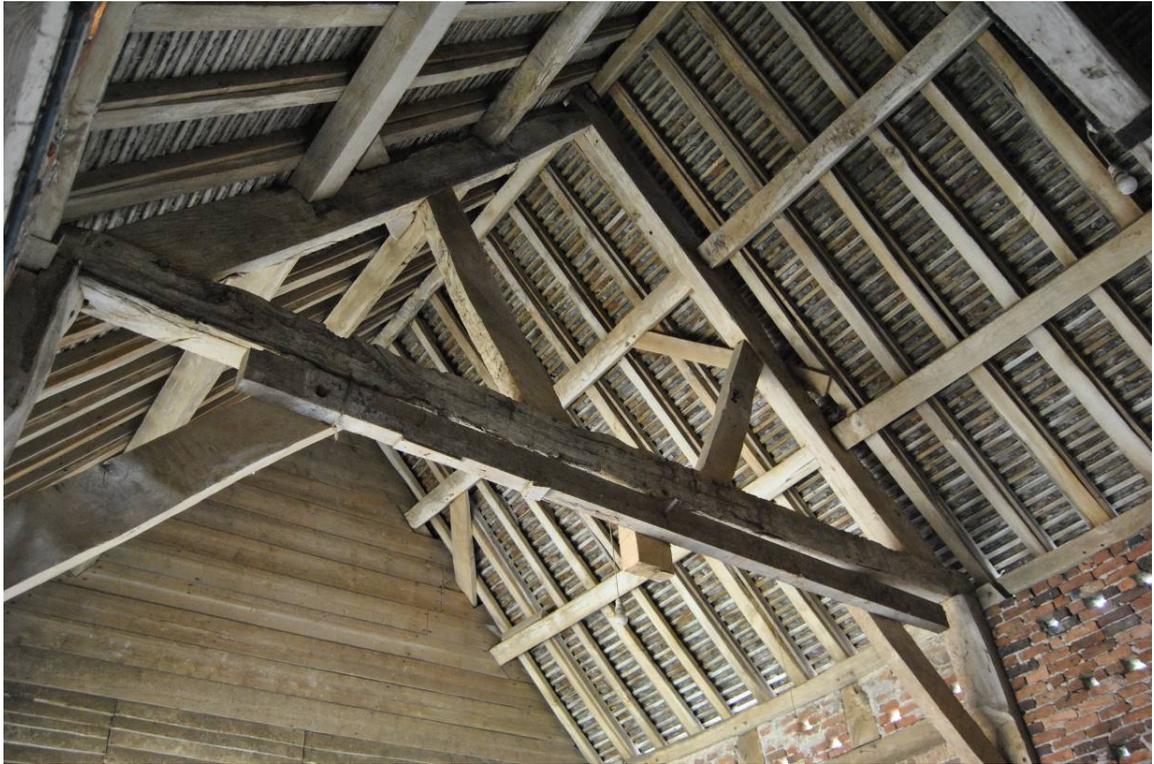
Plate 17: Primary truss **T4** with raking struts, note cut-off central, vertical stud beneath tie-beam.

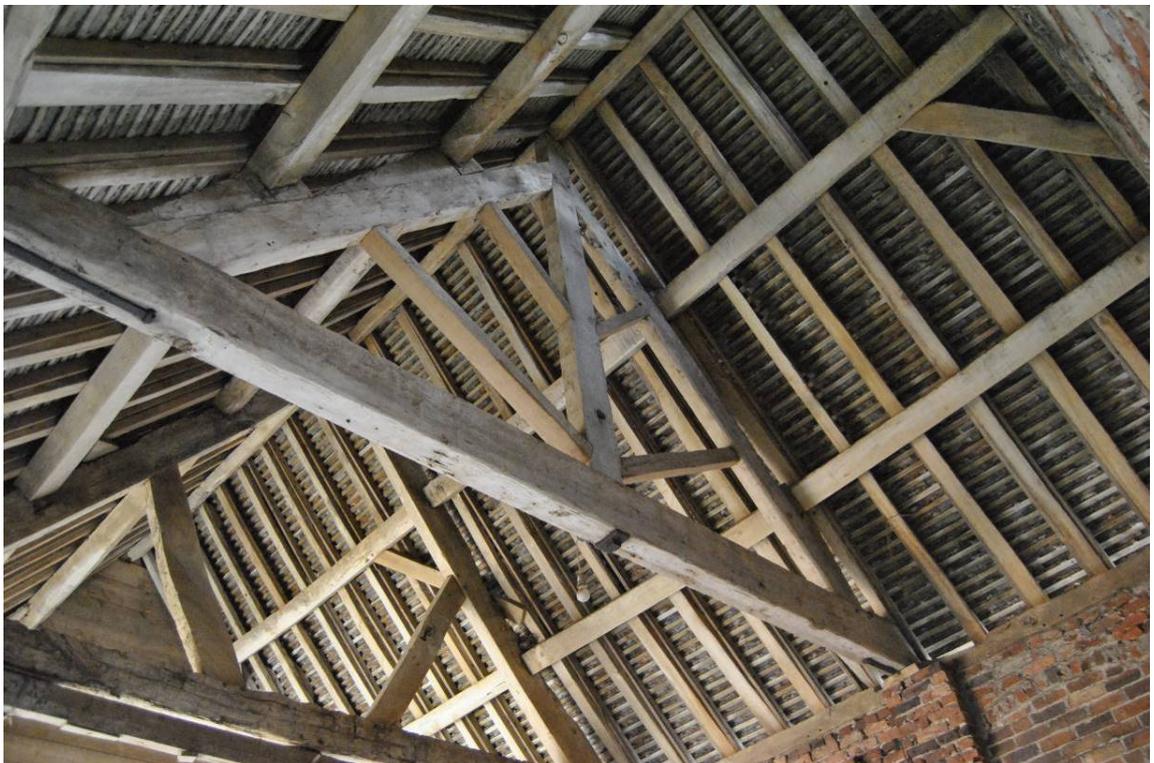
Plate 18: Secondary king-post truss **T5**.

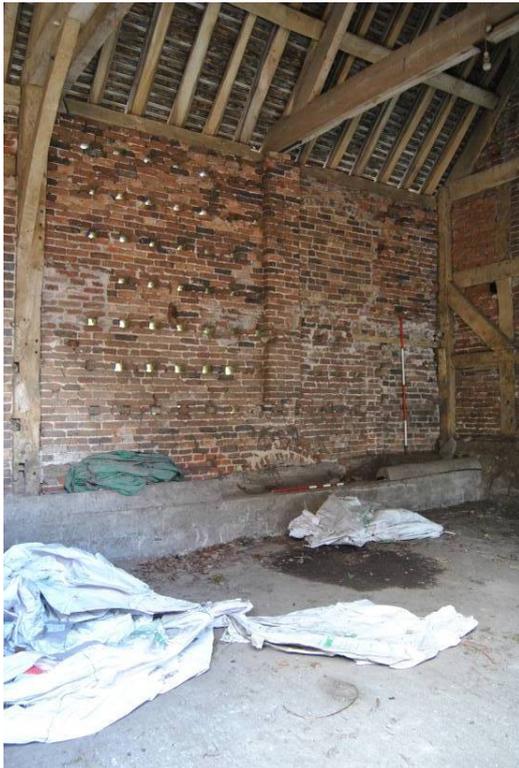
Plate 19: Secondary brickwork to Bays 4/5 (S); note inserted feed trough.

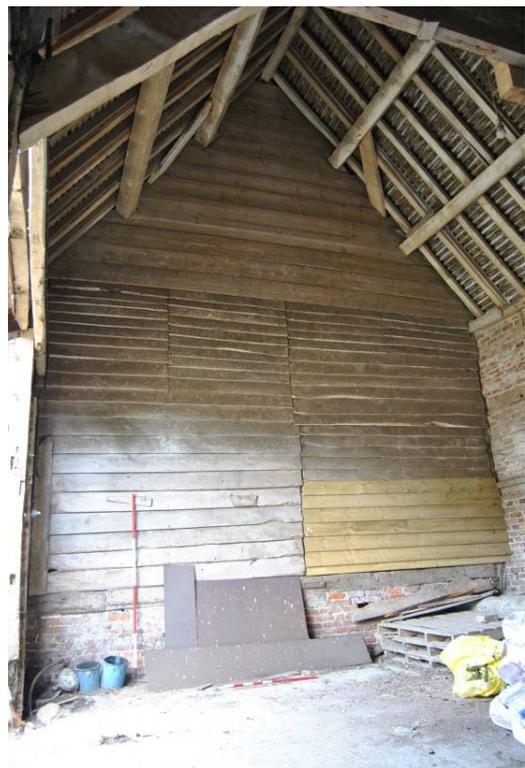
Plate 20: Secondary weatherboarding partition at T3 to east side of threshing bay (Bay 3).

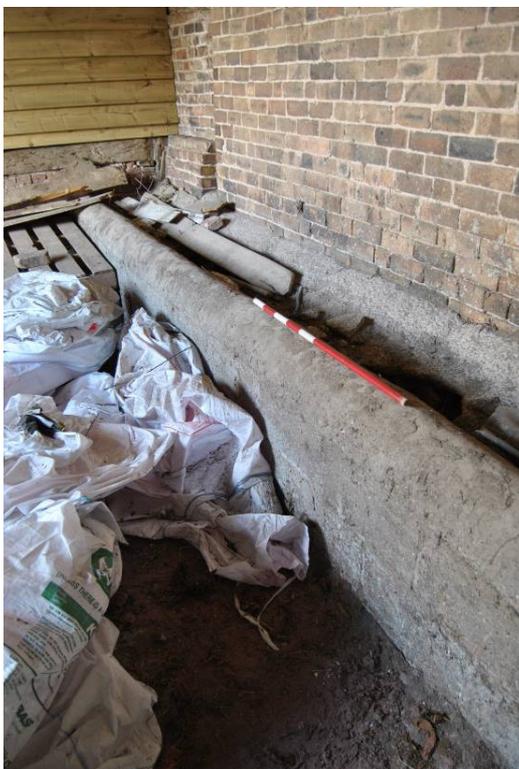
Plate 21: Inserted feed-trough to south wall.

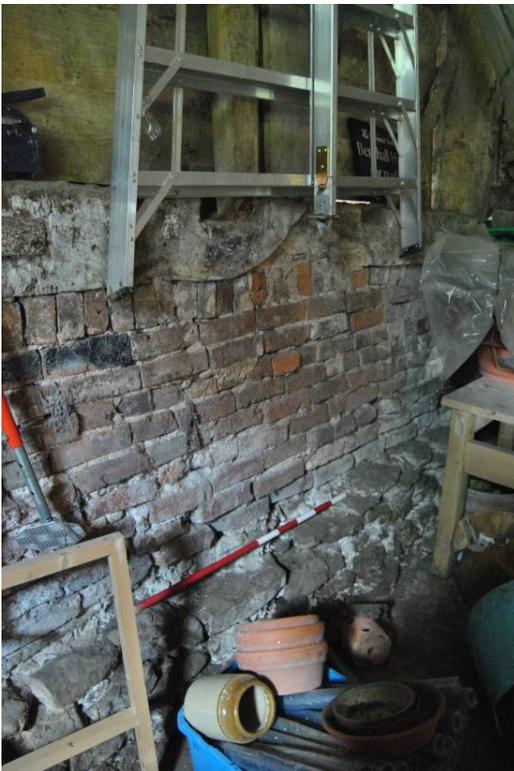
Plate 25: Low stone and brick transverse wall at Bay 2/3.

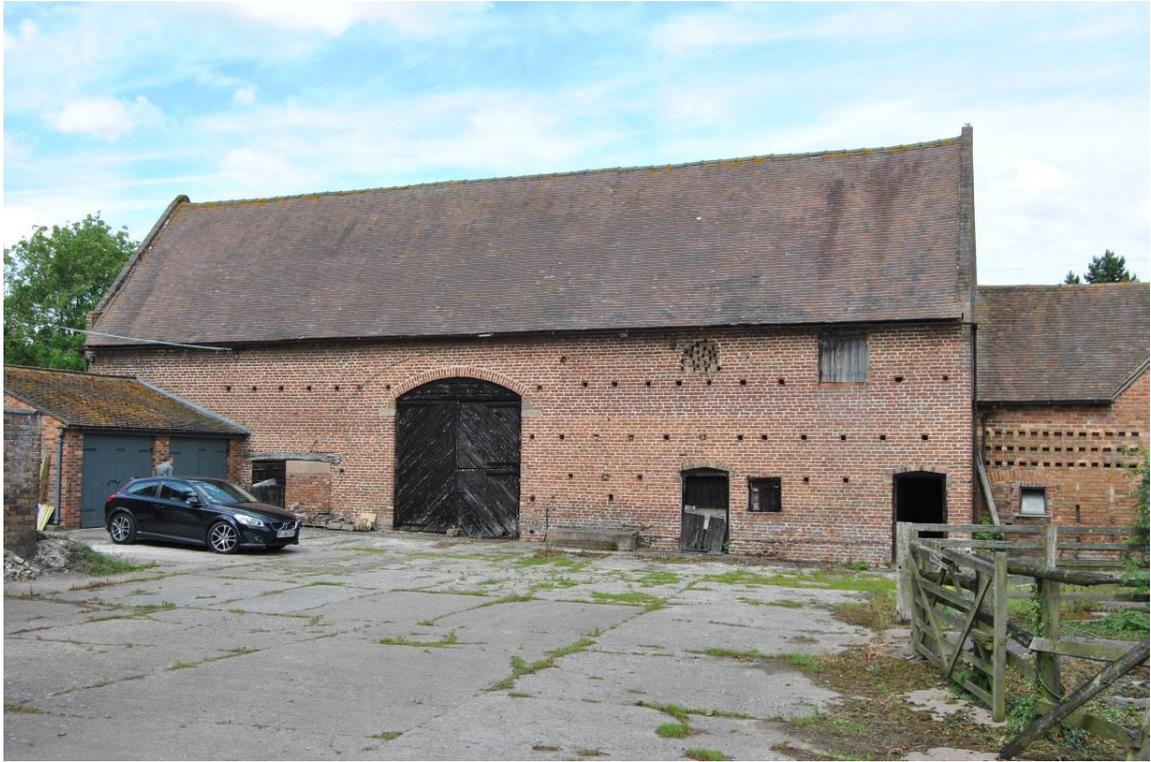
Plate 27: Barn B, west elevation looking east.

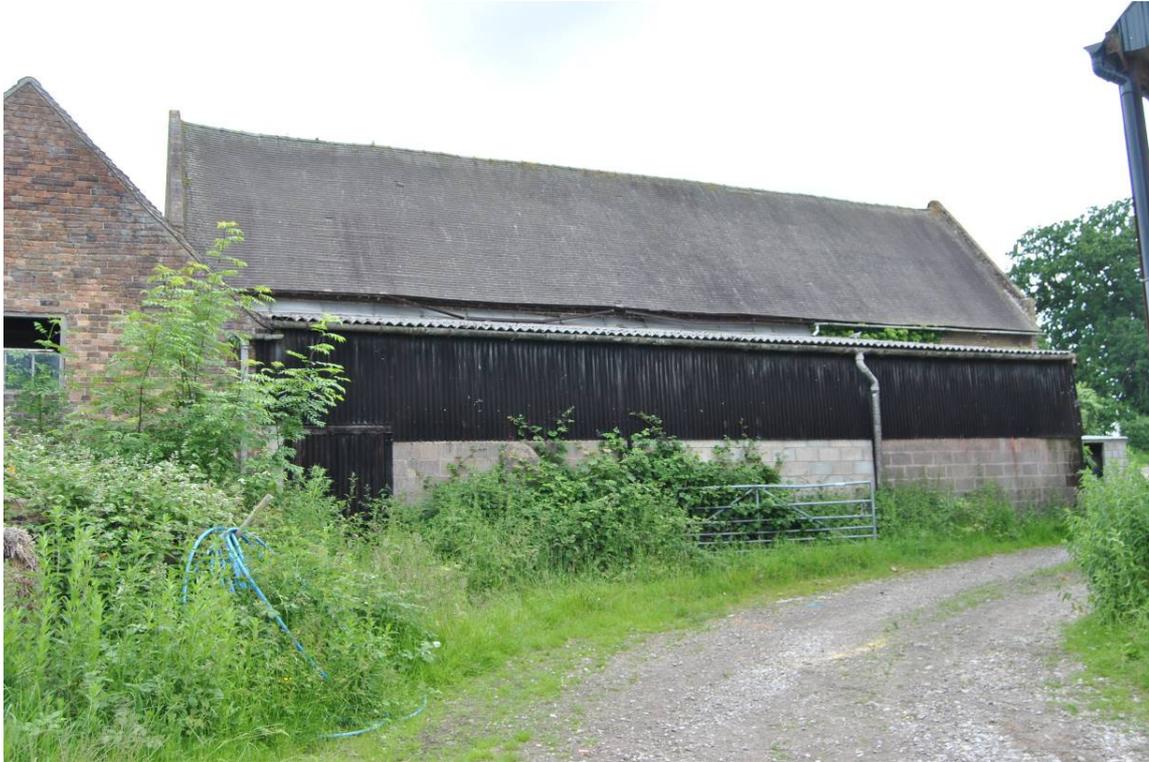
Plate 29: Barn B, west elevation, mainly obscured by lean-to shed M.

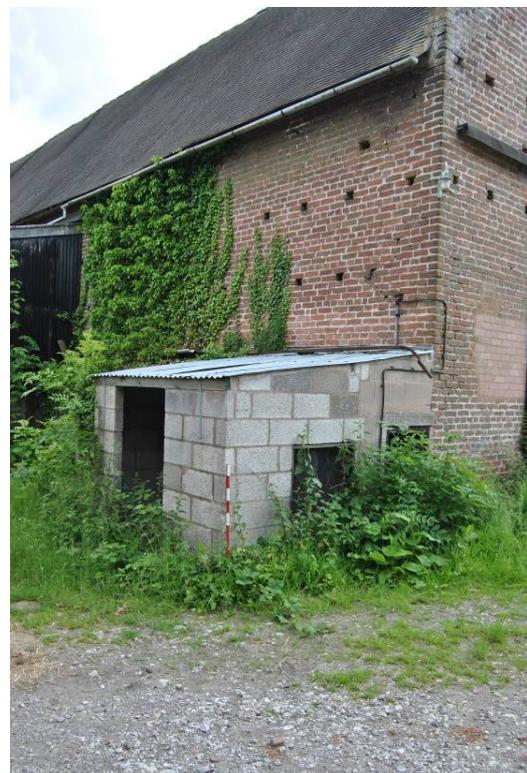
Plate 31: Barn B, west elevation (N end) with small breeze-block shelter for grain dryer plant.

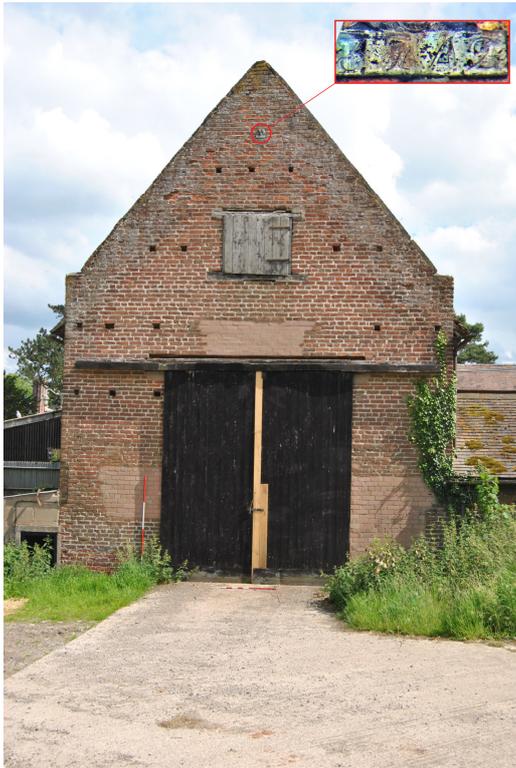
Plate 32: Barn B, north gable end with detail of SFO firemark.

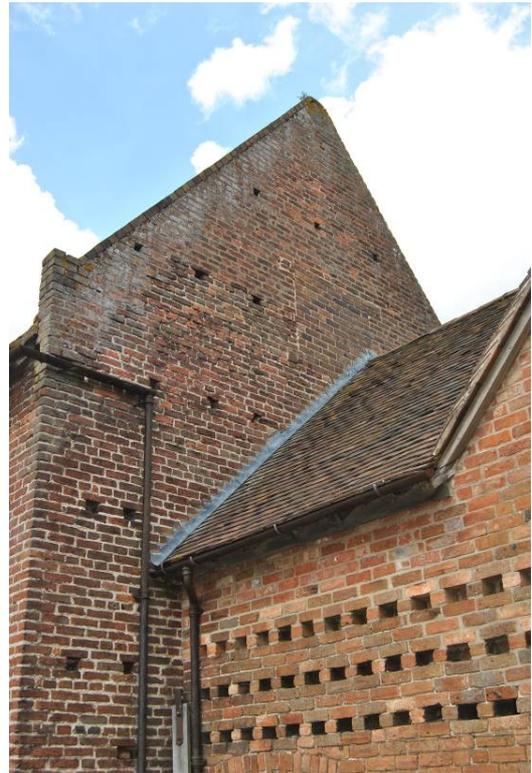
Plate 33: Barn B, south gable end above Bldg. C.

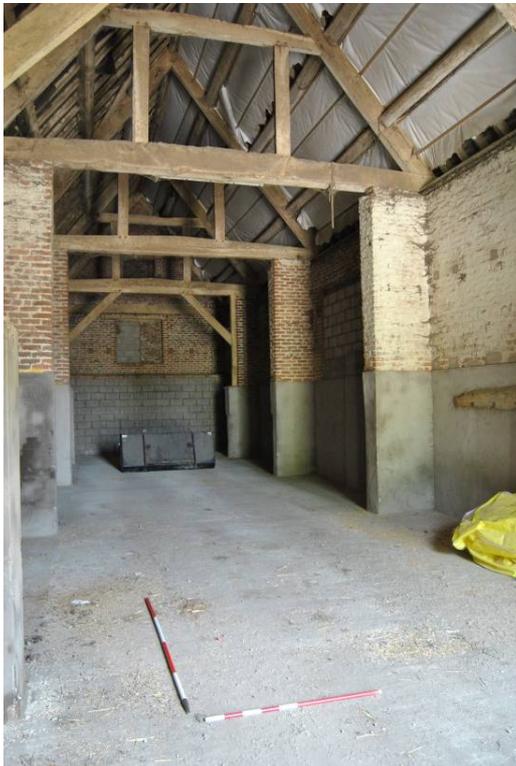
Plate 34: Barn B, interior looking south. NB. rendering of lower walls.

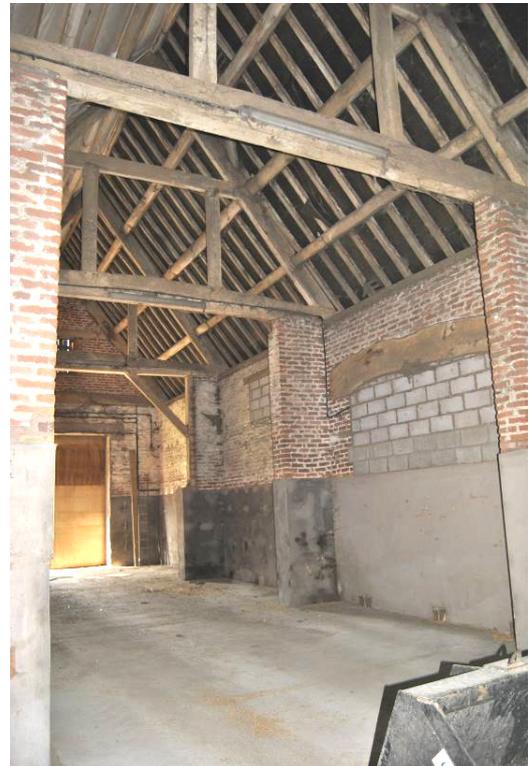
Plate 35: Barn B, interior looking north.

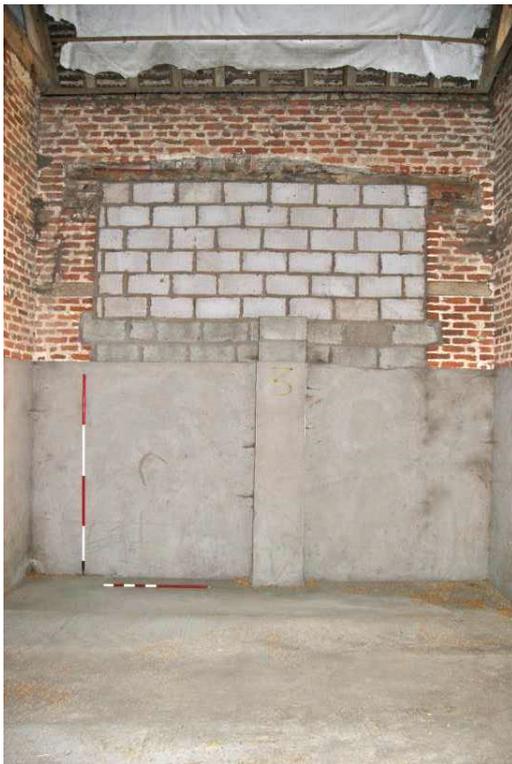
Plate 36: Blocked threshing door (E wall).

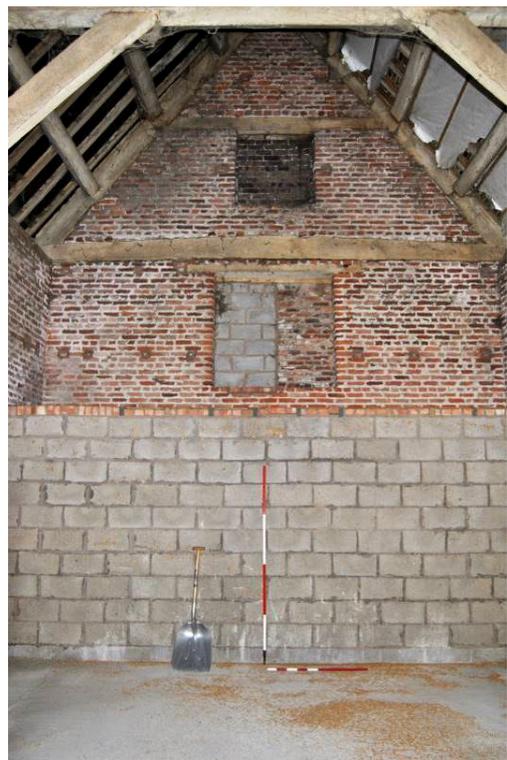
Plate 37: Breeze-block wall forming enclosed passage to south end of barn **NB.** superimposed hatch openings (blocked) to gable end.

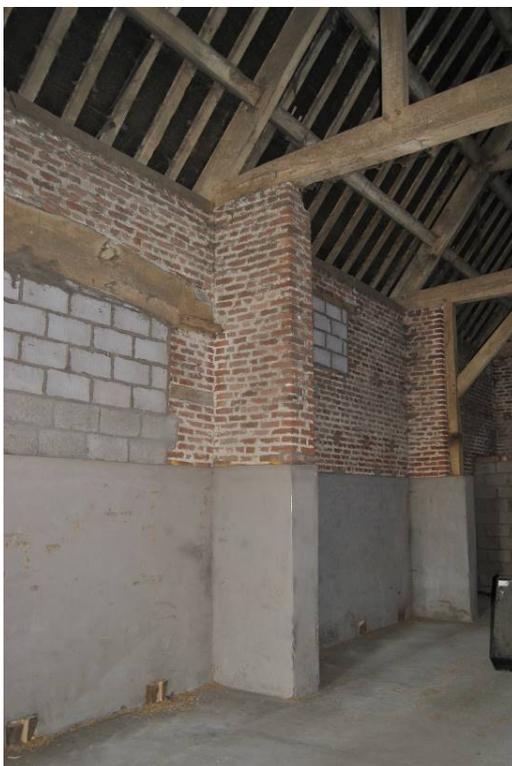
Plate 38: Brick pier at **T3**, west; blocked western threshing door to left.

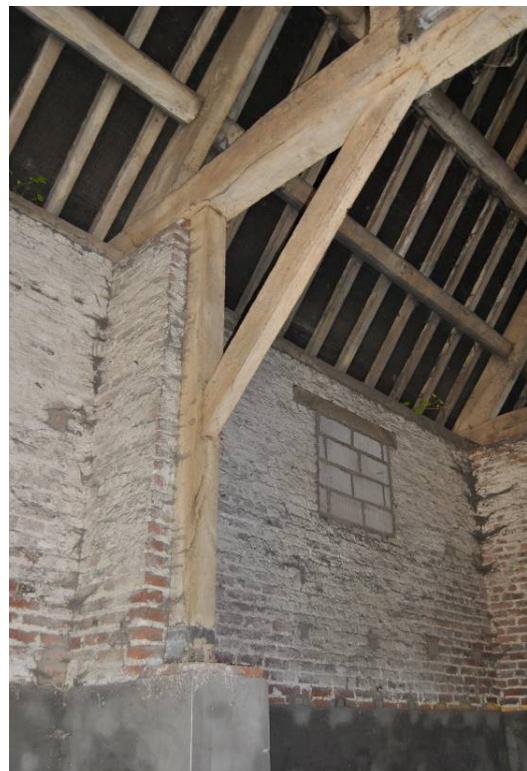
Plate 39: Variant detail with timber strut/up-brace arrangement at **T5**, west. **NB.** infilled joist sockets at level of render.

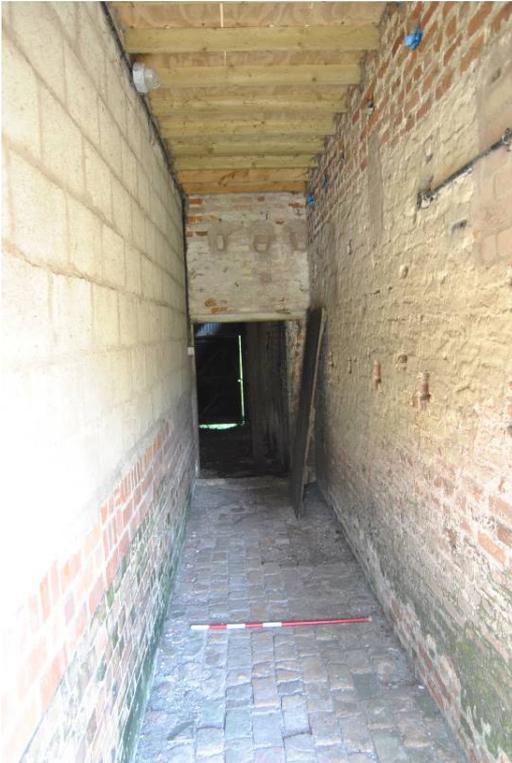
Plate 40: Transverse passage to S end of barn B.

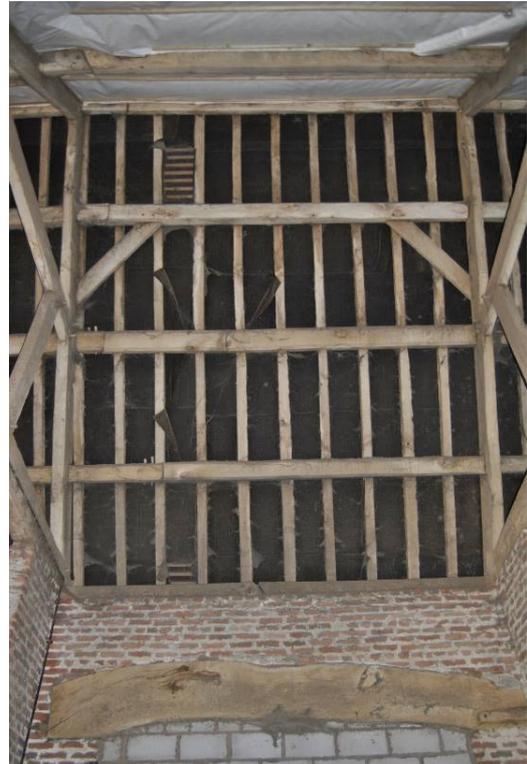
Plate 41: Roof over threshing bay, NB. wind bracing to upper purlin and massive timber lintel to threshing door.

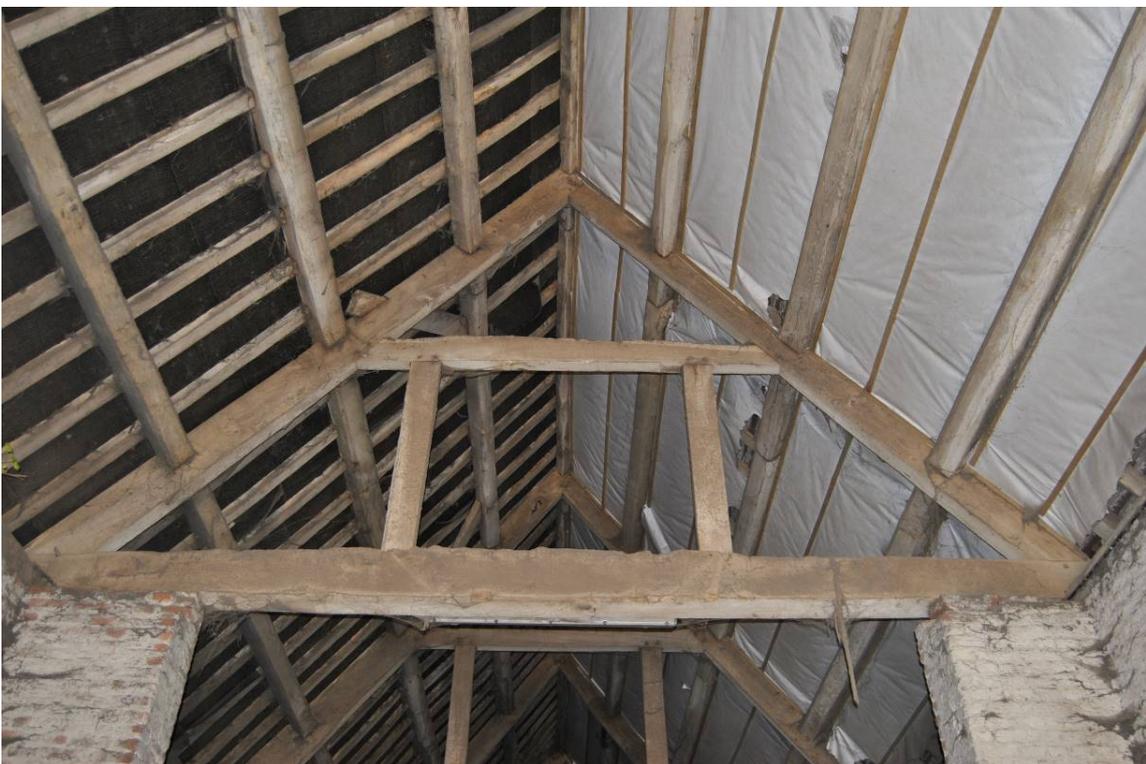
Plate 42: Barn B, queen-strut roof truss T4.

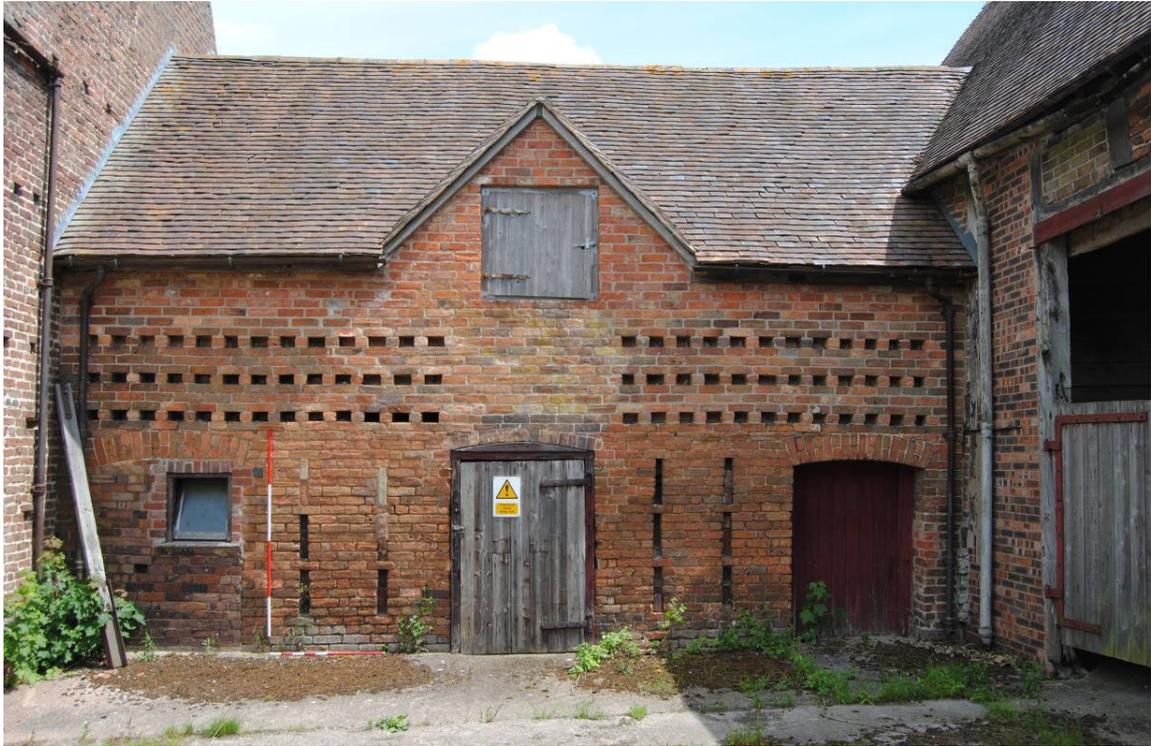
Plate 43: Building C, west elevation to yard, NB. rebuilt upper wall (1990).

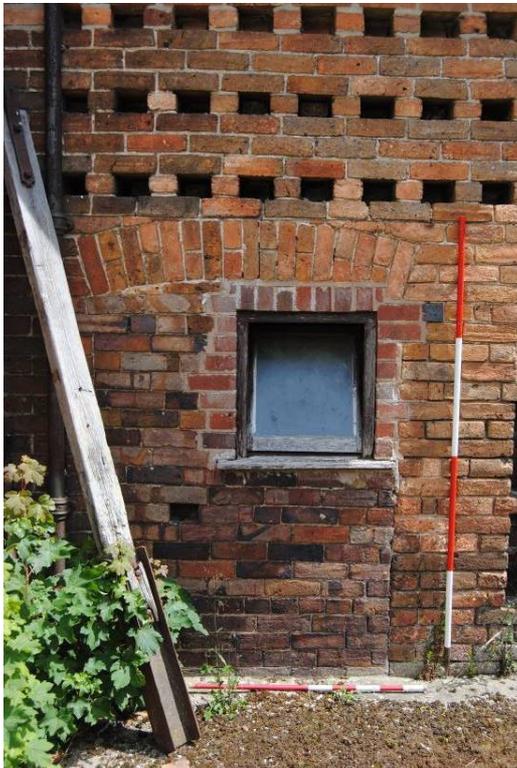
Plate 44: Building C, northern doorway (blocked).

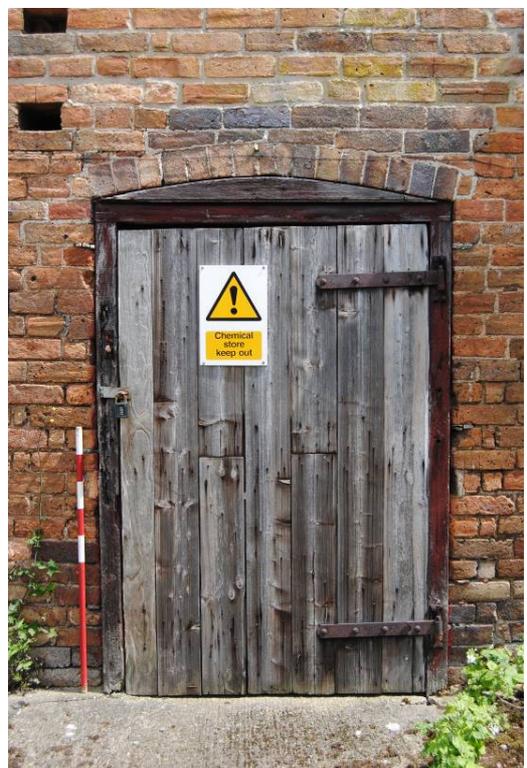
Plate 45: Building C, central doorway with variant head (remodelled).

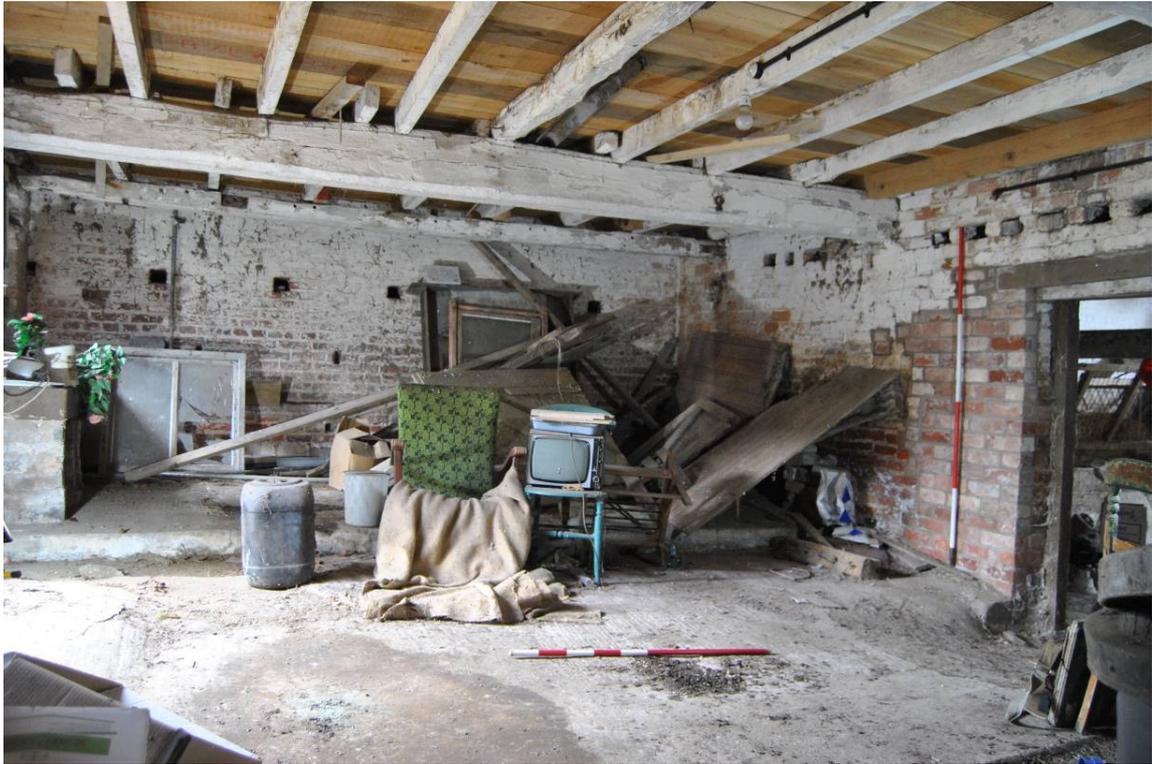
Plate 46: Building C, interior looking north. NB. vent holes of Barn B south gable.

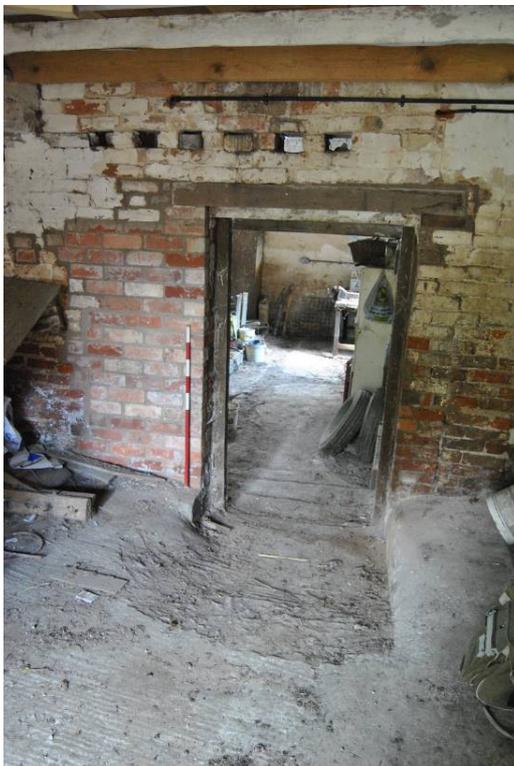
Plate 47: Inserted door leading through to Bldg. I to east.

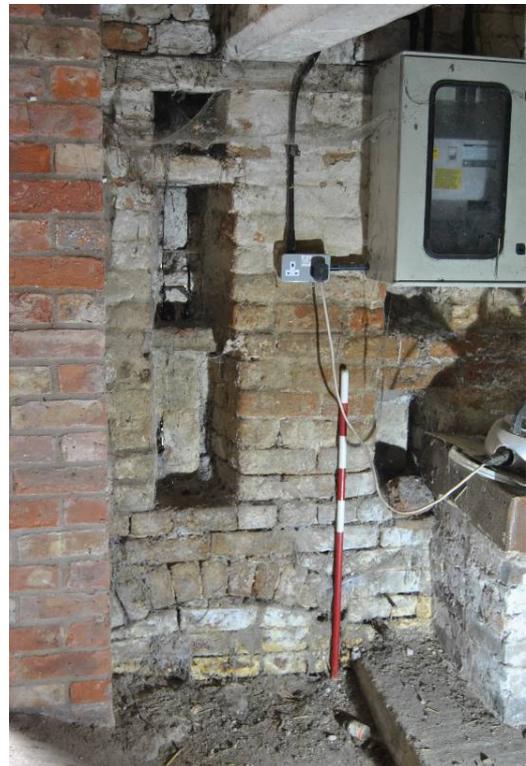
Plate 48: Interior detail of vents, with low-level arch below.

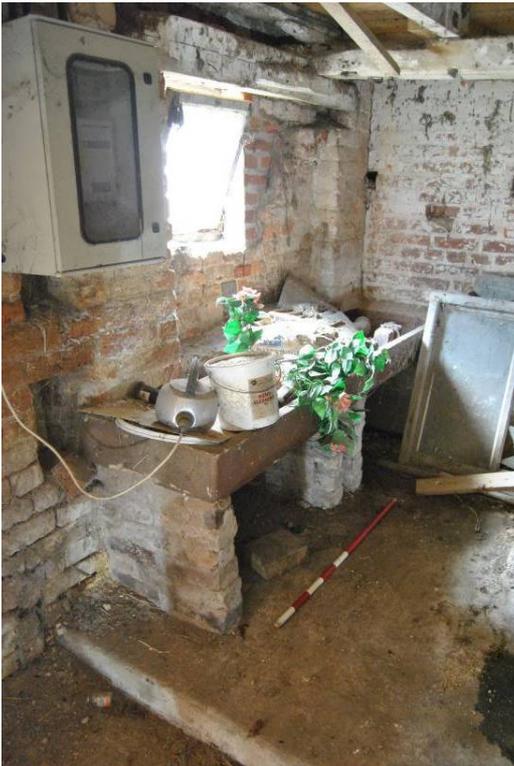
Plate 49: Stone double-sink on brick piers to north-west corner.

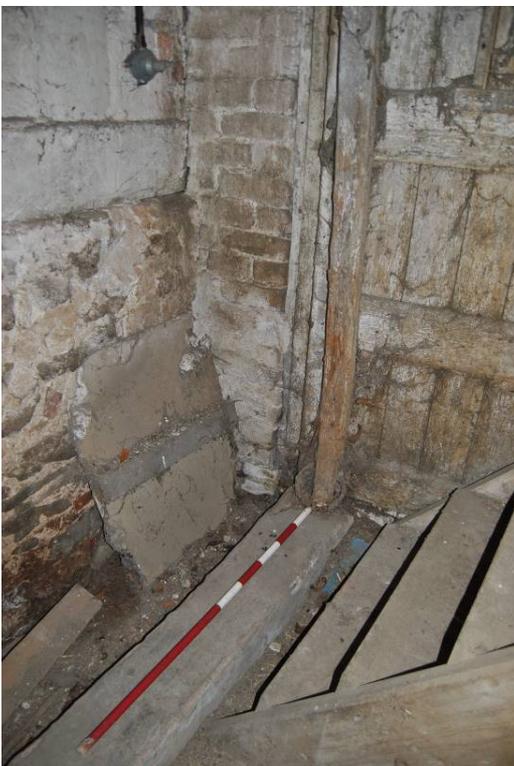
Plate 51: Surviving (secondary) post and tethering ring to south-west corner at base of inserted stair.

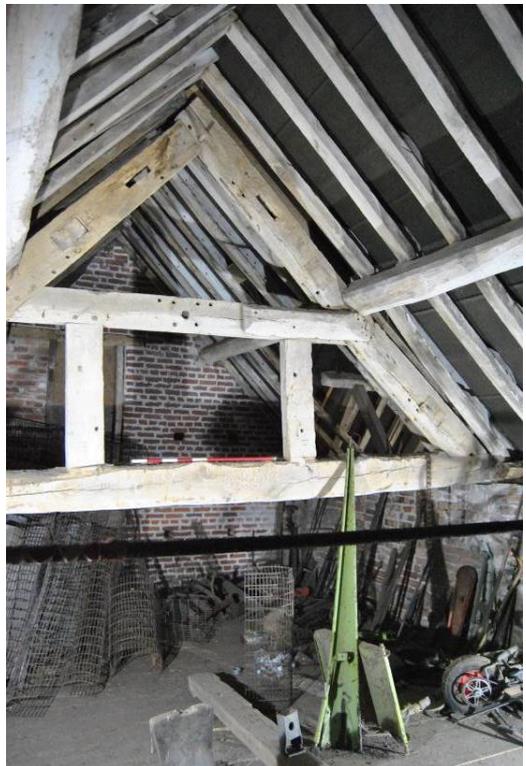
Plate 52: Queen-strut truss to Bldg. C, incorporating much re-used timber.

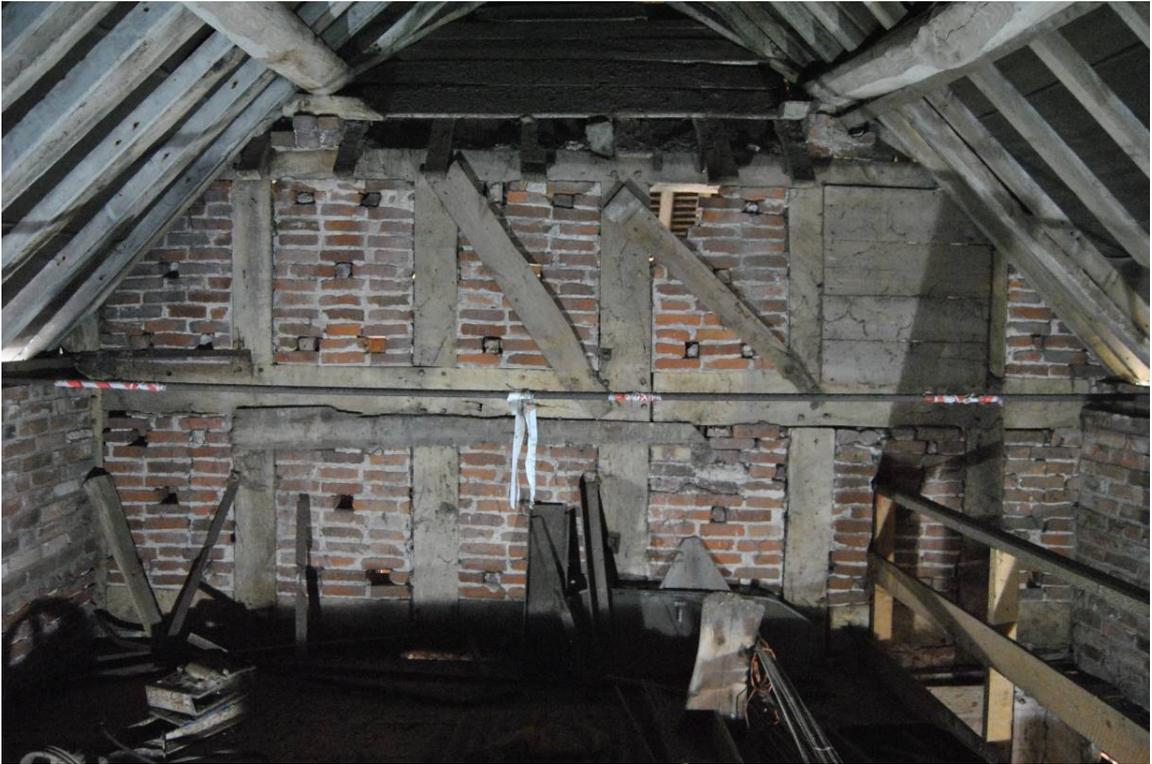
Plate 53: Timber-framing of Barn A (north elevation, Bays 1/2) exposed at loft level of Building C.
