BENTHALL HALL FARM

Benthall, Broseley, Shropshire

Historic Building Record and Assessment, 2017
(Vernacular Building Survey)

Report Ref.: 2017_001.v2.FINAL

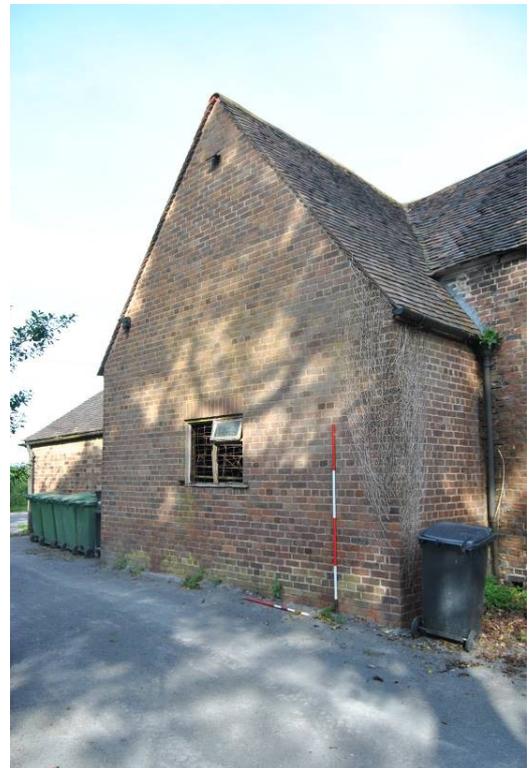
Plate 73: South gable end of Bldg. **F** (extended/rebuilt c.1960).

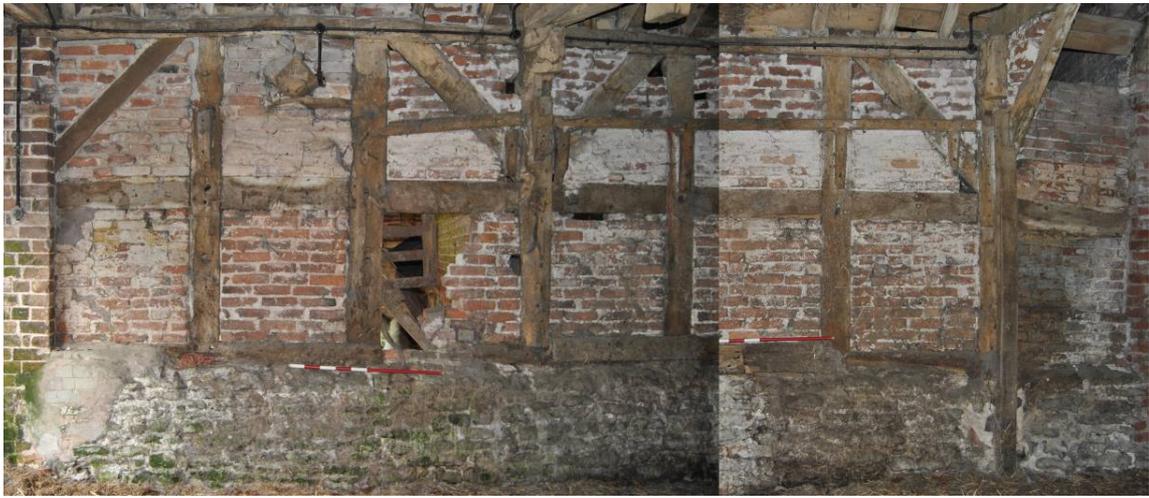
Plate 74: Small-square framing of Building F, east wall (composite).

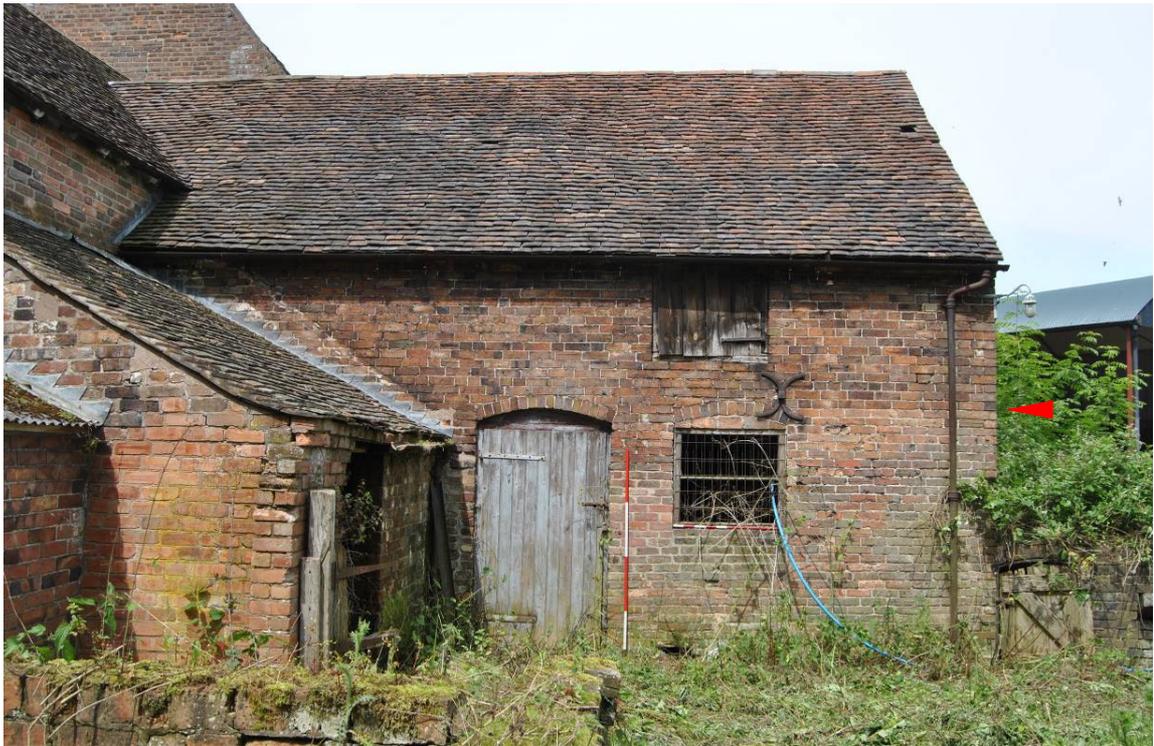
Plate 94: Building I, south elevation, note clear change in brickwork at c.7½ft. above ground level (marked with arrow).

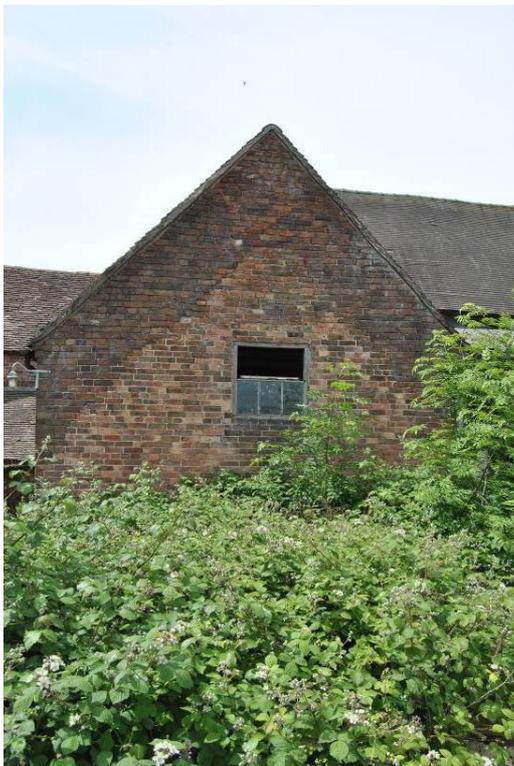
Plate 95: Building I, east gable showing clear change in brick evidencing raising of upper storey.

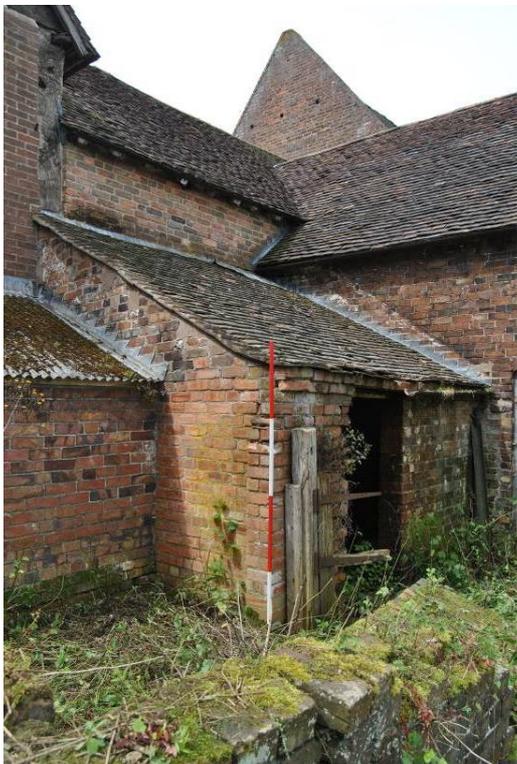
- 7.12.1 **Building K** (Figures 10/17/29; Plate 107a) is a simple, single-cell structure located in the south-east angle of Buildings I and C, brick-built beneath a pent, clay-tile clad roof.⁸⁵ It is approximately square in plan, measuring 12ft. (N/S) x 10ft. 4in. (E/W) internally, standing 6ft. tall to a double ¼-brick oversail eaves band to the east, and 12½ft. to the west, where it backs onto the eastern wall of Building C. The building is accessed via a simple doorway opening at the south end of the east elevation; the interior is floored in face-laid brick with a single stone pad (function unclear), though little survives to indicate former/original function. A blocked doorway (?former window) to the north formerly opened onto Building I, while straight joints in the brickwork of the south wall indicate some form of former opening.

Plate 107(a): Bldg. K looking north-west.

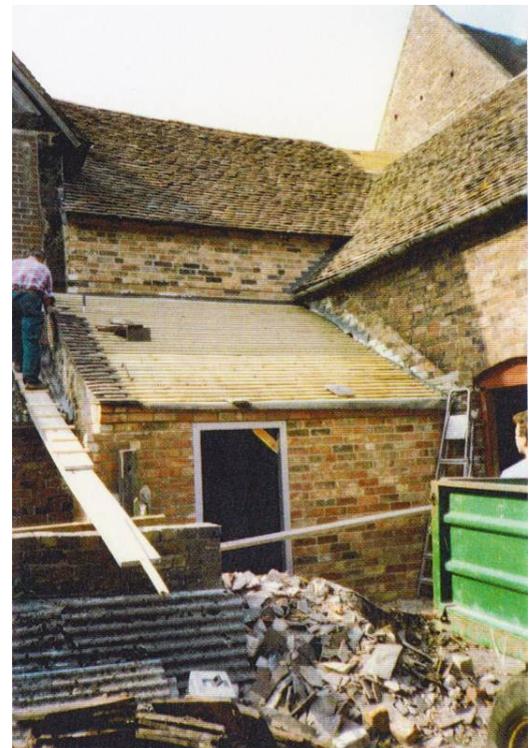
- 7.12.2 Building K was subject to extensive rebuilding and full re-roofing in 1990 (see Plate 107b) and its original function is unclear, though given its proximity to both pigsties L and cow houses C/I, it may have been related to feed preparation.

Plate 107(b): Similar view, Sept. 1990 during extensive reconstruction.

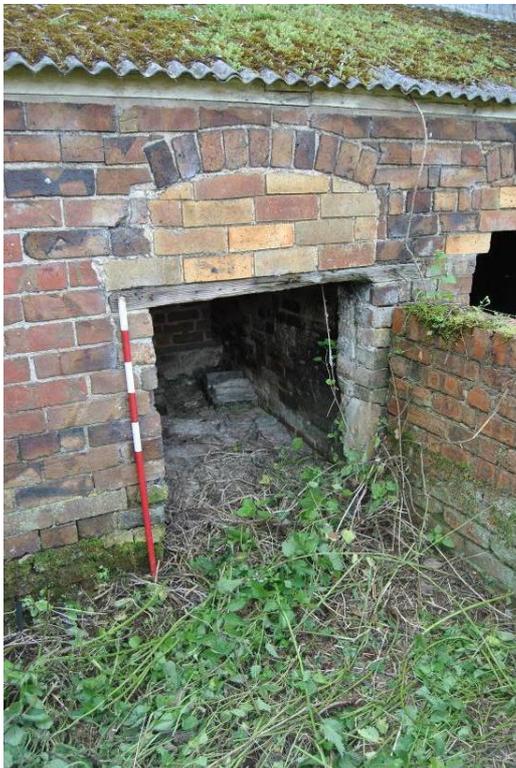
introduction of buff/yellow brick below the primary arch (Plate 109), supported on timber lintels (the northern jamb of the north sty has been rebuilt in similar brick).

Plate 109: Reduced doorway to southern inlet.

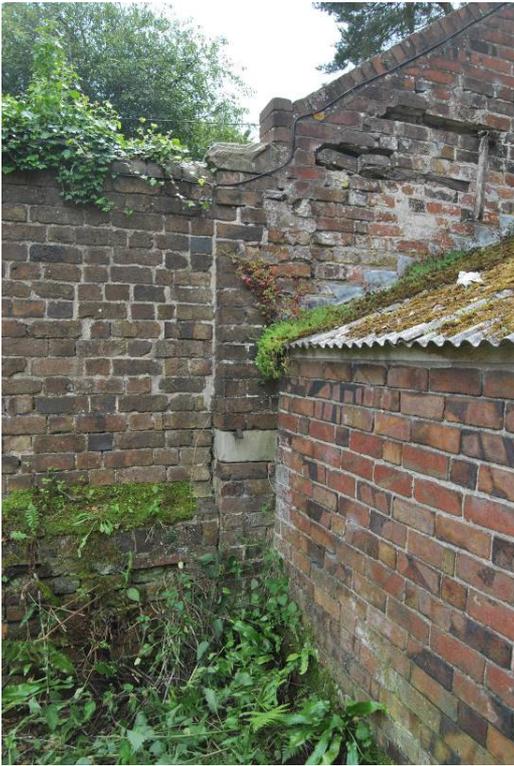
- 7.13.2 A feature of particular interest was noted in the southern flanking wall of the southern outlet, where a straight-joint with integral stone block supporting an iron latch-fastener (Plate 111) represents the western jamb of a former door/gateway serving the eastern, subsidiary yard from the south. The wall to the east of the surviving jamb has been rebuilt and it is thus not possible to establish the width of the door/gateway opening; it became redundant with the construction of sties **L**.
- 7.13.3 The sties and associated outlets are clearly shown on historical mapping as far back as the first edition Ordnance Survey of 1882 (inset at §.5.3.1), and on all subsequent editions, and thus represent structures of some antiquity, though the quality of the brickwork to the sties themselves suggests a phase of later rebuilding, maintaining the original plan.

Plate 111: Western jamb of former gateway.

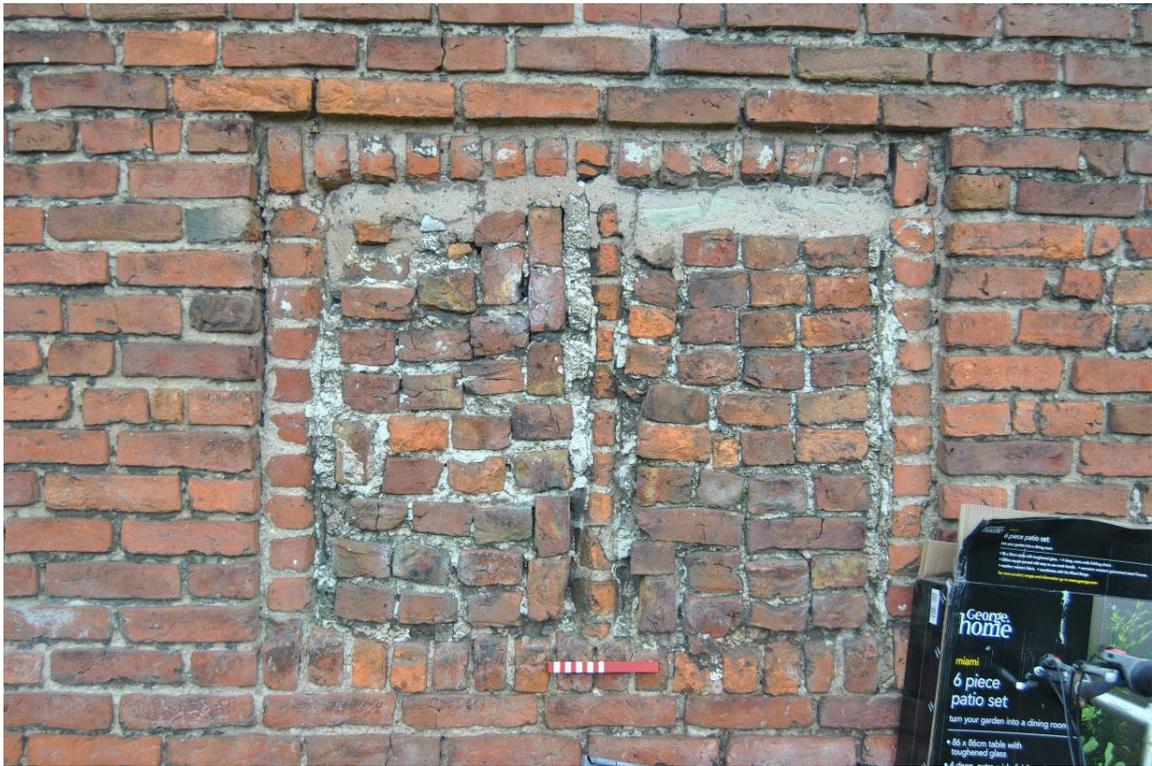
Plate 119: Ground floor blocked window with chamfered-brick surround and central mullion, central to early block A.

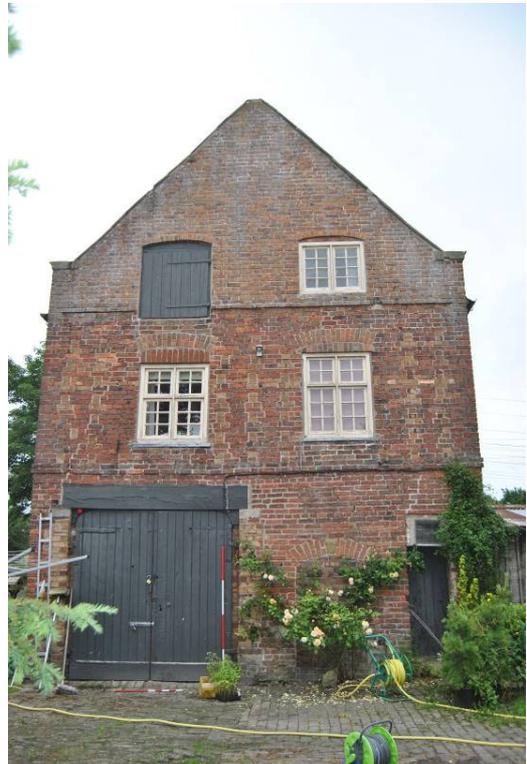
⁹⁶ The blocking of the windows lighting the stairwell, evident externally (§.7.16.3; Plate 124), may suggest that the alignment of the stair has been historically reversed.

Plate 124: Modified window openings.

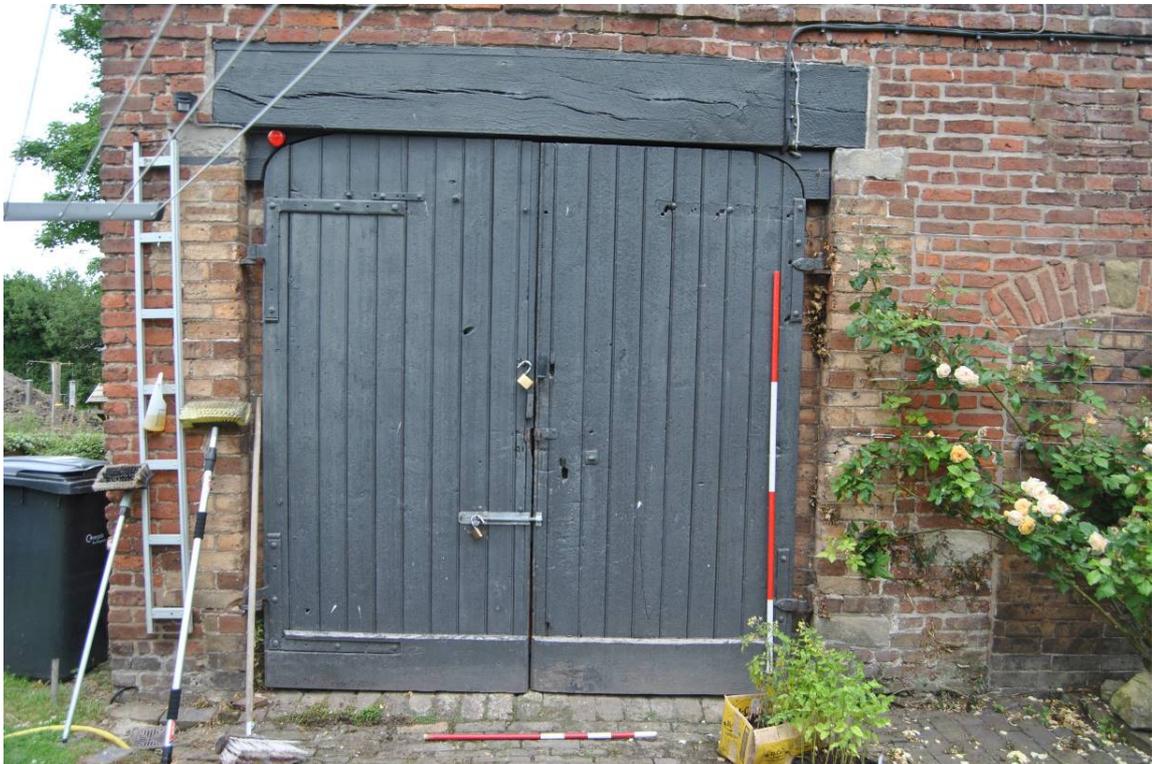
Plate 127: Southern door (inserted/adapted).

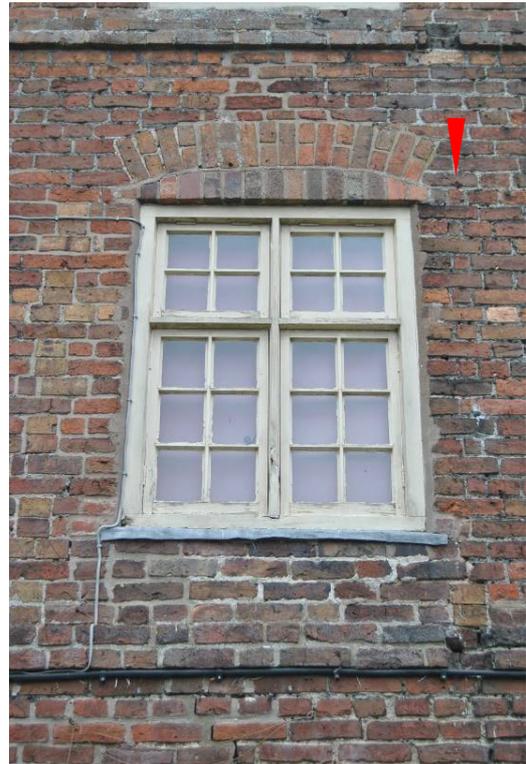
Plate 129: Detail of blocked vents at first-floor level.

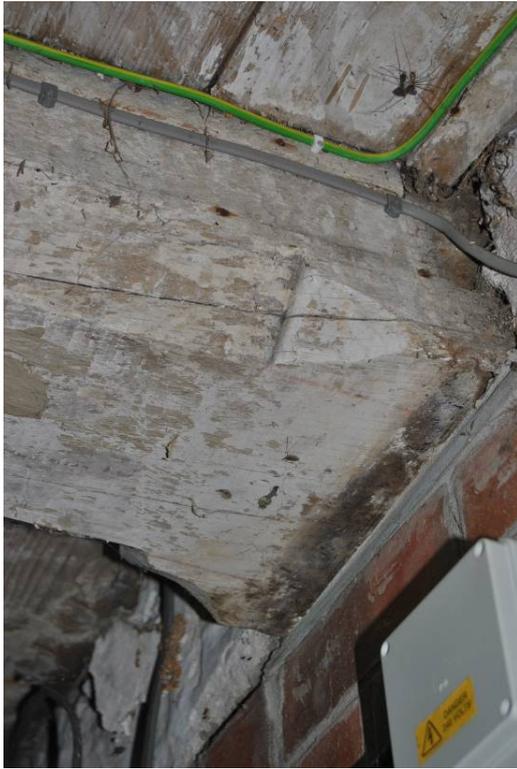
⁹⁵ The intersection of principal longitudinal and transverse beams is obscured by the brickwork of the supporting pier (Plate 132). The framework, originally exposed, was subsequently obscured by a lath and plaster ceiling (see Plate 134), and is currently hidden, for the most part, by a matchboard lining applied to the soffit of the common joists

Plate 132: Modern brick pier supports intersection of chamfer-stopped ceiling beams.

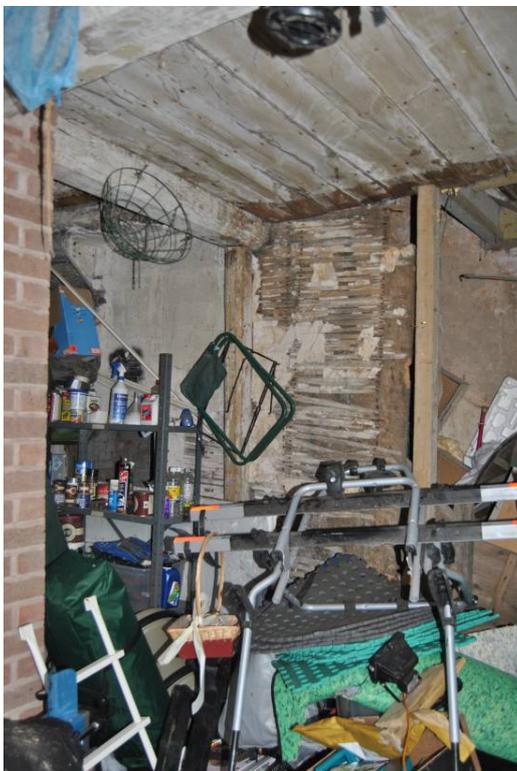
Plate 134: Chamfer-stopped common joists exposed above SE quarter of [G3].

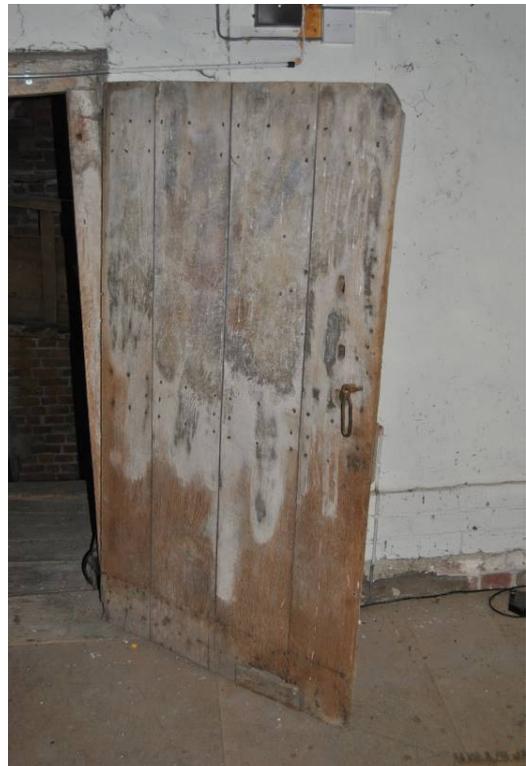
- 7.16.9 **Second Floor** (Figure 34) is accessed from within A only, via stair B rising from west to east at the south-western corner of the building (Plate 139); as at ground floor level, the southern longitudinal beam of the first floor ceiling has been cut through to form the well for stair B, where it is simply supported by an upright stud of the stairwell wall (Plate 139), indicating its insertion. The attic level is sub-divided on a simple bi-partite plan reflecting the A/B development of the core of the building, with [S1] to the east and [S2] to the west, interconnected by a single, plank and baton door at the south end of the party wall (Plate 140). Room [S2] currently houses two large, galvanised steel water tanks (Plate 142) supported on timber bearers set into the brickwork of the west gable and party wall to the east; Room [S1] is used for storage. Both rooms are lit by paired windows within the gable ends,⁹⁷ [S1] being furnished with a small fireplace (blocked) within a shallowly projecting chimneybreast. A three-course brick string (Plate 141) was noted just above floor level in the west wall of [S1] (*viz.* the original exterior wall of section A) and may reasonably be interpreted as an original eaves band for the early, north-south aligned block. The brickwork above the string is roughly finished (see Plate 143), clearly secondary and never external, and is furnished with a high-level hatchway (Plate 143).

Plate 139: Stair B rising from 1F – attic, looking east.
NB. cut-off longitudinal ceiling beam (arrow).

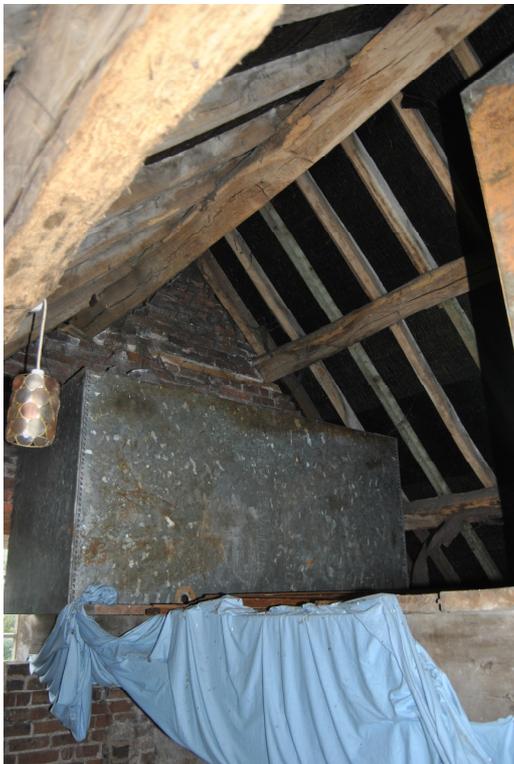
by the variant internal floor levels. The earliest section is reasonably the western part (**A**), which would have comprised a rectangular structure of two-storeys, suggested by the surviving 'eaves band' at attic level (Plate 141), aligned north-south. The function of the early range is not known - the interior carpentry is clearly above the status of an agricultural building, with ogee-stopped main beams and common joists to the ground floor ceiling, while the quality of the former, moulded-brick mullioned window of the north elevation is also of note. Original means of vertical access within this primary structure is unclear, as it would appear that stair **B** to the south side of the range represents a secondary insertion. The first phase of enlargement comprised the addition of **B** to the west, effectively doubling the floor area of the range, built up against and retaining the eastern wall of the primary building as an internal partition wall, at which stage the orientation of the enlarged building was turned through 90°, with a new pitched roof introduced, gabled to east and west. The ceiling beams of the enlarged range mirror the style and quality of the primary work, deeply chamfered with ogee-stops, though the presence of extensive vent holes (blocked) at first floor level to the western and south elevations of the enlarged building is suggestive of a use for crop storage, at least in part. Eastern extensions **C** and **D** were added in early to mid-19th century, most probably to form a kitchen and attached wash house, implying a domestic, residential function by that time at the latest. The cottage has undergone subsequent phases of modification and refurbishment, with Benthall's notes on water supply to the hall,⁹⁸ for example, recording that the cottage was being 'extensively altered' in 1982, while porch **E** represents the latest phase of work, added in c.2000.

Plate 141: Three-course former eaves band to east wall of block A, visible at floor level within [S1].

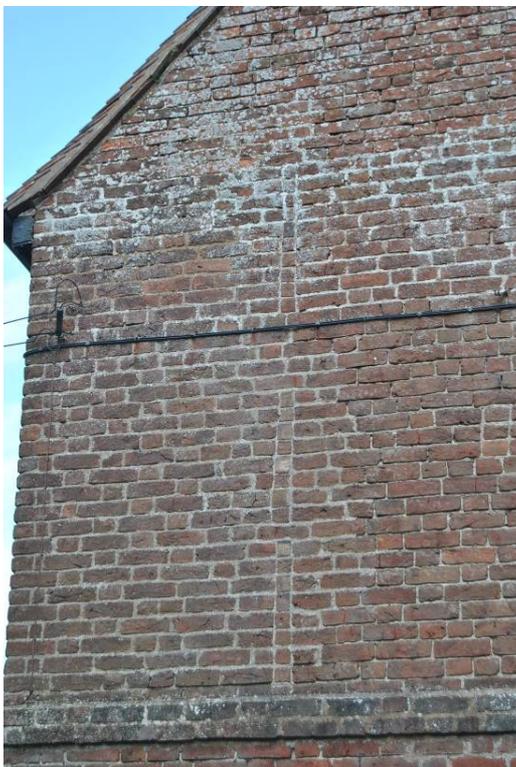
Plate 159: Blocked ventilation slits to upper west gable.

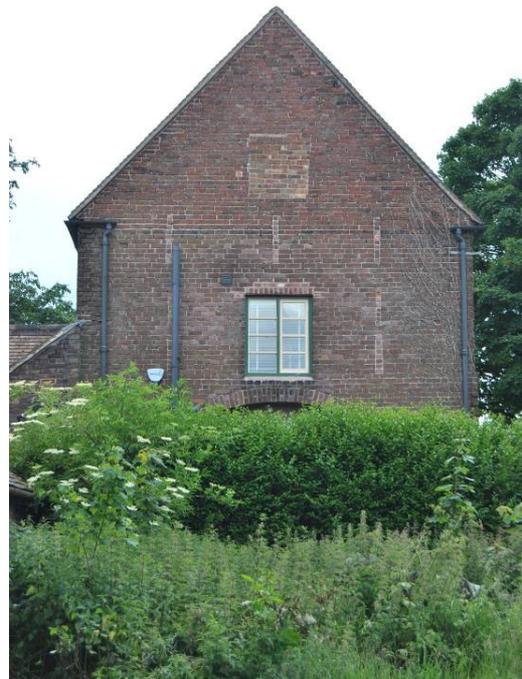
Plate 160: East gable end with upper ventilation slits and ground level cart entrance (obscured by hedge).
