FARM BUILDINGS AT MOSELEY OLD HALL

Featherstone, South Staffordshire Historic Building Record, 2019

Historic Building Record, 2019

Site Name: Farm Buildings at Moseley Old Hall, Featherstone, South Staffordshire

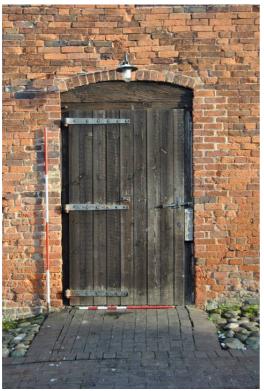
Plate 7: Door [d3] with evidence for insertion.

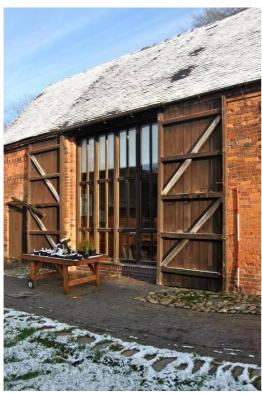
Plate 9: Double doors to threshing bay (Bay 3; W). with glazed screen of 1986.

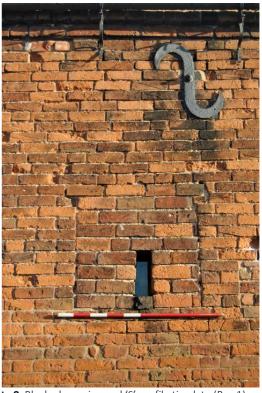
Plate 8: Blocked opening and 'S' profile tie plate (Bay 1).

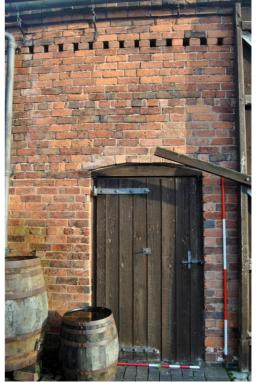
Plate 10: Bay 4 (W); door [d1] and vent holes.

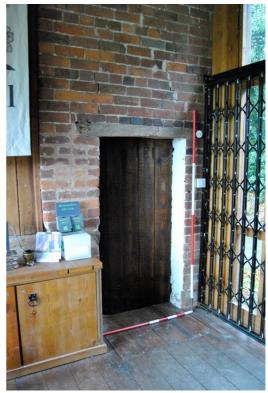
Plate 18: Door to (?) former cornhole at Bay 4(E).

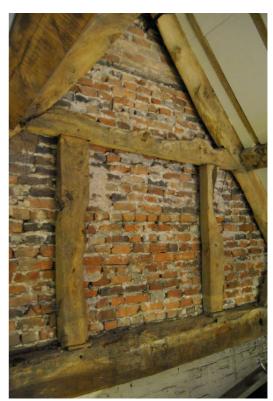
Plate 20: QS Truss T1 at south end of A1.

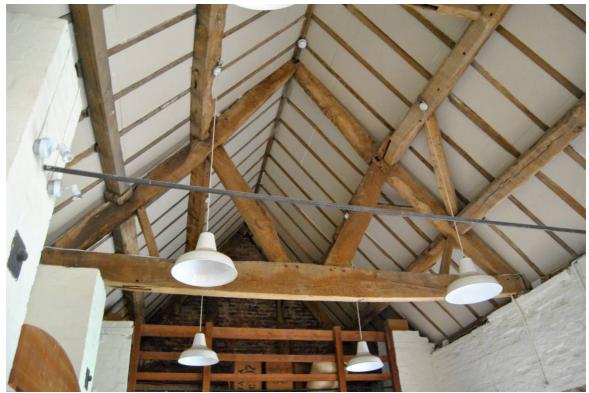
Plate 21: Truss T2 looking south.

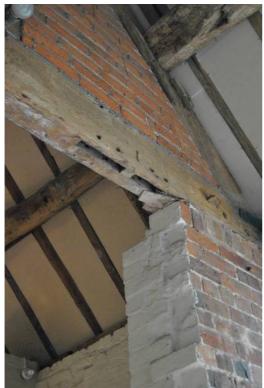
Plate 23: Detail of redundant mortices to soffit of T3.

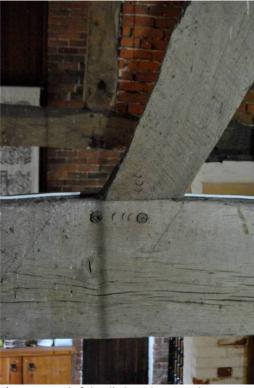
Plate 25: Detail of chiselled numbering and setting-out lines, truss **T2**, S face.

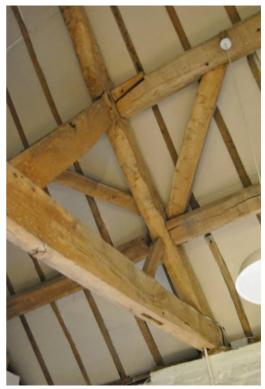
Plate 24: Wind-bracing to upper tier of purlins only at Bay 3/4 (E). NB. soffit mortice.

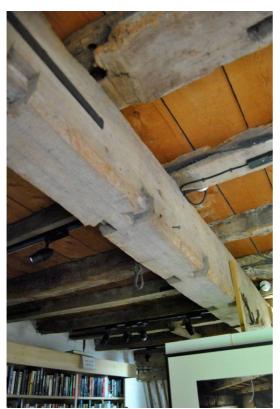
Plate 34: Inverted first floor girder.

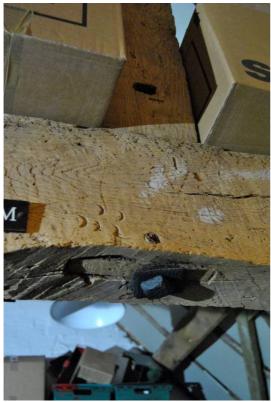
Plate 39: QP bolted at redundant mortice.

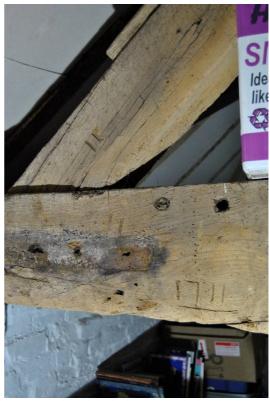
Plate 40: Date '1711' marked to west end of tie-beam.

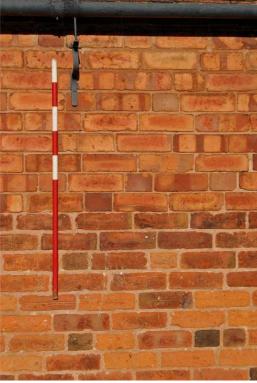
Plate 47: Detail of upper wall, rebuilt in 3in. brick (Flemish stretcher bond).

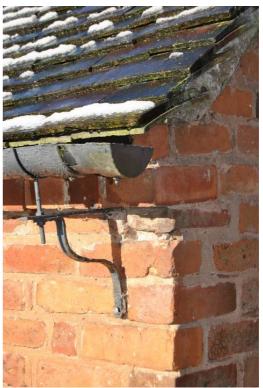
Plate 48: Eaves detail to rebuilt wall.

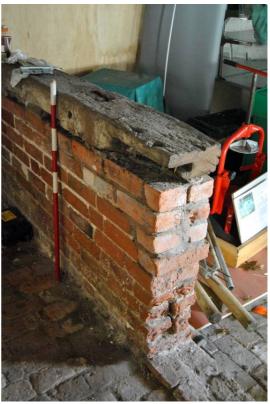
Plate 61: Opening formed within feedwalk partition.

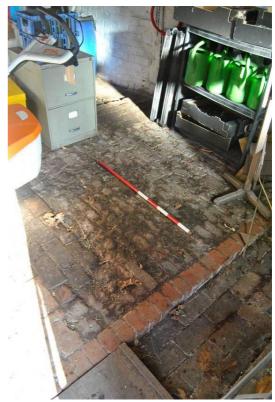
Much of the brick paving appears renewed, though a small area of 'old', weathered brickwork survives towards the eastern end of the stalling area (Plate 87).

Plate 87: Area of 'old' brick flooring

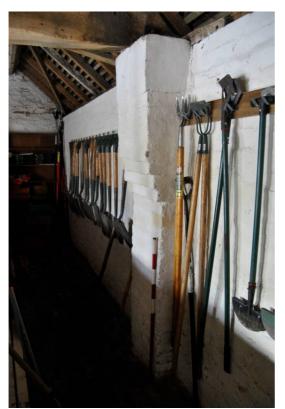
single side-purlin form, as per to cartshed D2 (Bays 3/4) to the west, and per cowhouse B to the east. The tie beam of T1 is supported on brick piers to north and south, the former being of 'stepped', corbelled form (Plate 91). Pegging and soffit mortices to the ends and centre of the tie beam, inconsistent with the truss' context, suggest it may have been re-used from another location.

Plate 91: 'Corbelled' brick pier to north end of T1.

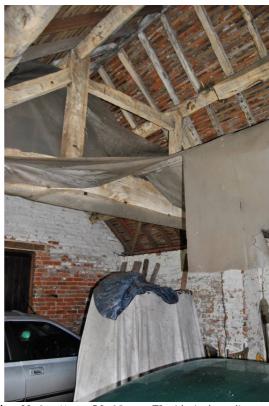
- 7.5.6 Cartshed **D2** to the west end of the range (Bays 3/4) is accessed from the exterior to the north via two *c*.10ft. wide entrances, allowing discrete access to each bay (Figure 31; Plate 83). It is of simple, open form with no evidence for an internal, transverse partition between bays. The cartshed is again open to the underside of its pitched **roof**, here carried on a single tier of in-line side purlins, scarfed to the west of central truss **T2**, the latter of queen-post form with joggled QPs braced by a horizontal straining beam and supporting the purlins directly (Figure 32b; Plate 92).

Plate 92: Cart House D2; QP truss T2 with single purlins.

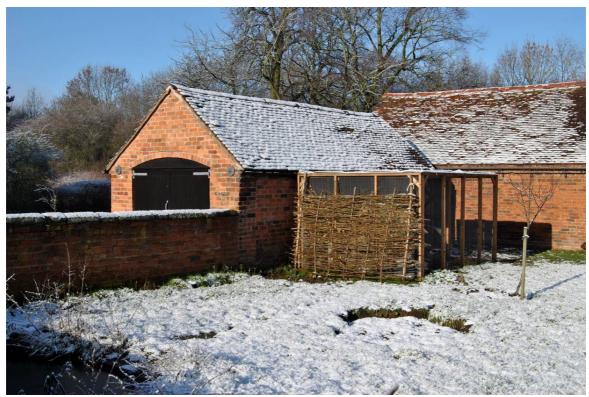
Plate 93: Former shelter shed / cowhouse E and re-aligned bounding wall to west side of enlarge foldyard.

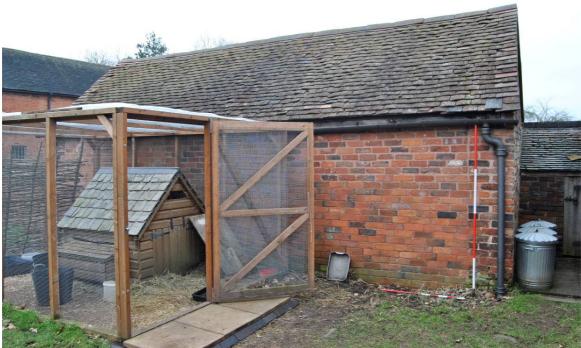
7.6.2 The **east elevation** (Figure 33b; Plate 94) presents a blind brick wall to the foldyard, partly obscured by an ephemeral hen house of timber and mesh construction. Clear vertical joints to north and south (Plate 96) suggest that the majority of the brickwork represents secondary infill, and reference to archival sources (old photographs; VBS notes/plan) indicates that, originally, the elevation was furnished with two openings, a narrow doorway to the south and a wider, open frontage to the north, serving an enclosed cowhouse and shelter shed respectively. Prior to recent modifications, the latter opening had historically been partly infilled in the mid-20th century by a low brick wall beneath 'an assortment of various lights' (see VBS notes, **Appendix B**). The **west elevation** (Plate 95) is again of brick construction, in pale orange/red brick (8½ x 4 x 3in.) laid to Flemish stretcher bond rising to a single, offset header-course eaves band (the two uppermost courses of brick appear to have been rebuilt; VBS notes record 'three projecting courses' to eaves level). A single, inserted pedestrian doorway [d2] opens to the south end of the range, with a narrowly projecting brick buttress (as per foldyard boundary walls elsewhere) immediately north thereof.

Plate 94: Former Cowhouse / Shelter Shed E looking west with secondary, infill brickwork.

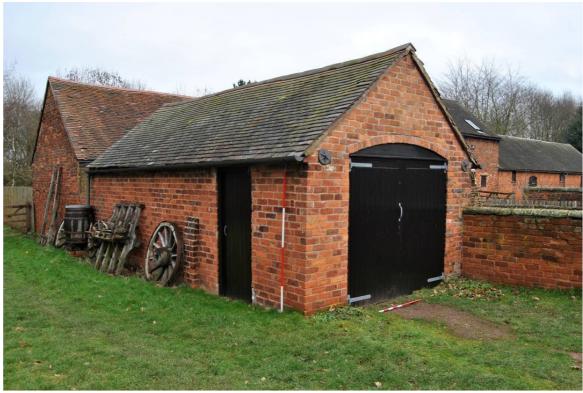
7.6.3 The **south gable end** (Figure 33d; Plate 95) has been extensively rebuilt and a wide, double garage-door [**d**1] inserted beneath a segmental brick arch of a single header-course (VBS notes record a vertical sliding-vent beneath a timber lintel, blocked). Contemporary with the introduction of door [**d**1], the western boundary wall of the foldyard was moved eastwards, ⁷⁵ to afford access to the remodelled range from without the foldyard; reference to graphic sources indicates that this occurred at some point between the Ordnance Survey edition of 1992 and the first available Google Earth aerial photographic imagery of January 1999. ⁷⁶ The **north elevation** is blind, forming the southern side of an enclosed yard area between range **E** and the rear wall of cart shed **D2** to the north, incorporating a small, lean-to structure, most probably representing a former dog-kennel (Plate 99).

- The interior of the range is accessed via the double garage doors [d1] to the south gable end (Figure 33d), and via inserted pedestrian doorway [d2] to the south end of the west elevation (Plate 95). In its current form, it comprises a single, unencumbered space, open to the underside of the pitched roof (Plate 97), the latter supported on a single tier of through side-purlins and plank-section ridge-piece, carried by a single, central king-post truss (Figure 33c), with purlins scarfed to north thereof. The truss is roughly constructed and incorporates a number of reused timbers evidenced by redundant mortices and peg-holes; the eastern and western wall plates are tied by a series of four further, roughly-converted timber ties. The range is floored in face-laid blue brick; formerly comprising a bi-partite plan (Figure 12), a transverse band of concrete (Plate 98) indicates the location of the former partition wall between the original northern shelter shed (E1; 14ft. 8in., N/S) and southern cowhouse (E2; 8ft., N/S), the alignment of brick pavers varies to north and south of the partition line. Historical VBS notes (Appendix B) record 20th-century, oak-lipped feeding troughs against the west wall (ie. no feed walk), though these have subsequently been removed; it is unclear how far these troughs extended (not marked on VBS plan; Figure 12).

Plate 95: Former Cowhouse / Shelter Shed E looking north-east, with west gable end of Range D to left.

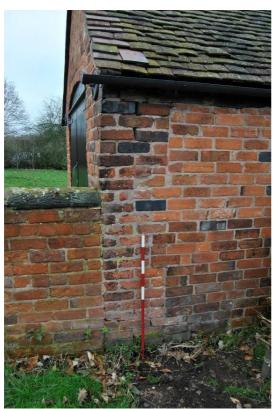
Plate 96: Range E; SJ to south end of east elevation.

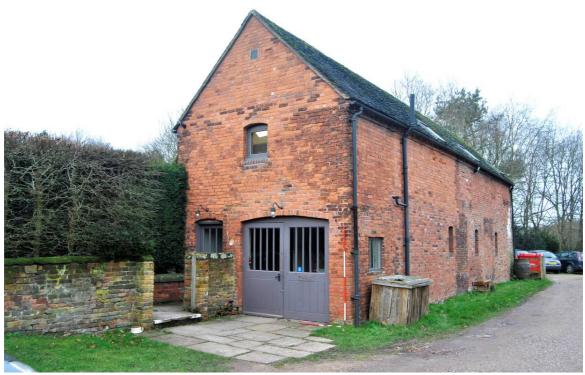
- 7.7.3 The north elevation (Figure 36; Plate 101) is ostensibly relatively plain in aspect, of brick construction rising through two storeys to an offset, dentillated eaves band beneath a pitched, clay-tile clad roof, gabled to east and west. The elevation is pierced by four window openings at ground floor level, viz. a square, fixed-light [w1] to Bay 7, and three, segmental headed openings [w2-4] to Bays 2, 3 and 5, the latter all representing 1980s insertions. Closer examination of the pattern of brickwork, however, indicates a somewhat more complex sequence of development. To the centre and west end of the elevation, early brickwork in a darker, purplishred brick laid to English garden wall bond ('EGW': A on Figure 36; Plate 105), defines the extent of the original range (Phase I; Figure 43a), occupying Bays 1-4 and standing c.10ft. tall. Two primary openings are evidenced within the early brickwork, at Bay 1/2 and Bay 3/4, measuring 8ft. 3in. and 7½ft. wide respectively, though both have been historically blocked. Clear, vertical 'straight joints', representing relic jambs, define precisely the width of the eastern opening (Plate 102), though that to the west is less clear, being defined by ragged joints. The form of the heads of both openings has been lost. The upper elevation to Bays 1-4 has been raised in a paler orange/red brick, laid to a regular Sussex bond (Plate 106), denoting the addition of an upper floor level to the original range (Phase II; Figure 43a), with a simple, square opening (?pitching door) at Bay 4 (blocked in 1980). That the Phase II brickwork extends into the width of the eastern original doorway at Bay 3/4, indicates that this opening was reduced contemporary with the heightening of the range, with a segmental-headed door being formed within the blocking material, the latter surviving down to 1980 (Figure 40), though ultimately blocked (blocking material incorporating window [w3]). Bays 5/6 were appended at Phase III (Figure 43b), again in Sussex bond brick, which survives to first floor level, though originally open at ground floor level as two coach doors, ⁷⁹ again surviving to 1980 (Figure 40), though blocked in EGW brickwork as part of the extensive remodelling. Bay 7 to the west end of the range represents a further phase of extension (Phase IV), appended to form a small saddle/tack room with chamber over, accessed from the east; it is lit by a single window [w1] to ground floor level. The precise chronology of the building's development is unclear, though all of Phases I-IV were in place by the Bushbury tithe map of 1845.

Plate 101: Coach House F; north elevation.

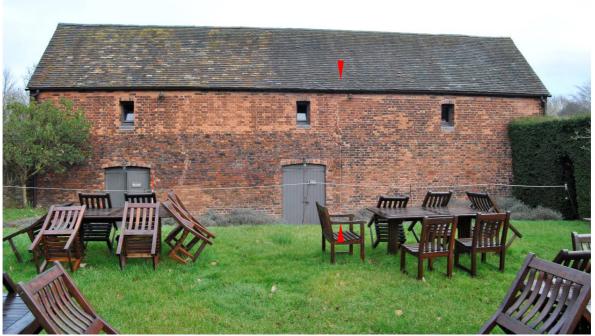
- The **south elevation** (Figure 37; Plate 103) is again of brick construction, rising through two full storeys, though the original two-course eaves band has here been rebuilt (flush) in the 1980s (Plate 108), beneath the reconstructed, pitched, clay-tile clad roof. Early (Phase I) EGW brickwork is again evident to ground level at Bays 1-4, rising to *c*.10ft., raised in paler orange/red Sussex bond brick to eaves level, as per the north elevation. The arrangements of the western bays vary from the northern aspect, however, with lower brickwork (to a height of *c*.9½ft.), laid to a regular Flemish bond, meeting the (Phase I) Bay 4 to the west in a clear, vertical straight-joint and extending uninterrupted to the full length of Bays 5-7; evidence recorded in the east gable end (§.7.7.6; Figure 38a) suggests this may represent a former, free-standing boundary wall, subsequently incorporated into the Phase III and Phase IV extensions (Bays 5/6 and 7 respectively; see Figure 43). Bays 5-7 have again been raised, abutting Bay 4 in an irregular, staggered-joint, though the Phase III/IV boundary at Bay 6/7 within the upper level brickwork is less distinctly demarcated than to the north. Bays 5/6 are constructed in an irregular EGW brickwork; brick size and colouration at Bay 7 are similar, though the

Plate 103: Coach House **F**, south elevation; note early EGW brickwork, GF west (left), raised in Sussex bond, with straight-staggered joints to GF/1F to right of door [d2] (marked with arrows).

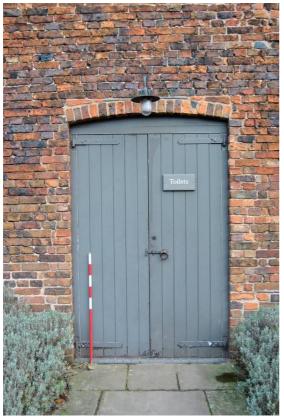
header courses of Bays 5/6 clearly do not continue within the easternmost bay. Doorways [$\mathbf{d}1/2$] (Plate 107) have been inserted to Bay 1/2 and 4, accessed via the sunken footpath flanking the elevation, with three small, first-floor window openings [$\mathbf{w}6-8$] beneath flat-arches at Bays 2, 4 and 6 (Plate 108), all dating to the 1980s remodelling (Phase V); historical survey drawings (Figure 40) indicate a fully blind elevation.

Plate 107: Door [d2] inserted within primary wall in early-1980s remodelling.

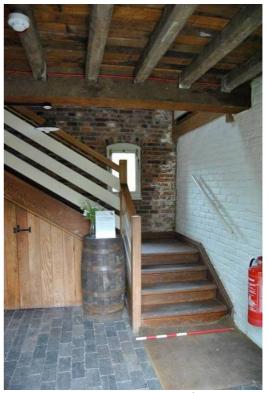
Plate 113: Stop-chamfered ceiling joists over [G1].

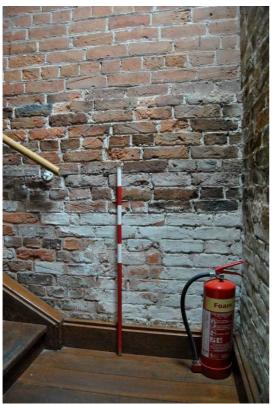
- 7.7.7 The coach house range was subject to extensive remodelling in the early-1980s, when a number of internal partitions were introduced at ground floor level, though the principal, early transverse walls survive largely intact. The **ground floor** (Figure 34) is accessed by doorways [d1] (lobby) and [d2] (lavatories), inserted to the west/centre of the south elevation in the 1980s (Bay 1/2 and Bay 4 respectively), and via doorways [d3/4] to the eastern gable end, [d4] comprising an adapted garage door (see §.7.7.9). Bays 1/2 to the west end of the range form an entrance lobby/circulation space [G1], floored in face-laid blue brick (new), lit by a single window [w5] to the west and by inserted window [w4] within the stairwell occupying the north side of the range (Plate 112). The ceiling structure to the south side of the range is exposed, with stop-chamfered joists jointed to a (renewed) axial beam with soffit tenons (Plate 113). The transverse partition closing the east side of Bay 2 meets projecting brick piers to north and south in clear straight-joints (Plate 114), suggesting it may originally have been open internally to Bays 3/4.

Plate 114: SJ at south end of transverse partition (Bay 2/3).
