BARN NORTH OF MORVILLE HALL

Morville, nr. Bridgnorth, Shropshire

Historic Building Photographic Record, 2019

Shropshire Council Planning Application Refs. **19/03448/FUL**; **19/03449/LBC**

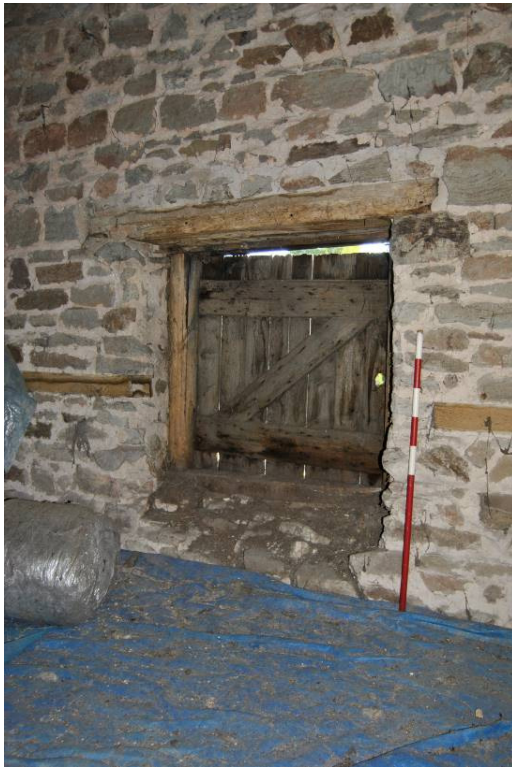
Plate 28: Pitching door [w8] to east gable.

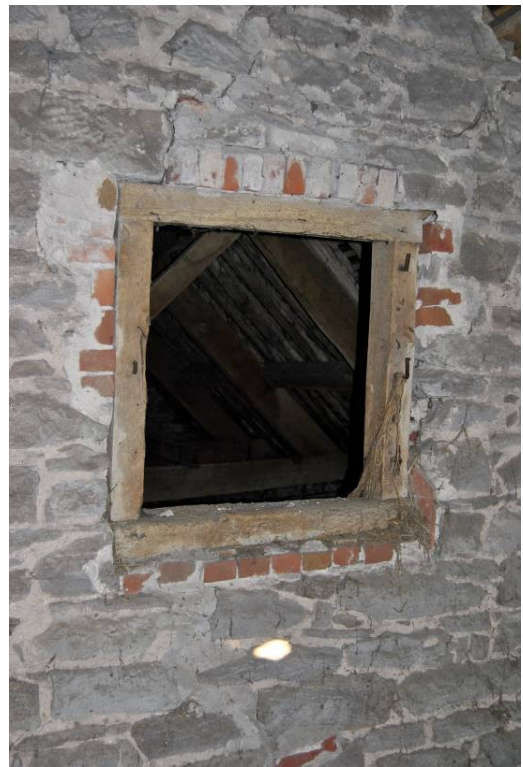
Plate 29: Pitching door [w10] to west 'gable'.

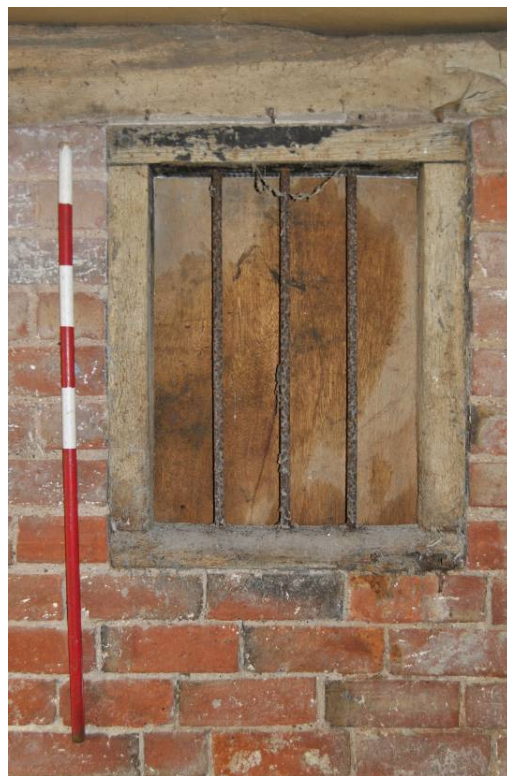
Plate 42: Detail of window in partition wall.

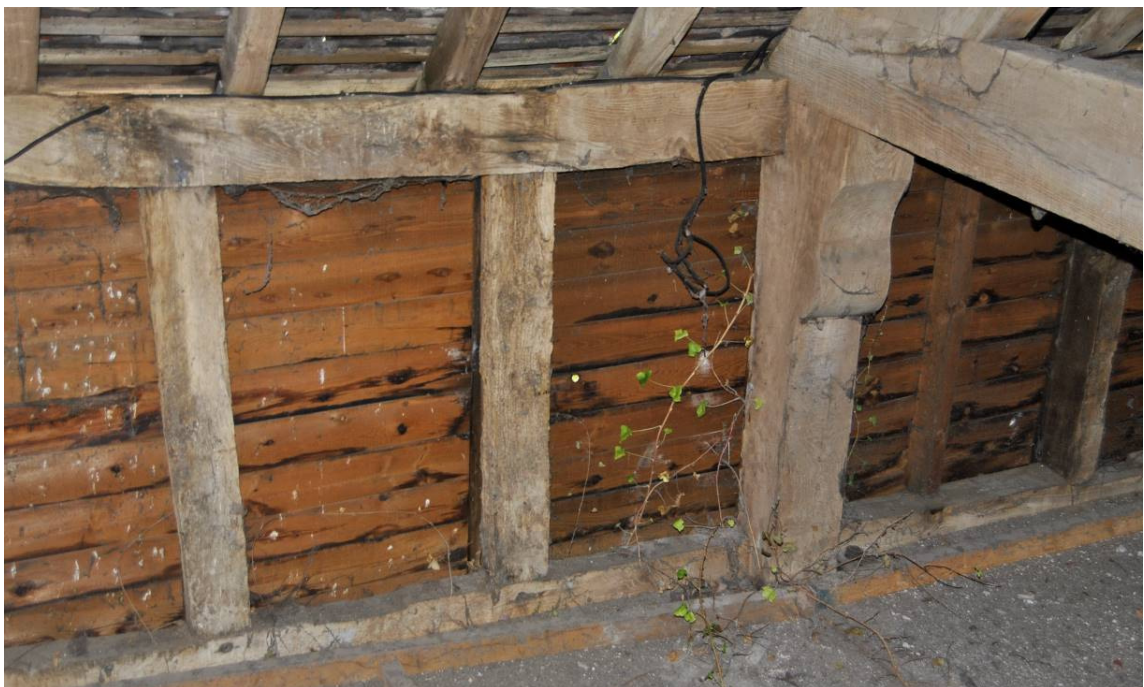
Plate 54: Studs extending between rail and wall plate at Bay 3 (S), pegged top and bottom.

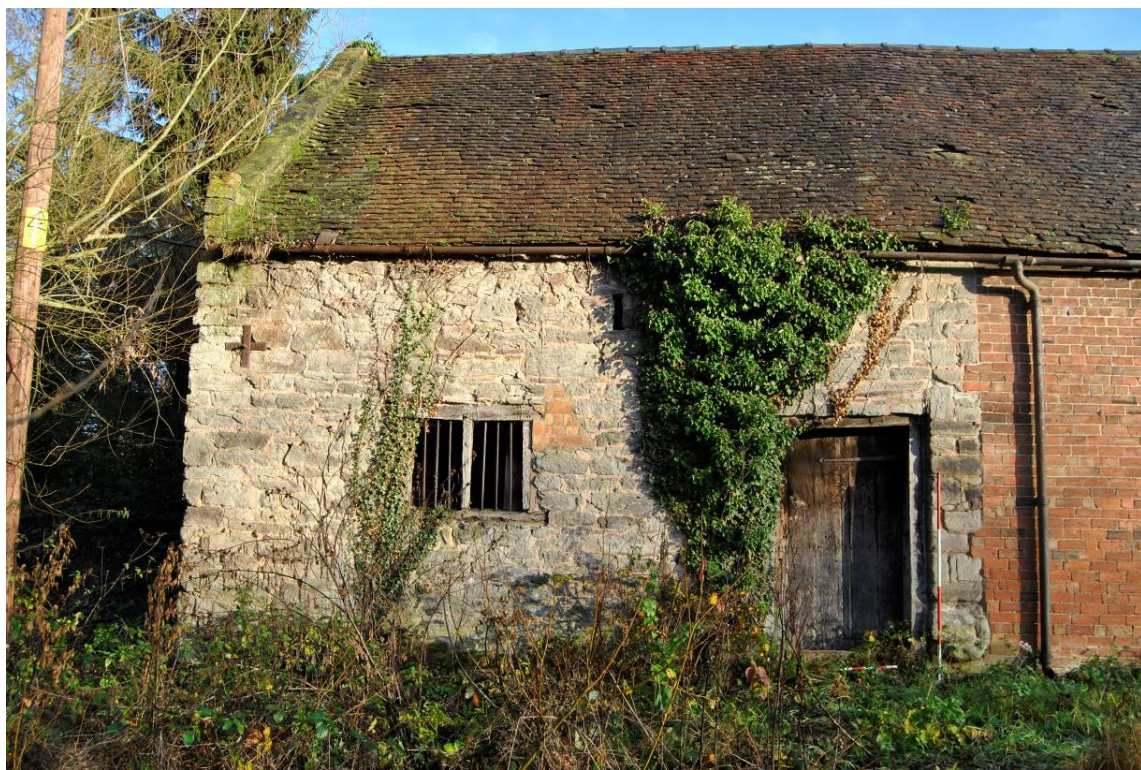
floor [F3] converted to residential use (grooms accommodation etc.). The range is accessed by a single, 5ft. wide doorway [d4] (Plates 57/65), set within a stout, pegged timber frame to the east end of the south elevation (Figure 3b; Plate 56),²³ and is lit by a single, two-light window [w4] to the west thereof (Plate 59), openings here lacking the monolithic stone lintels of Block A. The northern, roadside elevation (Figure 3a; Plate 60) is of coursed stone and includes a low-level, secondary door [d5] to the east side, beneath a timber lintel. The western gable end (Figure 3d; Plate 62) includes two widely-spaced, vertical ventilation slits to the ground floor, blocked externally in brick (Plate 63), and a two-light timber window set high in the wall towards the apex (Plate 64).

Plate 56: Western block [C]; south elevation.

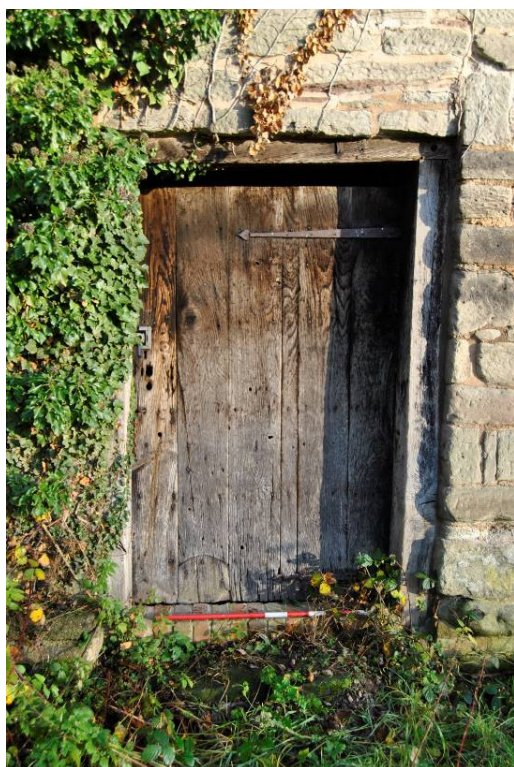
Plate 57: Door [d4].

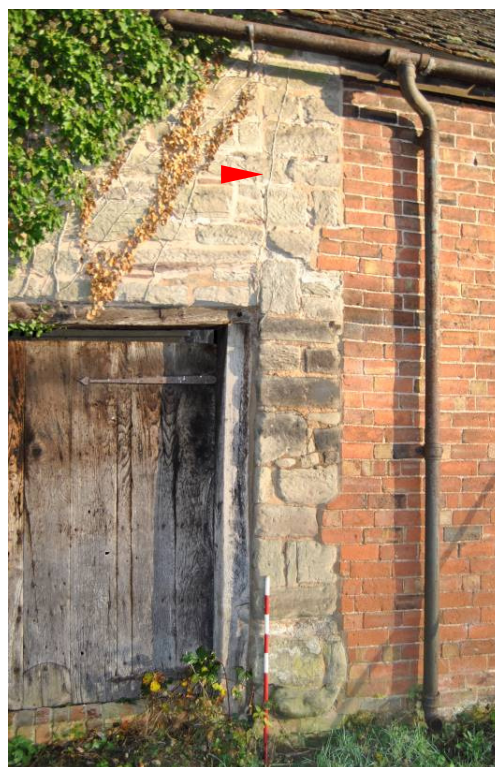
²³ The eastern jamb of the door forms the exterior, south-west angle of block B, and can be seen to extend vertically above the head of the door as a clear straight-joint (highlighted on Plate 58).

Plate 58: SJ extending above east jamb of [d4].

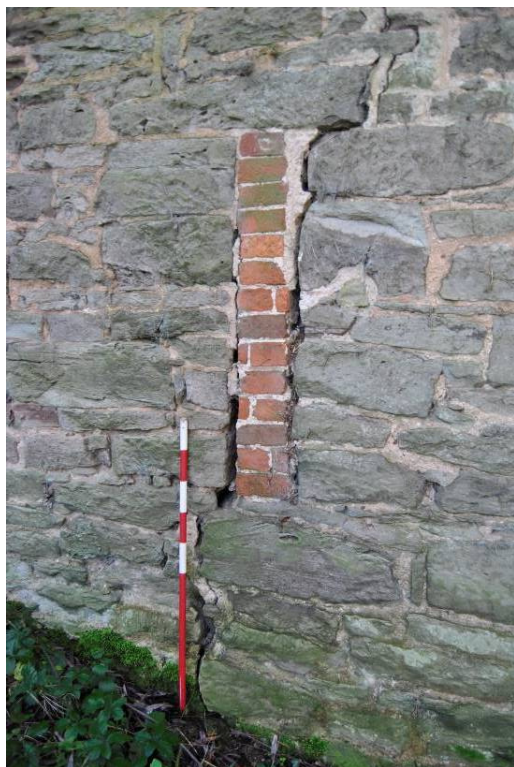
Plate 63: Blocked ventilation slot.

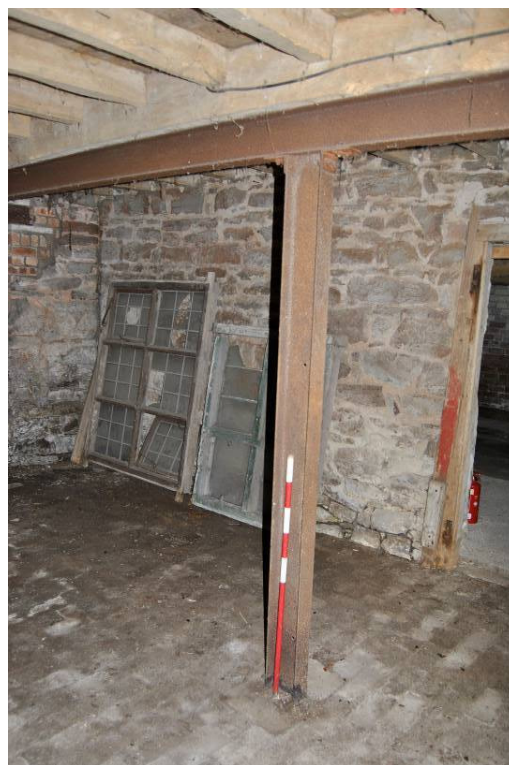
5.4.2 Internally, [G4] (Figure 4) comprises a single unencumbered space (Plate 66-8), floored in face-laid, 8½ x 4in. brick pavements laid on compacted earth (Plate 69), exposed around the principal doorway where pavements have been lifted. Doorway [d6] (Plate 70) in the east wall affords through access to [G3] within block B, while door [d5] in the north wall opens to the exterior (Plate 72). The first floor is supported by x2 substantial, transverse timber beams (9 x 8 in., unchamfered), strengthened by x3 inserted RSJs supported by two, I-section RSC stanchions; the floor structure is carried by common joists of 5 x 4in. scantling at 20in. centres. The presence of ventilation slots within the west gable wall, splayed internally (Plate 71), suggests an original grain/crop storage function, though little other evidence survives to indicate historical usage. A concrete pad against the centre of the west wall (Plate 73) formerly supported a small item of plant, presumably a small a.c. electric motor associated with the surviving switch gear by Brook Motors Ltd.,²⁴ mounted on the north wall (Plate 74); cable ducting extends to first floor level suggesting the former accommodation items of machinery at the upper level, the introduction of which may have necessitated the strengthening of the first floor in the 20th century with structural steelwork.

Plate 66: Secondary RSC support to 1F.

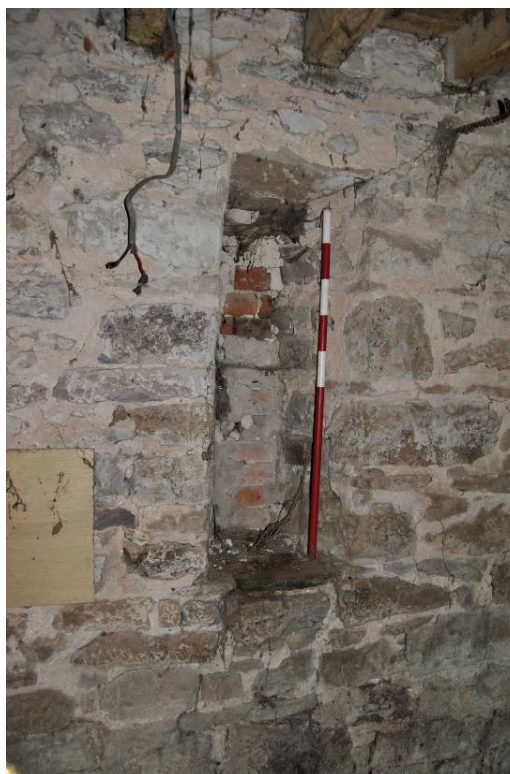
Plate 71: Splayed ventilation slot to west wall, blocked externally in brick.

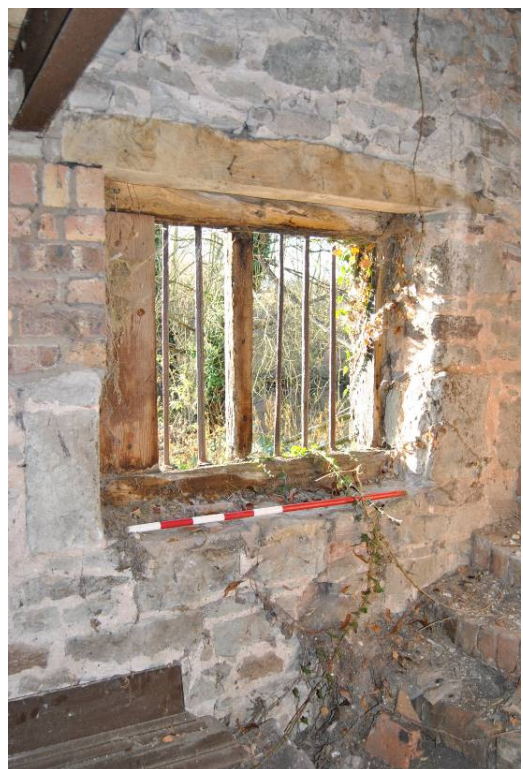
5.4.3 The upper floor [F3] (Figure 5) is approached via a brick stair (Plate 75) introduced at the south-west corner, the lower steps of which are lit by two-light window [w4] in the south wall (Plate 76). The stair forms a straight-flight, aligned east-west, of brick treads (in poor condition; Plate 77) rising to an upper ¼-turn with winders, the upper stairwell being enclosed by studwork walls with lath and plaster render (Plates 78/9). At the head of the stair, a panelled door (Plate 80) with round-ended 'Suffolk' latch (Plate 81) opens to the north onto first floor room [F3] (Plates 82/3). In its current state, the upper room is open to the underside of the pitched roof, the structure of which is carried by x2 side purlins per roofslope, supported by stonework gables to east and west and carried by a single, central king-post truss (T5; Figure 6b, Plate 82). Horizontal joists extending between the upper purlins survive in part, however, and retain evidence for a former lath and plaster ceiling (Plate 84), suggestive of a former 'domestic' function, while lath tacks are also present on the lower section of the common rafters, below the level of the upper purlins. The room is lit by a two-light window [w9] with a heavy, pegged frame and central mullion to the western gable (Plate 85), again of a 'domestic' aspect, while a pitching hole [w11] to the east (ie. within the original west gable of block B) has been blocked in brick (Plate 86). The room has latterly accommodated items of electrical machinery, evidenced by cable ducting (visible in Plate 79) associated with the switch gear surviving at ground floor level (Plate 74), the introduction of which probably necessitated the strengthening of the first floor structure.

Plate 77: Stair rising to 1F level.

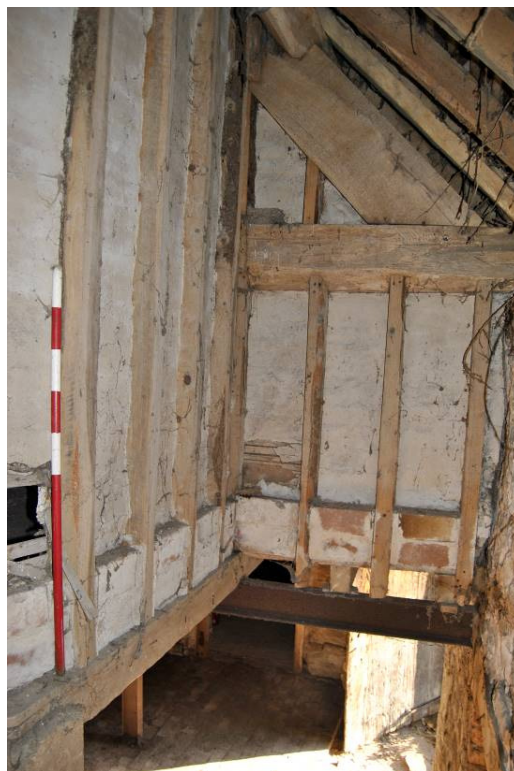
Plate 78: Detail of stairwell.

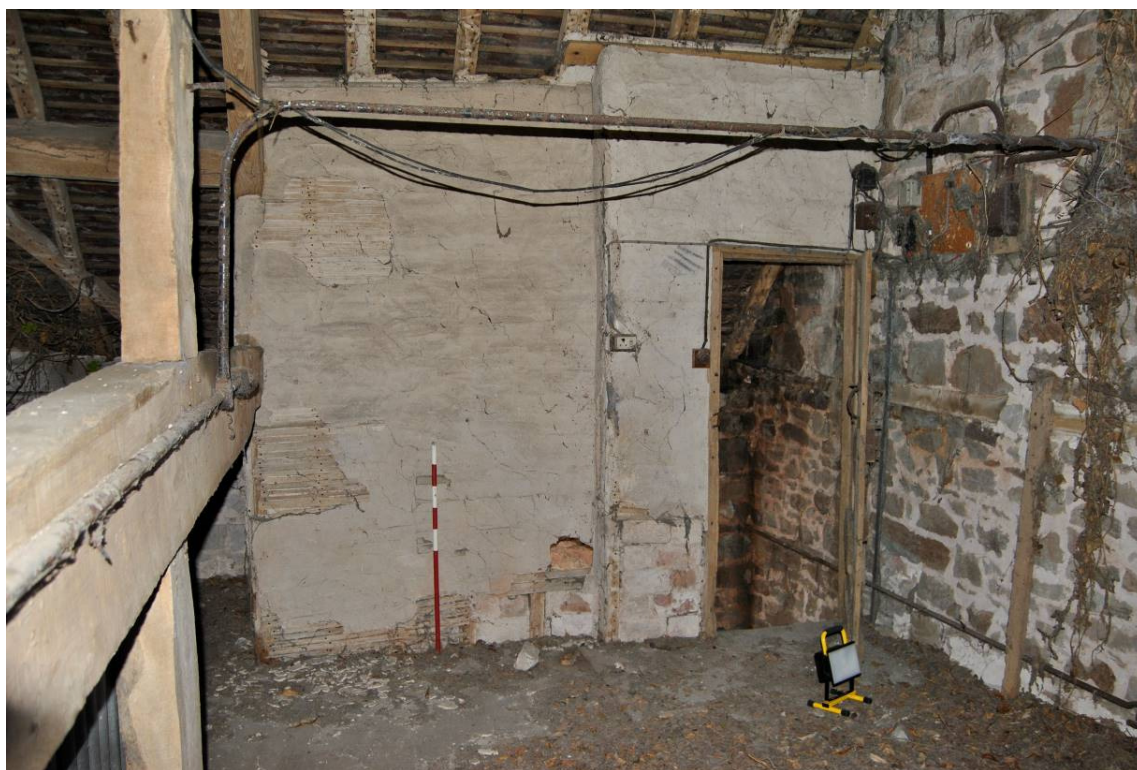
Plate 79: Detail of head of enclosed stairwell looking south. **NB.** ducted cable runs and switch-gear to west wall (right).

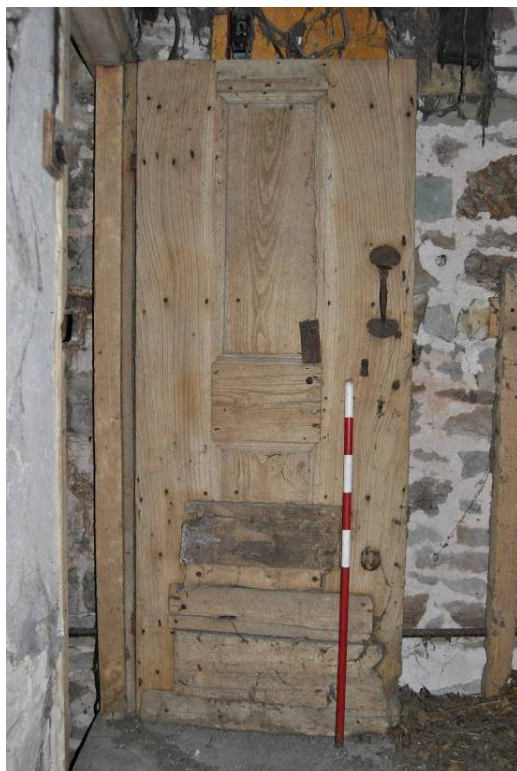
Plate 80: Panelled door to [F3].

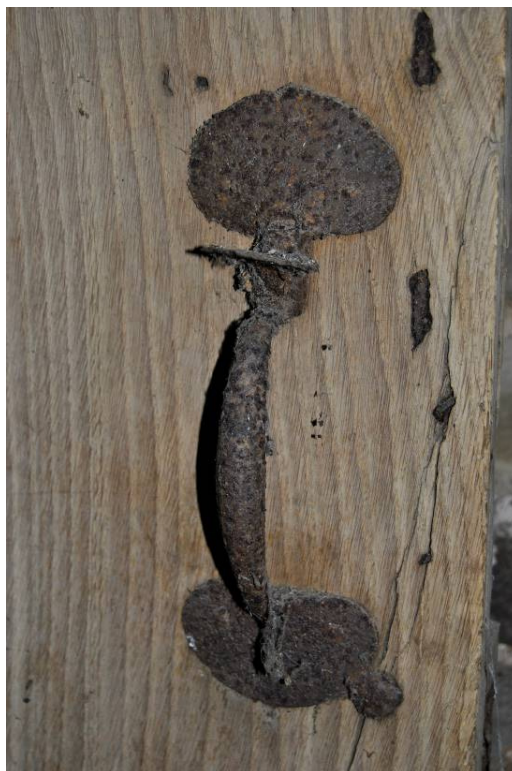
Plate 81: Detail of 'Suffolk' latch.

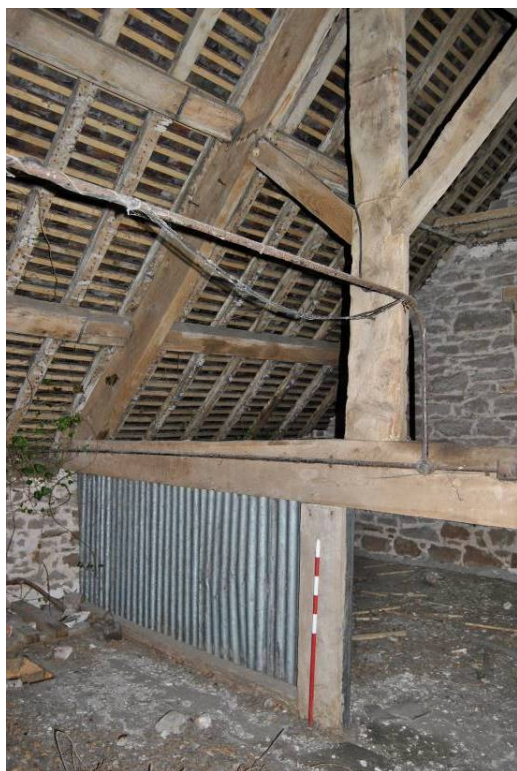
Plate 82: Room [F3] looking north-east (truss T5).

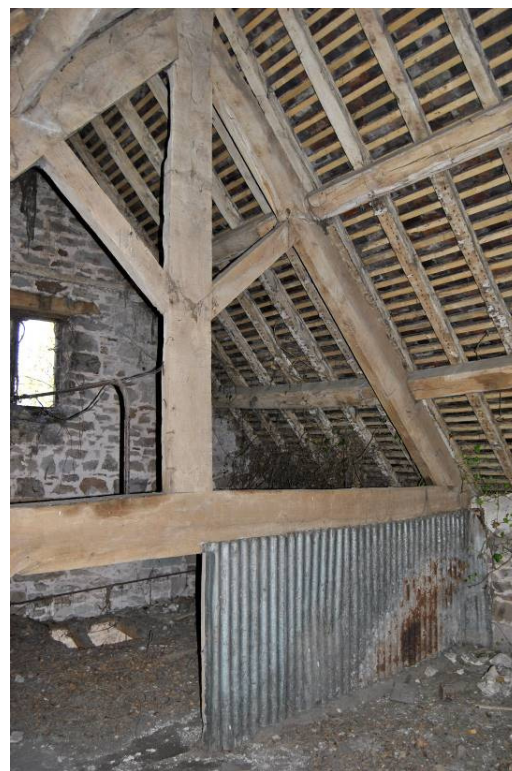
Plate 83: Room [F3] looking north-west (truss T5).

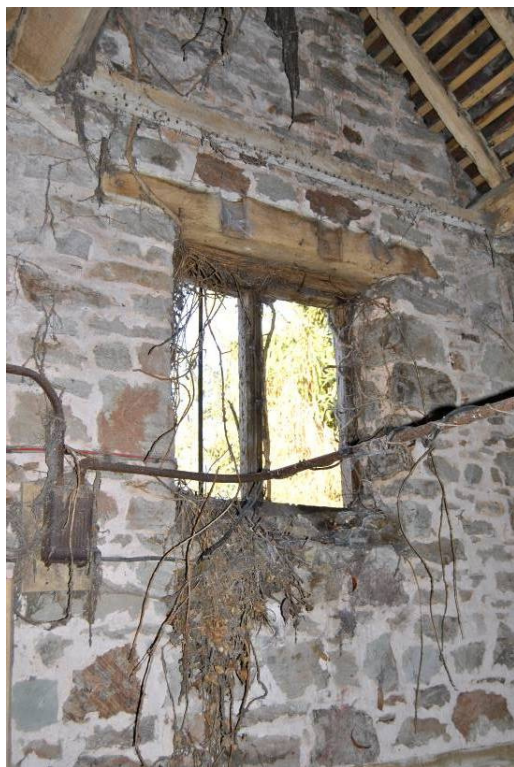
Plate 85: Room [F3], window [w9] to west gable end.

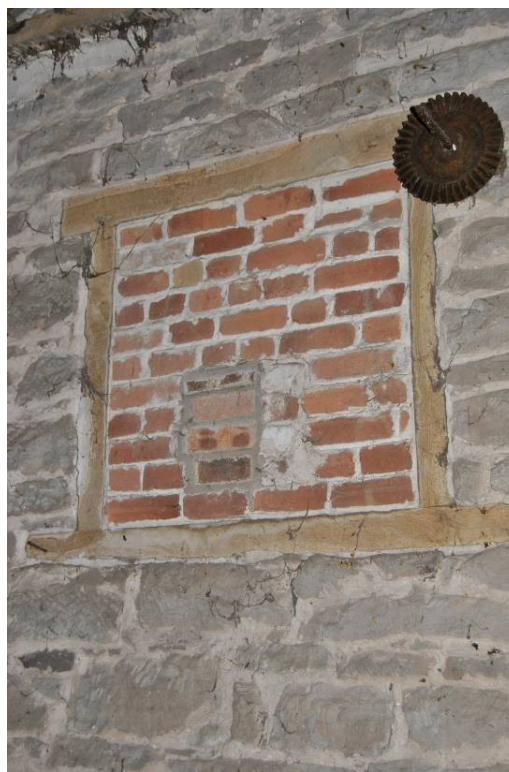
Plate 86: Blocked pitching door [w11] to east wall.
