## **UPPER BLAEN FARMHOUSE (BLAEN-OLCHON)**

Llanveynoe, Longtown, Herefordshire

**Historic Building Record, 2021**

Herefordshire Council Planning Application Ref. P191674/F: Condition 11

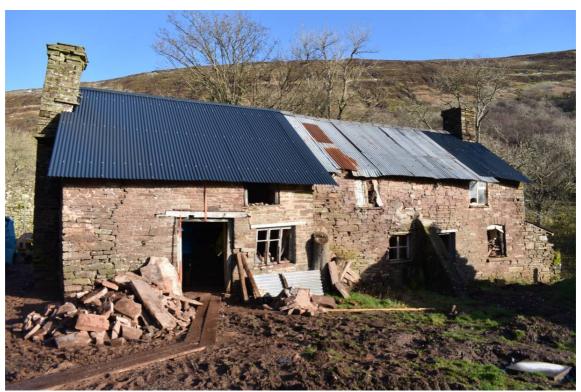
7.2.3 The principal **south elevation** of the range (Figure 5; Plate 4) measures 14m/46ft. long, standing to a maximum of 4m/13ft. high to the east. The western part of the building (**A**) measures 5.5m/18ft long, the eastern section

Plate 4: South elevation of farmhouse.

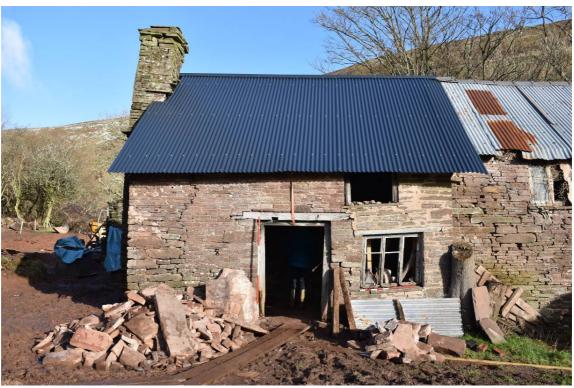
- 7.2.4 The western section (**A**; Plate 5) is furnished with a central exterior doorway [**ED2**] (Plate 8) and three-light window [**w**4] (Plate 9) to ground floor level, and a single window [**w**11] (Plate 10) to first floor level, the latter rising hard beneath the roof plate with a rebated frame for glazing-panels and mortices for a central mullion and diamond-section stanchions to the soffit of the lintel. At the south-eastern angle, the fabric of the short return wall of the western section abuts that of the eastern section in an unbonded 'straight-joint' (Plate 7) suggesting that the latter pre-dates the former; the wall has clearly been subject to significant historical rebuilding, however (including the insertion/modification of three-light window [**w**4]), and caution should be used in inferring a definitive chronological development from this observed 'stratigraphic' relationship (which is somewhat contradicted when viewed from the north).

Plate 5: South elevation, west end, looking north.

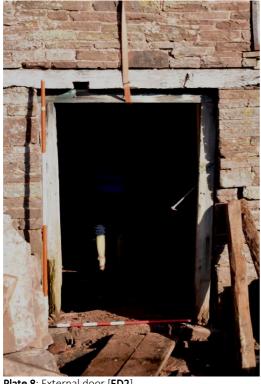
Plate 8: External door [ED2].

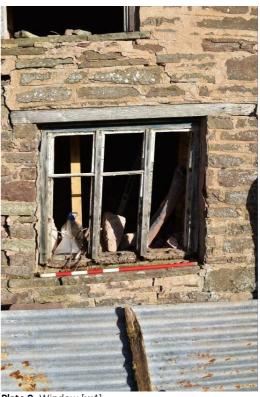
Plate 9: Window [w4].

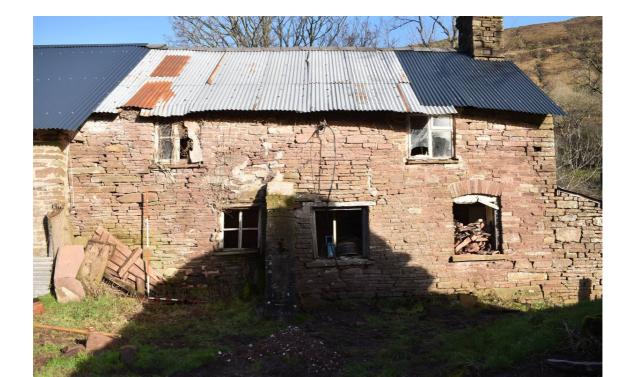
Plate 11: South elevation, west end, looking north.

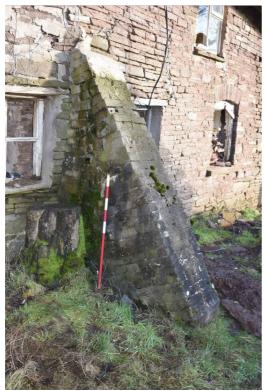
- (B), c.8.5m/28ft.; the junction of the two sections is defined by a 15in offset (Plate 7), the façade of the eastern section being set back from the façade of the western part. Gable stacks rise to east and west, that to the east flush, that to the west projecting. The roof cladding has been fully renewed in a combination of corrugated iron and steel sheeting of various dates, the latter introduced in 2017 as part of consolidation work; the ridge of the eastern roof is finished with capped, angle ridge-tiles. The fabric of the elevation is in generally poor condition, with a full-height, staggered crack evident to the west end (Plate 6), for example, and shows evidence for phases of historical rebuilding, in particular around windows [w1], [w2] and [w4]. An angled brick buttress (Plate 12) has been introduced mid-way along the eastern section of the range to prevent spreading of the lateral walls (post-1927; see inset at §.5.2).<sup>49</sup>

Plate 12: Brick buttress (post-dates 1927).

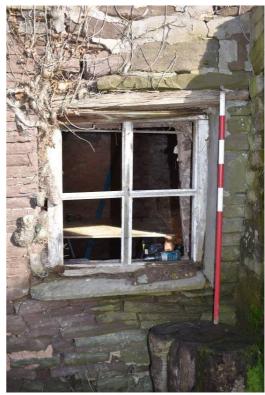
Plate 13: Window [w3].

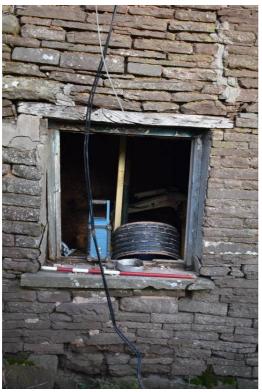
- 7.2.5 The eastern section (**B**; Plate 11) incorporates three windows to ground floor level, *viz*. a square opening with four-pane, cruciform frame [**w**3] (Plate 13), a larger, square-framed opening [**w**2] (frame lost; Plate 14) and, to the far east end, an inserted/modified opening [**w**1] (Plate 15), with segmental stone arch and tooled stone cill, arguably 18<sup>th</sup>- or 19<sup>th</sup>-century in date. First-floor level incorporates two windows, [**w**9] and [**w**10] (Plates 16/17) to east and west respectively, both housing two-light, side opening timber casements, [**w**9] being of 20<sup>th</sup>-century date, [**w**10] stylistically 19<sup>th</sup> century. With the exception of window [**w**1], ground floor openings are spanned by flat, timber lintels and are furnished with projecting, monolithic stone cills; first-floor windows are set hard beneath the wall plate. The upper 0.9m/3ft. of the wall here represents a secondary raising of the range to accommodate an upper floor level internally, reflected in a change in the general character of the masonry (*viz*. a higher proportion of larger, roughly-squared blocks), though this is more clearly expressed in the eastern gable end (see §.7.2.8 below; Figure 7a, Plates 24/5).

Plate 14: Window [w2].

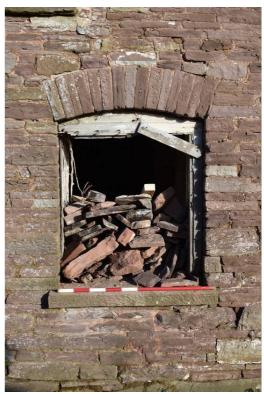
Plate 15: Window [w1].

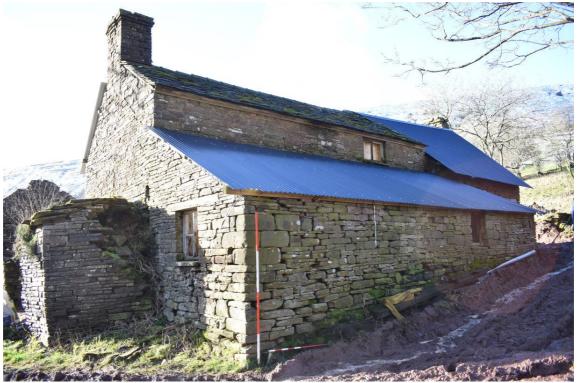
Plate 18: Oblique view of farmhouse and attached dairy extension, north elevation, looking south-west.

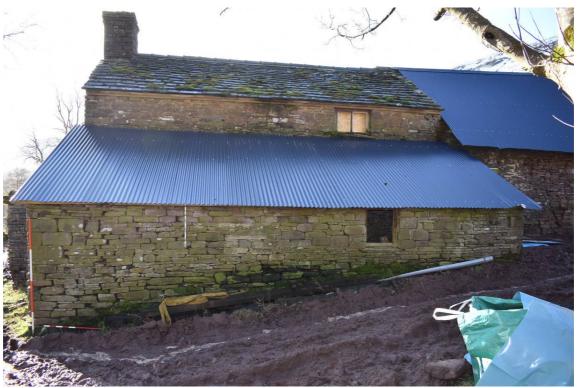
Plate 21: North elevation of farmhouse and attached dairy extension, looking south.

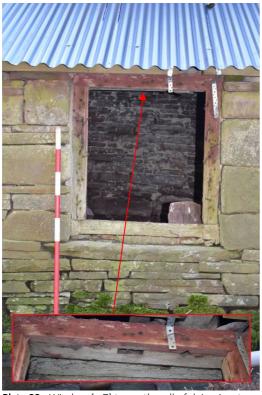
Plate 23: Window [w7] to north wall of dairy; inset detail of mortices to soffit of lintel.

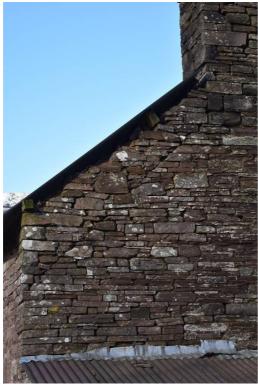
Plate 25: Line of former roofslope to south side.

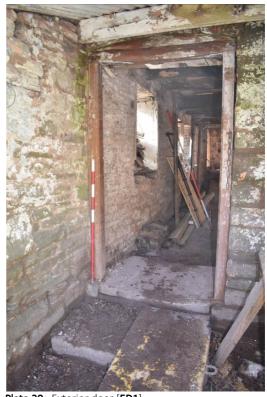
Plate 29: Exterior door [ED1].

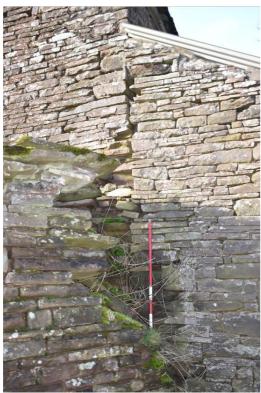
**Plate 32**: Straight-joint between gable and dairy extension.

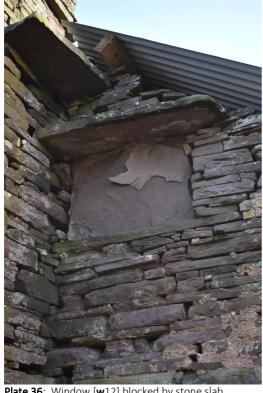
protected by a plain, deeply-projecting drip stone (Plate 36).<sup>55</sup> The south-west angle and lower stack retain traces of former external render; the north-west angle has been recently rebuilt as part of consolidation works undertaken by the current owner in 2017 (see Figure 11).

Plate 36: Window [w12] blocked by stone slab.

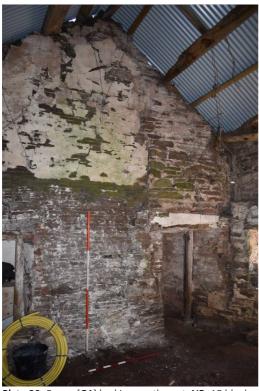
- 7.2.13 The east wall at first floor level retains relic render to apex level, indicating that the upper room was formerly open to the underside of the roof with no ceiling. An area of blocking material above the ground floor connecting door (Plate 39)<sup>56</sup> indicates that the first-floor levels of the western and eastern sections of the range were formerly interconnected.
- 7.2.14 The loss of the entire first floor structure negates the identification of location / form of any original vertical communication between the ground and first floor levels, though this may have been as rudimentary as a simple ladder access that would leave little, if any, trace on the external fabric.

**Plate 39:** Room [**G1**] looking south-east. **NB**. 1F blocked opening above GF connecting doorway (top, right).

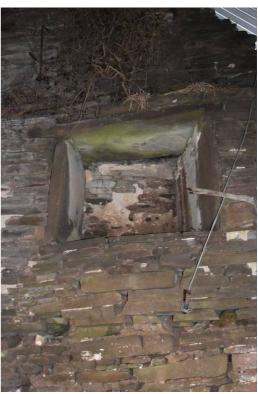
Internal observations indicate window [**w**12] was formerly furnished with diamond-profile mullions and intermediate stanchions (Plate 50).

**Plate 50:** Blocked window [**w**12]; note mullion mortices to soffit of lintel (inset).

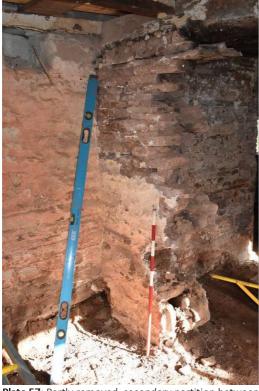
**Plate 57:** Partly removed, secondary partition between rooms [G2/G3].

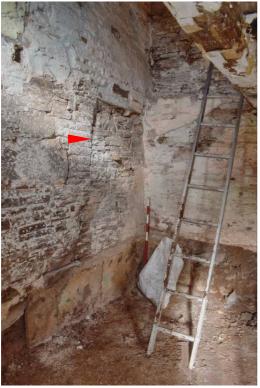
- 7.2.17 Room [G2] historically formed a stair lobby with a ¼-turn stair sited to the north-west angle, rising first south-north and then west to east against the north lateral wall; the profile of the stair is reflected by the 'scar' of the former curved string (Plate 59).<sup>58</sup> (The stair string crosses an apparent blocked opening in the party wall with (A) to the west, possibly indicating that the wall cupboard in the east wall of [G1] has been adapted from a former window opening). Lobby [G2] is lit by window [w3] in the south wall, a cruciform softwood frame within splayed reveals (Plate 61); the window opening has been modified, reduced to the east where the

Plate 59: Site of former stair at [G2]; NB. scar of curved string and possible blocked window (arrow).

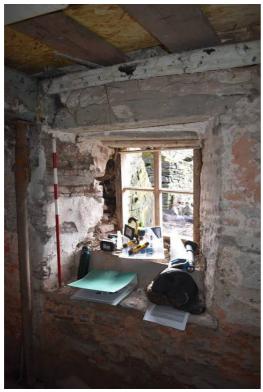
Plate 61: Reduced window [w3] lights [G2].
