Hallside Farm, Cambuslang
Standing Building Survey and Evaluation
Project 4068

Hallside Farm, Cambuslang

Standing Building Survey and Evaluation

Project Number: 4068

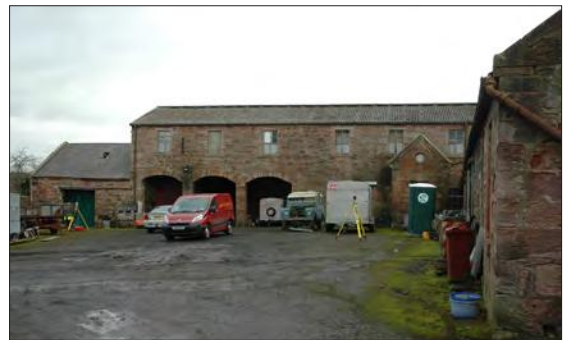
Plate 3: General shot of main barn, byre & yard.

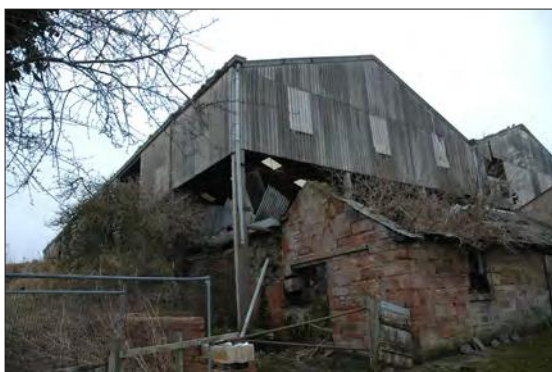
Plate 4: General view of modern corrugated barn joining earlier barn.

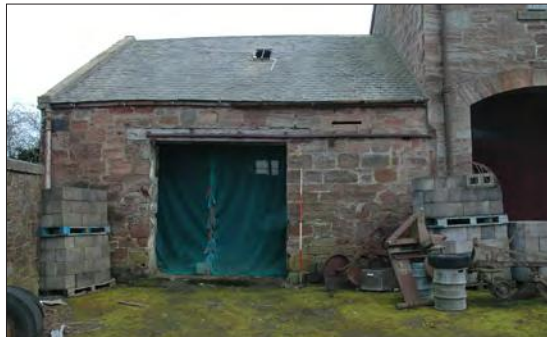
- 7.7.2 The west facing elevation of the building (elevation 2, Figure 2) consists of a one storey byre (Figure 4; Plate 9) to the north of the elevation. The byre has a large opening where a sliding door has previously existed, the metal bar structure is still visible above the entrance way (Plate 10). There is a thin horizontal stone vent found to the south of the door and a smaller opening found below the sliding door metalwork. The roof of the byre is constructed from slate and includes one metal window. It is suggested that the byre is a later edition to the main barn, where it abuts the two storey barn structure chamfering can be seen on the lower quoins.

Plate 10: General view of the west facing elevation of the byre.

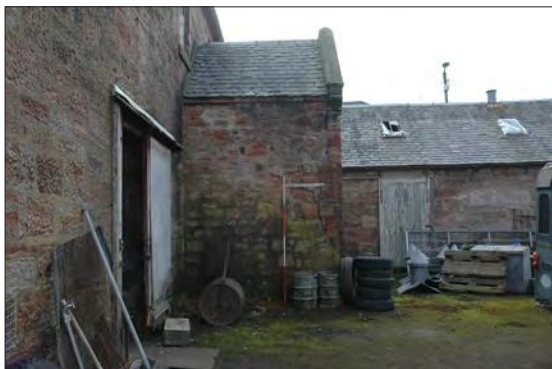
- 7.7.4 Towards the south of elevation 2 an annexe can be seen. It is constructed using the same semi coursed sandstone as the main barn on the north facing elevation (Plate 11), however the West and South facing elevations are constructed using a using a far more regularly coursed structure with tighter mortar joins. The north face appears to have had several repairs with large patches of mortar being visible. It is worth noting that the lower stones are yellow in colour rather than the pink colour of the rest of the buildings. The west facing elevation is particularly ornate in comparison to the rest of the barn structure with dressed stone surrounding the main timber window and a smaller hexagonal window with a stepped stone decoration is seen directly above this (Plate 12). The roof of the annexe is constructed from slate.

Plate 11: North facing elevation of annexe.

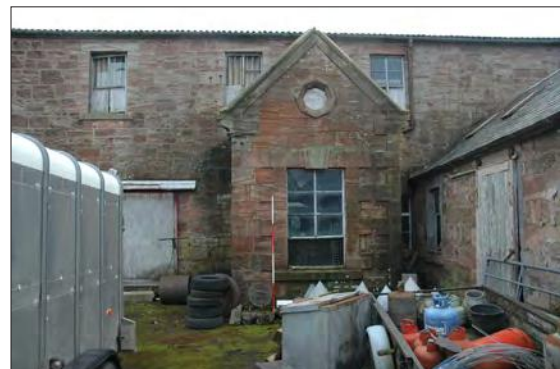
Plate 12: West facing elevation of annexe.

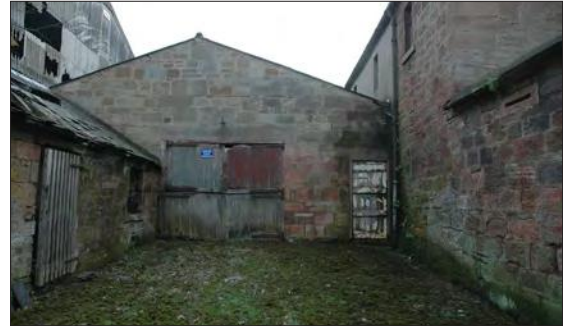
- 7.7.5 North facing elevation 6 of the main barn is a gable end shows evidence of weathering on the stonework with considerable amounts of moss found at the base of the elevation. Below the peak of the elevation a dovecot is visible (Plate 13). In line with the base of the roof line two horizontal linear stone vents can be seen. Elevation 8 consists of a semi coursed predominantly grey stone structure and relates to room 3 in figure 2 (Plate 14). It is a gable end of the later structure that has been added to the main barn and has a corrugated iron roof. There is a large central timber double door within the elevation that abuts the join between elevations 8 & 9 and a timber single door to the west.

Plate 14: General view of north facing elevation 8.

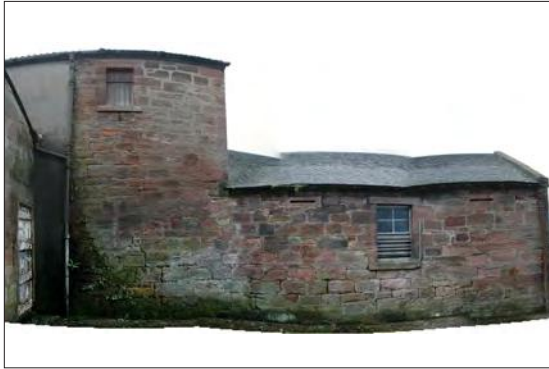
- 7.7.7 The east facing elevation of the main barn is only partially visible to the north and south of the buildings due adjacent structures. Stonework is primarily visible on elevation 7 with rendering visible at the southern end of the elevation (Plate 17). There is evidence of repair visible where the two storey main barn joins the single storey byre (Plate 17a). The presence of thicker areas of mortar and the use of small packing stones within this area would provide further evidence to the suggestion that the byre was a later addition to the main barn. Two windows are visible on the elevation, on the first floor of the two storey building and centrally on the single storey building. Two horizontal linear stone vents are also visible towards the top of the single storey building. A blocked vertical linear vent can be seen adjacent to the downpipe of the two storey building. Elevation 54 is constructed of exposed stonework and contains a large opening raised approximately 0.8m above ground level, an internal timber sliding door is visible (Plate 18). A degraded Timber slab ramp is used to gain access to the building. Elevation 55 is a rendered elevation and contains a large opening with visible internal timber sliding door (Plate 19). The opening is slightly overlapped by the modern corrugated iron barn structure. Elevation 55 is part of a later construction of the main farm building which relates to Room 4 on Figure 2. The roof is constructed of corrugated iron.

Plate 17: Merged photographs showing east facing elevation 7 of the main barn.

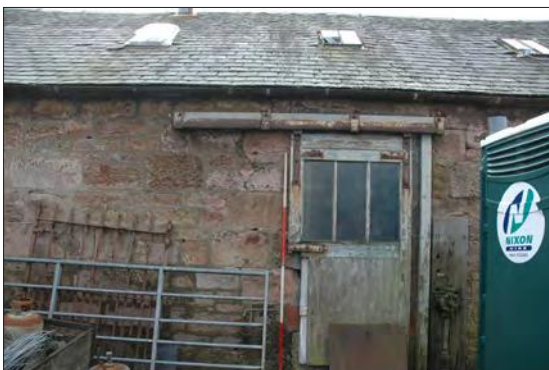
- 7.8.1** The South barn abuts the main barn on its western edge (Figure 2). It consists of a single storey semi coursed stone building and has a slate roof. The north elevation (elevation 4) has five door openings four of which are timber sliding single width doors (Figure 5; Plate 20). There are two timber windows visible on the main elevation at either end of the elevation, the windows appear to be in good condition. There are also ten metal roof windows visible, many of which have broken panes. Adjacent to the second door from the east is a water pipe (Plate 21). There are three round metal chimney vents on the roof along with a standard ceramic chimney.

Plate 21: Detailed view of water pipe on elevation 4.

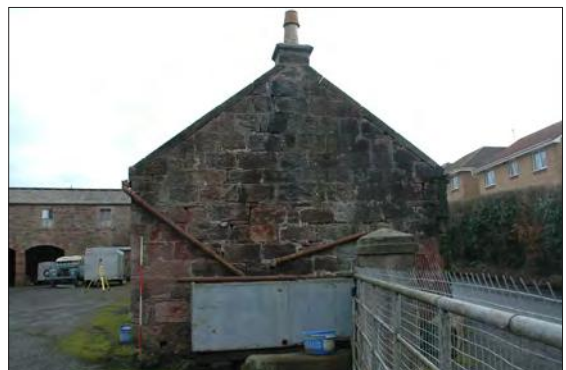
Plate 22: General view of elevation 5.

- 7.8.2** The west facing elevation 5 is a gable end of exposed stone (Plate 22). There is little detail to note on this elevation, a small opening can be seen in the lower north corner of unknown use. A large water tank sits in front of the elevation which is fed by two angled downpipes, with a third lying across the tank itself. Visibility of any other features on this elevation is greatly compromised by the presence of the water tank and boundary wall.
- 7.8.3** The south facing elevation 52 comprises the single storey pitched roof elevation of the south barn and towards the east the two storey gable end of the main barn. Along the south barn

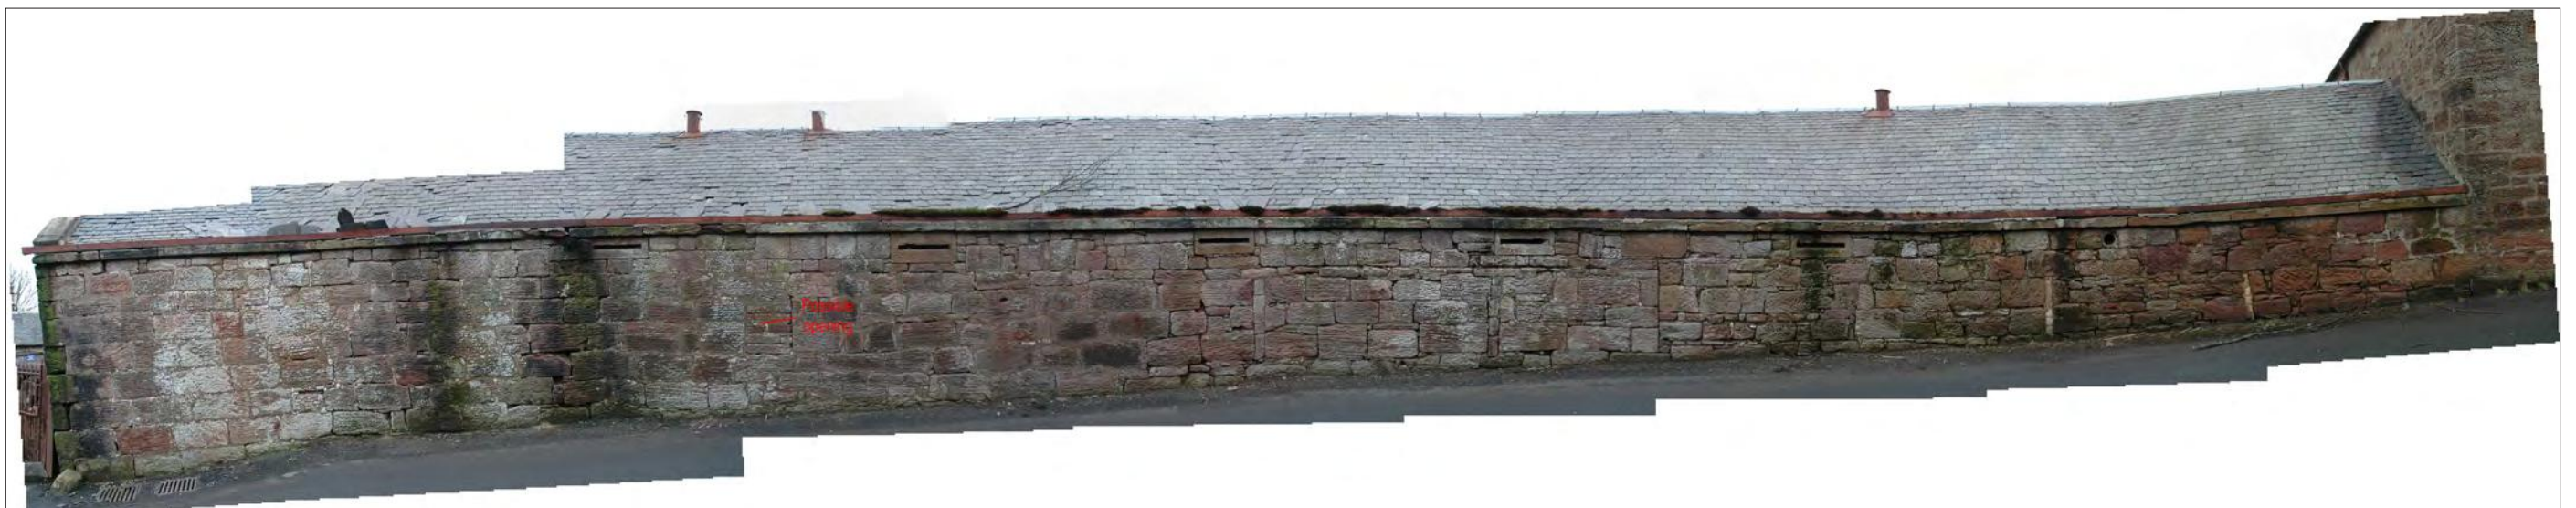
Plate 23: Merged photographs of the western end of elevation 52.

elevation there are five horizontal linear vents visible and one circular vent along the length of what would be the largest room of the south barn (Plate 23). There is a possible small blocked opening visible towards the eastern edge of the building. Along the elevation it is possible to see several T-shaped stone settings, these are believed to be the remnants of stall placements which have since been removed from the interior (Plate 24). There are many slate tiles missing from the roof and several gathered in the metal gutter towards the western end. Overall the stonework is in good condition however there is some evidence of water damage where gutters have overflowed. Towards the east of elevation 52 we see the gable end of the main barn (Plate 25). There are three window settings visible, the two lower windows have been blocked with stone whilst the first floor window has been covered over with a board.

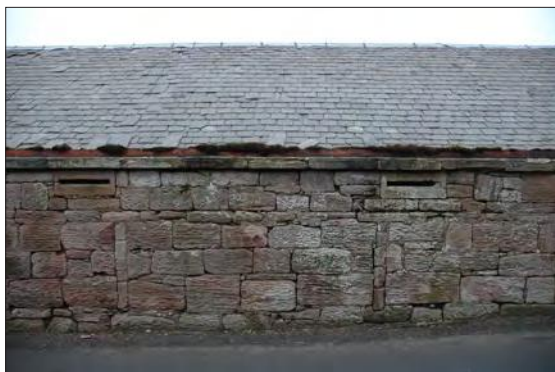
Plate 24: Detail of T shaped stall evident on elevation 52.

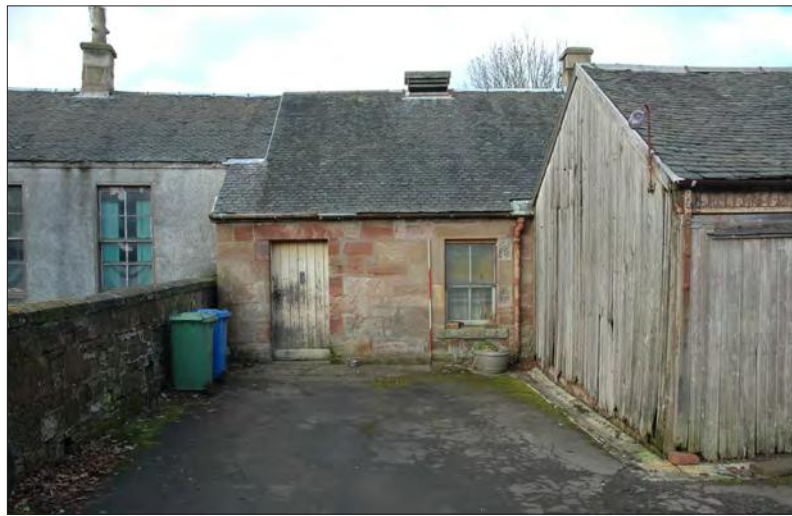
7.9.1 The boiler house is constructed of a T-shaped semi-coursed stone building with a timber panelled extension to the south west. It is in a poor state of repair with two areas of collapse visible on the northern pitched roof (Figure 6; Plate 26). The roof is constructed of slate tiles and is visible further along in elevation 11 (Figure 2). There are four timber vents remaining on the ridge of the roof, two of which are in good condition. There is also a stone chimney stack visible but no pots. On elevation 15 there is evidence of repair to the structure of the wall evident in the presence of large areas of mortar filled cracks. There are three stone circular vents visible along the top of the wall. The stonework for elevation 13 appears to be in good condition however the adjoining timber panelled structure has suffered from damp at its base (Plate 27). A chimney with two pots is visible central to the stone gable. There are two large openings on the timber structure, a timber sliding door and internal door. Due to the dangerous nature of the building no internal data was recorded. Elevation 11 is in good condition. A single timber door and timber framed window are visible (Plate 28).

Plate 28: General view of elevation 11.

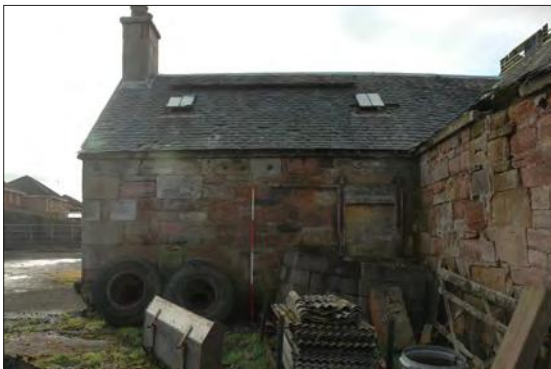
- 7.9.2 The east facing elevation 14 contains a single timber sliding door and two metal roof windows (Figure 7; Plate 29). Elevation 16 is the eastern gable end of the structure (Plate 30). It contains a single timber sliding door. There are large cracks evident in the northern edge of the gable. There is no roof evident at this end of the building due to collapse, a number of small stones can be seen piled along the roof line of the wall. There are few significant features visible along the eastern end of elevation 17 (Plates 31 & 32). Circular vents can be seen running along the length of the elevation. Two metal brackets can be seen towards the centre of the elevation, perhaps used for structural support (Plate 33). Towards the west end two covered windows can be seen, adjacent to this is where the farmhouse structure abuts the earlier building.

Plate 29: General view of elevation 14.

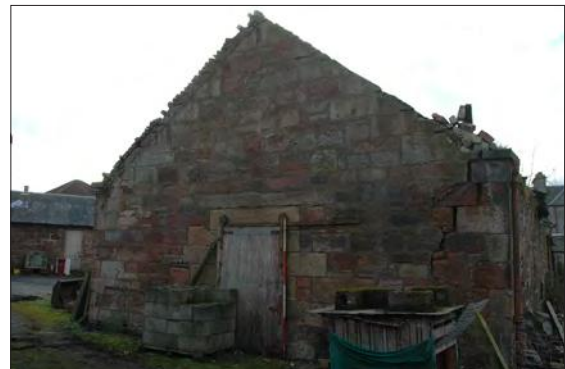
Plate 30: General view of elevation 16.

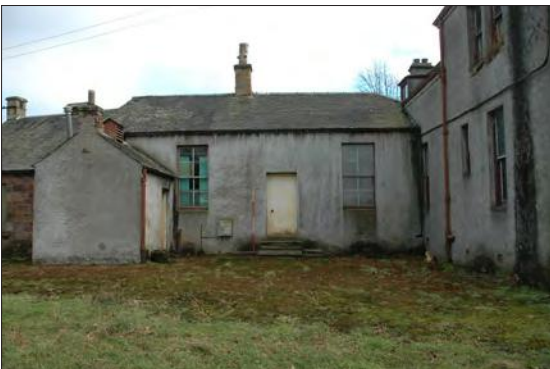
Plate 34: General view of farmhouse elevations 19, 20 & 21.

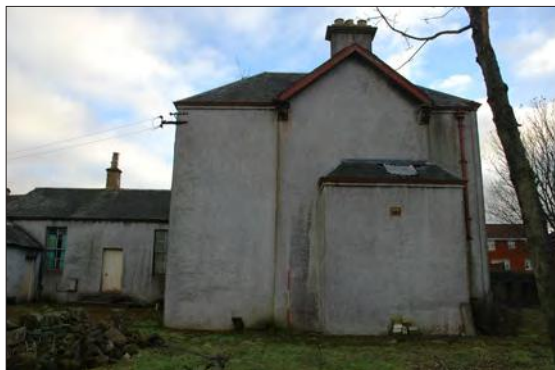
Plate 36: General view of farmhouse elevations 21 & 23.

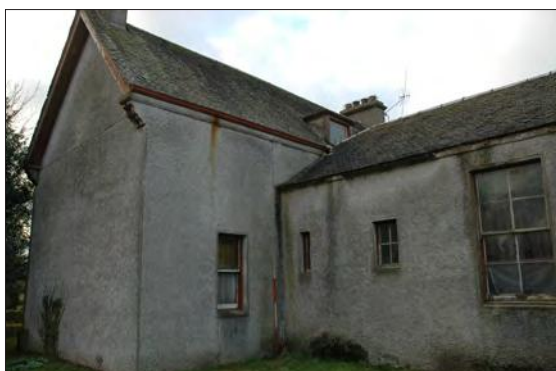
Plate 38: General view of farmhouse elevations 26, 27 & 28.

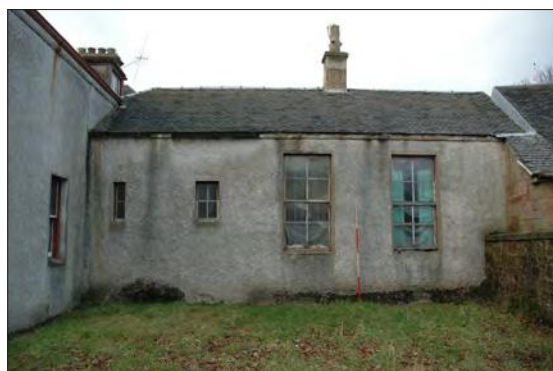
Plate 39: General view of farmhouse elevations 27 & 28.

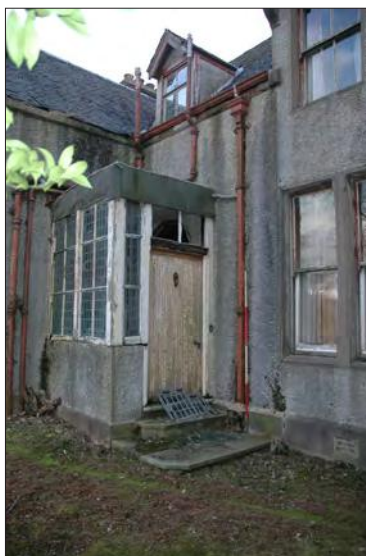
Plate 40: General view of farmhouse porch area.

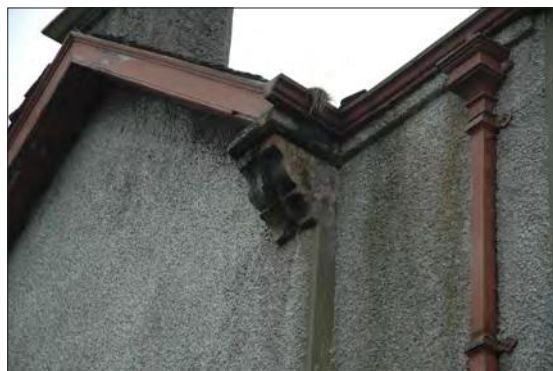
Plate 41: Detailed view of stone corbels.

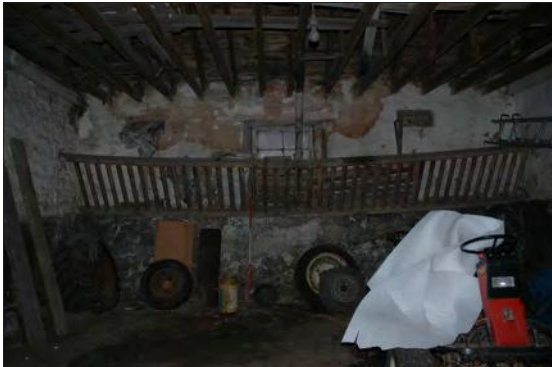
7.11.1 This room is accessed from the courtyard and measures 7 m by 7.5m. There is a window opening on the west facing wall and vents on all four walls (Plate 42). The vent on the internal north facing wall has been created through a recessed shelf in room 2 (Plate 43). There is no evidence of a link to the main barn building.

Plate 42: General view of byre west facing wall.

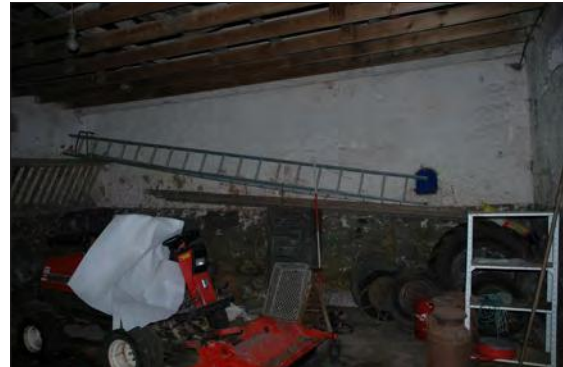
Plate 43: General view of byre north facing wall.

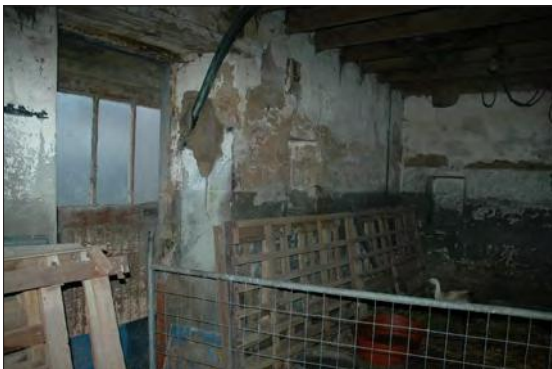
Plate 44: General view of the recesses visible in the south facing and west facing walls of the south barn.

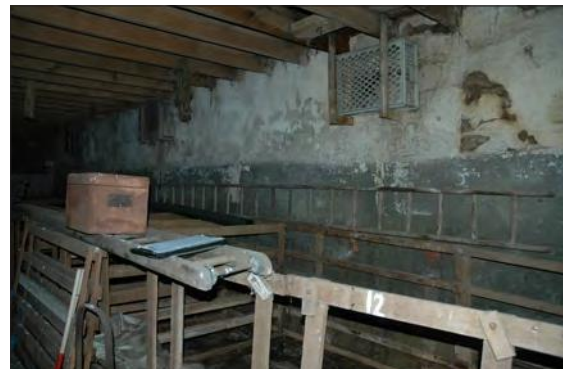
Plate 45: General view of north facing internal elevation of the south barn showing stall positions.

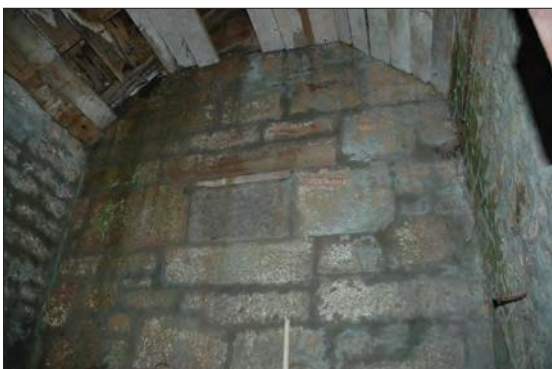
Plate 46: View of possible blocked opening on west facing internal elevation of the annexe.

7.13.1 This room is accessed from the courtyard and measures 2.3 m by 2.3 m. There are two windows within the room, as visible on the external elevation 1. The door way is constructed of a single width externally opening double door. On the west facing wall there is possible evidence of a blocked opening into the main barn room 1 (Plate 46). On the south facing elevation 32 there is further evidence of blocked openings (Plate 46a). These have been identified by the farm owner Mr Letham as the possible location for former drive shafts or belts.

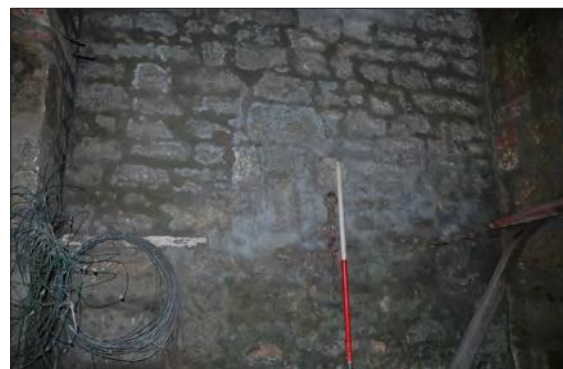
Plate 46a: General view of south facing elevation 32.

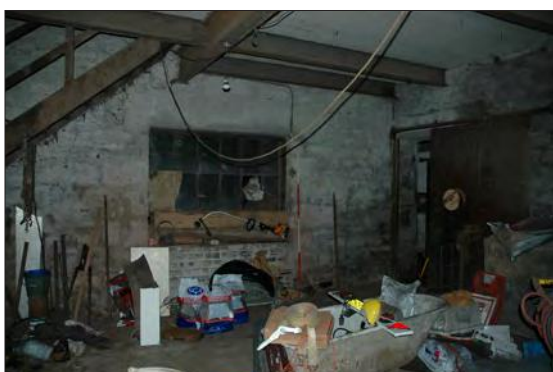
Plate 47: View of window present on internal elevation 43 in room 1 of the main barn.

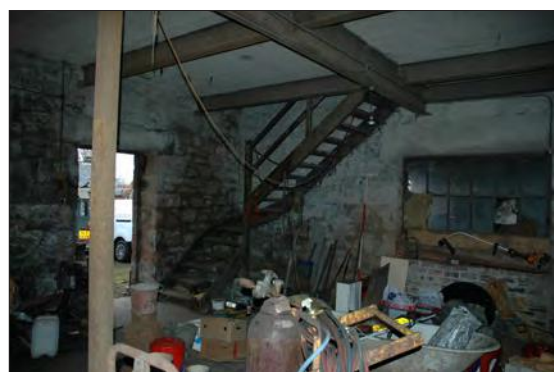
Plate 48: View of stairs, beams, column, window and external doorway in room 1 of the main barn.

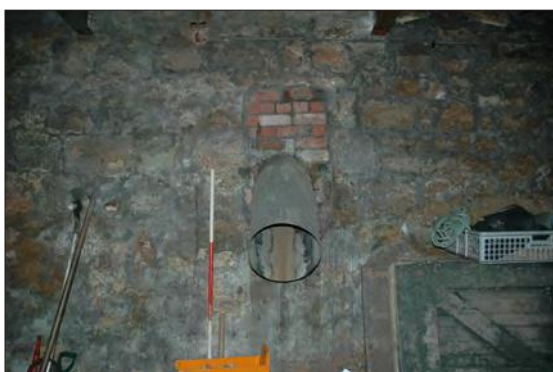
Plate 49: Detailed view of elevation 40 chute.

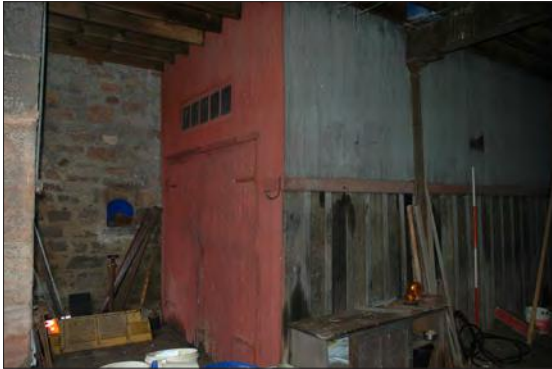
7.15.1 This room is currently used for storage, it is accessed via the courtyard and measures 10.8 m by 7.3 m. Within the north east corner of the room there is a timber panelled structure which measures 3.3 m by 5.4 m around its exterior (Plate 51). This area was not accessed during the survey but is the assumed location of the blocked vertical vent identified on elevation 7. Two recessed shelves can be seen in the room on elevations 33 & 38 (Plate 51). A hole has been

Plate 51: General view of timber panel structure and recess in room 2.

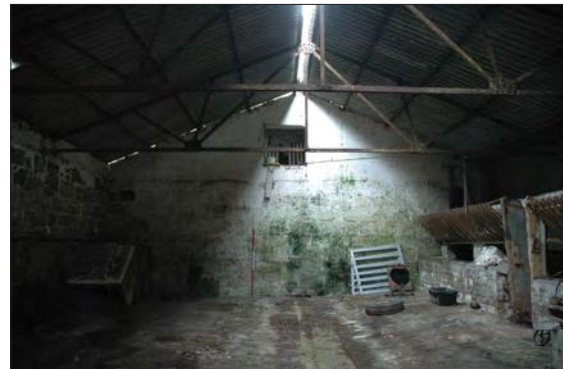
Plate 54: General view of elevation 38 in room 3 showing feeding troughs and separating wall.

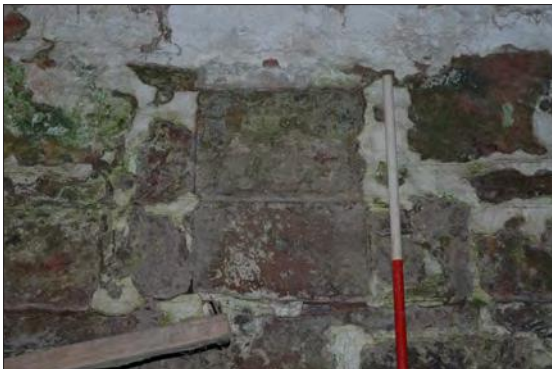
Plate 55: Detailed view of blocked opening from elevation 37 in room 3.

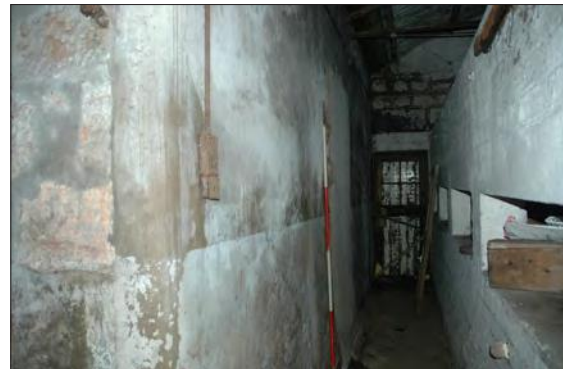
Plate 56: General view of single door found on elevation 36 in room 3.

7.16.1 This room is accessible from room 1 and the rear courtyard behind the byre. It measures 12.5 m by 9.8 m. The room is split into two areas by a 0.87m thick brick wall which runs the length of the room offset 1 m from the east facing wall. A large window can be seen on the north facing elevation 38 linking rooms 3 & 4. The larger area of the room was previously used for feeding animals (Plate 54). Along the west facing elevation 37 three blocked openings are visible approximately 1.4 m above floor level c 0.4 m by 0.6 m each in size, these are possible windows that have been blocked up during the construction of the modern barn (Plate 55). The south facing elevation 36 contains two doorways, a large double door found within the feeding area and a single door found at the end of the wall separated corridor (Plate 56).

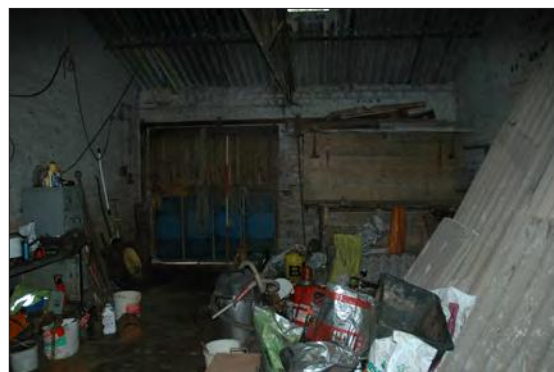
Plate 57: General view of elevation 45 in room 4.

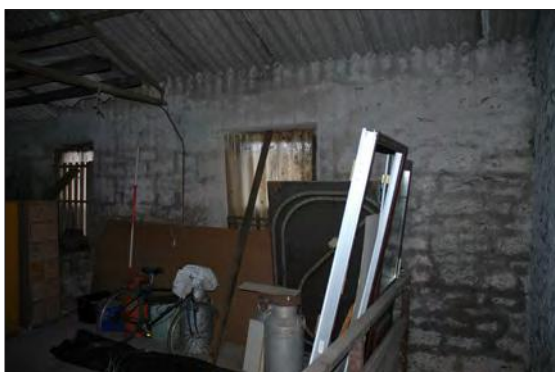
Plate 58: General view of the elevation western end of elevation 49 taken from the doorway between rooms 5 & 6.

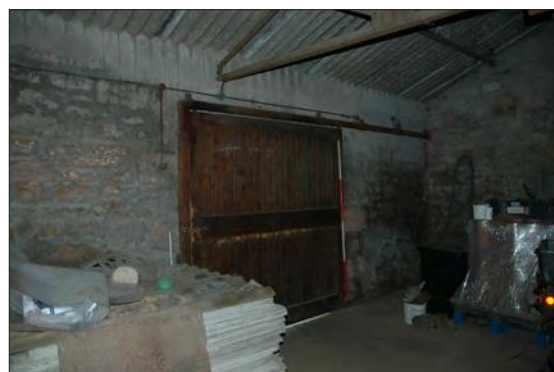
Plate 59: General view of the timber sliding door found on elevation 51.

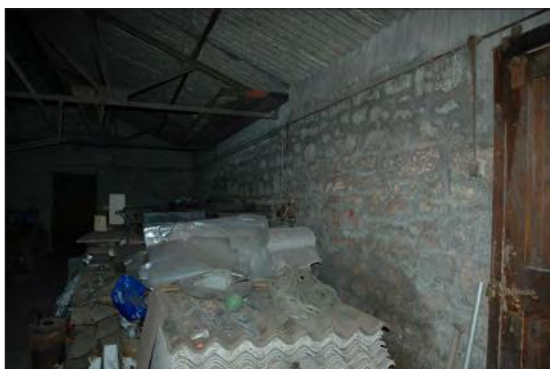
7.18.1 This room is the first accessible room on the first floor of the main barn building (Figure 3). It is accessible via a timber staircase from room 1 and the rear of the barn. The ground level at the rear of the barn is just below the level of this floor. The room measures 15.7 m by 7.48 m. This room is currently being used for storage, the original timber floor has been replaced with concrete, the walls are bare with evidence of concrete render found below the roof line (Plate 58). The bare corrugated iron roof and open metal trusses are visible in the ceiling. There are three timber framed windows found on the east facing elevation 49 towards the north of the room and a further window found on the north facing elevation 50. A timber sliding door can be seen towards the south east corner of the room (Plate 59). Directly beneath the window on elevation 50 a trap door can be seen that gives access to the chute below. Large amounts of material found within the room make it difficult to identify any further features (Plate 60).

Plate 60: General view of elevation 48 taken from the sliding doorway of elevation 51.

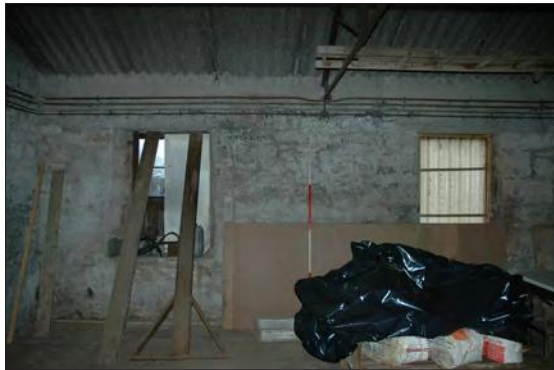
Plate 61: General view of south west corner of room 6 showing concrete render below roof line.

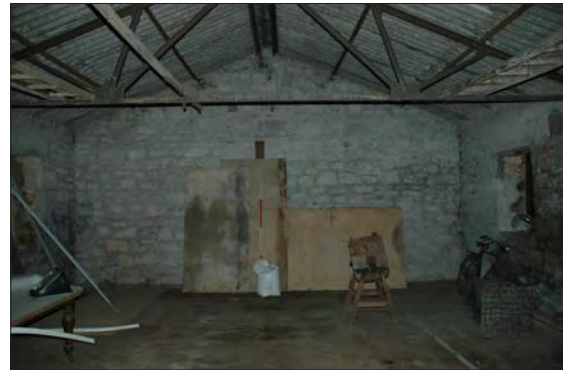
Plate 62: General view of northern end of room 6 showing concrete render below roof line. of elevations 59 & 57.

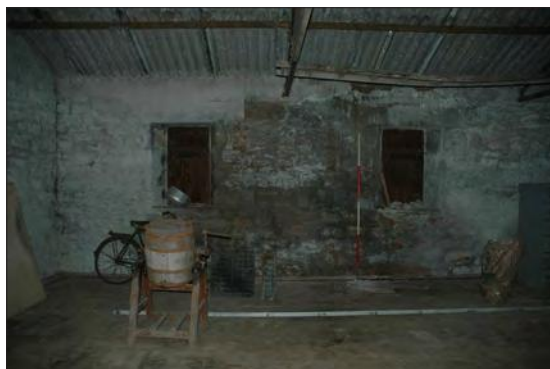
Plate 63: General view of southern end of west facing elevation 59.
