Newstead Farm, Quarry Street, Woolton, Liverpool, L25 6DY (20F/0184)

A Programme of Historic Building Recording

Document No: 3491.R02a July 2020

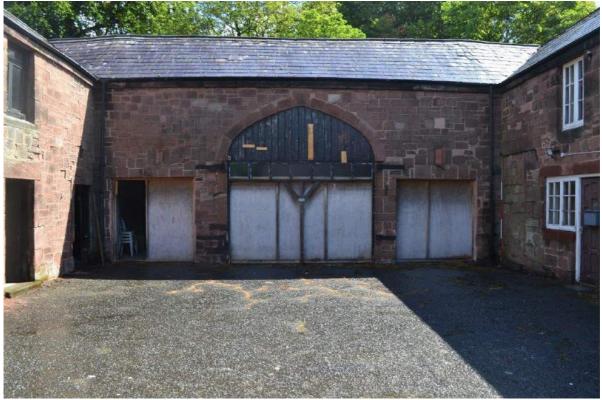
Plate 10: Sightline to the east from the farmyard showing the west-facing, random-coursed elevation of the barn with the cart-entrance blocked up and two doorways inserted either side of it, curtailing the arrow slit vents.

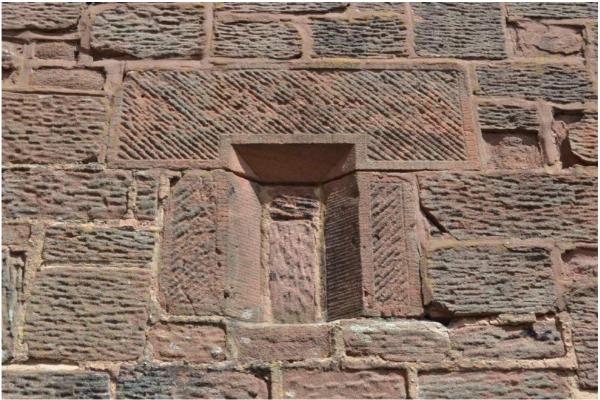
Plate 15: Detail of curtailed and blocked arrow-slit vent.

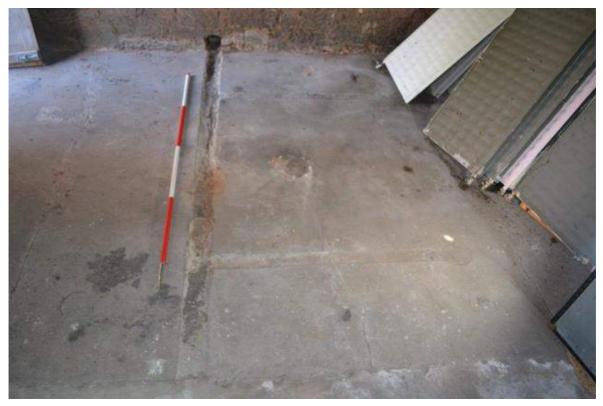
Plate 20: Concrete floor of the barn, with shallow channels leading to an aperture in the northern wall.

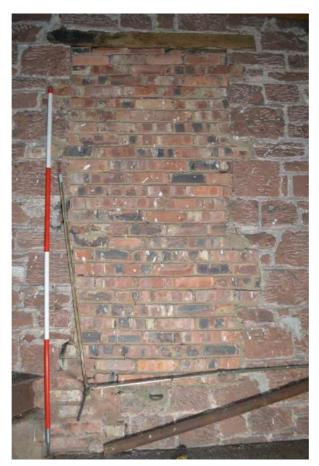
Plate 25: Detail of bricked-up door way into the first floor of the farmhouse
