# Woolsington Hall

*Woolsington, Tyne and Wear*

Post-fire recording works, clearance and materials recovery

Project AA.1964

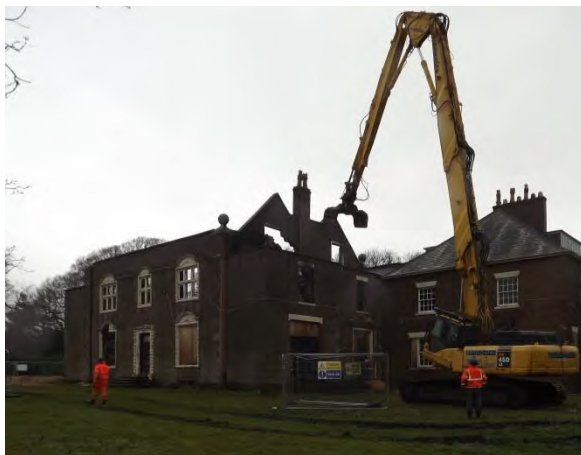
*Plate 6 Mechanical demolition*

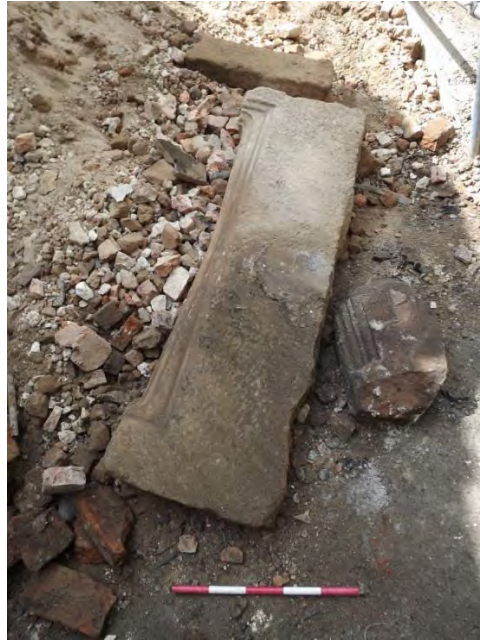
*Plate 9 Fallen lintel and other elements of a 17<sup>th</sup> century fireplace*

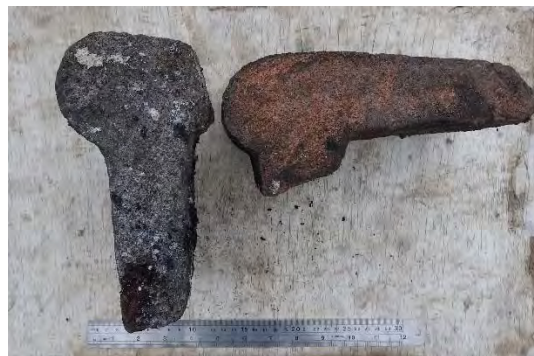
The roofing slate was very noticeable by its absence from the deposits mostly represented by small fragments and only a small handful of partial slates; the majority were evidently completely destroyed in the fire. A small number of copper slating nails were seen on the conveyor belt. The roof ridges (find no 067) were all heavily heat affected and shattered into small friable lumps of coarse grained sandstone but a few were intact enough to reconstruct the profile (*figure 1*).

Figure 6 roof ridge profile (find no 067)

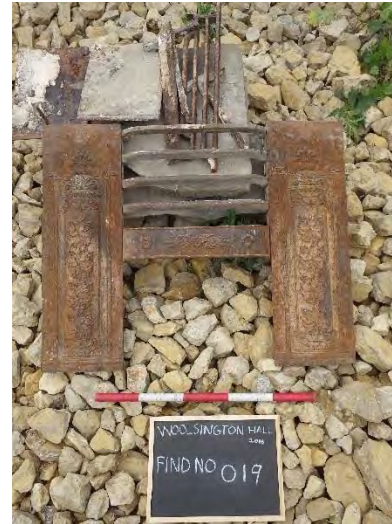
Plate 21 S09 fireplace as recovered (find no 019)

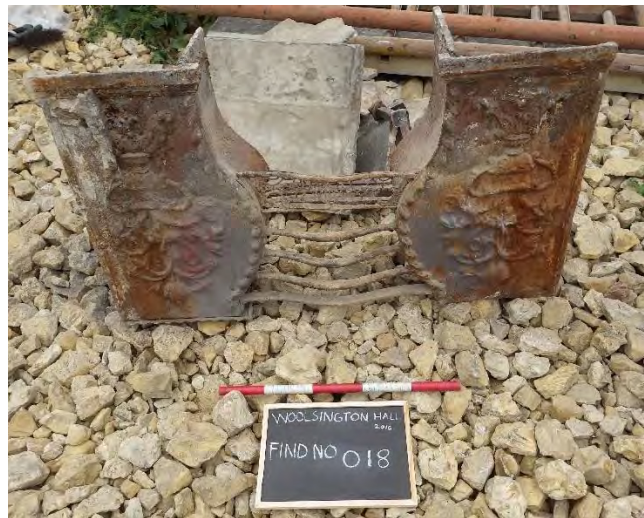
Plate 25 S08 fireplace as recovered (find no 18)

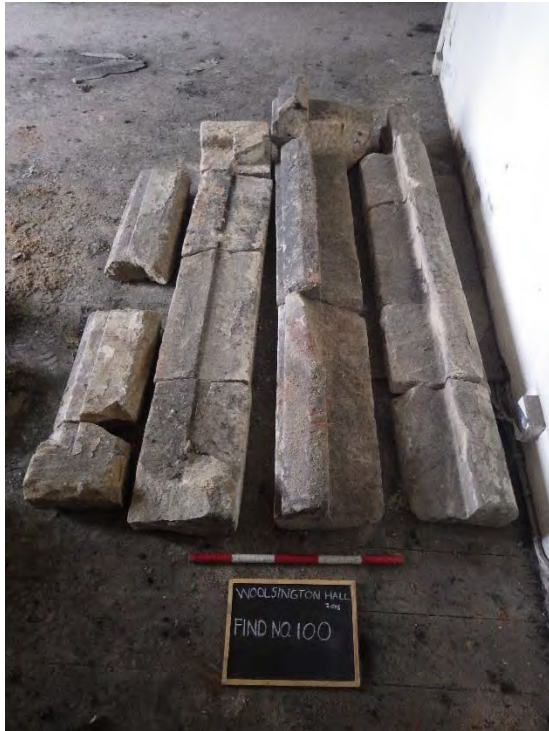
The gable window to the east was largely recovered in pieces (find no. 100) but all were recovered apart from parts of the shattered lintel.

Plate 26 room S08 window (find no 100)

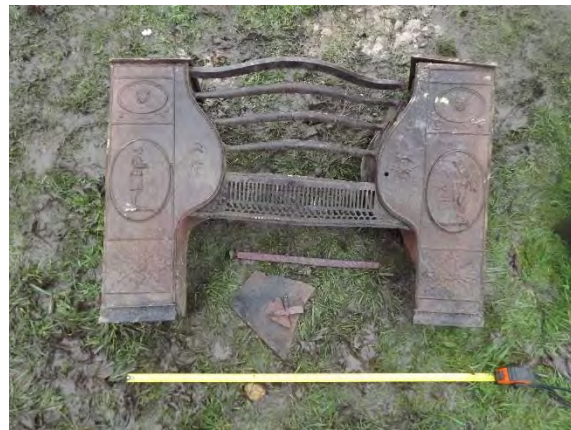
Plate 29 S07/6/5 fireplace as recovered (find no 007)

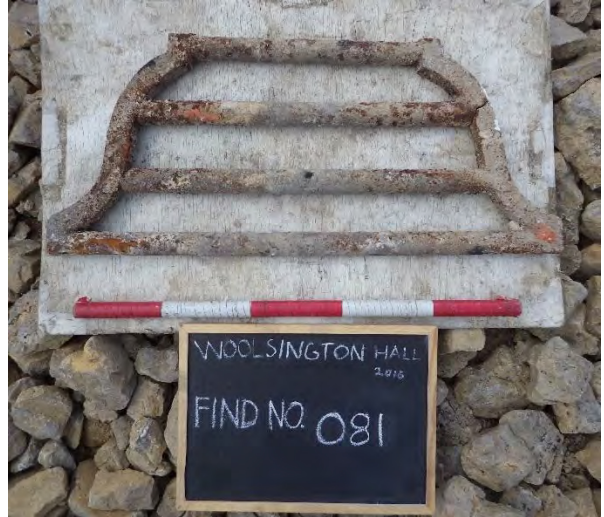
Plate 31 S04 fireplace as recovered (find no 081)

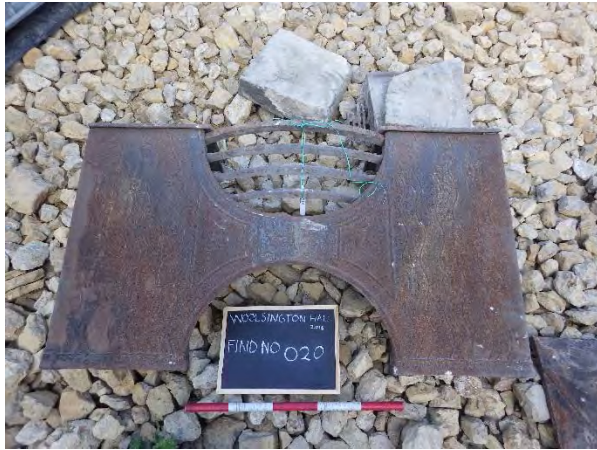
Plate 36 F04 fireplace as recovered (find no 020)

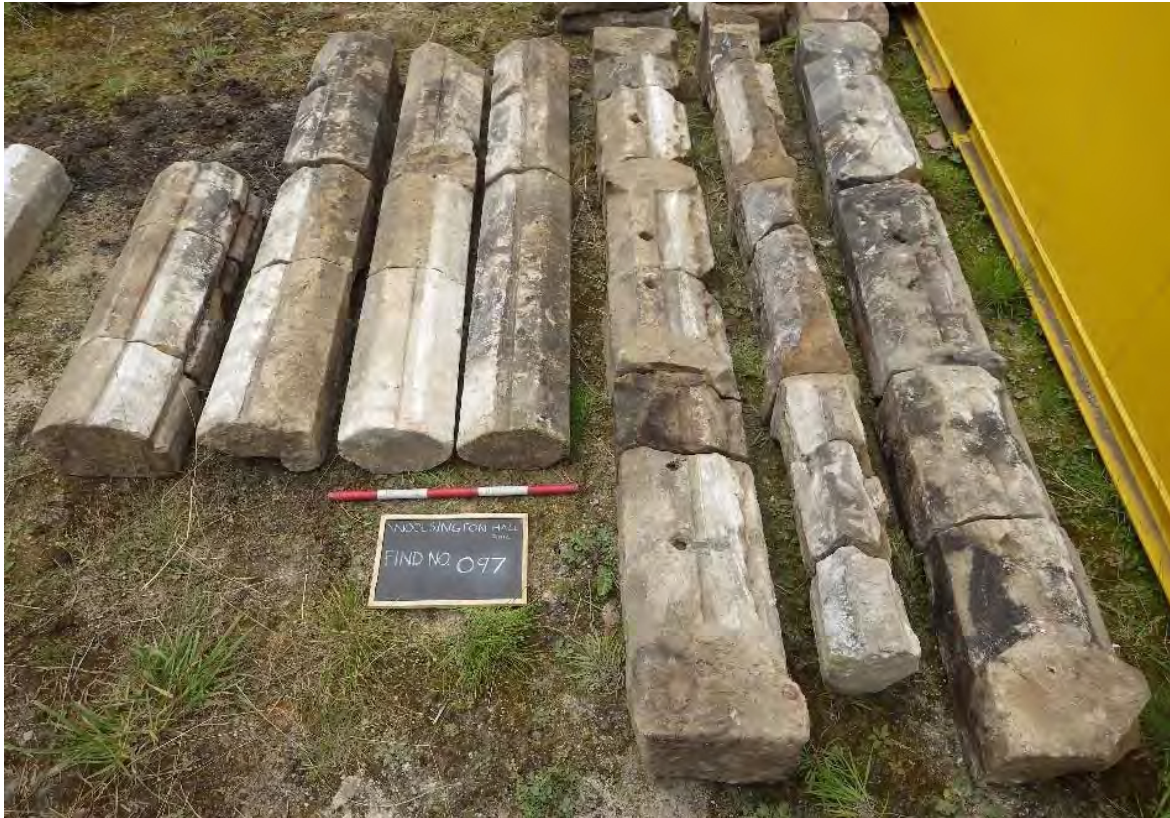
The blocked up original mullioned window within the west wall of room F04 had been visible within the later westwards extension (room F05) before the fire. This fell when the walling and gable above collapsed. Its masonry (find 097) was recovered but the pieces were mostly broken. However by piecing the bits together a record and reconstruction of the original form was made from measurements from the fragments.

Plate 39 Room F04 original window remnants as recovered (find no 097)

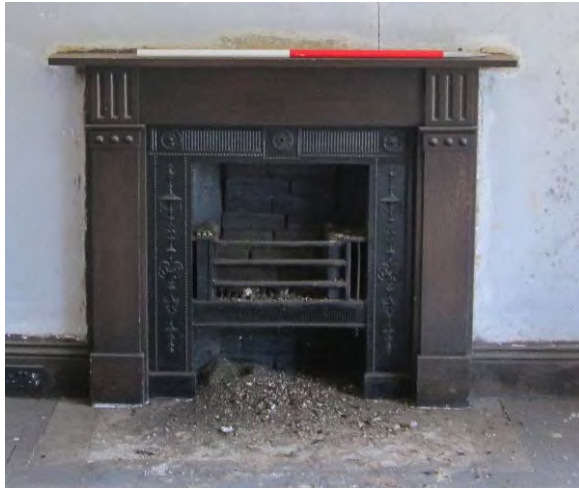
Plate 40 F06 fireplace in situ

The fireplace on the south wall of room F6 (find 022) appeared to have had a timber surround but this was revealed to have been of grey, veined marble painted to look like wood. This fireplace collapsed into the basement below during the fire and was buried beneath the demolition rubble, this collapse breaking the cast iron work within and the marble slips recovered in multiple fragments.

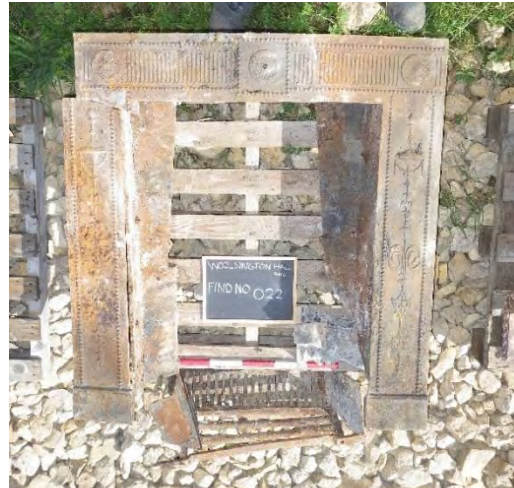
Plate 41 F06 fireplace as recovered (find no 022)

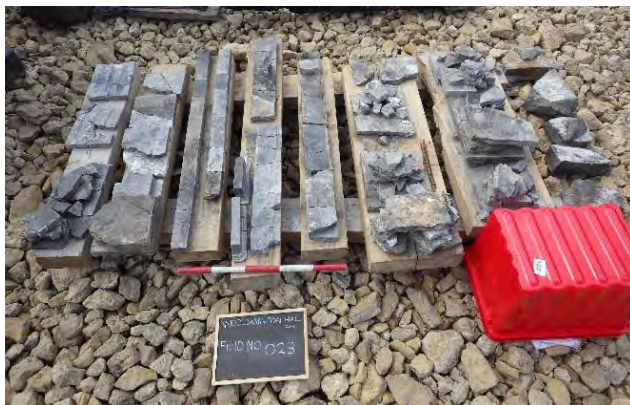
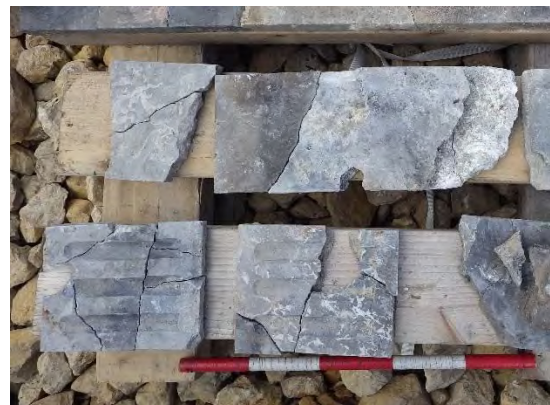
Plate 42 F06 marble surround? (find 023)

Plate 43 F06 marble surround detail (find 023)

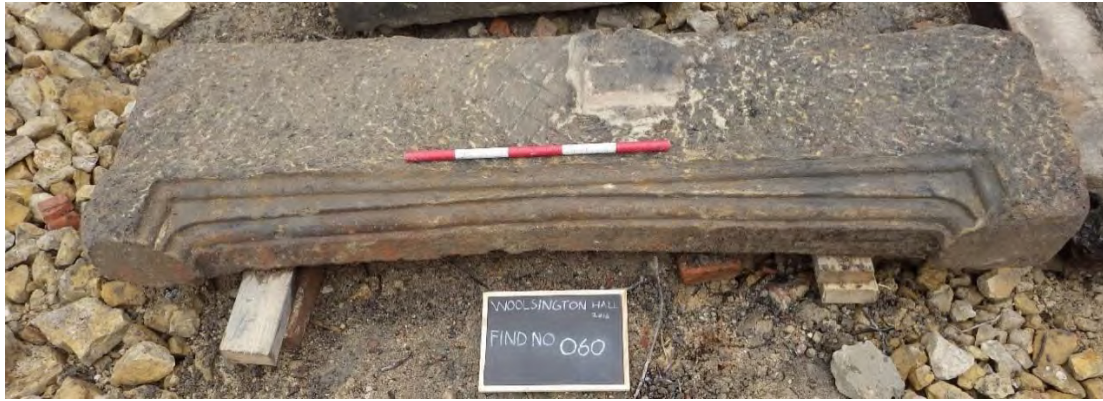
Plate 44 F06 large stone lintel

Also fallen into the basement was a massive stone fireplace lintel of 17<sup>th</sup> century character (find 060); this had evidently been concealed behind plaster; parts of the jambs of the feature were also recovered.

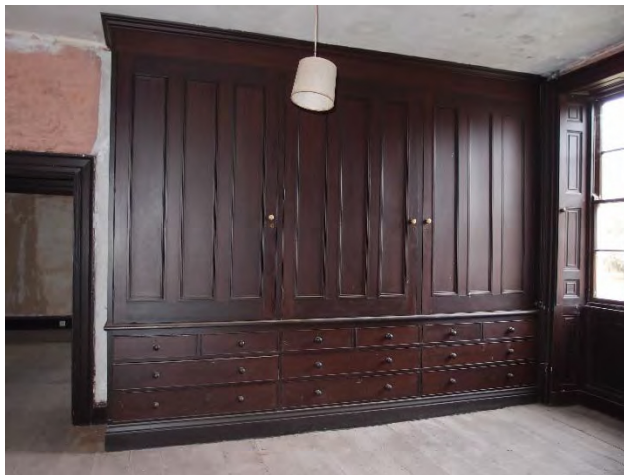
Plate 45 F08 linen cupboard pre fire

Formerly existing along the west side of room F08 was a full-length linen press, possibly of later 19<sup>th</sup> century date. Although wholly destroyed a number of its door/drawer locks were recovered.

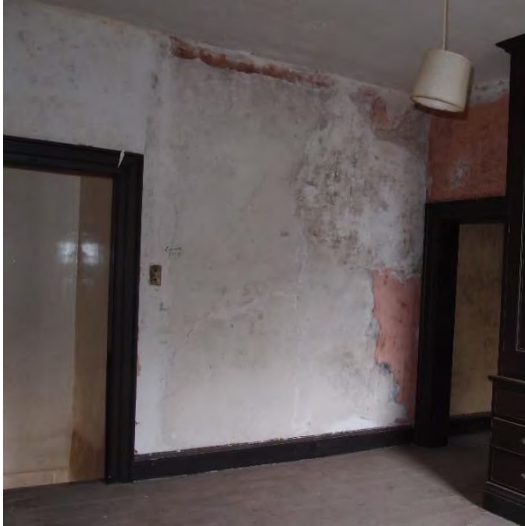
Plate 47 F08 south elevation pre fire

The walls within the room had been fully lined and plastered but following the fire and collapse/demolitions a large stone fireplace surround was revealed on the south wall, this of the same character as that seen in F06 (find no 060), of late 17<sup>th</sup> century date. The stones of the feature were recorded in situ before that part of the chimneybreast was dismantled and the stones recovered.

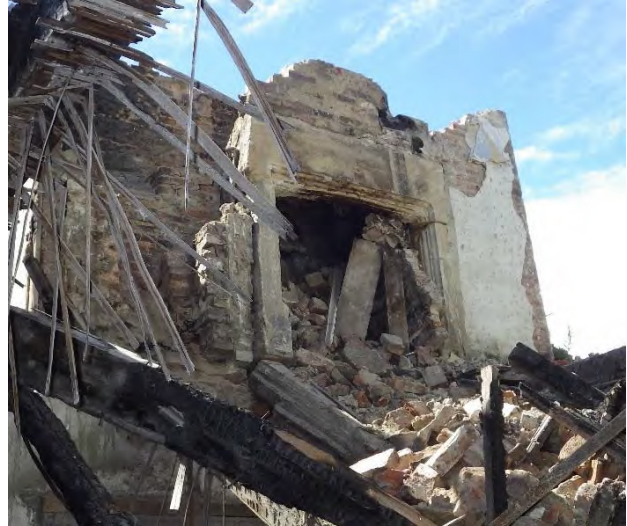
Plate 48 F08 south elevation post fire , fireplace (find no 025) exposed

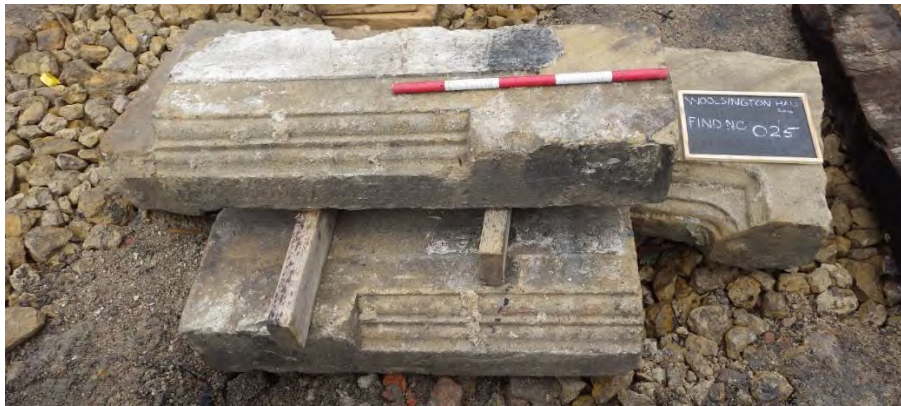
Plate 49 F08 stone fire surround recovered (find no 025)

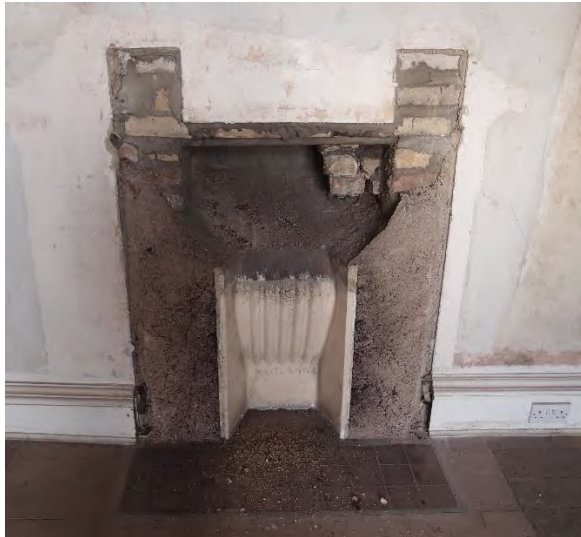
Before the fire the surround of the fireplace on the north wall of room F09 had already been removed; but it was clear from what remained of its interior that this must have been of 20<sup>th</sup> century date. During demolition this later work proved to be an infill within an original fireplace opening; the large side slabs of the original revealed still to be *in situ*.

Plate 50 F09 - modern fireplace infill

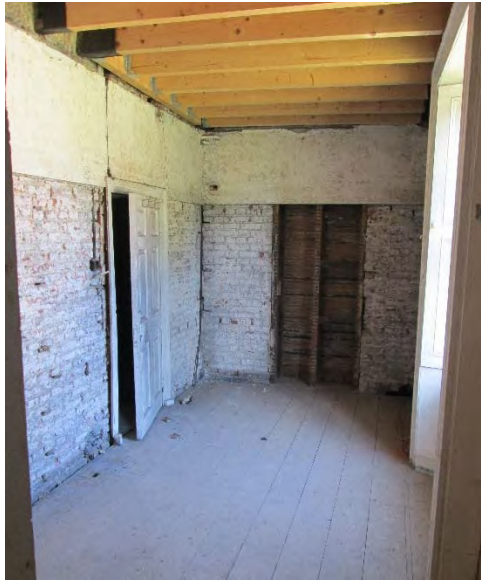
Plate 52 room F11 pre fire

The corner brick fireplace at the south-west angle of the room was of plain character and had seen secondary bricking-up. It had been constructed within the cavity of an early window that had been central to the east frontage of the original mansion house. The interior parts of the feature were exposed during the demolitions.

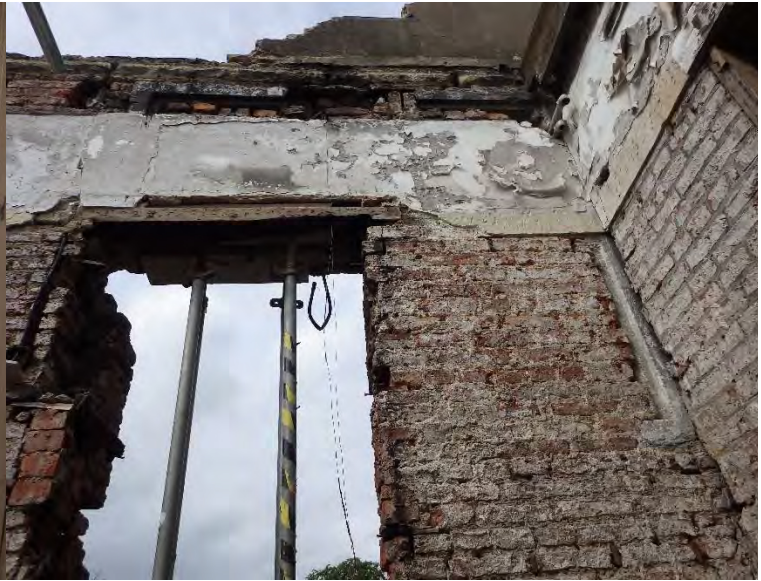
Plate 53 room F11 shows early window (find no 058)

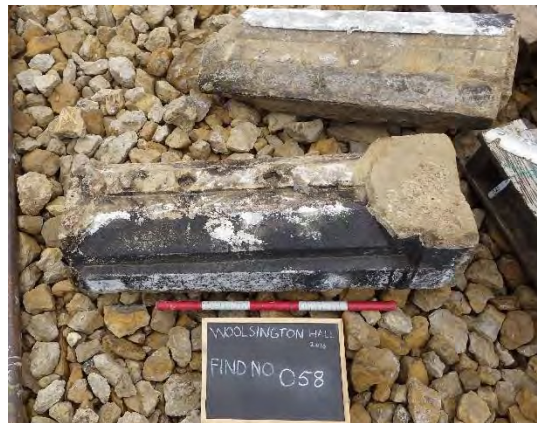
Plate 54 room f11 (find no 058) recovered window remnants

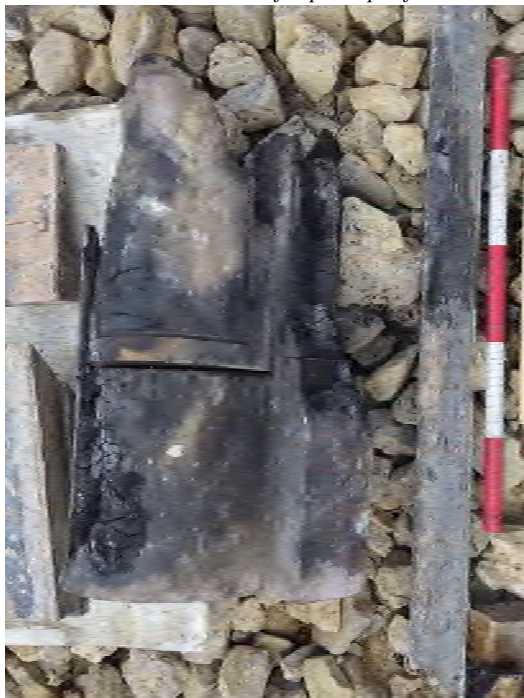
Plate 59 room G03 remnant of timber fire surround (find no 080)

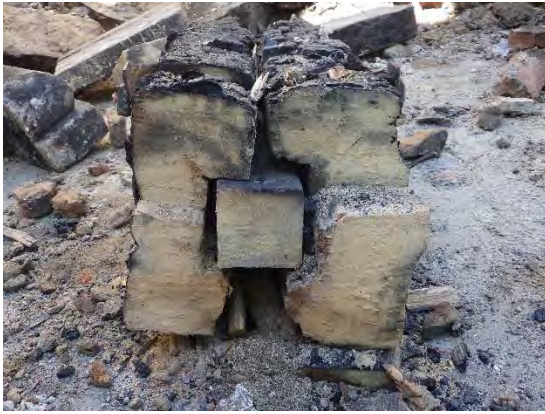
Plate 61 major beam G03/4

Part of the western gable at ground floor level had previously been slapped out into an extension. The major timber beam that had been inserted to support the gable was of interest. It was a composite of three timber parts cramped and bolted together. The parts comprised a 40cm square beam sawn in half with a check for a 12.5cm square beam running down the middle. All were held together by a number of bolted plates (find no 073).

This beam, despite its size, had completely burnt through to the south and the gable above had collapsed as a result.

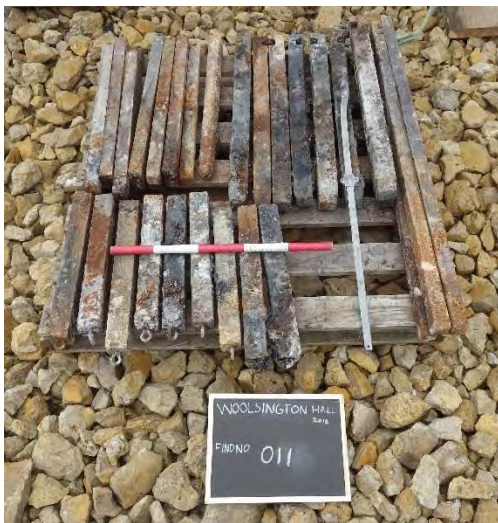
Plate 62 find no 011 bay window sash weights

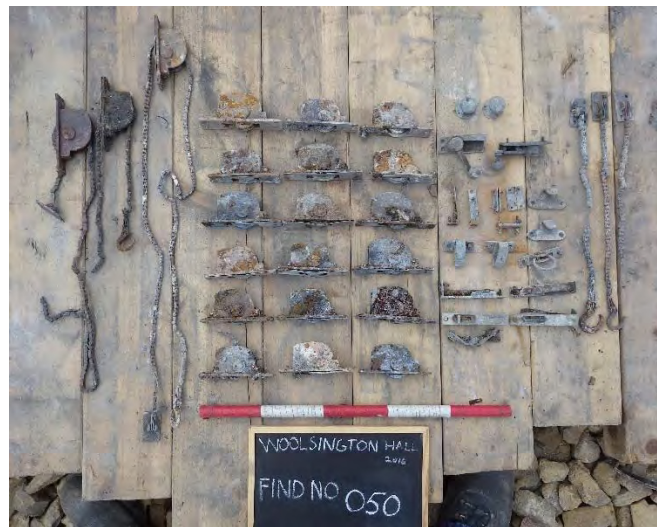
Plate 63 find no bay window fittings

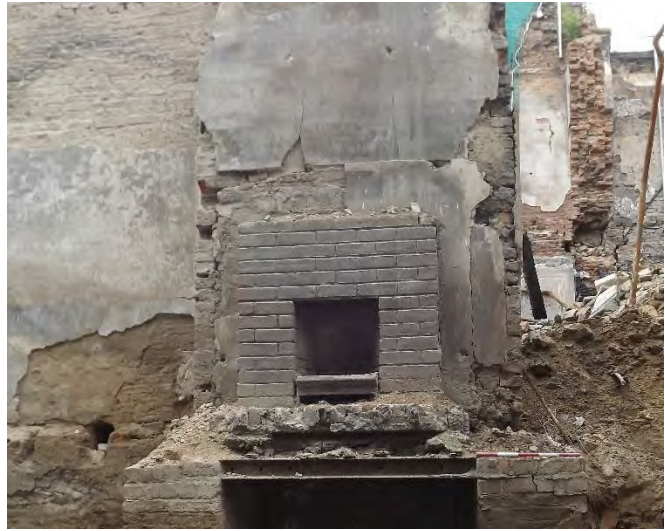
Plate 65 G06 fireplace post fire

The large fireplace to the south remained intact, although some small cracking was noted on the lintel and in the brickwork.

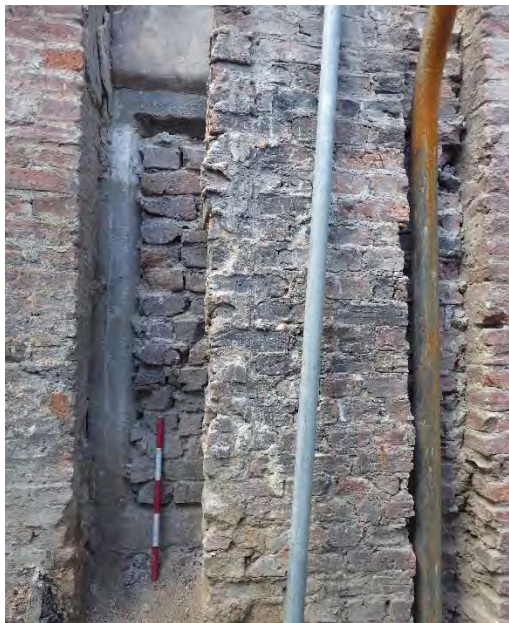
Between room G03 and G05 the width of the chimney stack would have formed a corridor with doors either end into the rooms. This corridor was lighted by an original window, which was latterly blocked with brick and covered with cement on the exterior. Service channels for pipe work were formed within the blocking on the interior. The window was partially exposed in the demolitions and clean up; on the exterior the cement ran up to the corner downpipe which had melted, leaving a jamb exposed. On the interior, removal of piping partially exposed the plastered ingo and soffit of the window; this showed two coats of plaster on the square ingos, with the earlier pecked for grip. The window jamb also showed no evidence for a transom, showing it to have been an open window.

Plate 66 early window G03/G05

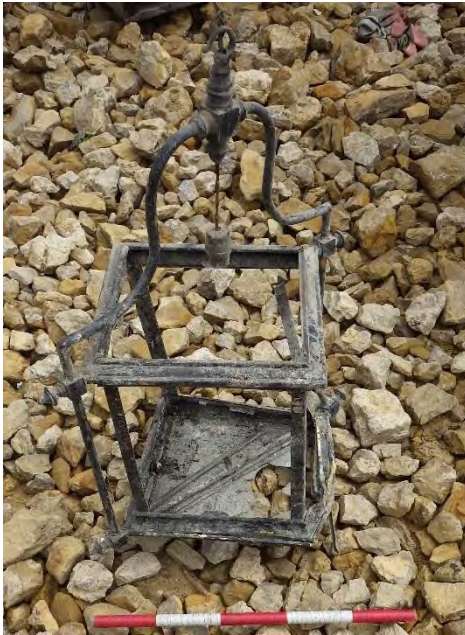
*Plate 68 find no 026*

Light fittings from the room were recovered as find no 026, the square lantern, which was recovered slightly crushed and find no 027, the triangular fitting formerly beneath the stairs to the west. The square lantern looked to have been originally a gas lantern, which was latterly converted for an electric bulb.

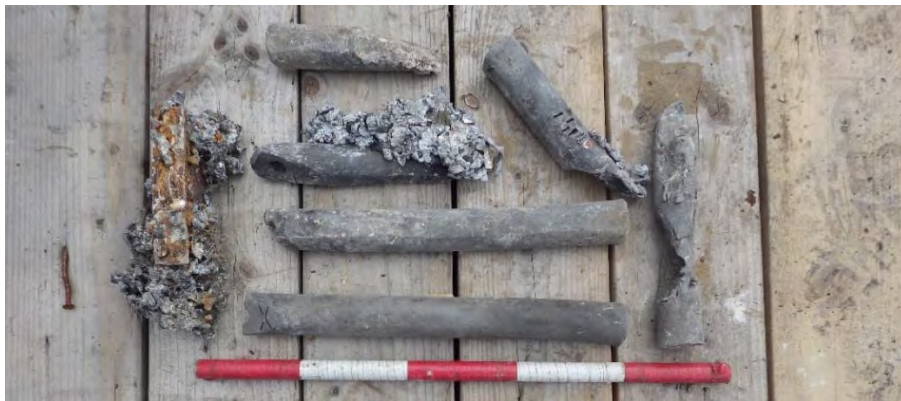
Room G10 is an extension corridor infilling the space between the eastern extension and the range to the north-east and gives access to the linen cupboards in F08 above. This room was largely intact although infilled with rubble from the gable collapse. A number of lead sash weights (find no 034) were recovered from here, mostly partially melted. In the surviving exterior window of G10 was a similar lead sash weight, partially exposed within the window.

Plate 72 lead sash weights find no 034

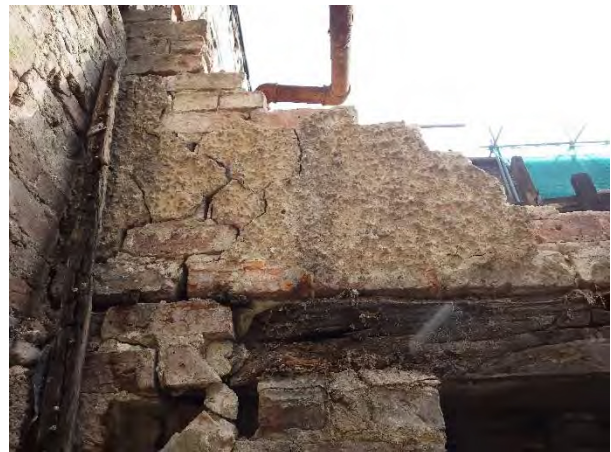
Plate 74 exterior of eastern extension shows finish

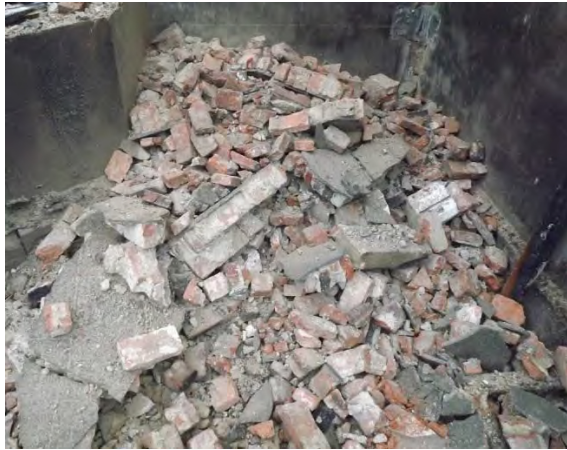
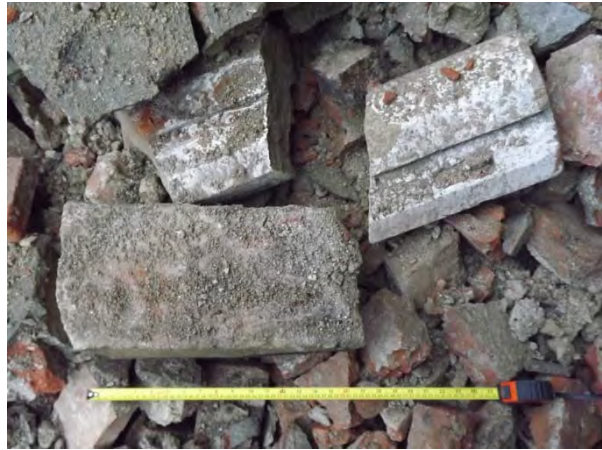
*Example - initial identification, recovery and laying-out of shattered dressed window elements, prior to recording labelling and storage*
